**Assessment Report on
Feasibility of Tree Support Systems proposed in
Study on Stonewall Trees on Slope no. 11SW-A/R577
Bonham Road, Hong Kong**

Highways Department
April 2013

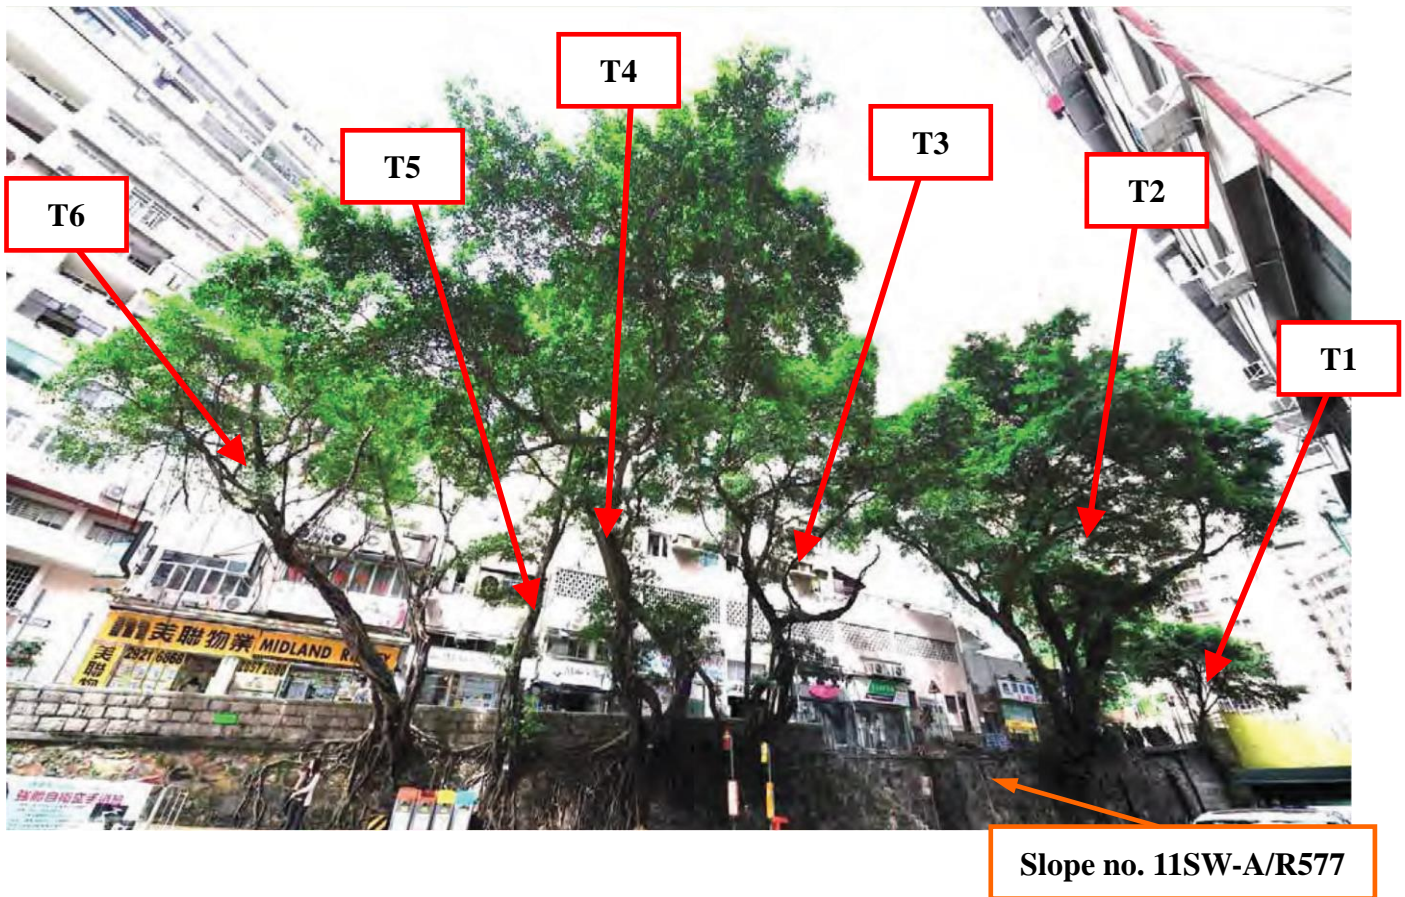
Photo 1.1 – Overall view of the 6 stonewall trees

- (i) T1 – This is a small tree with little structural problem or decay problem. Tree hazard assessment has a score of 5 (see remarks below) and is rated as **low risk level**.

- (ii) T2 – This is an Old and Valuable Tree (OVT) with the Registered Number LCSD CW/14. The tree is generally in good health and has a well-formed scaffold. Tree hazard assessment has a score of 5 and is rated as **low risk level**.

- (iii) T3 – This is a semi-mature size tree with much confined scaffold development. Tree hazard assessment has a score of 5 and is rated as **low risk level**.

- (iv) T4 – This is a twin stemmed mature size tree which is the most tilted of the 6 stonewall trees at the site. The tree has low live crown ratio and incipient anchorage failure. Tree hazard assessment has a score of 9 and is rated as **medium risk level**. However, as the tree has one additional risk factor [root detachment from stonewall], it is therefore described as **alarming risk**.

- (v) T5 – This is a mature size tree with low live crown ratio, narrow & confined crown and

large cavity with decay at the trunk base. Tree hazard assessment has a score of 8 and is rated as **medium risk level**. However, as the tree has one additional risk factor [large trunk base cavity], it is therefore described as **alarming risk**.

- (vi) T6 – This is a twin stemmed mature size tree with heavy lean, asymmetrical crown. Tree hazard assessment has a score of 5 and is rated as **low risk level**.

- 4.1 In view of the significant risk to public safety and in accordance with the general advice promulgated by DEVB⁴, the trees T4 and T5 are recommended to be felled as soon as possible before the onset of typhoon season in May this year, as well as to follow the requirement of prompt action for the completion of necessary action to remove the identified risks of problematic trees.

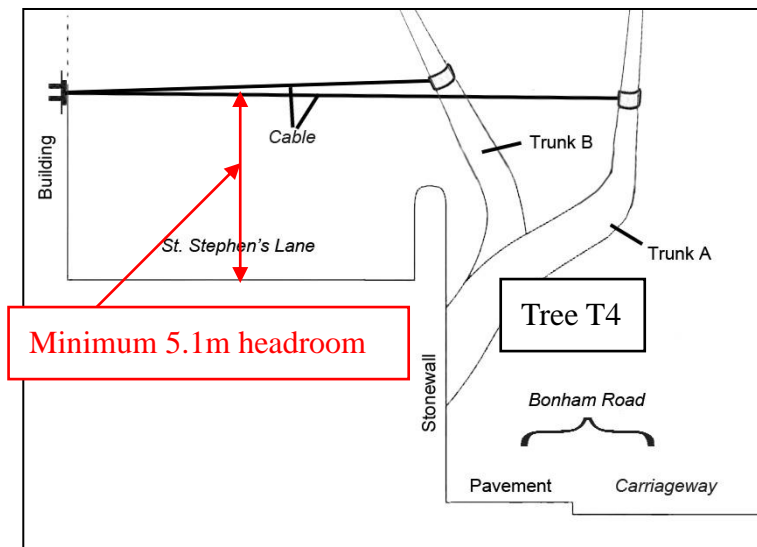
Sketch 2.1

2.3.1 Method A is considered infeasible for the following reasons:

- (i) There are no statutory powers for government authorities including HyD to anchor the cable system on private structure/building. The general view of nearby building is shown on Photo 2.1. As the building facade does not belong to individual owner, consents from owners' incorporation or all building owners are required. However, there is no incentive for the building owners to agree the installation of cables on their building. Furthermore, as extra loading due to cable anchorage will be applied on the building, the liability and maintenance issues are difficult to be resolved. The works will also affect and limit future maintenance of building facade and redevelopment of the building.

- (ii) Even if agreement can be obtained from the owners, the anchorage of the proposed cable bracing system will have to be provided at the facade of the common podium of the nearby Golden Phoenix Building to avoid potential structural and visual impact to individual residential units. With this cable supporting system, large tension force (in the order of 30 tonnes for T4 and 4 tonnes for T5) will then be induced in the cables to support or stabilise the tree due to the dead weight of the tree and wind loads acting on the tree. There can be detrimental damage to the adjacent buildings and severe injury to the public caused by the immense destructive force from the failure of trees/branches/cables and associated parts during typhoon or strong gust/monsoon wind. It is estimated that two anchorage plates of 550mm x 550 mm size with four 24mm diameter high tensile strength bolts anchoring 210mm in the building are required (with at least 270mm thick concrete being required to hold the bolts). However, as the building is quite old, the condition of concrete is uncertain. Moreover, the estimated wall thickness is only 250mm (Photo 2.3). Therefore the suitability of the anchorage is in doubt. The anchorage depth of 210mm

would also affect the existing reinforcements inside structural members of the building.

- (iii) As a minimum headroom¹ of 5.1m has to be maintained at St. Stephen's Lane for vehicular traffic, the cables should be mounted at a high position of the tree where the tree branches may not be strong enough to take the high tension forces. (Photo 2.2)
- (iv) The structural stability of the building will be affected due to the extra loading from the cable system which has not been allowed for in the original design of the building. The stability of the building is required to be reassessed and strengthening works on the building will probably be required. Submission to Buildings Department for their approval is also required for the proposed works and it will take considerable time for the required processes while the public is being exposed to the risk of tree failure.

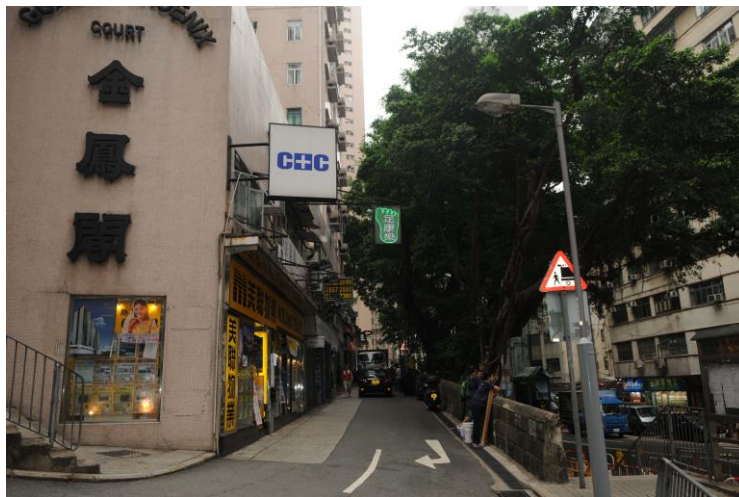
Photo 2.1 – General view of nearby building

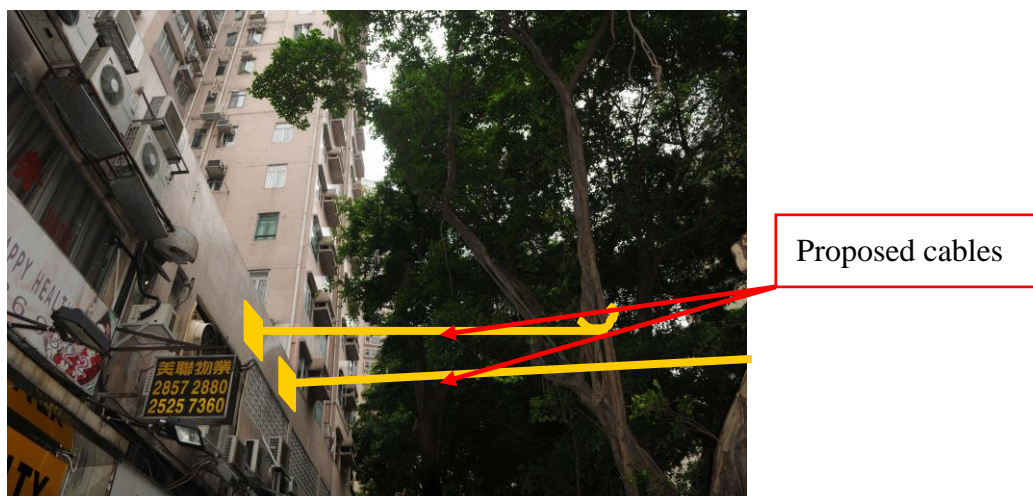
Photo 2.2 – Proposed cables anchor on the nearby building

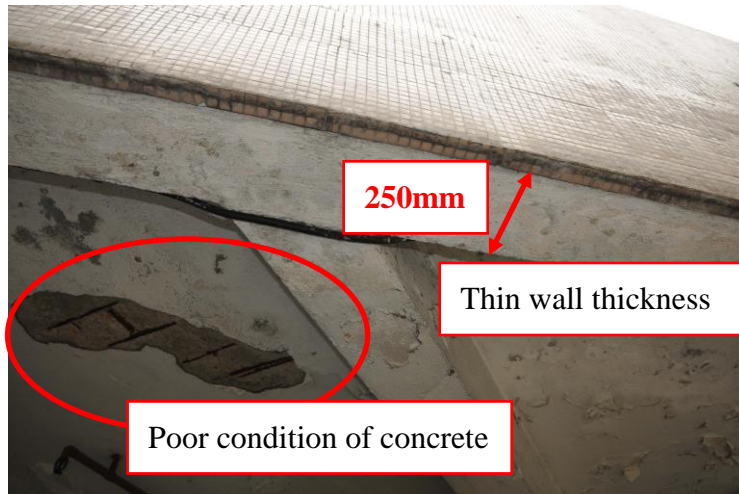
Photo 2.3 – Existing condition of nearby building

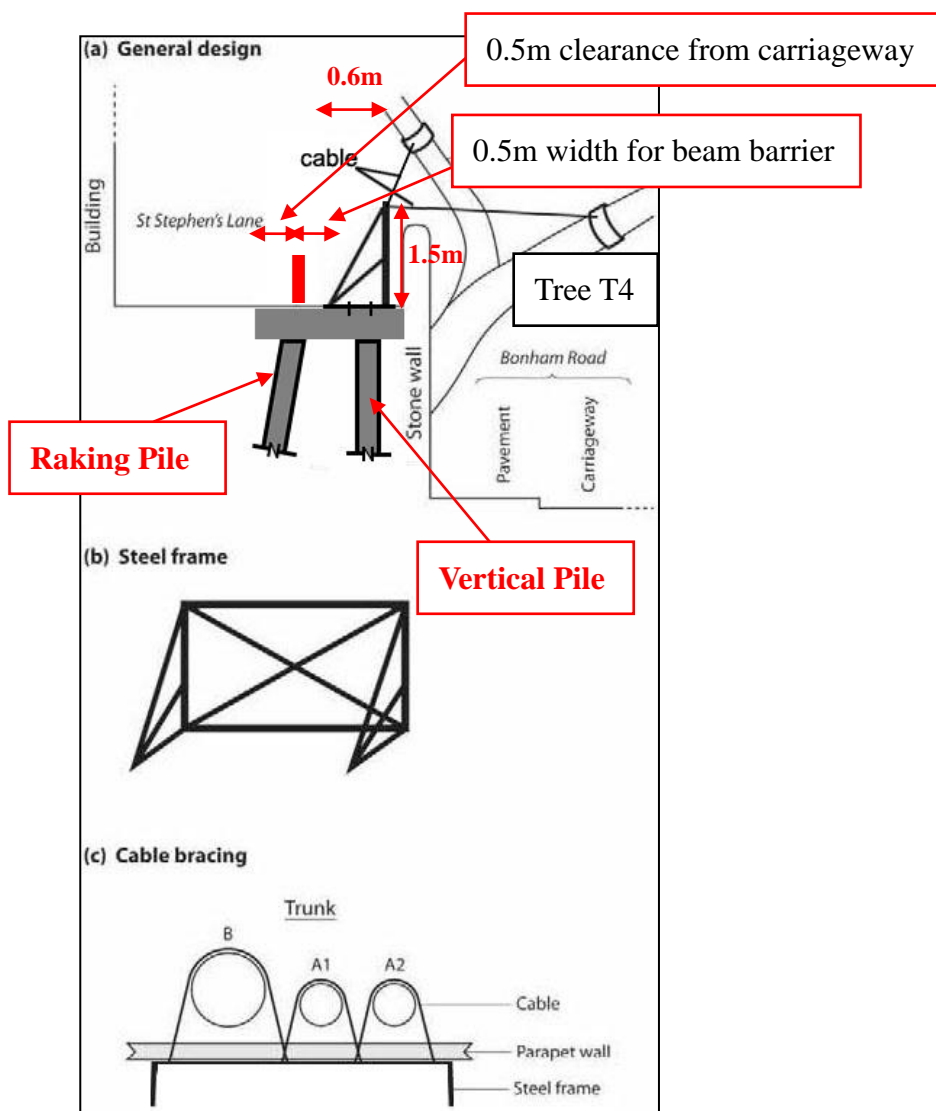
Sketch 2.2

2.4.1 Method B is considered infeasible for the following reasons:

- (ii) The estimated size of the supporting frame would be 0.6m in width perpendicular to the parapet wall. With 0.5m width allowed for erecting a beam barrier to protect the frame and 0.5m clearance from the barrier to edge of carriageway, the structure will occupy 1.6m road width at least. Even the widest section of St. Stephen Lane (about 5m) cannot provide the required road space for the proposed structure because a minimum clear road width of 3.5m as mentioned in (i) above is required.

- (iii) Due to leverage effect, a large force (in the order of 85 tonnes for T4, and 15 tonnes for T5) will be induced in the cables in order to support or stabilise the tree due to its dead weight and wind loads acting on the tree. As the supporting frame is to be installed close to the top of the stonewall, the transfer of extra loading to the crest of the stonewall will create extra overturning moment and lateral force on the stonewall. Additional stonewall strengthening such as provision of soil nails into the soil strata behind the stonewall around the tree is required to ensure that the masonry wall itself is stable. However, substantial works in close vicinity of the stonewall trees will damage the tree roots and adversely affect the stability of the stonewall trees. The damaged tree roots would be susceptible to fungal infection which will further affect the health and stability of the stonewall trees, thus defeating the purpose of remedial measure.

- (iv) To avoid transferring extra loading to the crest of the stonewall, the foundation of the steel frame for supporting the tree has been preliminarily assessed to take the form of seven mini-piles (three vertical and four raking piles) at St. Stephen's Lane in order to tie the steel frame firmly onto the ground. The vertical piles would certainly hit the masonry blocks behind the stonewall. To resist the estimated lateral and pulling force, the raking piles would also extend across the lane and encroach into the building lot boundary, hitting the building foundation. The scheme is therefore considered infeasible. Moreover, the tree roots growing under the St. Stephen's Lane behind the masonry wall will be damaged

and the masonry wall structures will also be adversely affected due to the piling works.

- (v) In addition, according to the utility records, there are at least two numbers of underground electricity cables located at the St. Stephen's Lane. Underground utility diversion will result in closure of the whole lane for a long period. Together with the supporting frame construction works, St. Stephen Lane will have to be closed for prolonged period which is unacceptable as the lane serves as emergency vehicular access to adjacent buildings.

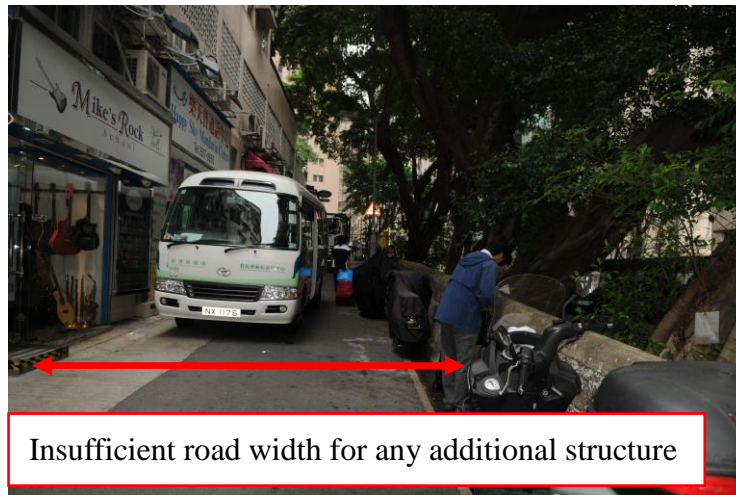
- (i) St. Stephen's Lane is a one-lane two-way carriageway of about 4.5m width, being shared use with pedestrians. The existing road width is not up to current standard due to site constraints. The road width at the location of Tree T4 and T5 are 4.25m and 4.50m respectively. As the absolute minimum carriageway width requirement for a single track access road serving as emergency access² is 3.5m and the horizontal clearance requirements for carriageway to building/structure/obstruction³ is 0.5m on each side, the existing road width is already below or at the minimum standard. It is not viable to install any structures at St. Stephen's Lane due to the road width constraint. (Photo 2.4)

Photo 2.4 – St. Stephen Lane

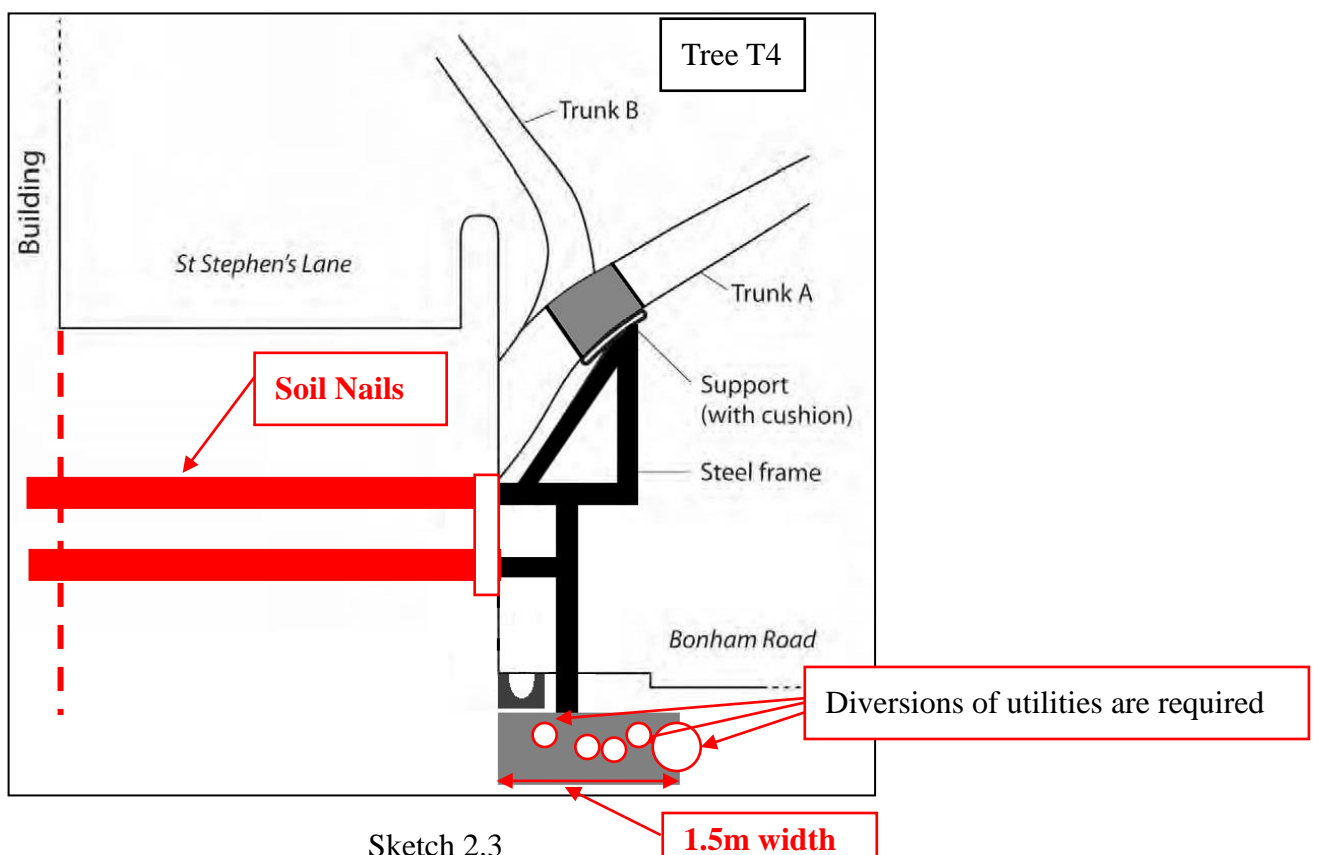
Sketch 2.3

2.5.1 Method C is considered infeasible for the following reasons:

- (ii) Similar to Method B, the proposed structure (steel frame) will induce extra loading and overturning moment onto the stonewall. To provide the restoring force, installation of two layers of soil nails with 6m long under and across St. Stephen Lane is required. However, the soil nails will hit the foundation of the nearby building and is therefore impractical. Diversion for underground electric cables at St. Stephen Lane, which are expected to be buried at depth greater than 900mm, may also be required. (See also Method B, para. 2.4.1 (iii) and (v).)

- (iii) In addition, the supporting frame will have to stand on the narrow southern footpath of Bonham Road with a foundation of about 1.5m x 1.5m in size. According to the utility records, there are underground utilities such as drainage pipes, electricity cables, gas pipes located at the section of the footpath. Underground utilities also exist at the opposite footpath so that the space available to accommodate utilities diverted from the southern footpath is limited. Underground utilities diversion to provide space for the supporting frame will result in closure of traffic lane at Bonham Road for a long period and will cause serious traffic disruption.

- (iv) The stonewall trees are fronting directly above the busy bus stop on Bonham Road.

Relocation of bus stop and cancellation of bus lay-by to free more space for the proposed works has also been considered. However, as advised by Transport Department (TD), there is no alternative lay-by along Bonham Road (westbound) for the bus stop relocation. Without the bus lay-by, on-street picking-up/dropping-off of passengers on Bonham Road will severely disrupt traffic flow in the area. TD and the locals will not support the proposal of relocating the bus stop.

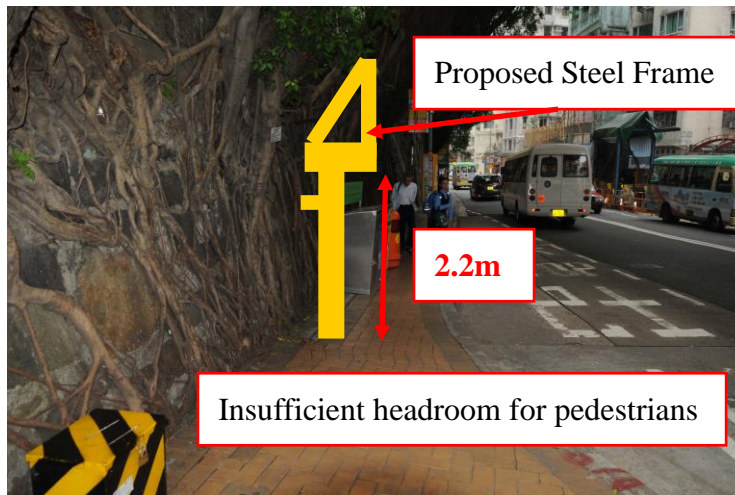
- (i) From our survey, the lower part of the tree is only 2.5m above the existing footpath at Bonham Road. The estimated size of the supporting beams is 0.3m in depth. As such, minimum headroom of 2.3m for footpath cannot be maintained if the supporting frame is to be constructed on the masonry wall adjacent to the footpath. (Photo 2.5)

Photo 2.5 – Southern footpath at Bonham Road (viewing from the east)

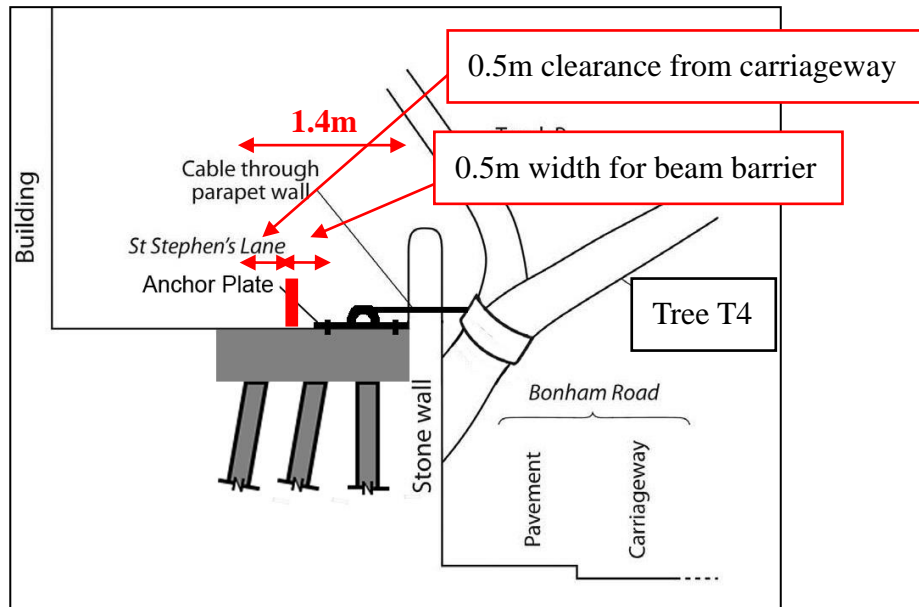
Sketch 2.4

2.6.1 Method D is considered infeasible for the following reasons:

- (i) The estimated size of the anchor plate is 0.4m in width. With 0.5m width allowed for beam barrier to protect the plate and cable and 0.5m clearance from the barrier to edge of carriage way, the structure will occupy 1.4m road width at least. However, as mentioned above, there is insufficient road space at St. Stephen Lane to provide the required road width.

- (ii) Moreover, any transfer of extra loading to the crest of the stonewall will create extra overturning moment and lateral force on the stonewall. Additional stonewall strengthening works will be required. (See also Method B, para. 2.4.1(iii).)

- (iii) Owing to low anchorage point, the overturning moment of the dead load and wind load of the stonewall tree will create a very large tension force on the cables (in the order of 260 tonnes for T4 and 42 tonnes for T5). The foundation of the structure would be in the form of eighteen mini-piles (twelve raking and six vertical piles) at St. Stephen's Lane to

provide the required lateral resistance. The raking piles would hit the foundation of the nearby building and make the scheme infeasible. (See also Method B, para. 2.4.1(iv).)

- (iv) In addition, diversion for underground electric cables at St. Stephen Lane is required. (See also Method B, para. 2.4.1(v).)

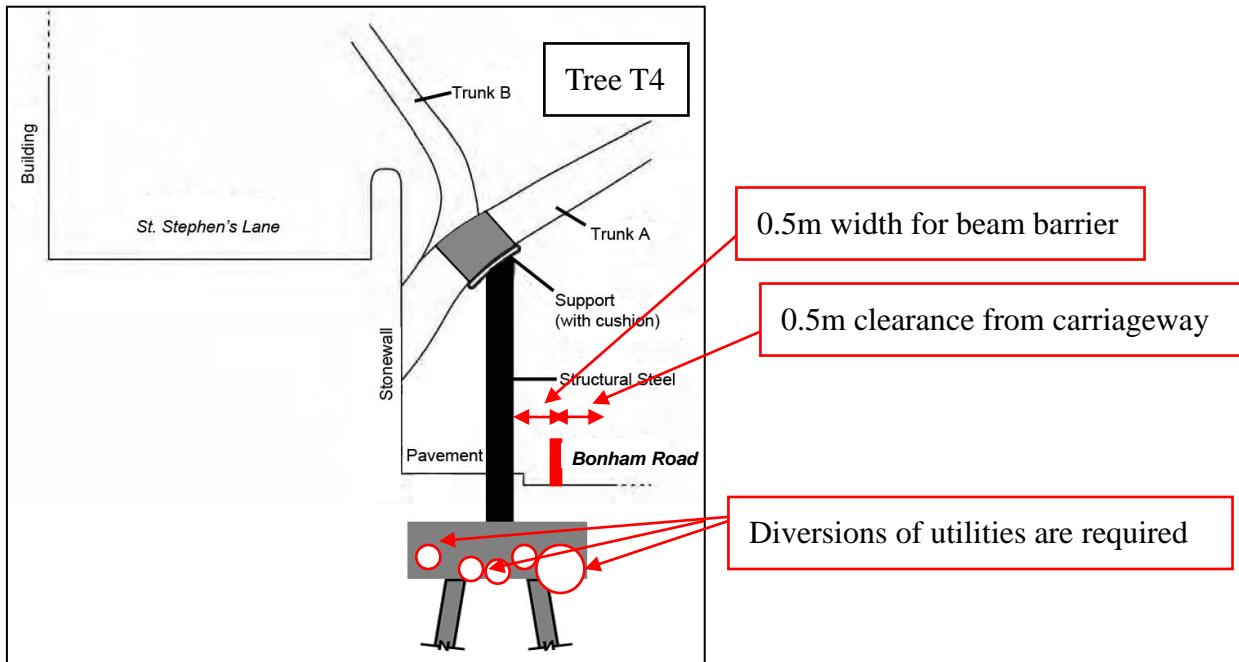
Sketch 2.5

2.7.1 This method is considered infeasible for the following reasons:

- (ii) Relocation of bus stop and cancellation of bus lay-by to free more space for the proposed works has also been considered but impractical. (See also Method C, para. 2.5.1(iv).)

- (iii) Large supporting moment (in the order of 2300KNm for T4 and 360KNm for T5) to support or stabilise the trees by the steel pole and foundation is required to counterbalance the bending moment induced from the dead weight of the tree and wind loads acting on the tree. The foundation of the steel structure in the form of four raking mini-piles is required. The pile cap size will be in the size of 2.5m x 2.5m. Diversions of utilities at

the southern footpath of Bonham Road are required. (See also Method C, para. 2.5.1(iii).)

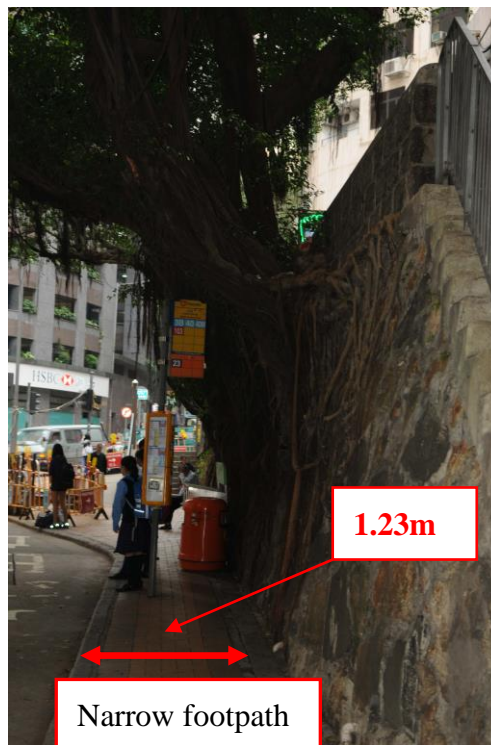
- (i) The existing footpath width near tree T4 and T5 is only 1.23m (Photo 2.6) which is not up to current standard. It is already too narrow to accommodate both pedestrians and passengers waiting at the bus stop. The construction of structures occupying extra footpath spaces is therefore impractical.

Photo 2.6 – Southern footpath at Bonham Road (viewing from the west)

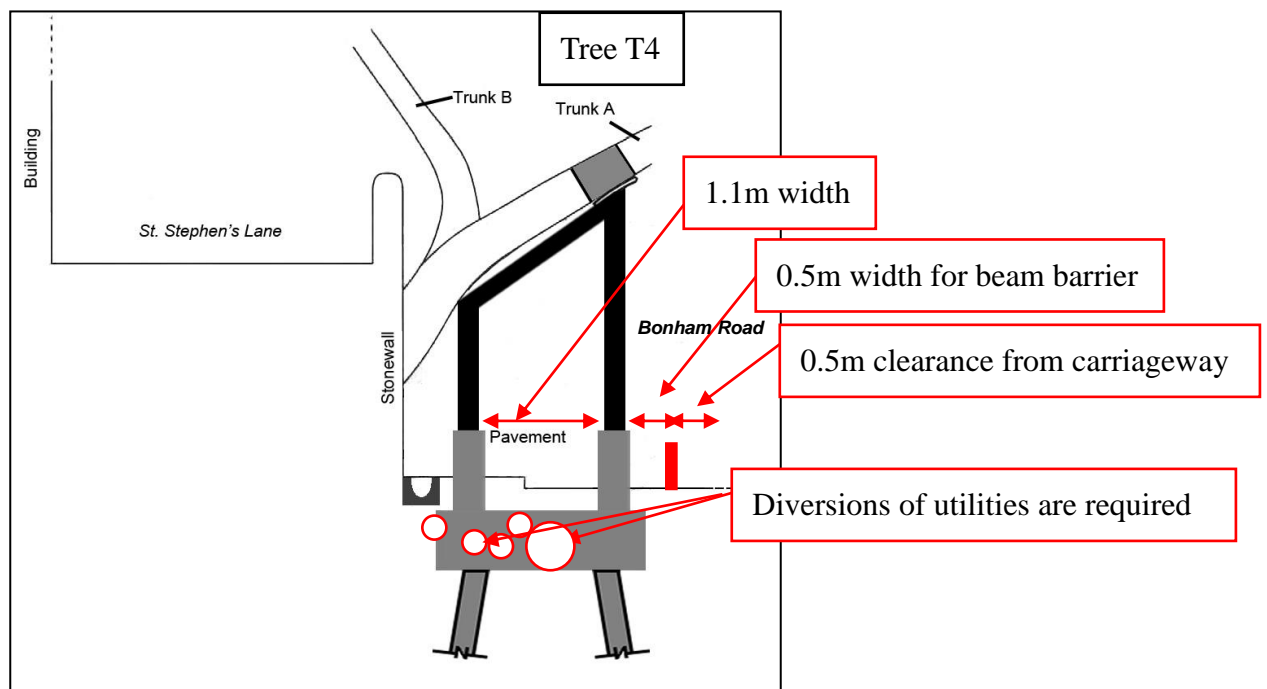
Sketch 2.6

2.8.1 This method is considered infeasible for the following reasons:

- (i) The existing footpath width near tree T4 and T5 is only 1.23m. (See also Method E, para. 2.7.1(i).)
- (ii) If the bus stop could be relocated, an additional road width of about 2.4m might be available. With the provision of beam barrier and 0.5m clearance from the carriageway, the remaining road width for pedestrians is only 1.1m (Sketch 2.6) at most which is undesirable. Most importantly, the relocation of the bus stop is impractical. (See also Method C, para. 2.5.1(iv).)
- (iii) Diversions of utilities at the southern footpath of Bonham Road are required. (See also Method C, para. 2.5.1(iii).)

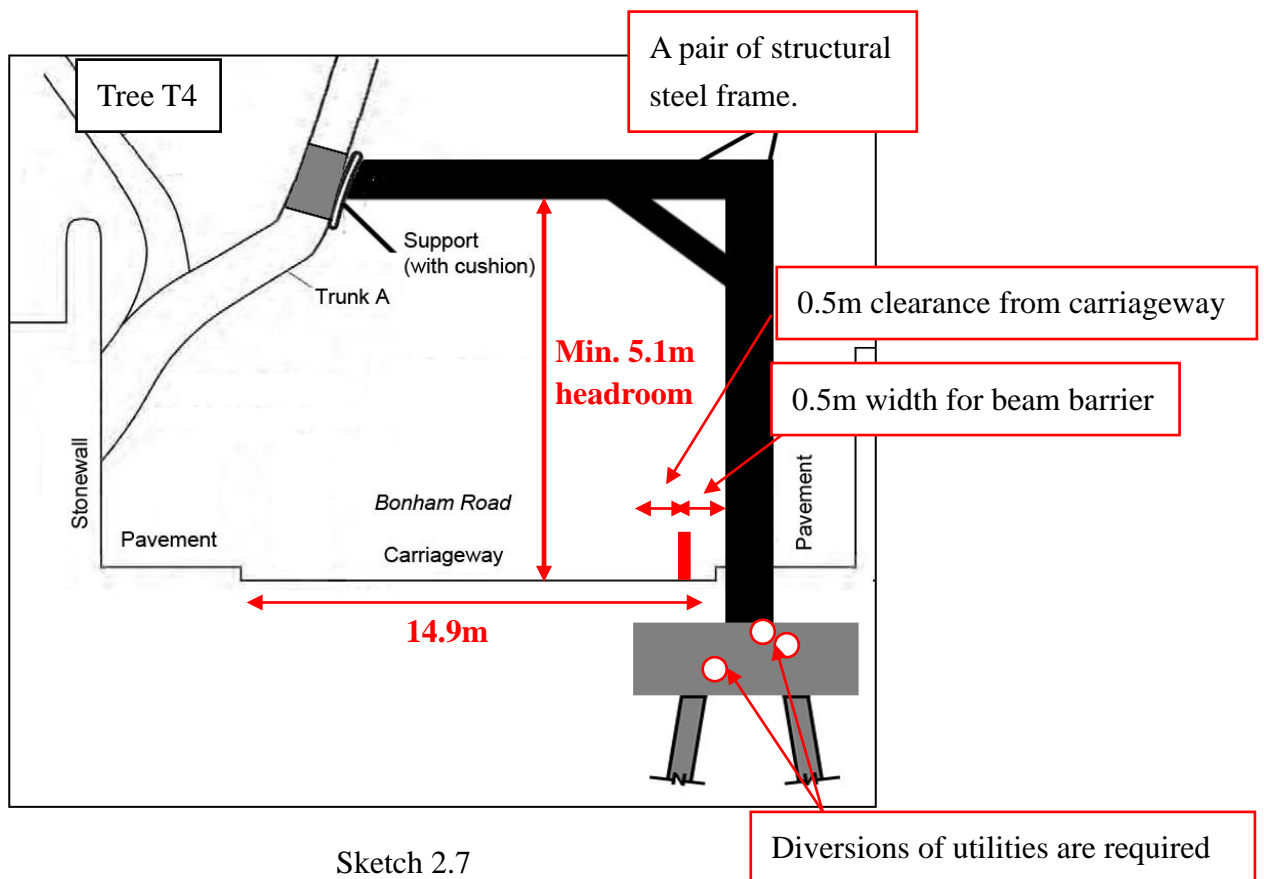
2.9.1 This method is considered infeasible for the following reasons:

- (i) As the proposed structure will span over the carriageway of 14.9m width, the bending

moment (in the order of 7000KNm for T4 and 1400KNm for T5) and torque (in the order of 5700KNm for T4 and 850KNm for T5) induced on the structure will be very large and the structure members will be very massive.

- (iii) Large supporting moment (in the order of 7000KNm for T4 and 1400KNm for T5) to support or stabilise the trees by the steel pole and foundation is required to counterbalance the bending moment induced from the dead weight of the trees and wind loads acting on the trees. The long cantilever arm also induces very large bending moment and torsion. The foundation of the steel structure has been preliminarily assessed to take the form of six raking mini-piles. The pile cap is in the order of 3.7m x 4.7m. According to the utility records, there are underground utilities with at least one drainage pipe, one water pipe, and one gas pipe located at the northern footpath of Bonham Road. Underground utilities also exist at the opposite footpath so that the space available for utility diversion is limited. Underground utilities diversion will result in closure of traffic lane at Bonham Road for a long period and will cause serious traffic disruption.

- (iv) The proposed massive structure will cause unacceptable adverse visual impact.

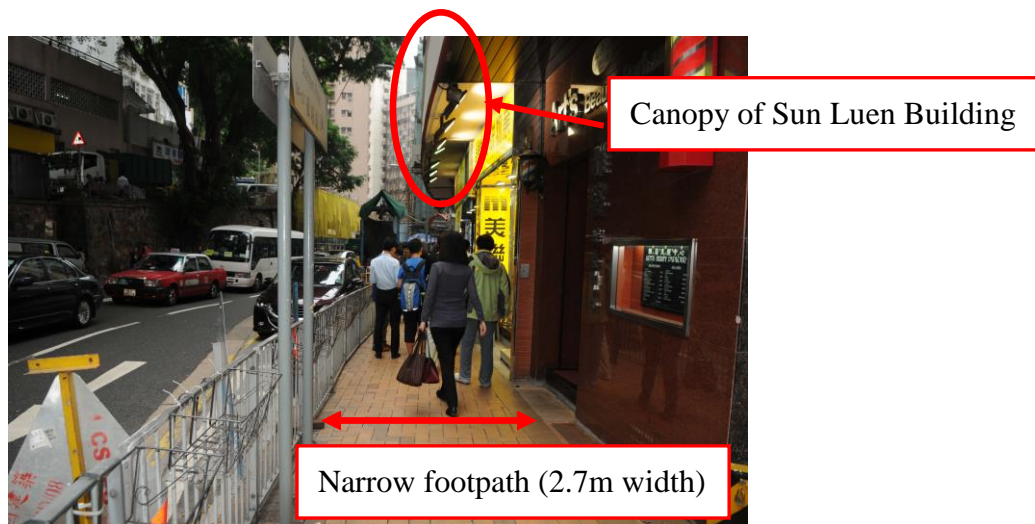
- (ii) The footpath at the opposite side is 2.7m wide only. In addition, the existing canopy of Sun Luen Building will obstruct the steel structure (Photo 2.7). With the 0.5m clearance requirement from the carriageway and 0.5m width for beam barrier, there is insufficient footpath space to accommodate the massive structure steel post (about 1m width steel post).

Photo 2.7 – Northern footpath at Bonham Road
