Resistograph micro-drilling to Estimate Wood Density

Contract Number: 04/HY/2010
Date of Works: 31/10/2012

Tree Location: Bonham Road (11SW-A/R577_0)

Tree ID: T2 LCSD CW/14

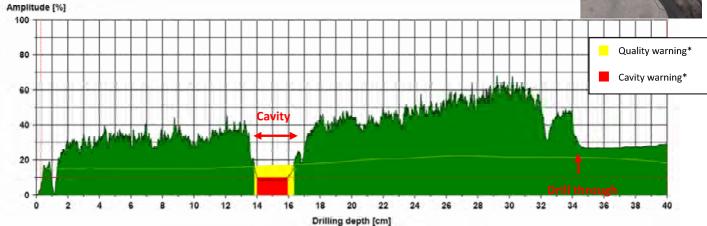
LCSD CW/14 Point 1:

LCSD CW14 Point 1 was set on the South-eastern trunk where exposed dead wood was observed. Strong partial aerial root fusions were observed on trunk surface.

A small central cavity was noted between 13cm & 17cm. This could be correlated with the dead wood partly exposed on south-eastern face of trunk. The drill bit then entered the solid sound wood from 18cm to 34cm. It then drilled through the trunk at 35cm. (The circumference of the stem where the reading was taken was 1200mm.) This Resistograph reading reflects a normal density of wood on aerial roots on both side of trunk. This implies a good formation of reaction wood enclosed decayed old wood and re-strengthened the trunk.

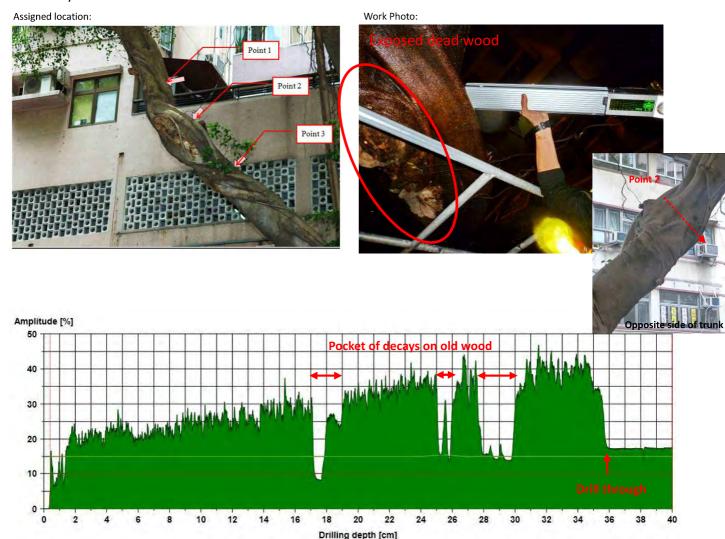
LCSD CW/14 Point 2:

Point 2 was set on a south-eastern limb where exposed dead wood was observed. Partially fused aerial roots were observed around the old wood to strengthen the area. The reading was taken behind the protruded aerial roots to avoid abnormal reading due to aerial root fusion.

Troughs were identified on LCSD CW/14 Point 2 between 17cm & 18cm. It could be possibly a pocket of decay existed on old wood. Aerial root formed strong reaction wood on both sides of the old wood to compensate lost strength. Sound wood is observed from 2cm to 17cm, which contribute to at least 30% of trunk girth. The bit drilled through the trunk at 36cm. (The circumference of the stem where the reading was taken was 1500mm.)

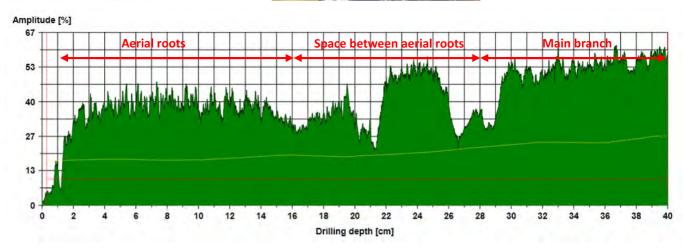
Point 4 was set on a branch on top of SE crown. An aerial root partially fused with the main branch in the location. The reading was taken as an opposite position due to site restriction.

Sound structure of aerial root was indicated the curve between 2cm & 14cm. Between 14cm & 29cm, vigorous fluctuations were observed when the drill bit passed through space between aerial roots. Smaller aerial roots and epicormics affected the drill bit and caused fluctuations. The drill bit entered the main branch again at 29cm. Normal density of wood was reflected by the slowly ascending curve between 29cm & 40cm.

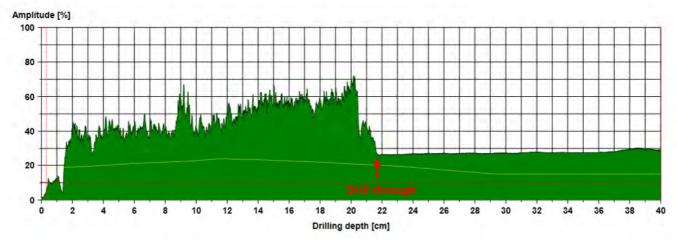
T2-P5 LCSD CW/14 Point 5:

Point 5 was set on a branch on SE crown with an open cavity. The reading was taken as an opposite position due to site restriction.

This Resistograph reading reflects a normal density of wood on the trunk. No significant drop of wood density behind open cavity was recorded. The bit drilled through the trunk at 21cm. (The circumference of the elliptical stem where the reading was taken was 660mm.) Based on the result, it was likely that the decay was fenced off by wall 4 from spreading inside. Good wound wood formation was observed to close the cavity.

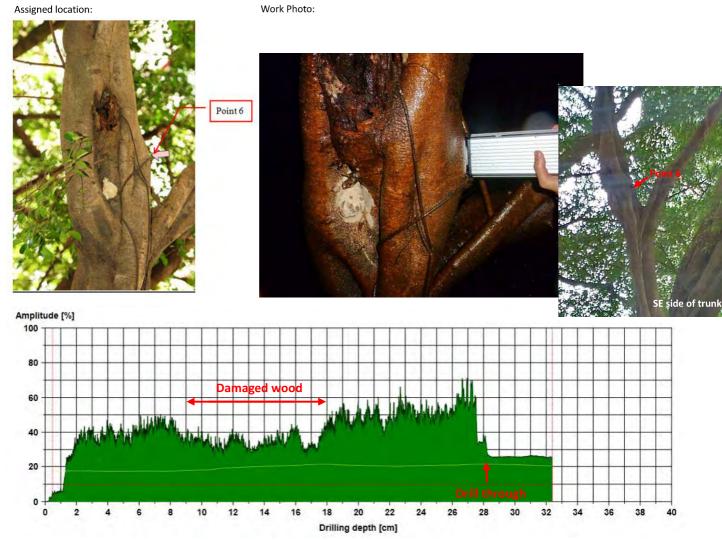
Point 6 was set on a branch on SE crown. A jagged wound of previous branch failure and insect nest were observed near the position. Partially fused aerial roots were observed on surface.

The bit drilled through the trunk at 28cm. (The circumference of the elliptical stem where the reading was taken was 1150mm.) Damaged wood was recorded between 9cm & 18cm. Luckily, thick sound wood (between 2cm & 9cm, 18cm & 27cm) was observed on both side of branch. Risk of failure was not high based on this result (>50% wall thickness). On the other hands, there were aerial roots laid (where they were not included into this Resistograph record) on this branch to strengthen the old wood. Risk is expected to be further lowered.

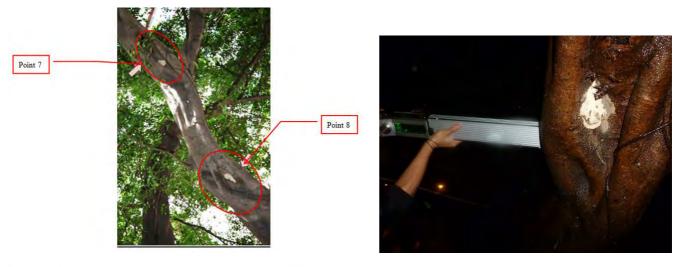
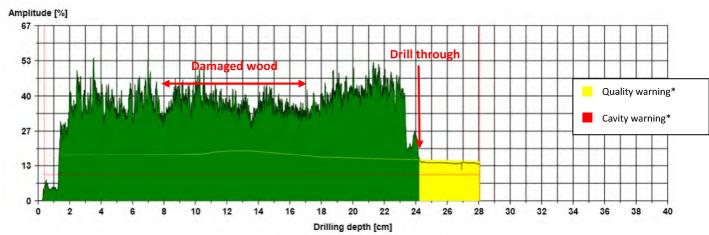
Point 7 was set on the same location opposite to Point 6. A jagged wound of previous branch failure and insect nest were observed near the position. Partially fused aerial roots were observed on surface. The bit drilled through the trunk at 24cm. (The circumference of the elliptical stem where the reading was taken was 1150mm.) Wood with suspected decay was recorded between 8cm & 17cm. Luckily, thick sound wood (between 1cm & 8cm, 17m & 23cm) was observed on both side of branch. On the other hands, there were strong aerial roots laid (where they were not included into this Resistograph record) on top of this branch to strengthen the old wood. Risk is expected to be low.

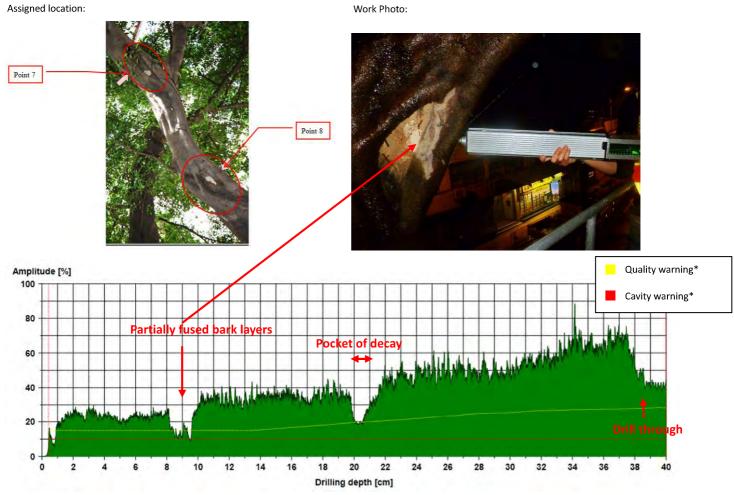
Point 8 was set on a branch on SE side of crown below Point 7. Insect nest was observed on trunk surface. Partially fused aerial roots were observed on surface.

The bit drilled through the trunk at 37cm. (The circumference of the elliptical stem where the reading was taken was 1200mm.) Troughs were recorded between 8cm & 10cm and 20cm & 22cm. Troughs recorded between 8cm & 10cm was likely due to the presence of partially fused bark layers; while another was likely to be a small pocket of internal decay. With normal wood density observed between 1cm & 8cm (aerial root), 10cm & 20cm and 22cm & 38cm, the risk of failure was expected to be low.

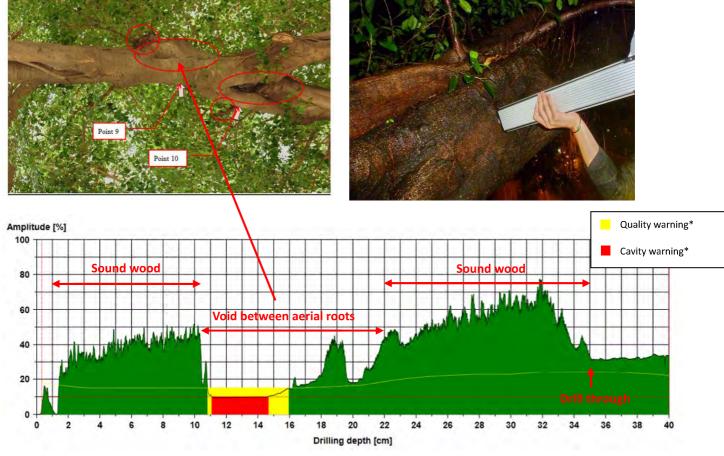
T2-P9 LCSD CW/14 Point 9:

Point 9 was set on a branch on NE side of crown. A pruning wound was observed close to the location. Also strong aerial root fusions were observed on surface.

The bit drilled through the trunk at 35cm. Large area of reduced resistance was recorded between 10cm & 22cm. Without significant cavity or observable signs of decay, this area of low resistance is due to the presence of space between main branch and aerial roots. Complicated fused structures between main branch and aerial roots made Resistograph readings more difficult to be interpreted. However large proportion of sound wood was observed on both side of structure making it more likely to be stable.

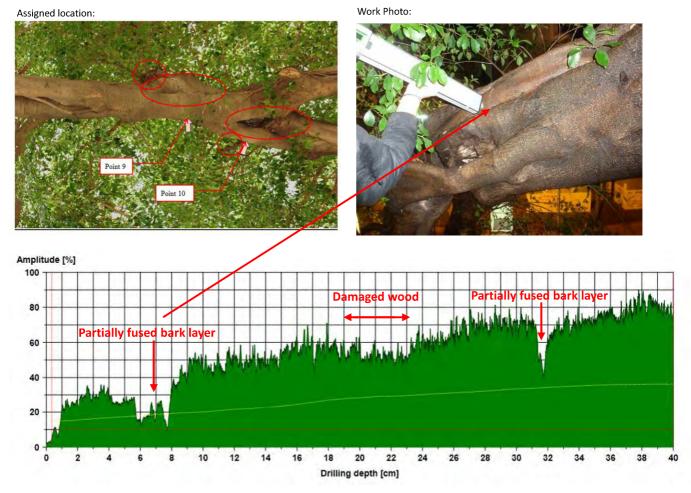
T2-P10 LCSD CW/14 Point 10:

Point 10 was set on a branch union on NE side of crown. A few wounds of previous branch failure were observed around the region. Also strong aerial root fusions were observed on surface.

Troughs were recorded between 5cm & 8cm and 31cm & 32cm. These troughs recorded between 5cm & 8cm was likely due to the presence of a partially fused bark layer. Small flat area was observed between 19cm & 23cm, it is suspected to be decay spread from nearby wounds. Normal wood density was observed generally between 8cm & 19cm, 24cm & 30cm and 33cm & 40cm. This branch was believed to be sound based on the above result.

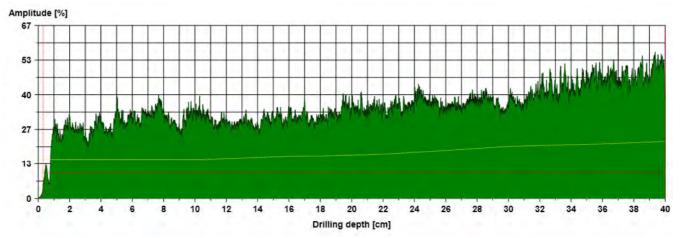
hyd_hk_11sw_a_r577_0_wt4 Point 1:

Point 1 was set on a bended trunk of hyd_hk_11sw_a_r577_0_wt4. A clean surface without any fused aerial roots was observed.

Point 1 shows a general normal density of wood. No particular concern is raised.

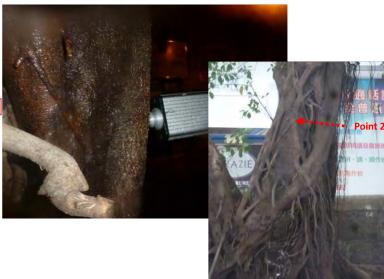
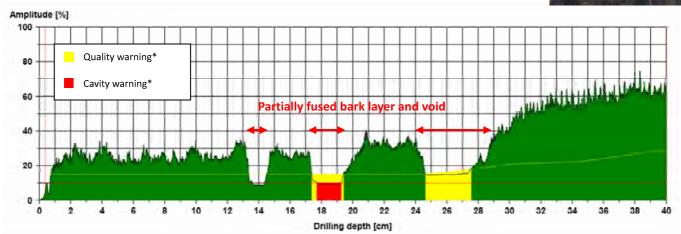
hyd_hk_11sw_a_r577_0_wt4 Point 2:

Point 2 was set on the second trunk of hyd_hk_11sw_a_r577_0_wt4. Multiple partly fused aerial roots can be found on the trunk surface.

Areas of reduced resistance were recorded between 10cm & 22cm, 17cm & 20cm and 24cm & 29cm. This tree part was made up of multiple fused aerial roots. Small gaps of different width were observed under different degree of fusion. Without significant cavity or observable signs of decay, this area of low resistance is due to the presence of space between aerial roots or partially fused bark layers. These partially fused structures made Resistograph readings more difficult for direct interpretation. However large proportion of sound wood was observed on both side of structure making it more likely to be stable.

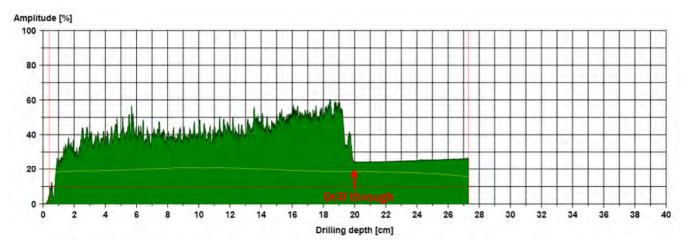
T4-P3 hyd_hk_11sw_a_r577_0_wt4 Point 3:

Point 3 was set on a branch close to a wound from previous branch failure.

The reading was taken as an opposite position due to site restriction. The bit drilled through the trunk at 20cm. (The circumference of the elliptical stem where the reading was taken was 630mm.) The curve shows a general normal density of wood. No particular concern is raised. There was no decay spread from the nearby wound.

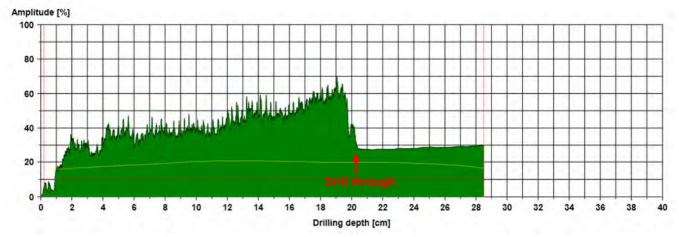
hyd_hk_11sw_a_r577_0_wt4 Point 4:

Point 4 was set on a branch union close to a wound from previous branch failure.

The bit drilled through the trunk at 20cm. (The circumference of the elliptical stem where the reading was taken was 700mm.) The curve shows a general normal density of wood. No particular concern is raised. There was no decay spread from the nearby wound. Branch attachment was believed to be intact.

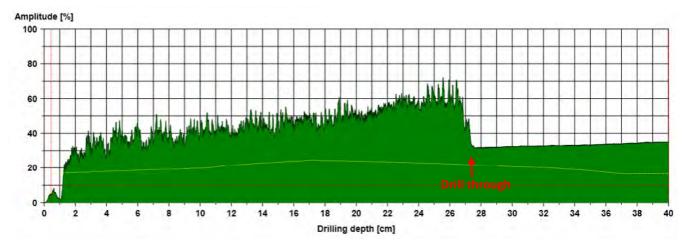
hyd_hk_11sw_a_r577_0_wt4 Point 5:

Point 5 was set on a branch union close to a wound from previous branch failure.

The curve shows a general normal density of wood. No particular concern is raised. The bit drilled through the trunk at 27cm. (The circumference of the elliptical stem where the reading was taken was 1000mm.) There was no decay spread from the nearby wound. Branch attachment was believed to be intact.

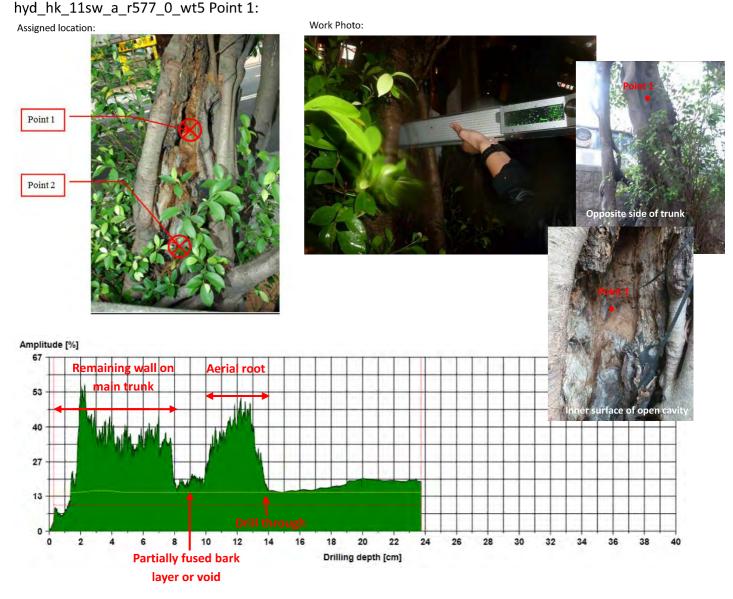
15-P1

Point 1 was set at the inner surface of the upper open cavity. The drill bit passed through the remaining wall of main trunk at 8cm. A drop of resistance observed between 8cm & 10cm was likely to be made up of void space and bark layer of aerial roots. The drill bit entered the aerial root again at 10cm and drilled through the whole structure at 14cm. The residual thickness was less than 8cm. (The circumference of the whole trunk where the reading was taken was 1180mm.) Yet this residual thickness was not the only factor to conclude the trunk stability. Additional supports from the aerial root system should be evaluated.

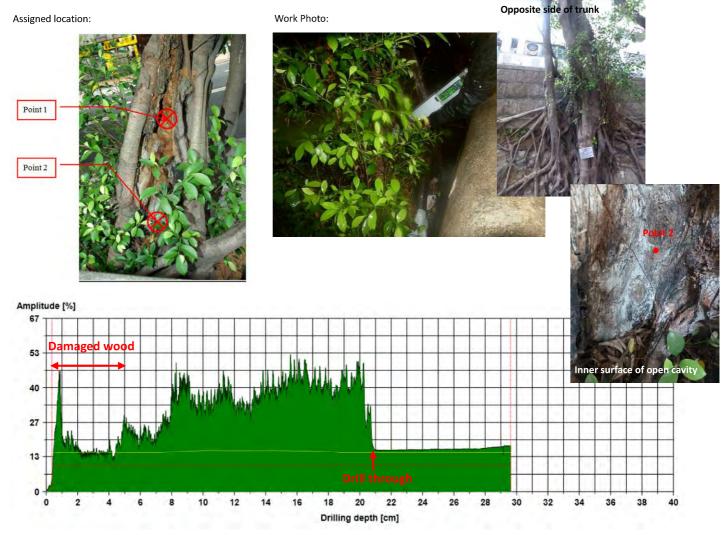
Another point, Point 2, was set much lower than Point 1, near the bottom of the open cavity. This was also the root collar region of hyd_hk_11sw_a_r577_0_wt5.

An area of lower resistance was observed between 1cm & 5cm. It was the decayed inner surface of the open cavity. The curve climbs slowly until 21cm where the drill bit passed through the remaining wall of main trunk. The residual thickness of sound wood was about 13-14cm. (The circumference of the whole trunk where the reading was taken was 1350mm.)

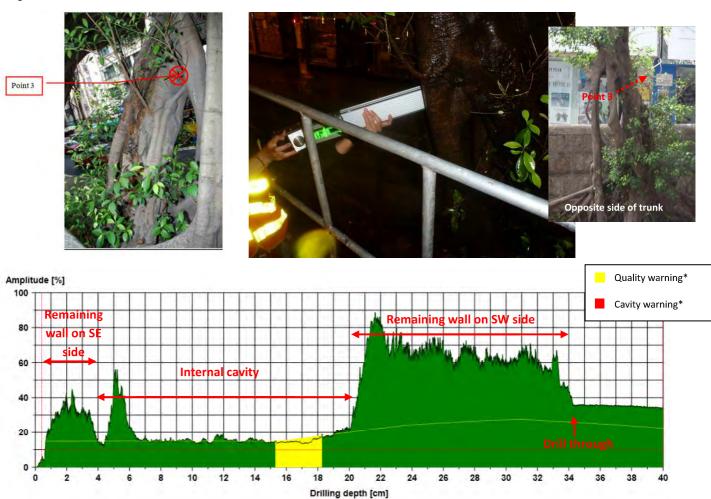
Point 3 was set above the open cavity to gain internal reading of the influence on main trunk above this cavity.

Large area of low resistance was recorded between 4cm & 21cm, indicative of an internal cavity. The residual wall thickness on SE side (LHS of curve) was as thin as 3cm. The bit drilled through the trunk at 34cm. (The circumference of the stem where the reading was taken was 1100mm.) Yet this residual thickness was not the only factor to conclude the trunk stability. Additional supports from the aerial root system should also be evaluated as a whole.

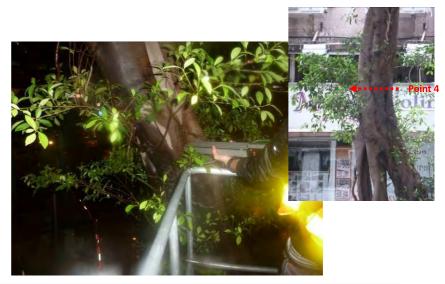
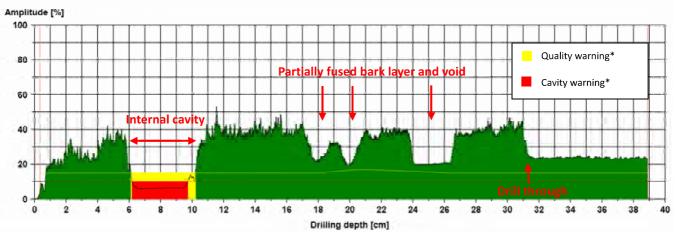
hyd_hk_11sw_a_r577_0_wt5 Point 4:

Another point, Point 4, was set around 30cm above Point 3 in an opposite direction. In this area the main trunk was fused with multiple aerial roots to form a complex.

Area of low resistance was recorded between 6cm & 11cm. Internal cavity was suspected in this area Troughs recorded at 18cm, 20cm and 24cm to 27cm were likely to be partially fused bark layers and voids formed between main trunk and aerial roots. The bit drilled through the trunk at 31cm. (The circumference of the elliptical stem where the reading was taken was 1300mm.)

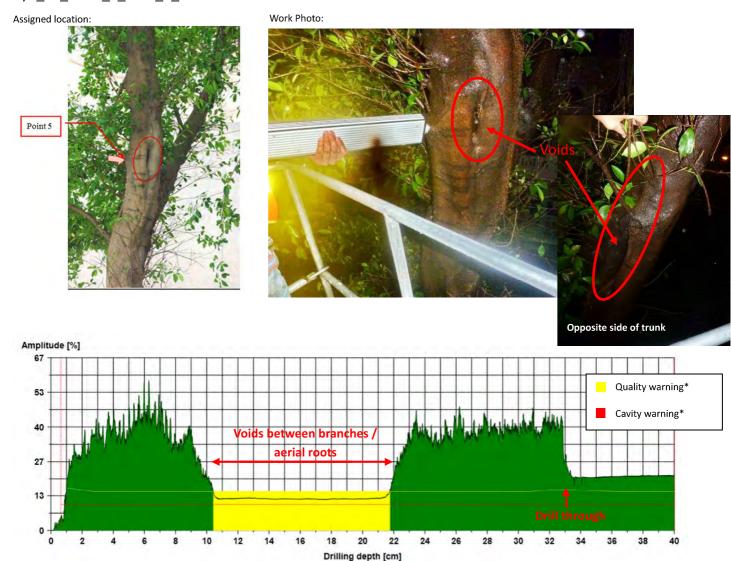
hyd_hk_11sw_a_r577_0_wt5 Point 5:

Point 4, was set on the upper part of hyd_hk_11sw_a_r577_0_wt5 where a few branches/aerial roots joined to form a trunk. Voids were visible from both side of trunk.

The bit drilled through the trunk at 33cm. (The circumference of the complex where the reading was taken was 960mm.) Normal wood densities were observed between 1cm & 10cm and 22cm & 33cm.
