Assessment of Wall Trees on Slope 11SW-A/R577 at Bonham Road

**Highways Department
HKSAR Government**

**C.Y. Jim
The University of Hong Kong
hrajcy@hku.hk**

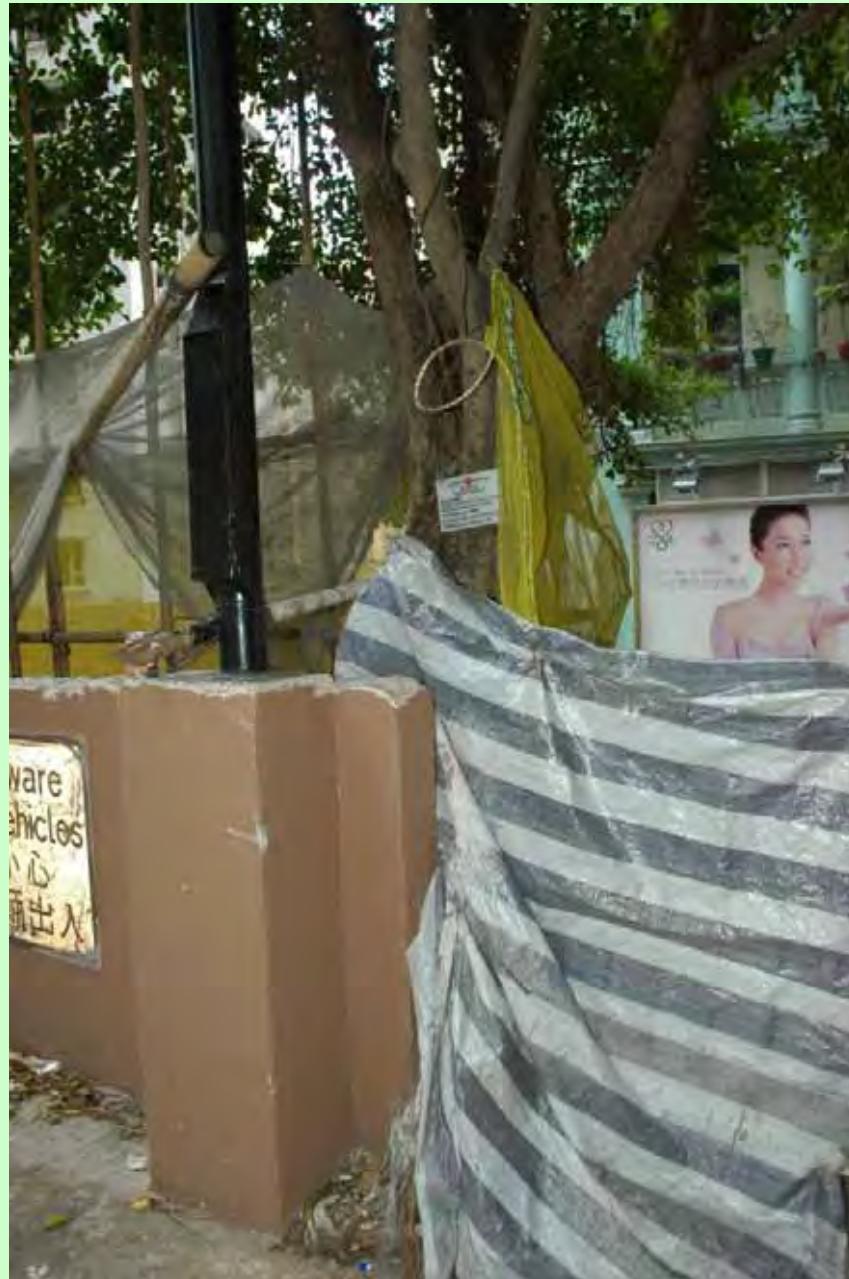
Photo T1-8. Renovation work at the adjacent building has used the tree to support its nylon net and sheet.

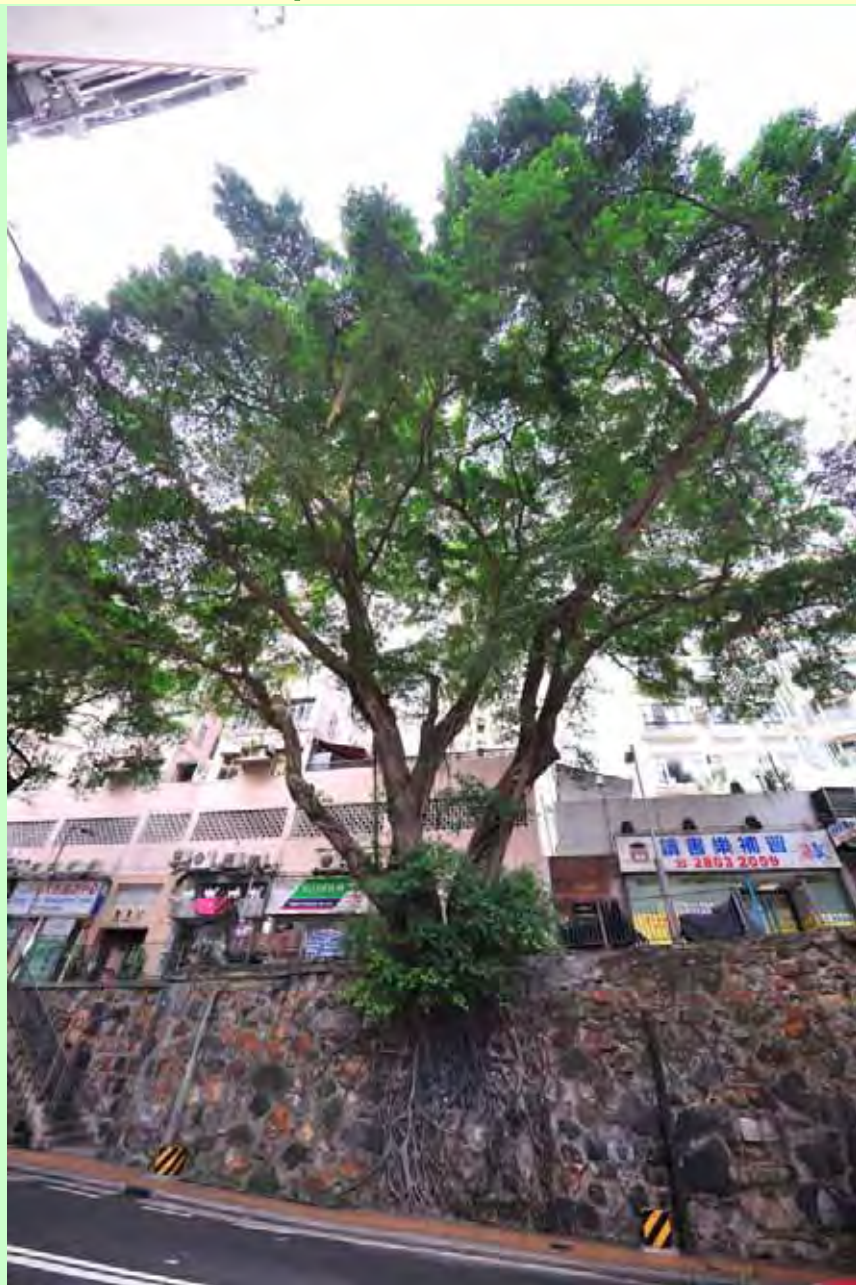
Photo T2-1. One of the largest stonewall trees that excel in trunk diameter, height, crown spread, tree form, health and vigour.

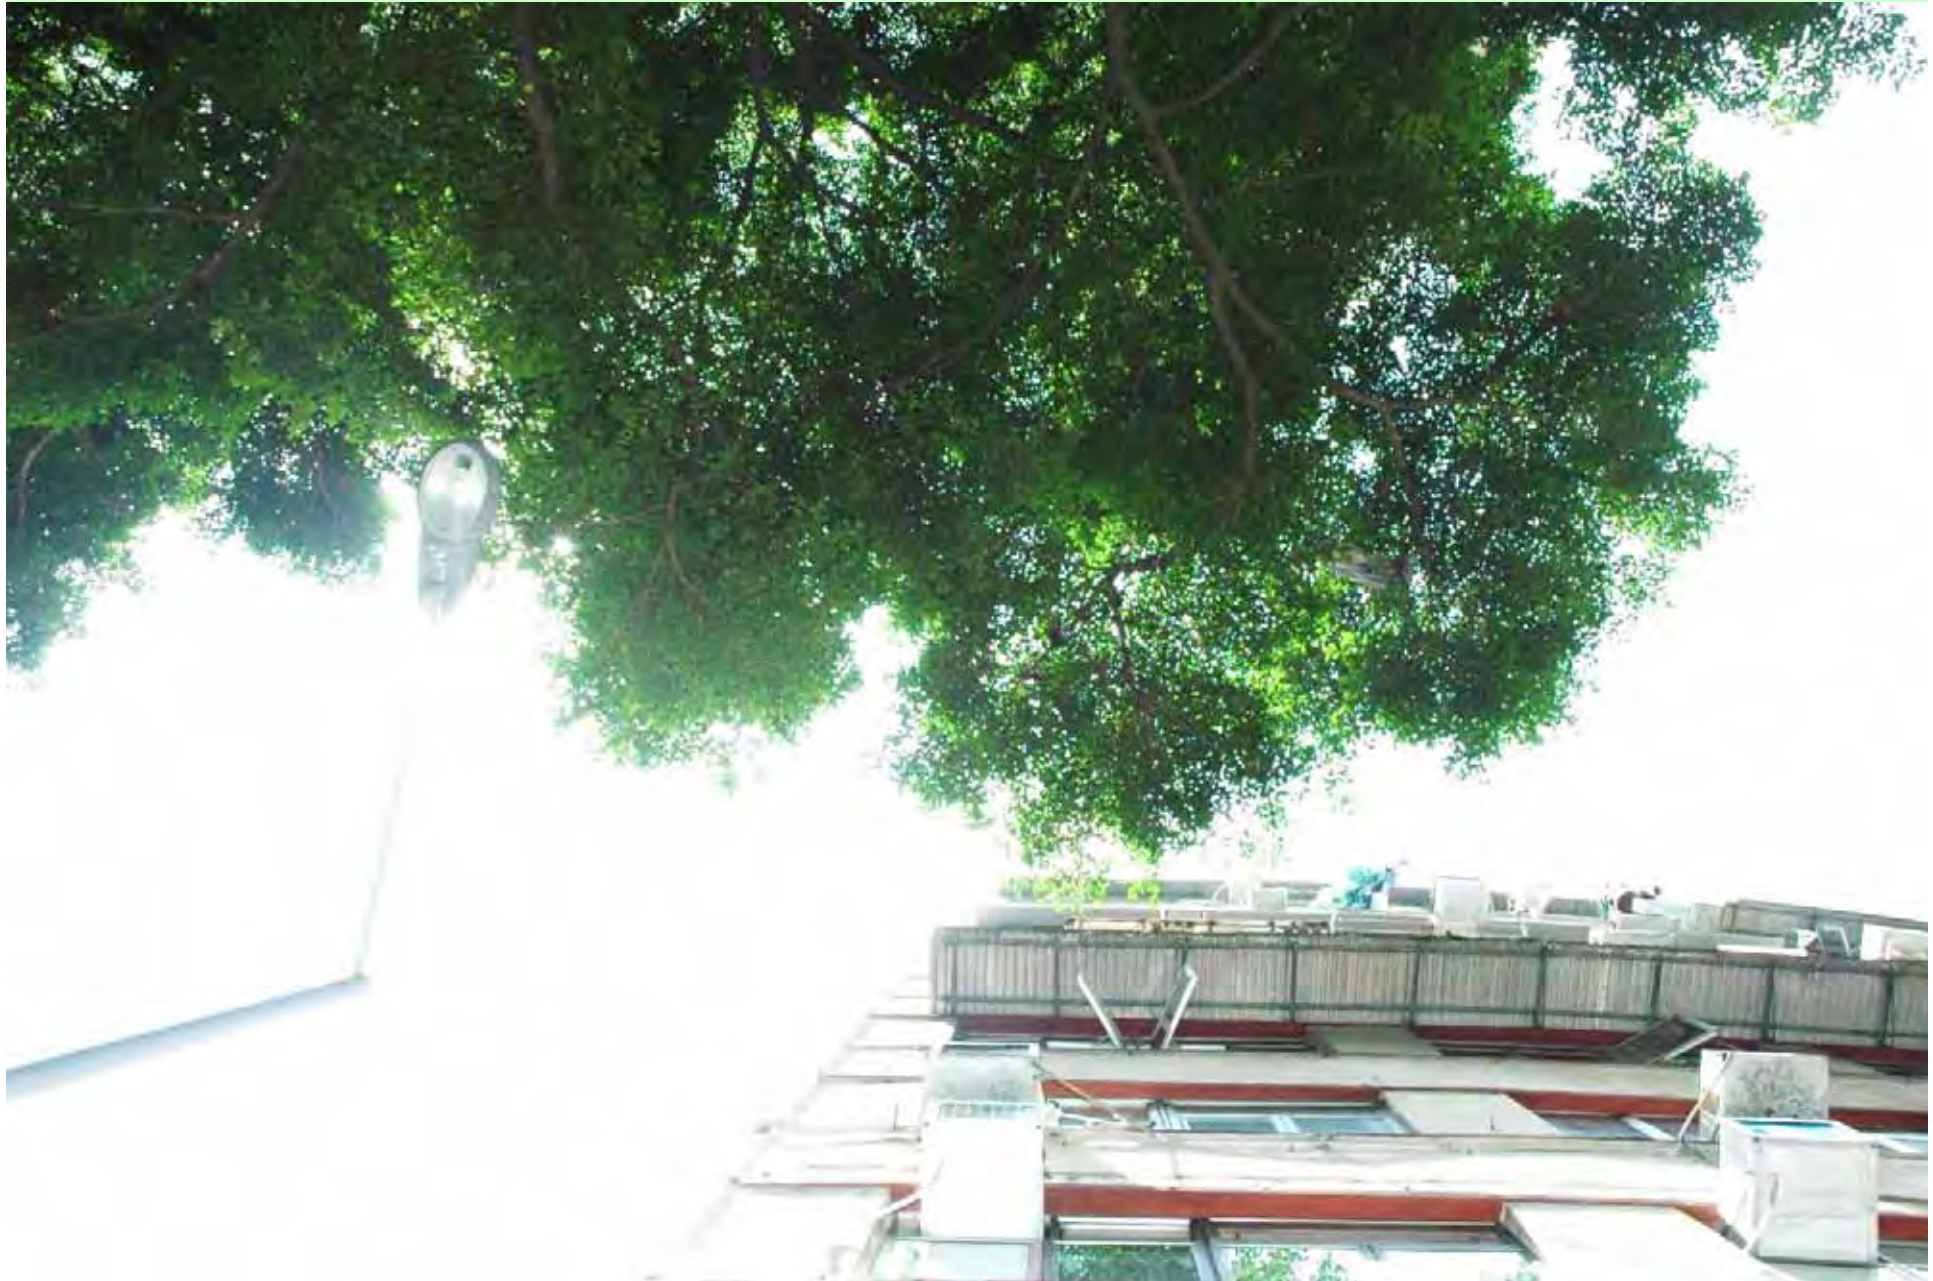
Photo T2-29. Close proximity of the east part of the crown to the building on the opposite side of Bonham Road.

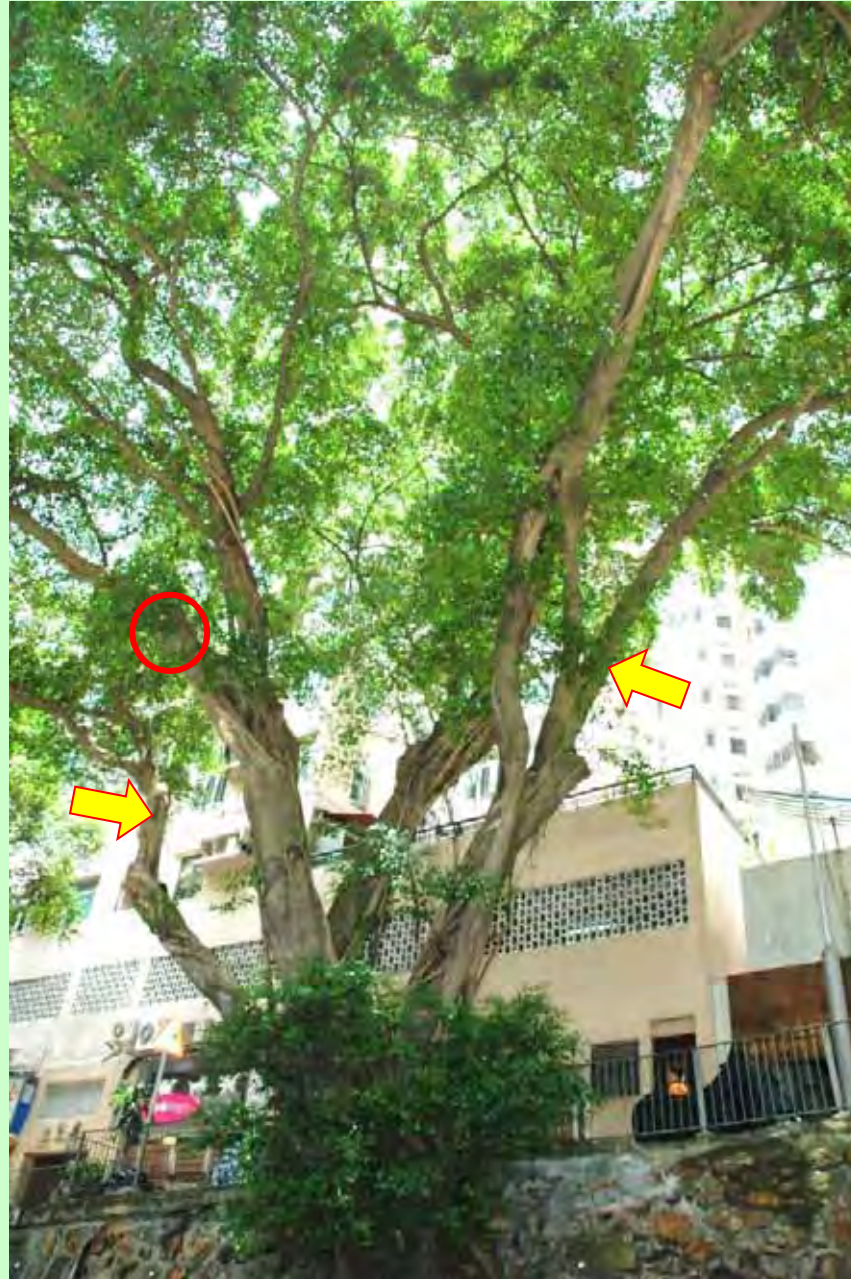
Photo T2-30. Stems A1 and C have replacement limbs of expanded epicormic branches. Tipped limb at stem B (circle).

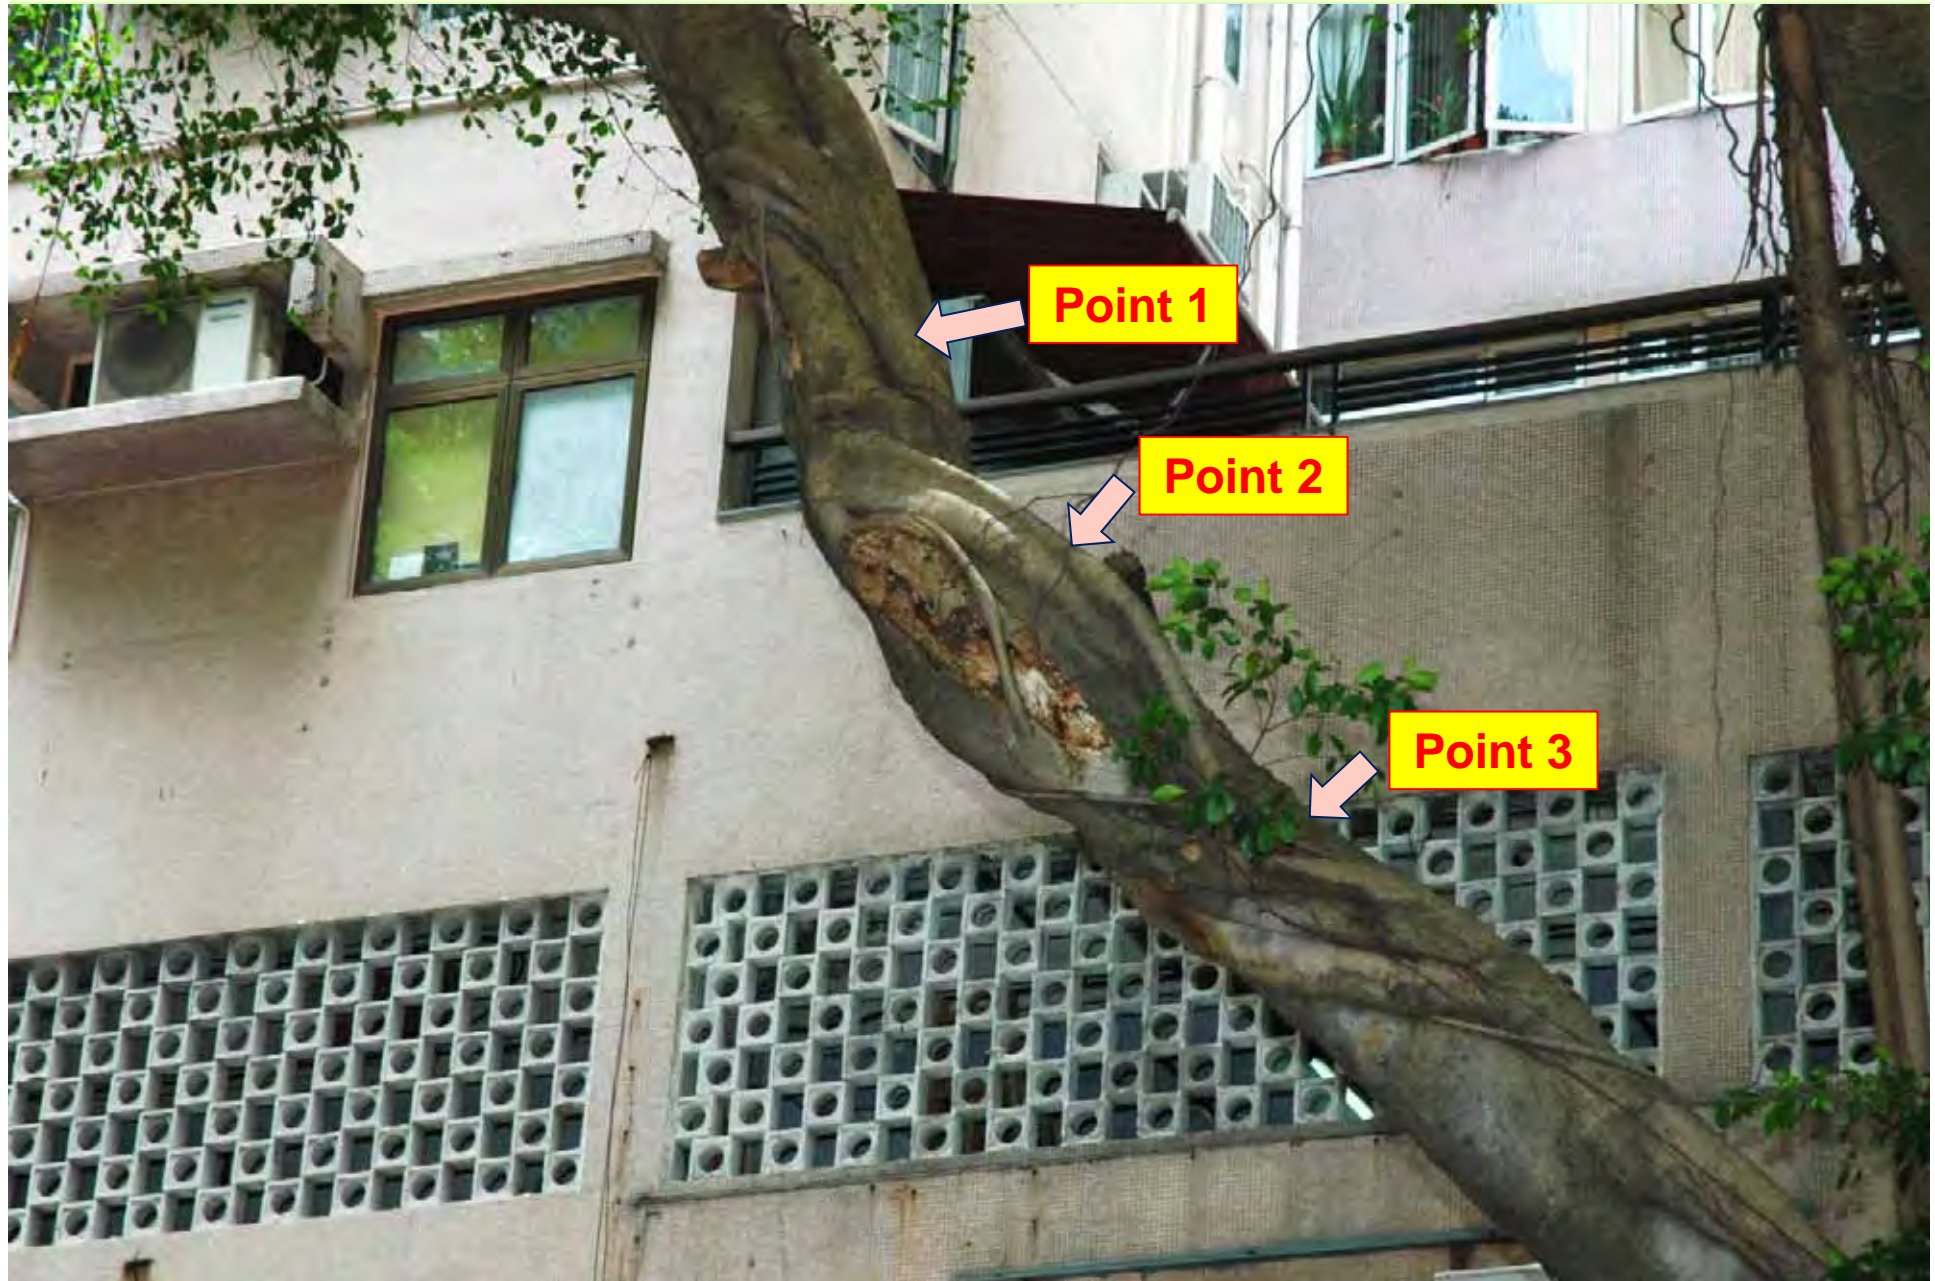
Photo T2-31. Stem A1 has a large wound with decay and bulgewood formation. Arrows indicate drilling positions.

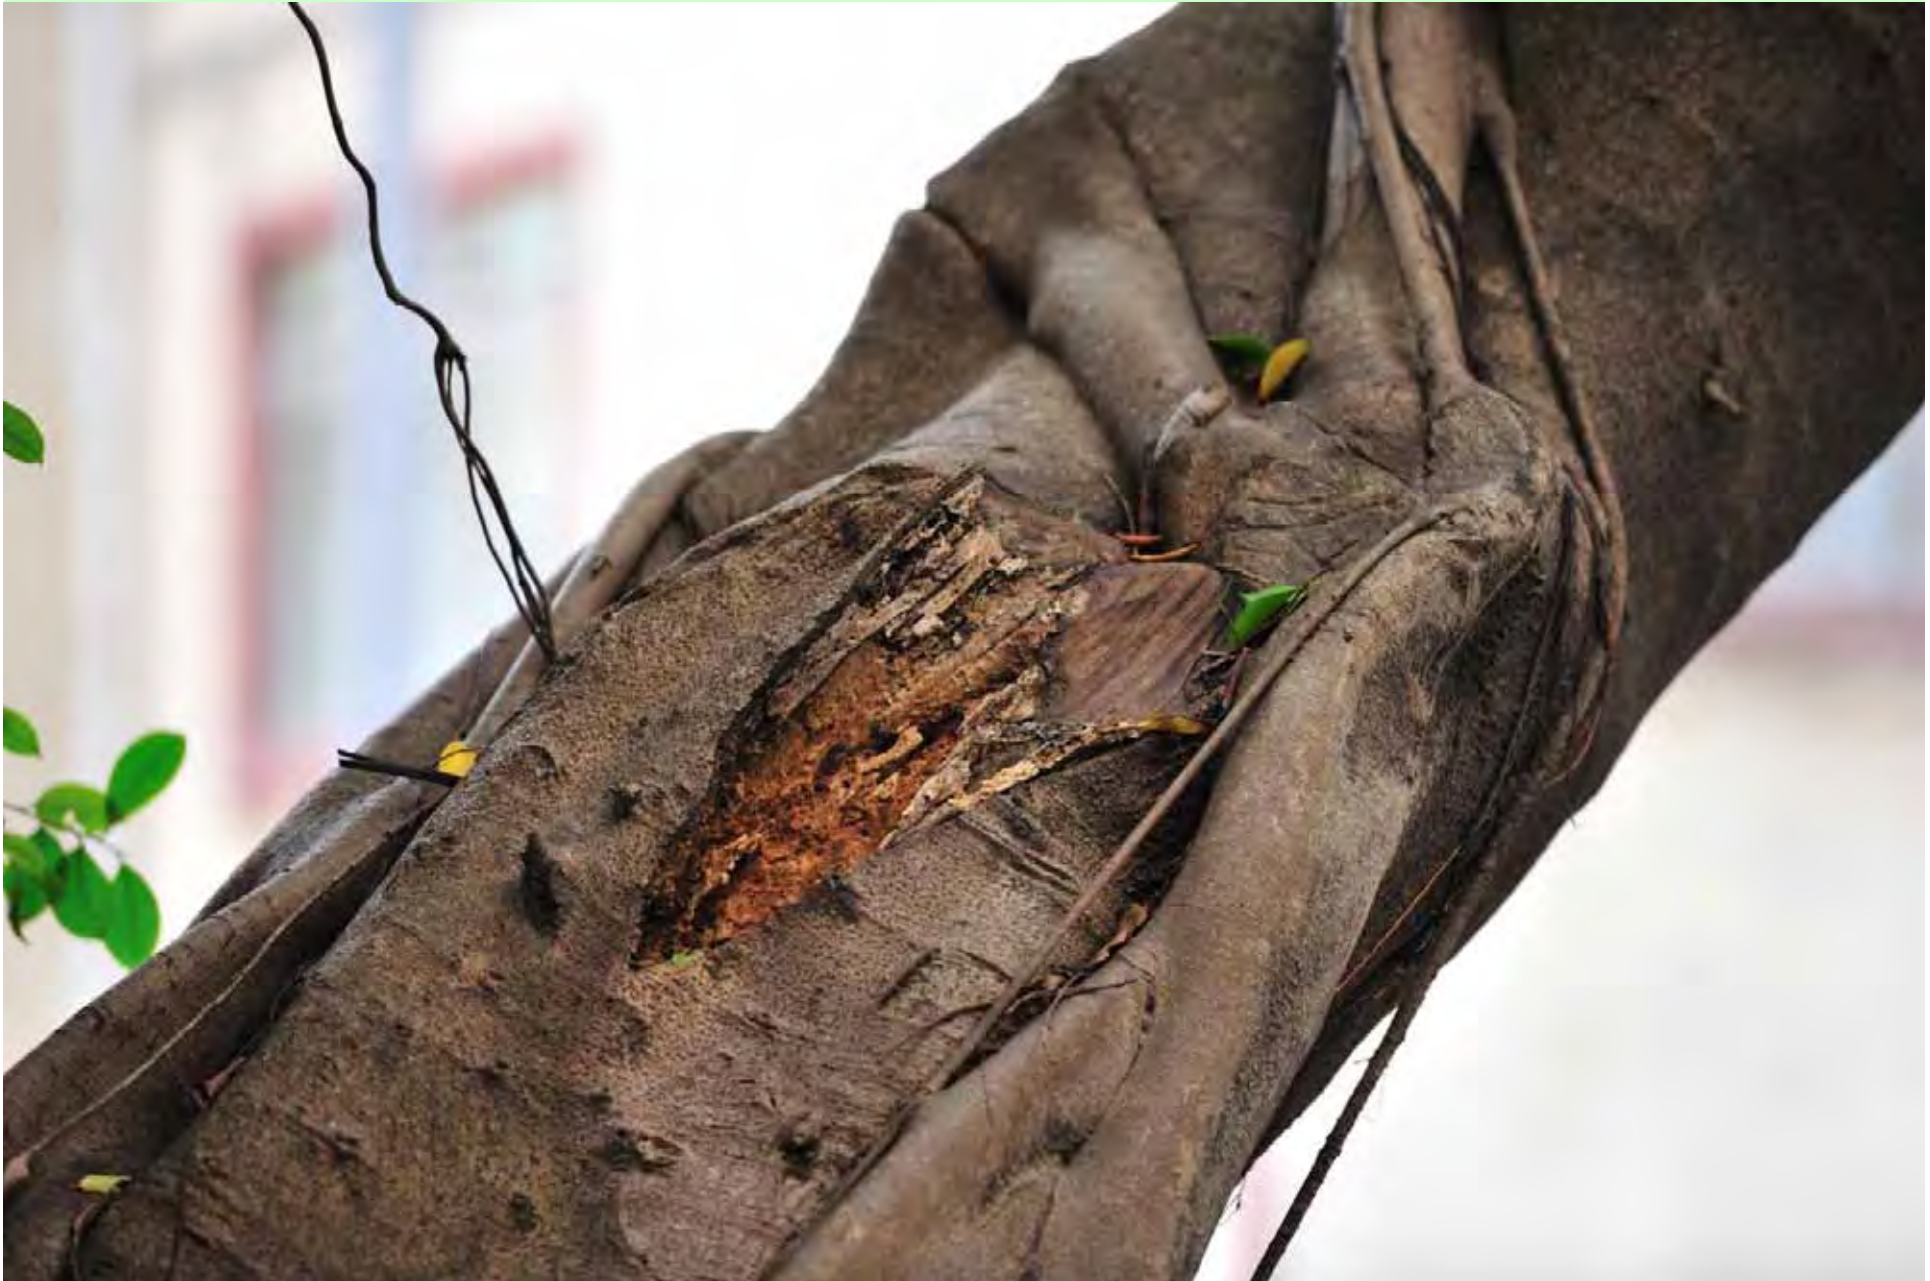
Photo T2-32. South side of stem A1 has an old branch breakage wound with advanced decay and possible termite attack.

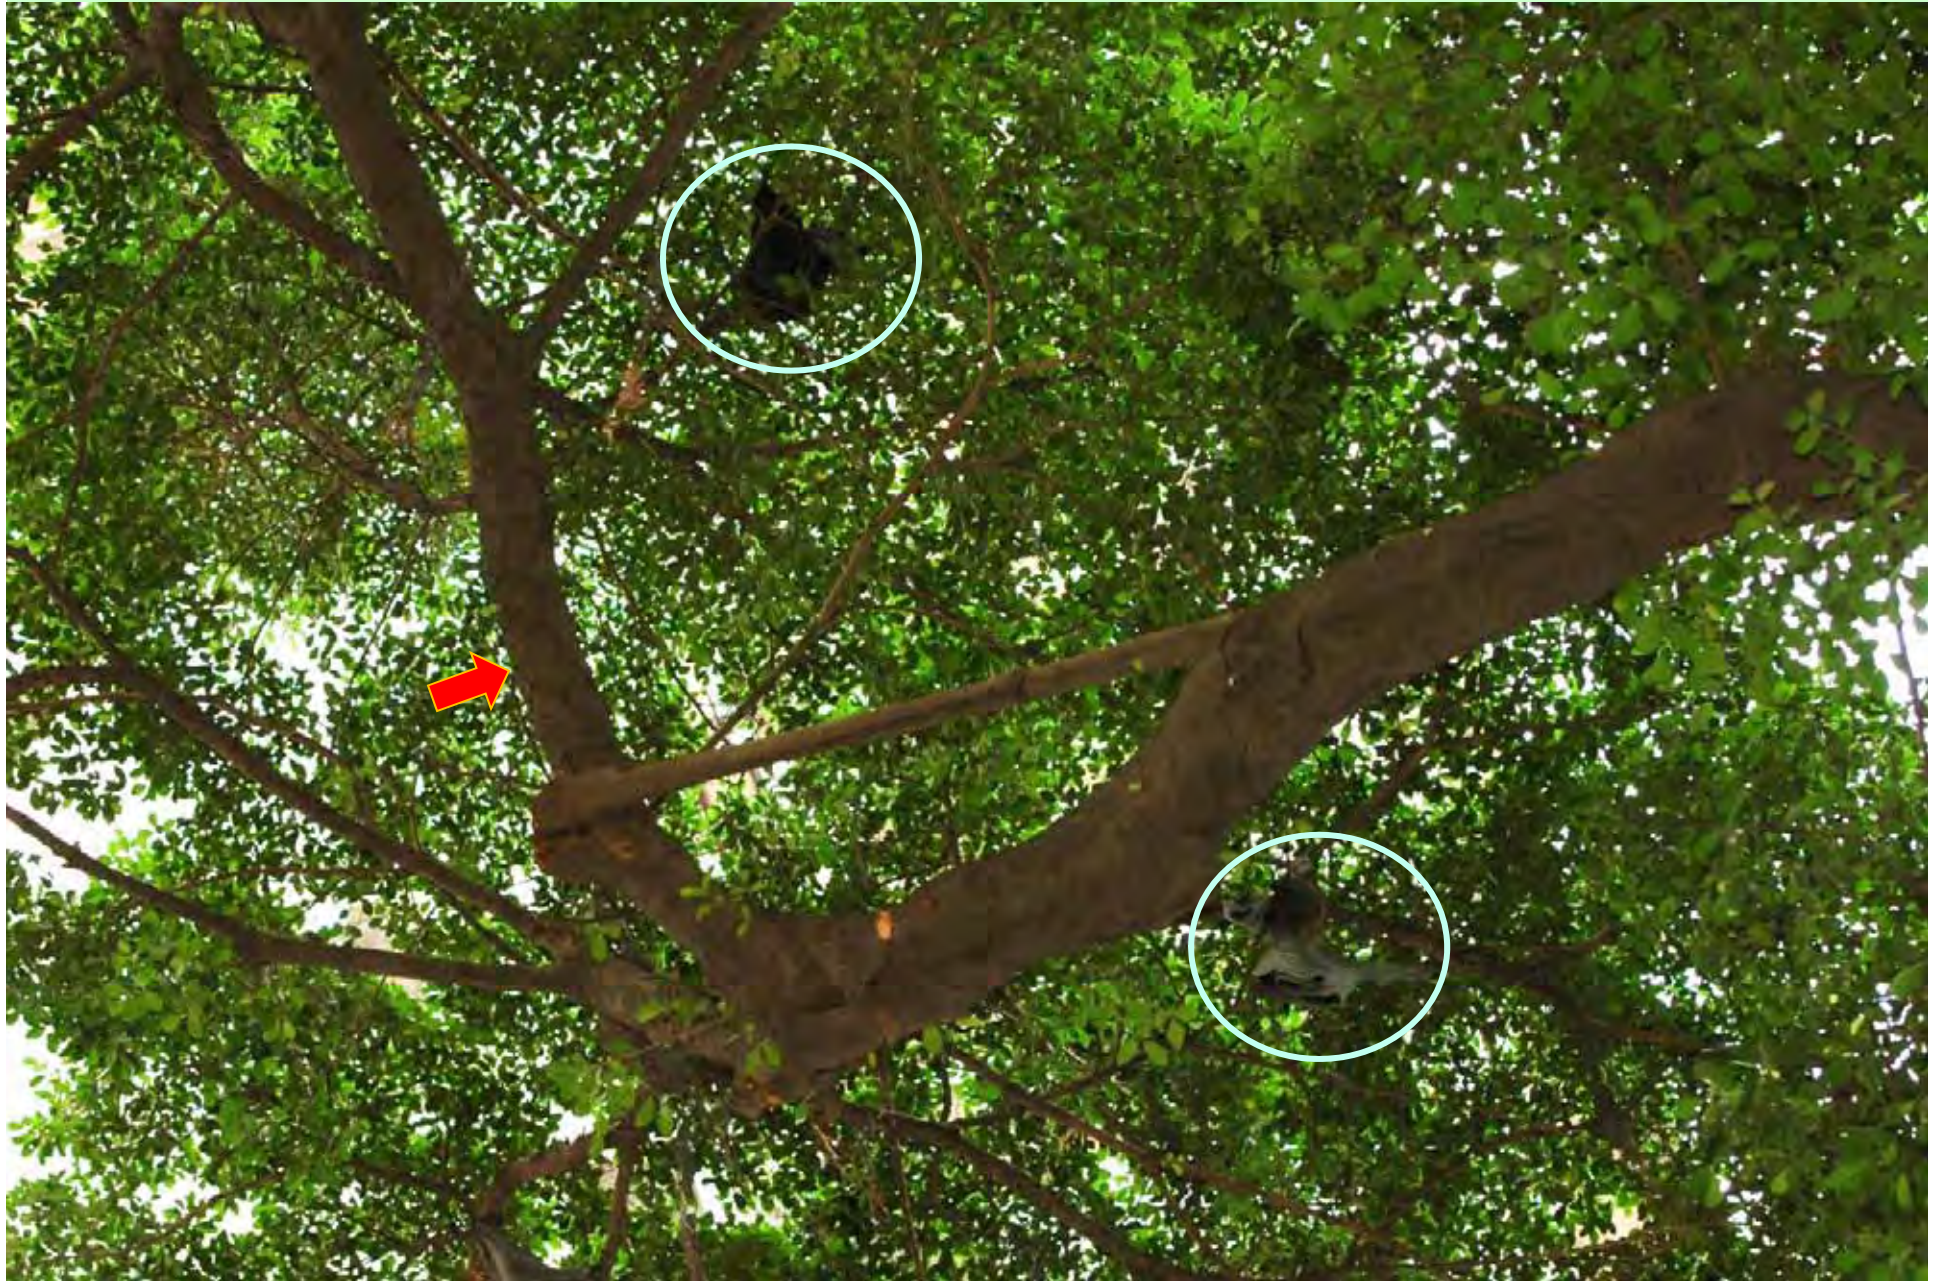
Photo T2-35. Thick epicormic branch of stem A1 curving upwards from old branch tipping wound. Rubbish hanging on branches.

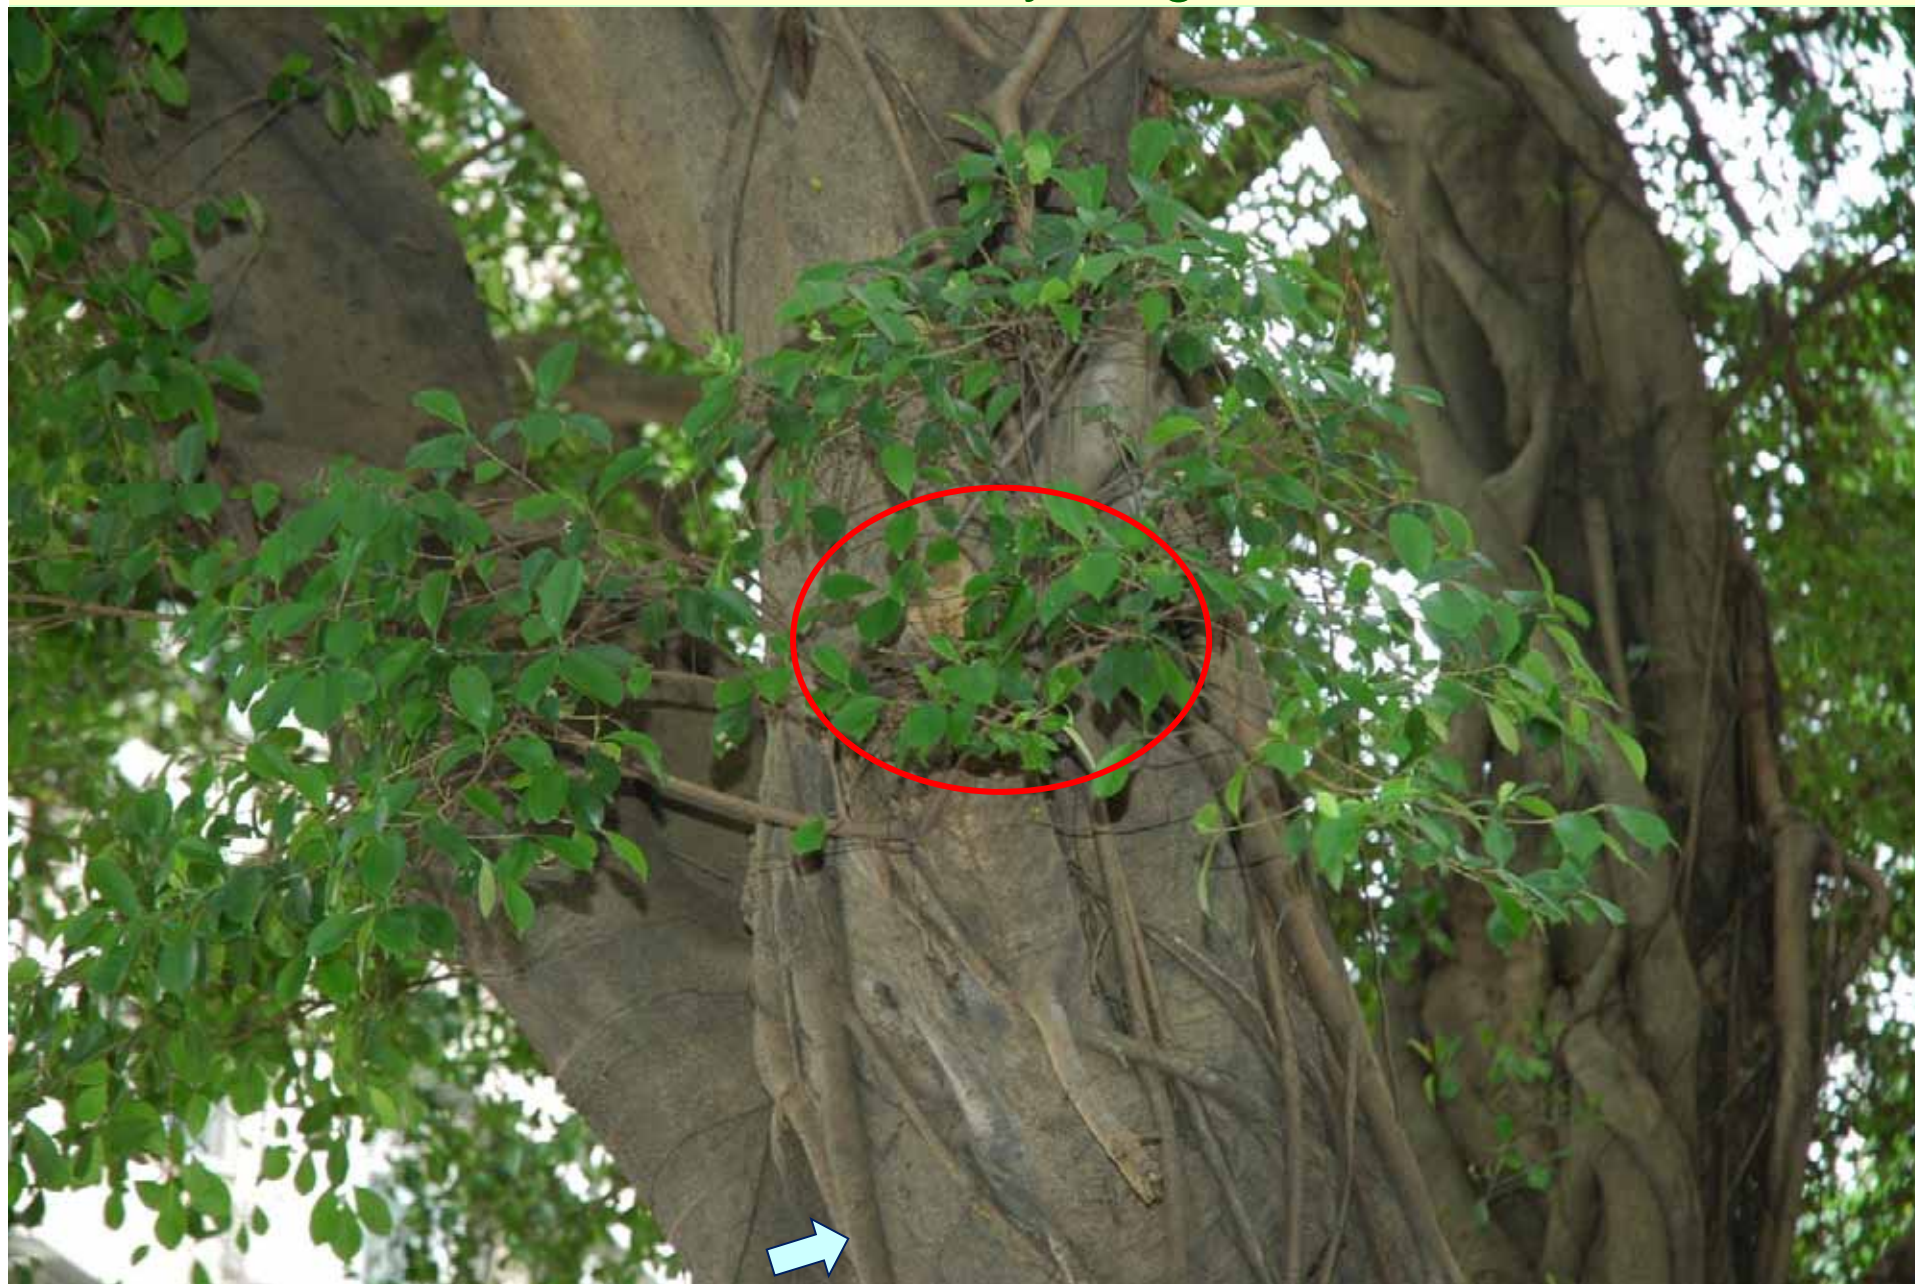
Photo T2-36. Stem A2 with truncated branch wound invaded by wood-decay fungi.

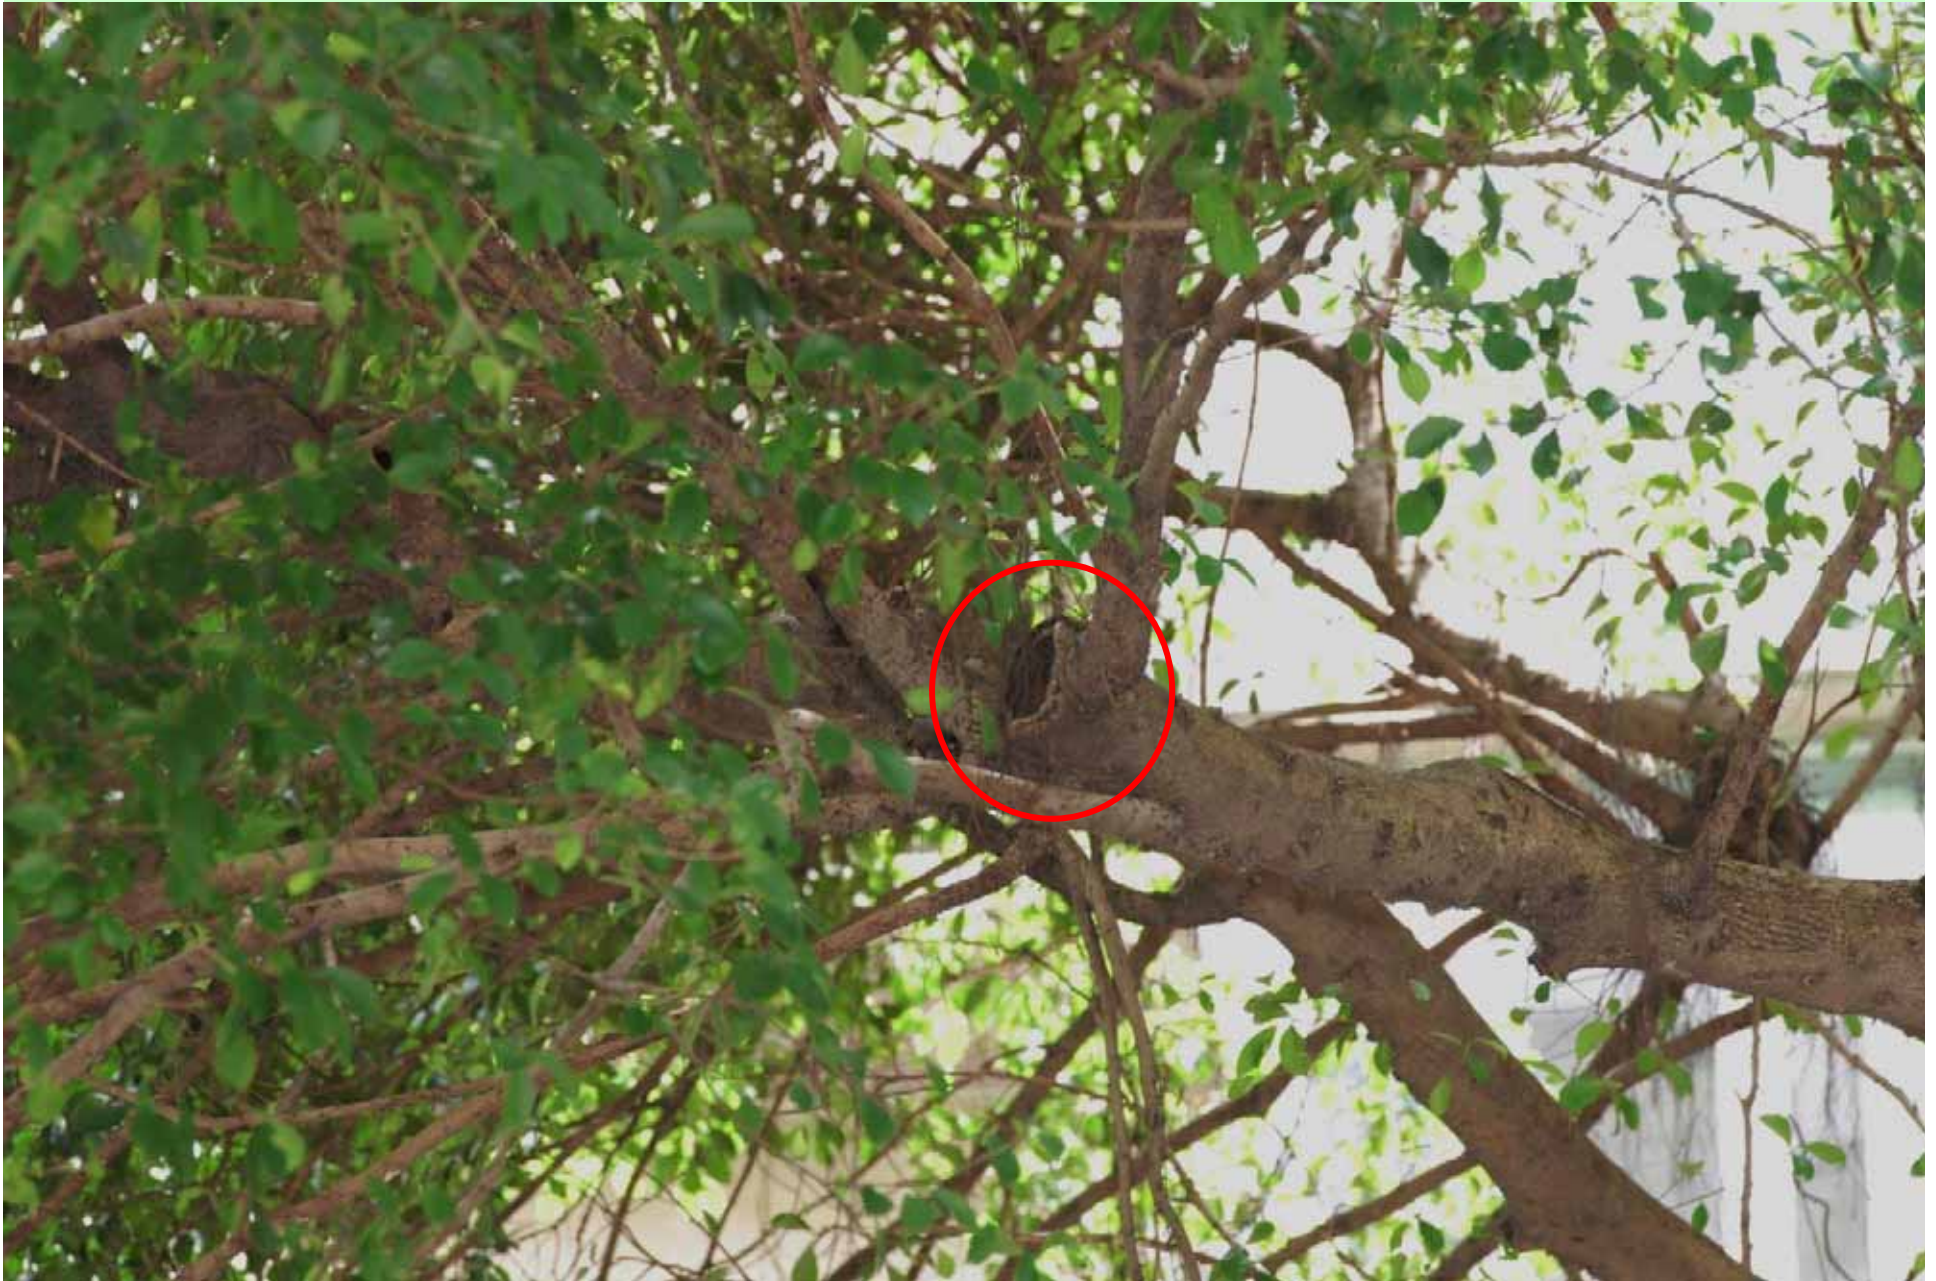
Photo T2-37. Stem B with tipped and decayed branch and multiple epicormic sprouts at and near wound.

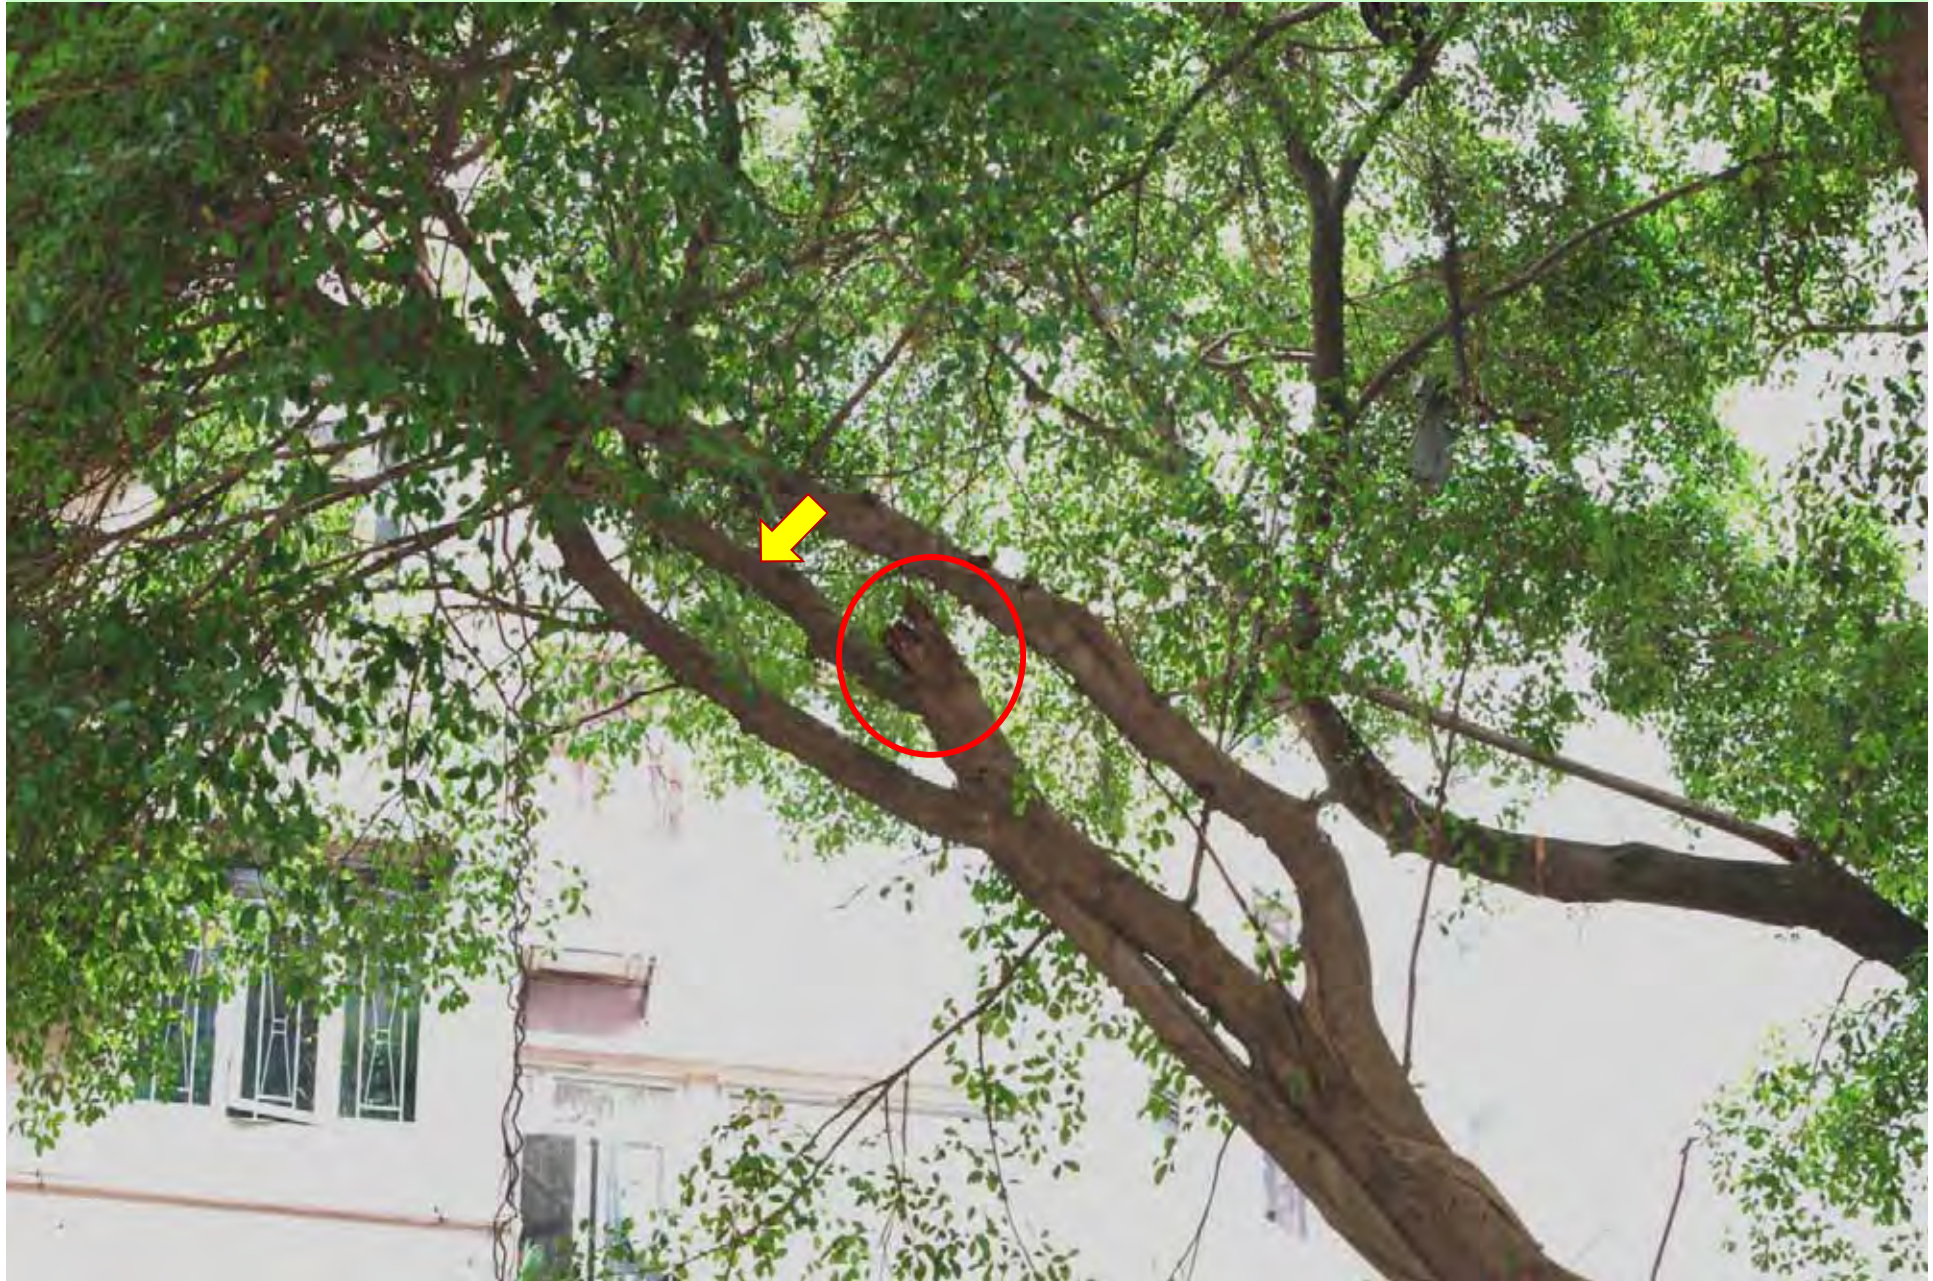
Photo T2-38. Stem B with fractured-decayed branch end supporting expanded epicormic branch. Three parallel branches.

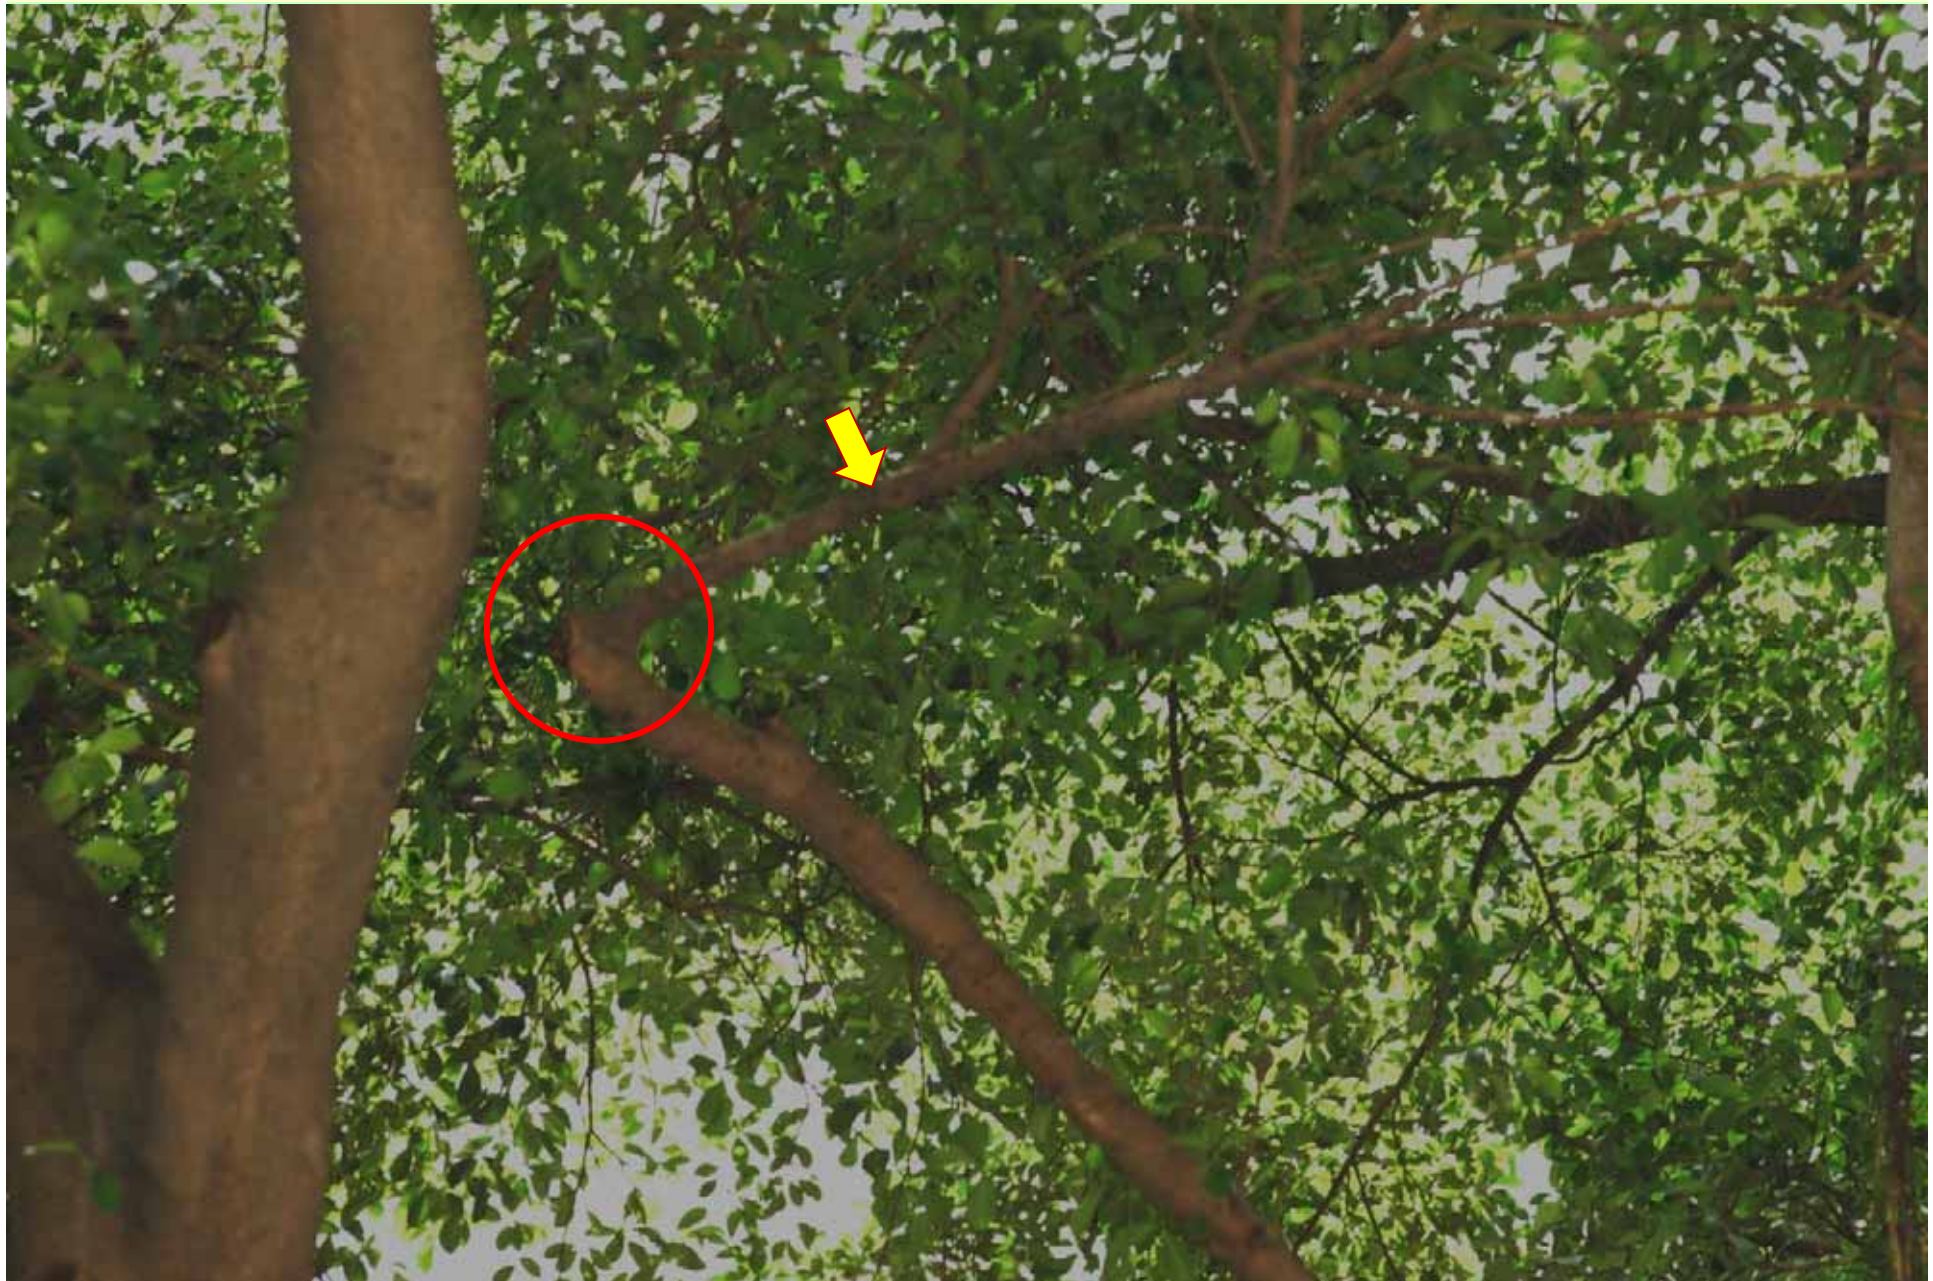
Photo T2-41. Stem B with tipped branch and an epicormic branch attached to the parent with an elbow joint.
