Assessment of Wall Trees on Slope 11SW-A/R577 at Bonham Road

**Highways Department
HKSAR Government**

**C.Y. Jim
The University of Hong Kong
hrajcy@hku.hk**

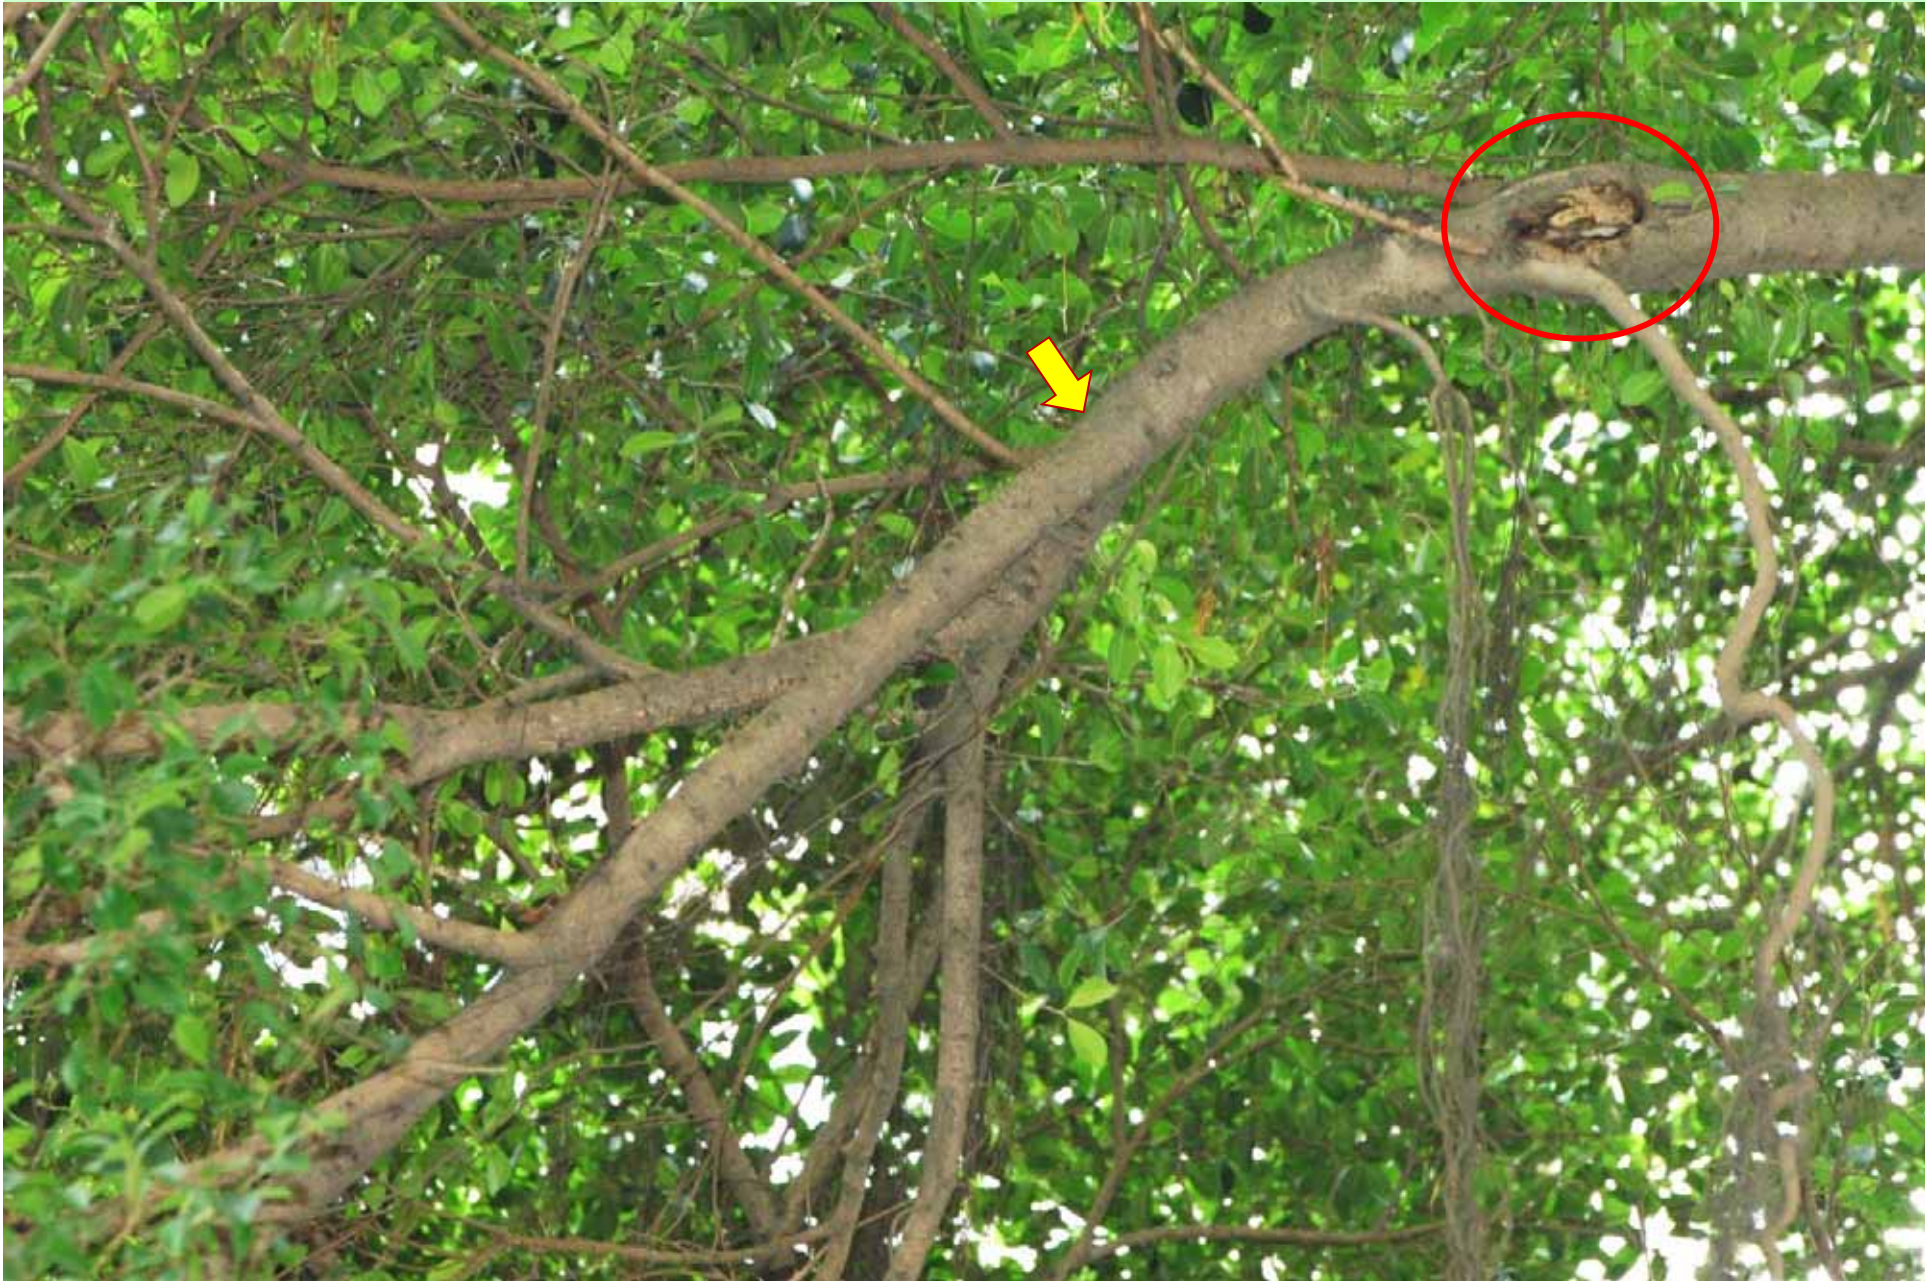
Photo T2-42. Stem B branch with decay, cavity and bulgewood supporting a curved branch end.

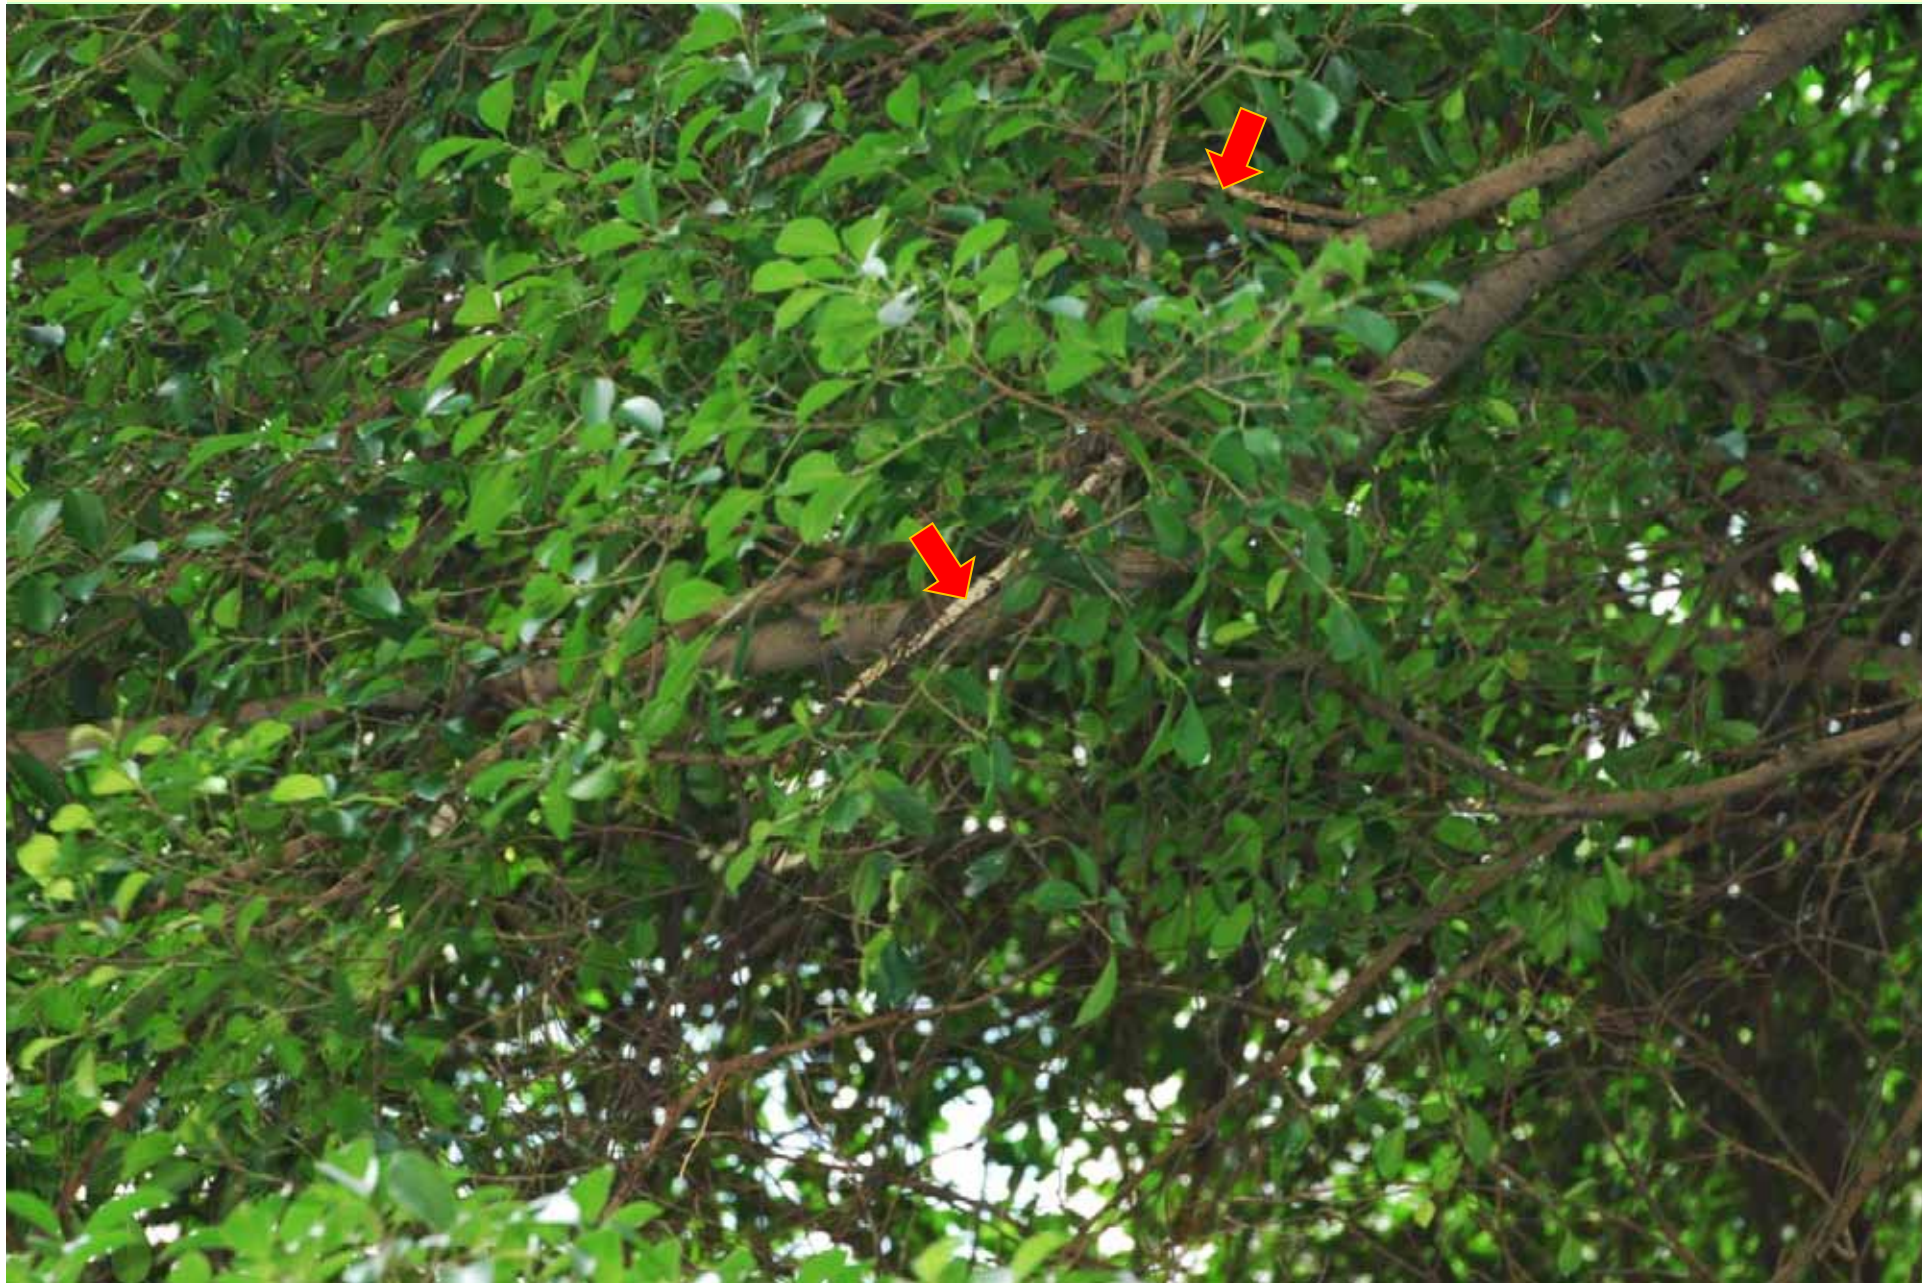
Photo T2-43. Stem B with crowded sprouts at branch end and decayed branchlets.

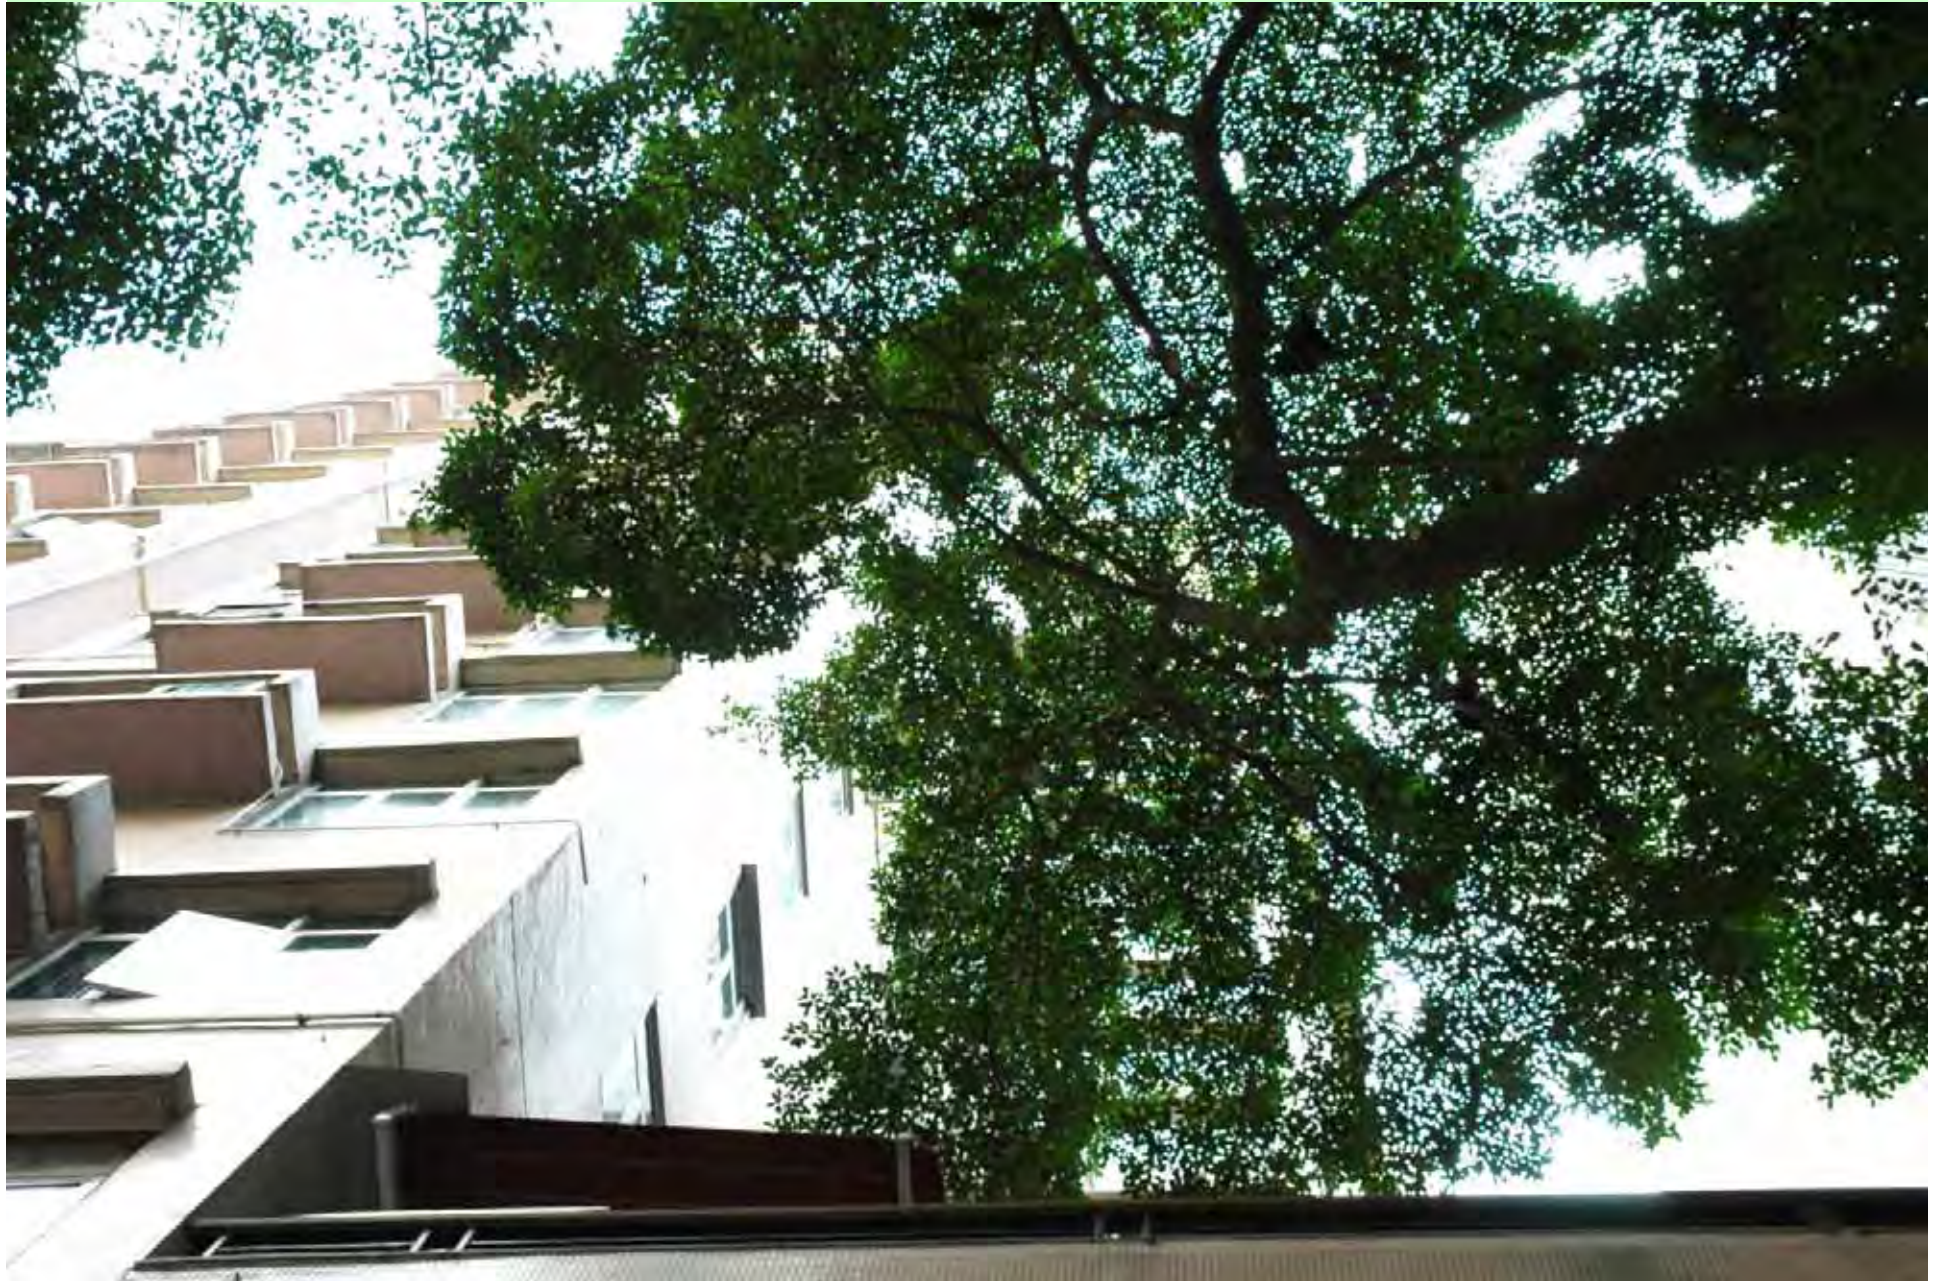
Photo T2-50. South part of the crown extending above the building podium at St Stephen's Lane.

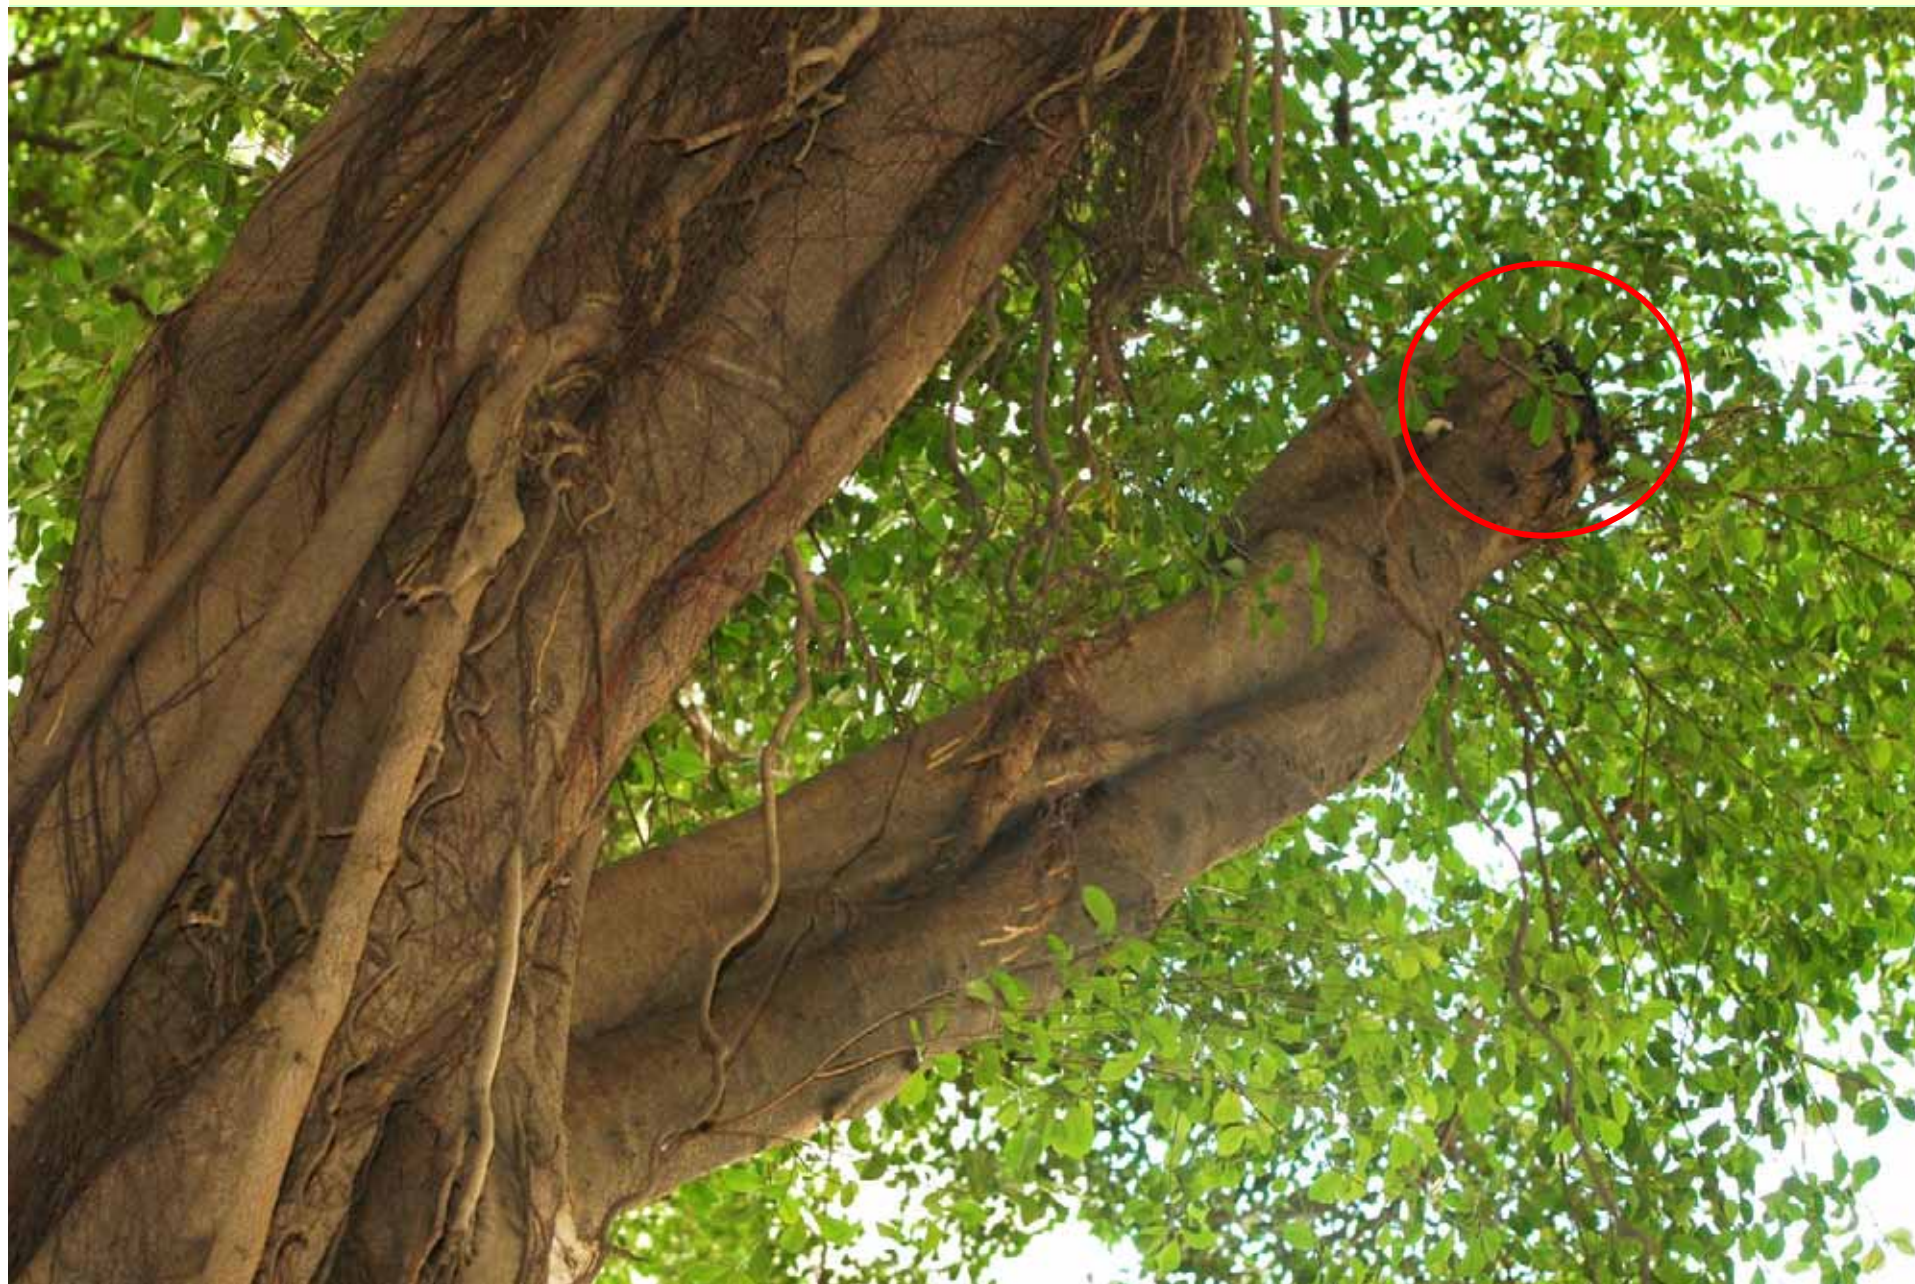
Photo T2-51. Stem B with a large truncated limb developing decay at the wound.

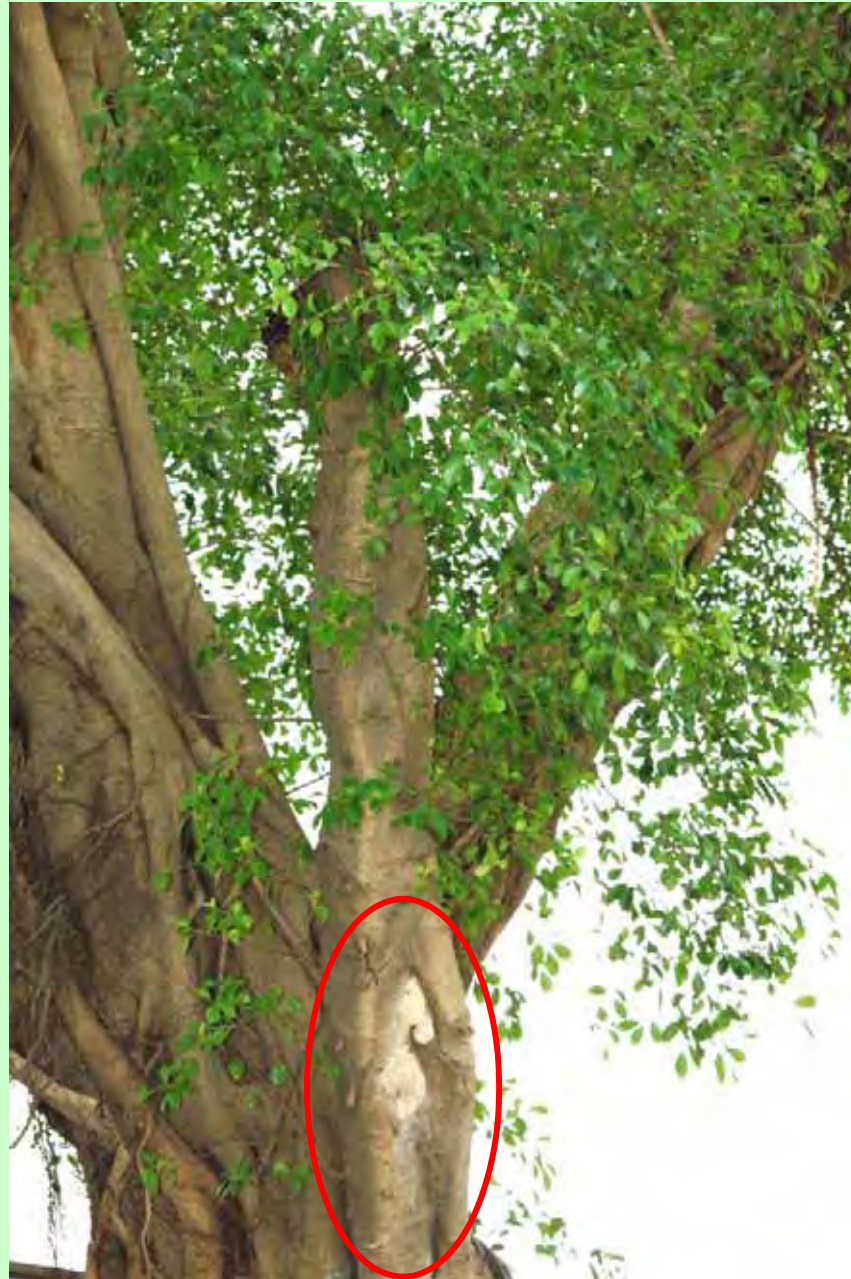
Photo T2-52. Base of the truncated limb of stem B has a decayed and depressed wound with bulgewood and a wasp nest.

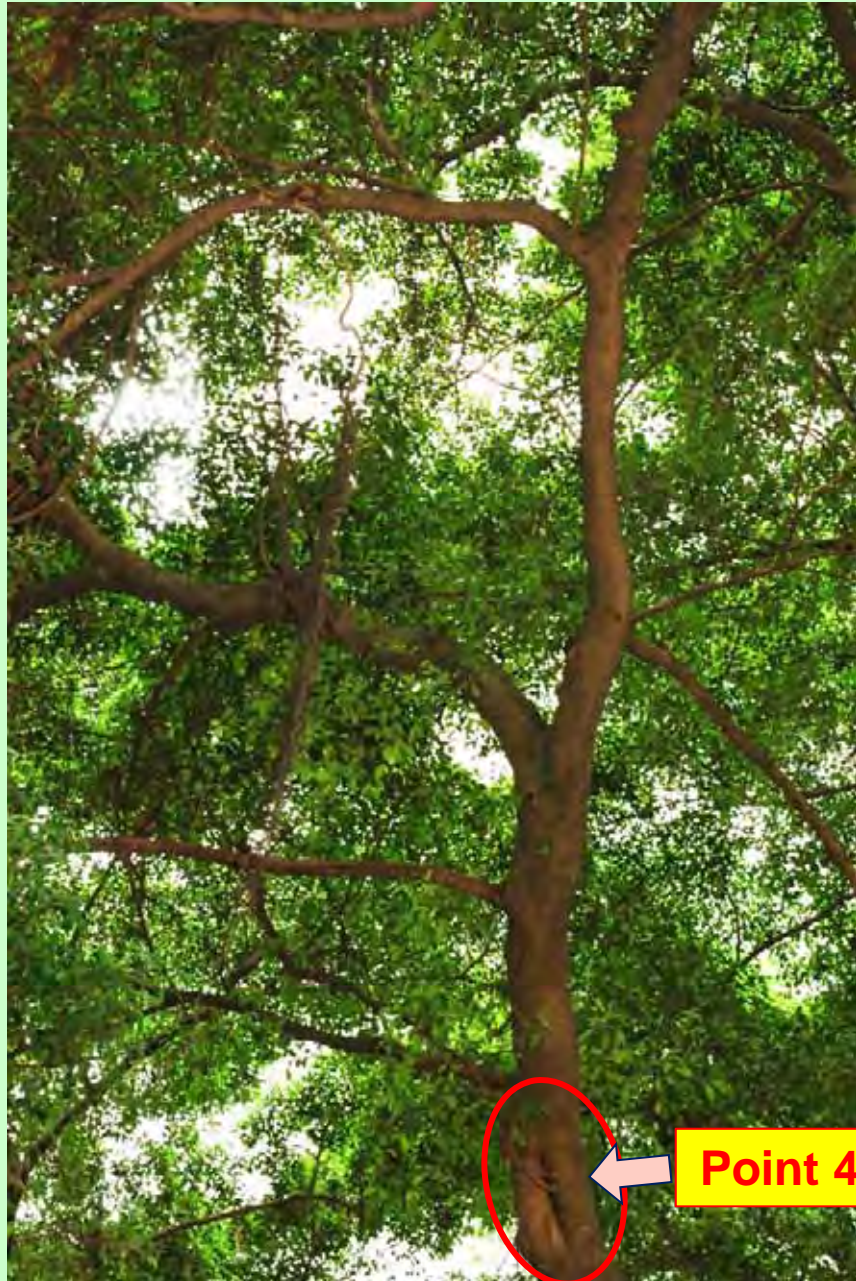
Photo T2-53. Stem B has a seam with bulge wood indicating internal decay. Arrow denotes drilling position.

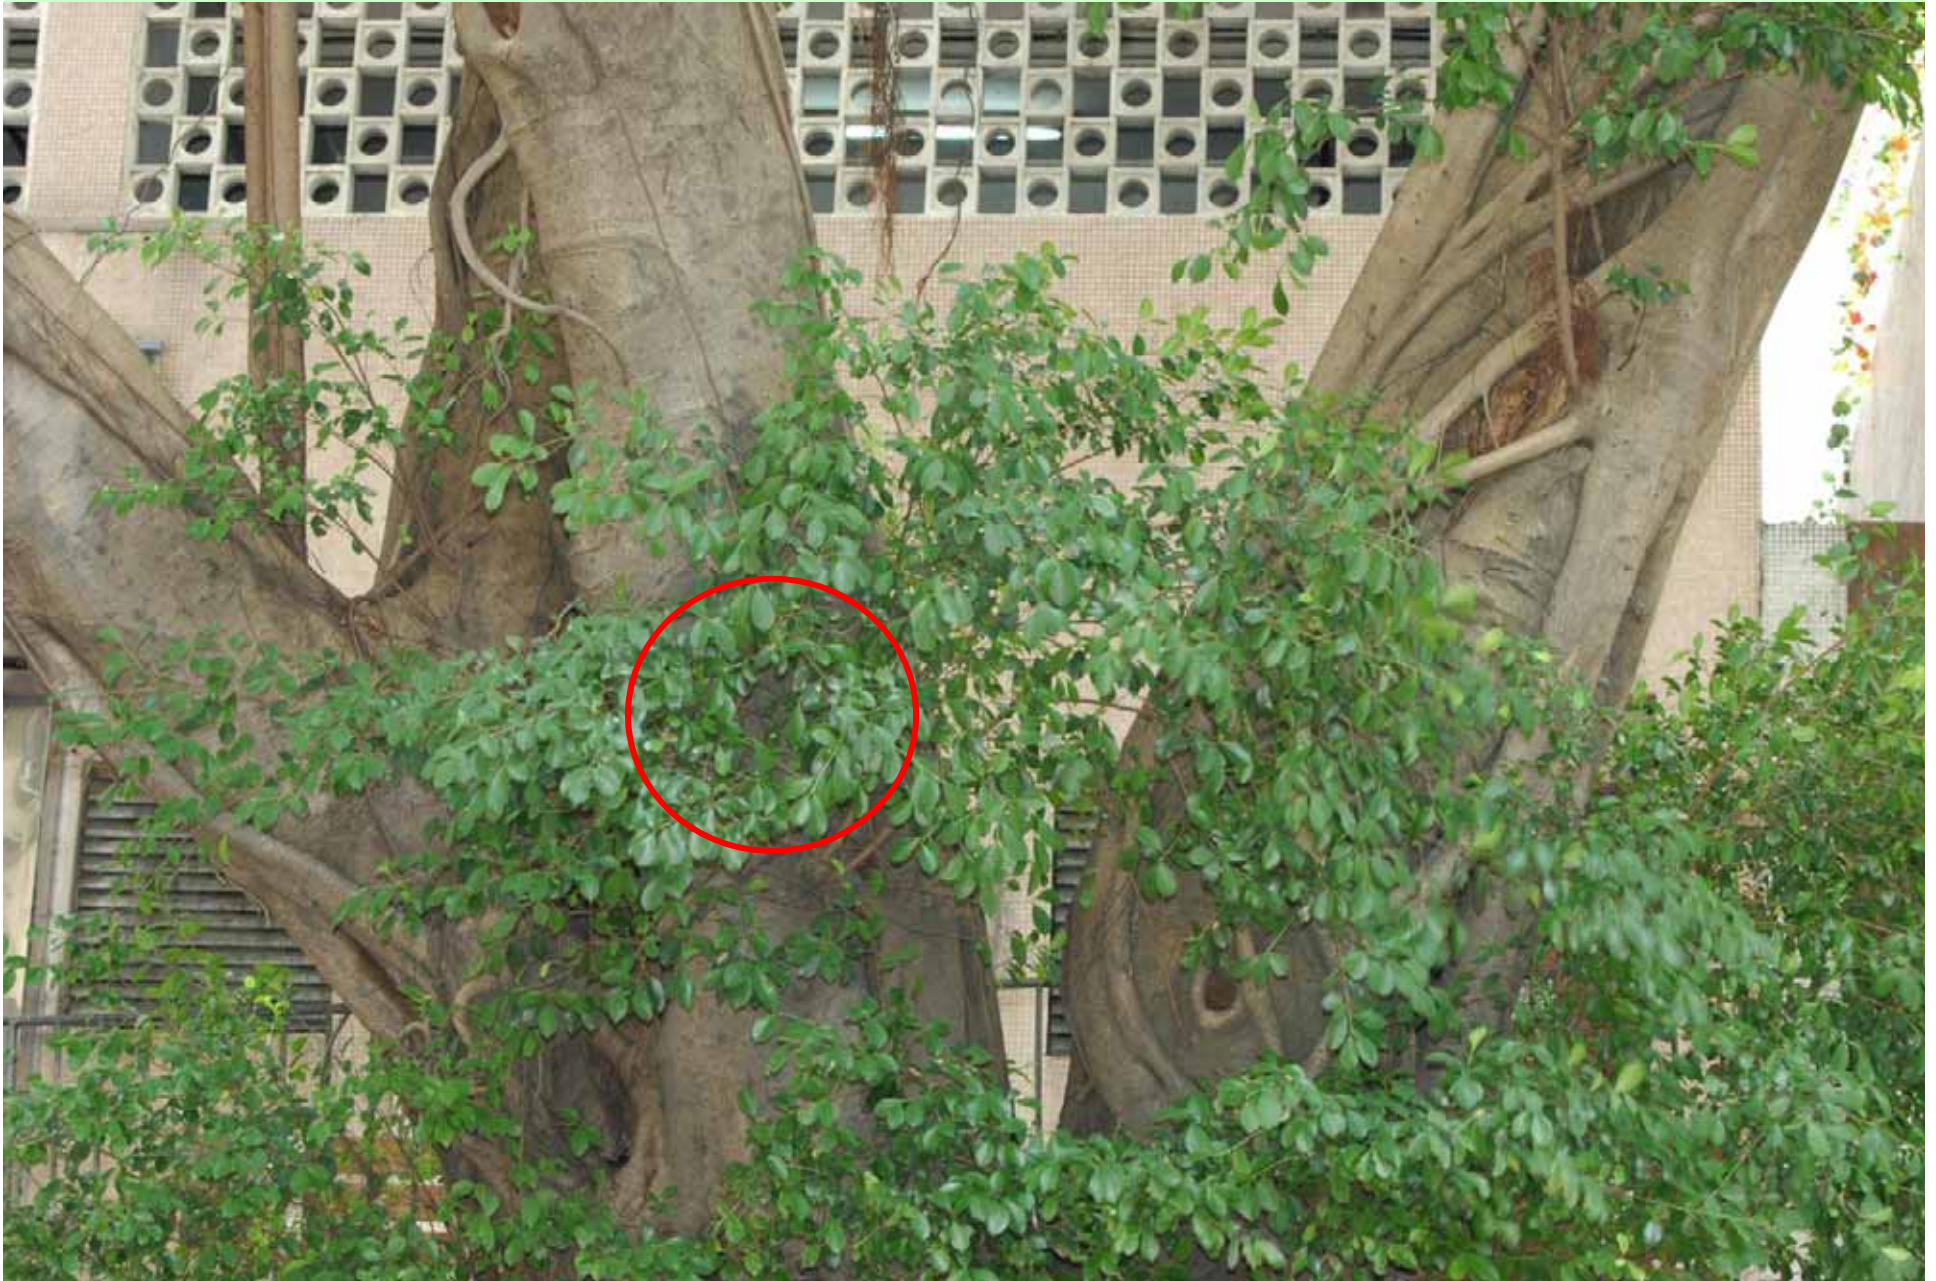
Photo T2-54. Stems B with limb-loss wound, decay and sprouts.

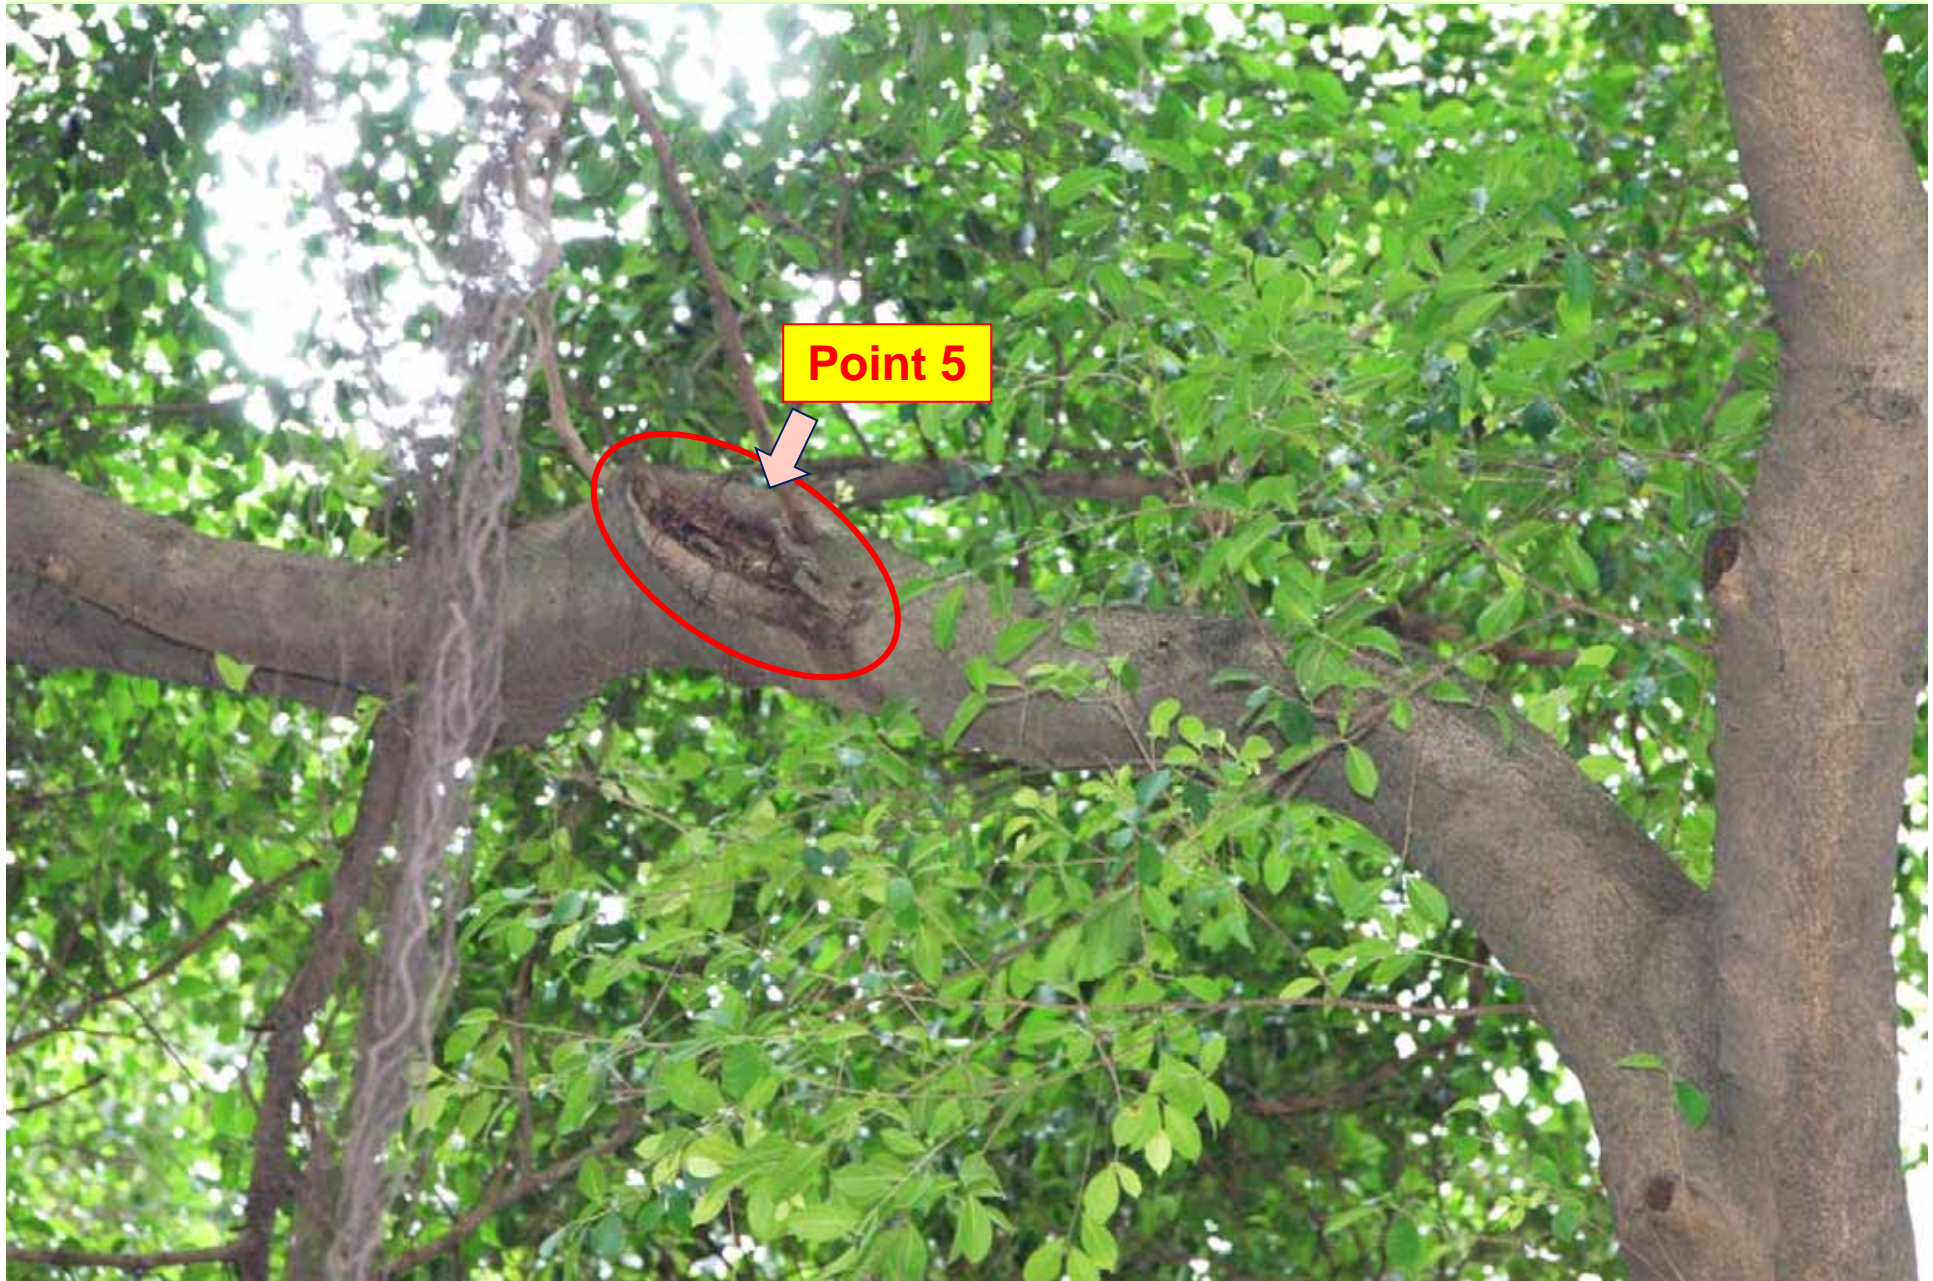
Photo T2-55. Decayed wound with incomplete callus formation on a wavy branch of stem B. Arrow denotes drilling position.

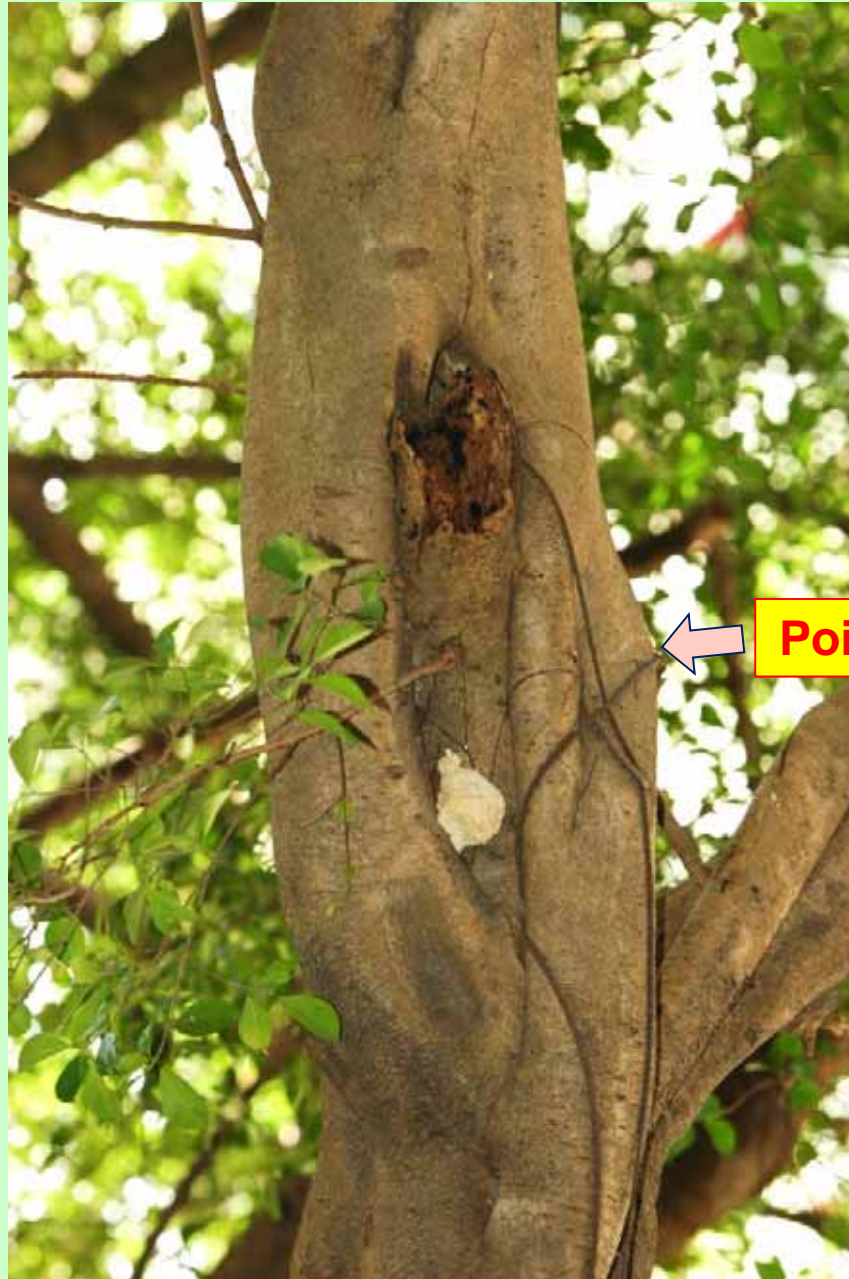
Photo T2-56. Stem A1 with decayed stub, bulgewood and wasp nest. Arrow denotes drilling position.

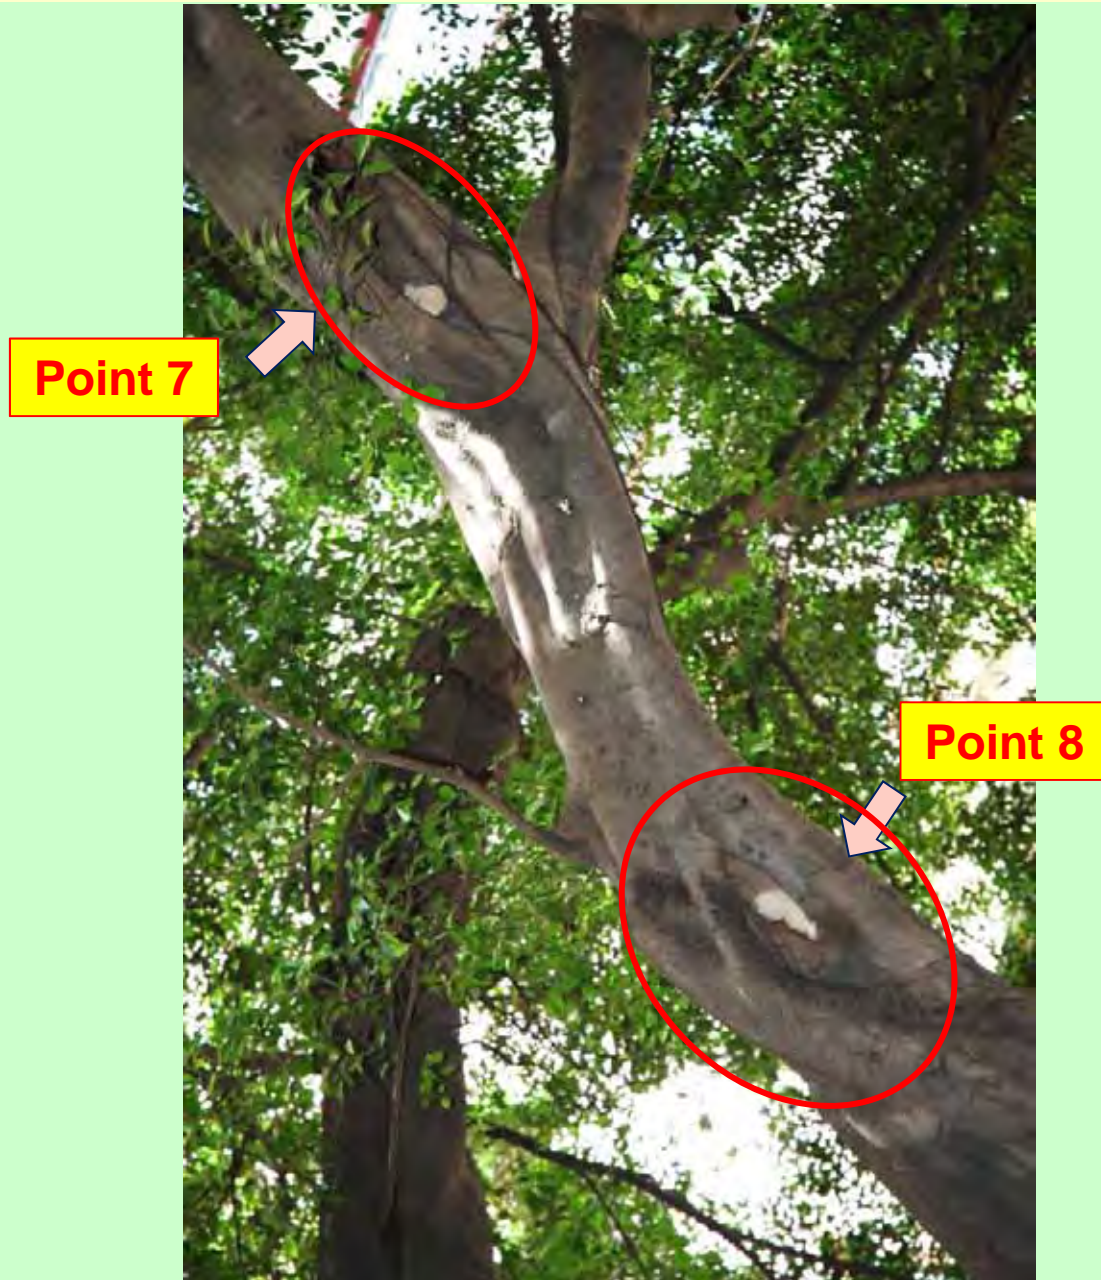
Point 6

Photo T2-57. South side of stem A1 with decayed and depressed wounds and wasp nests. Arrows denote drilling positions.

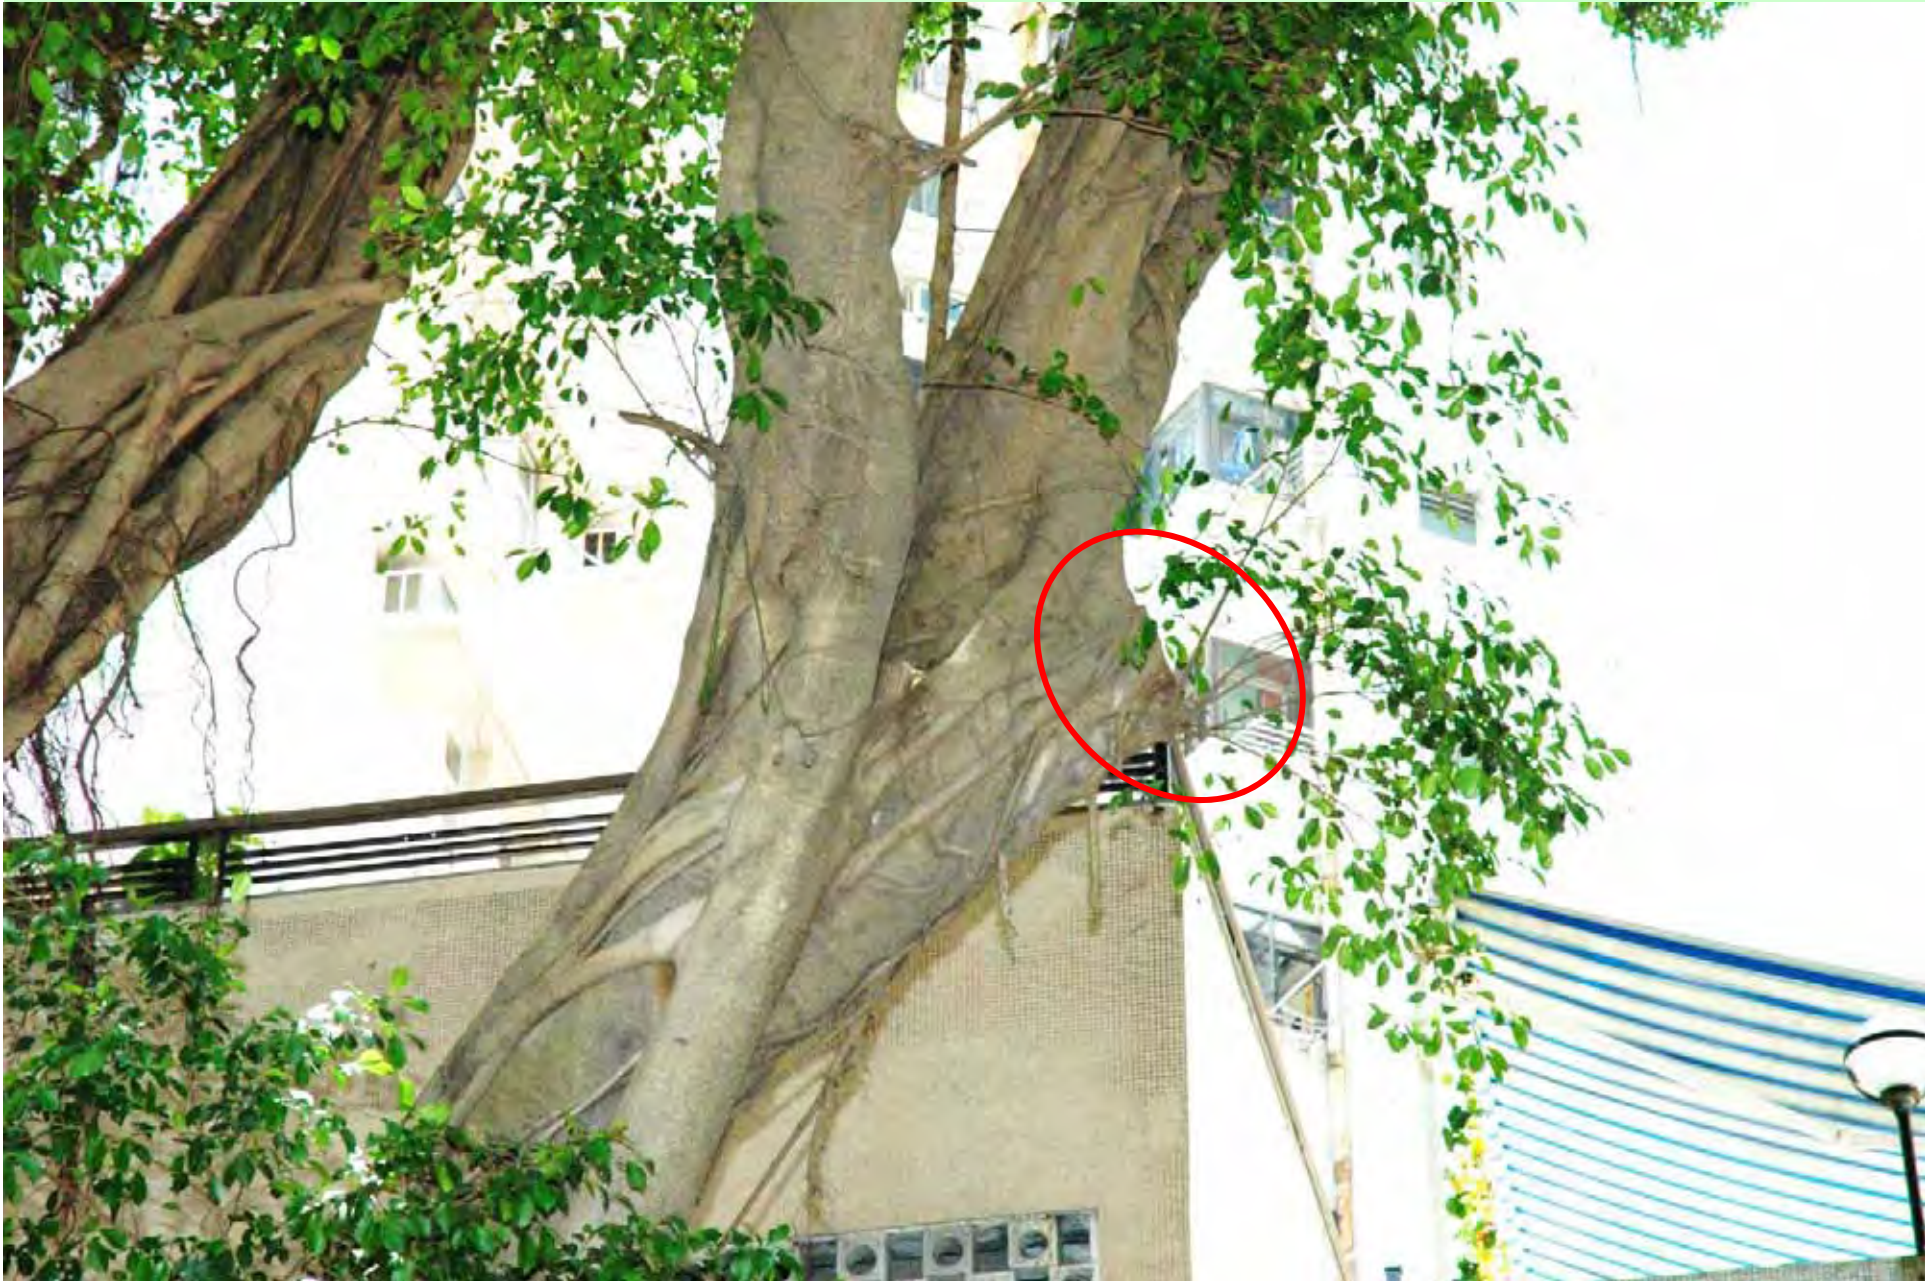
Photo T2-58. Decayed large wound at stem C left by truncation of a thick limb.
