Assessment of Wall Trees on Slope 11SW-A/R577 at Bonham Road

**Highways Department
HKSAR Government**

**C.Y. Jim
The University of Hong Kong
hrajcy@hku.hk**

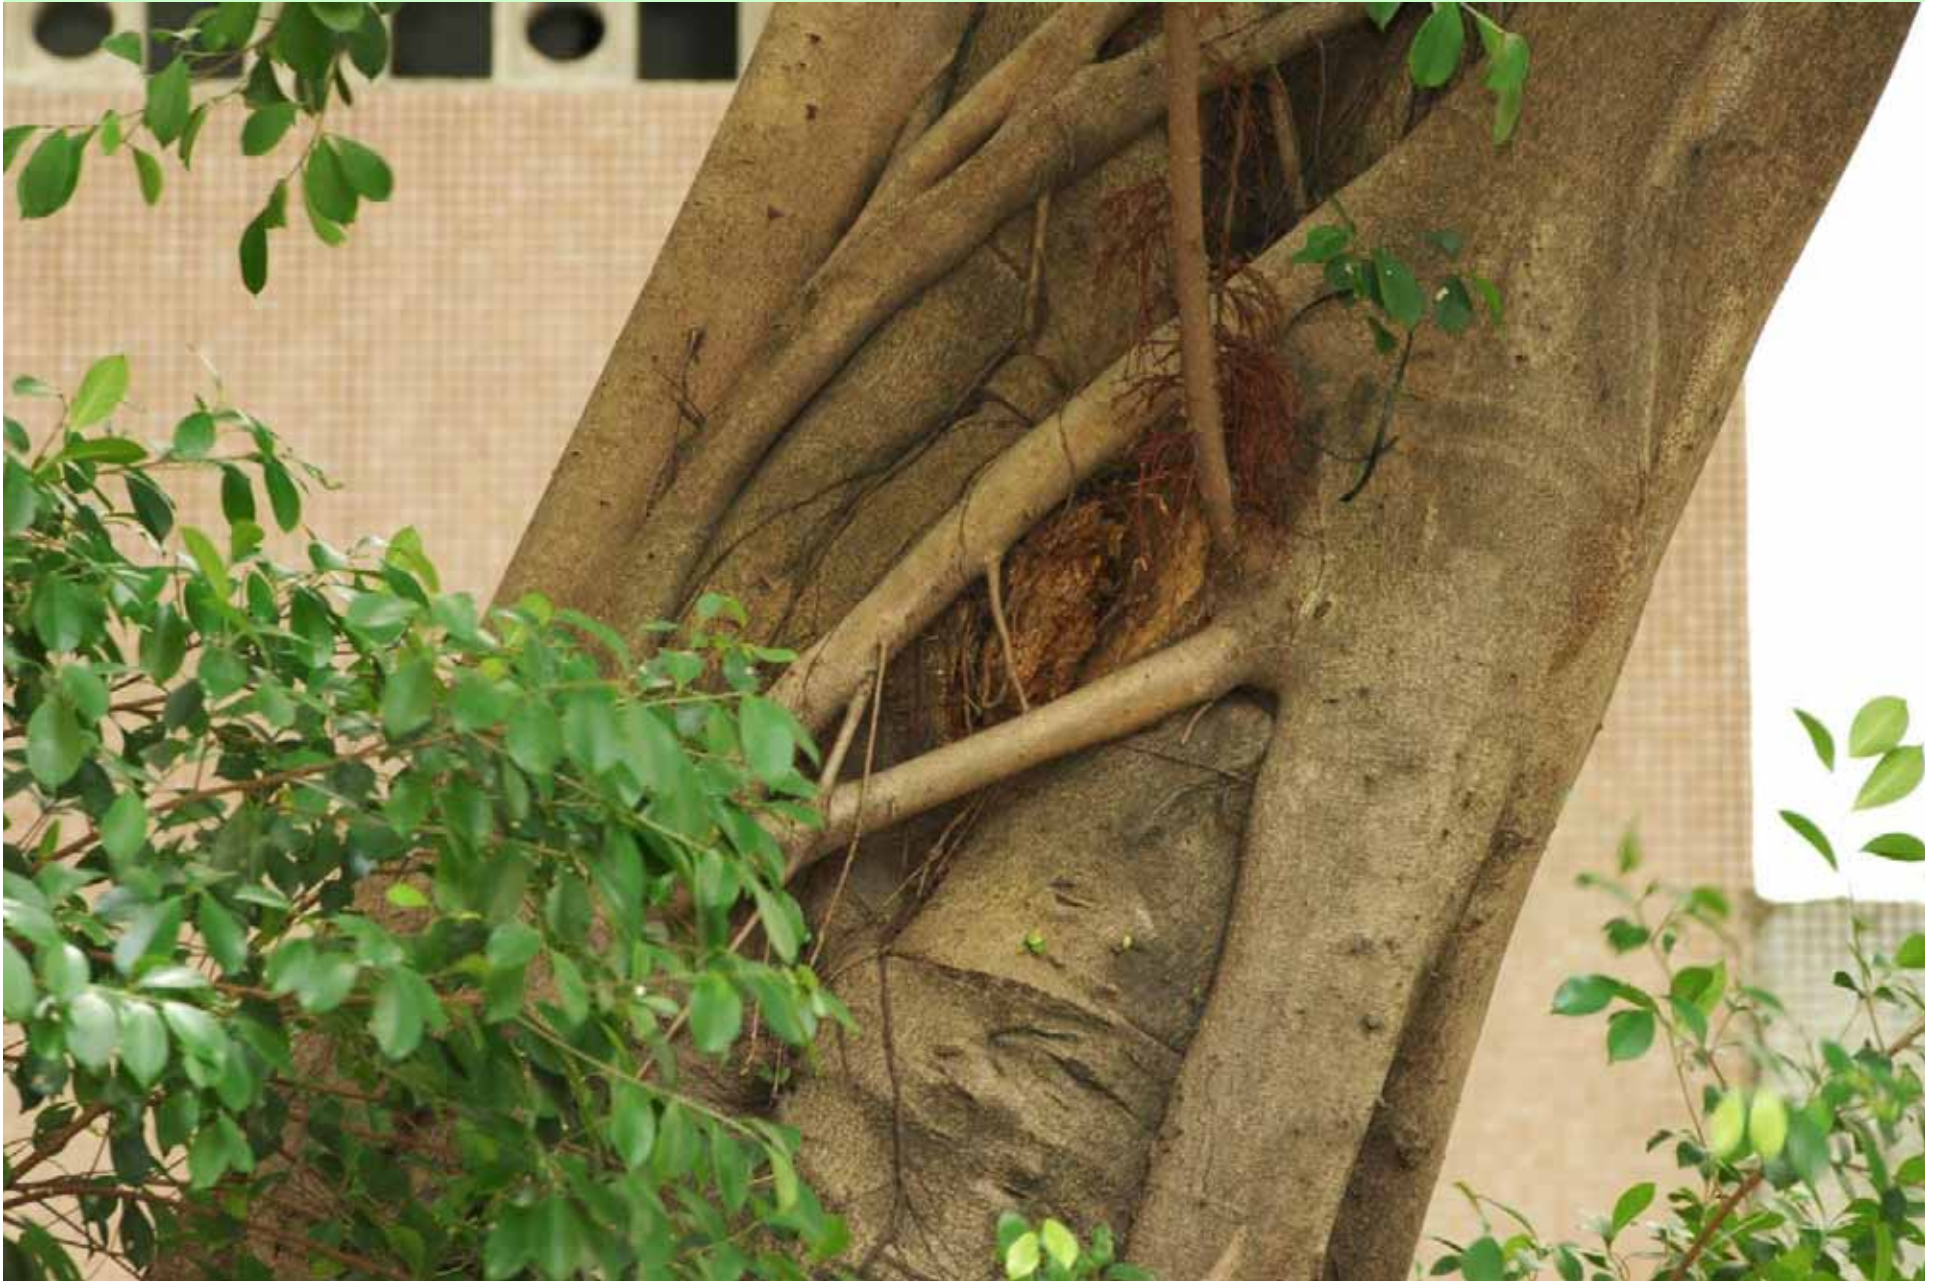
Photo T2-59. Stem C with decayed wound in a recessed niche.

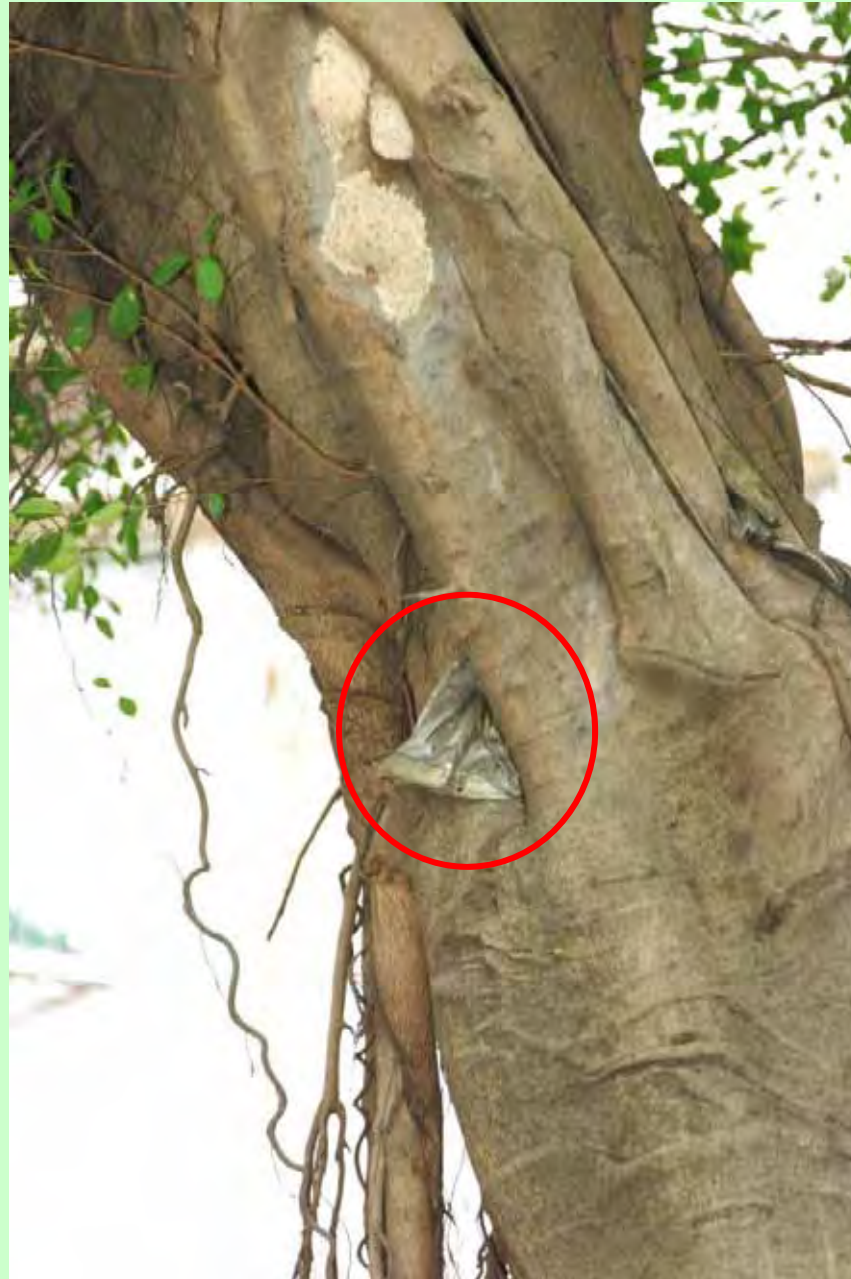
Photo T2-60. Plastic rubbish trapped by wood growth in Stem C.

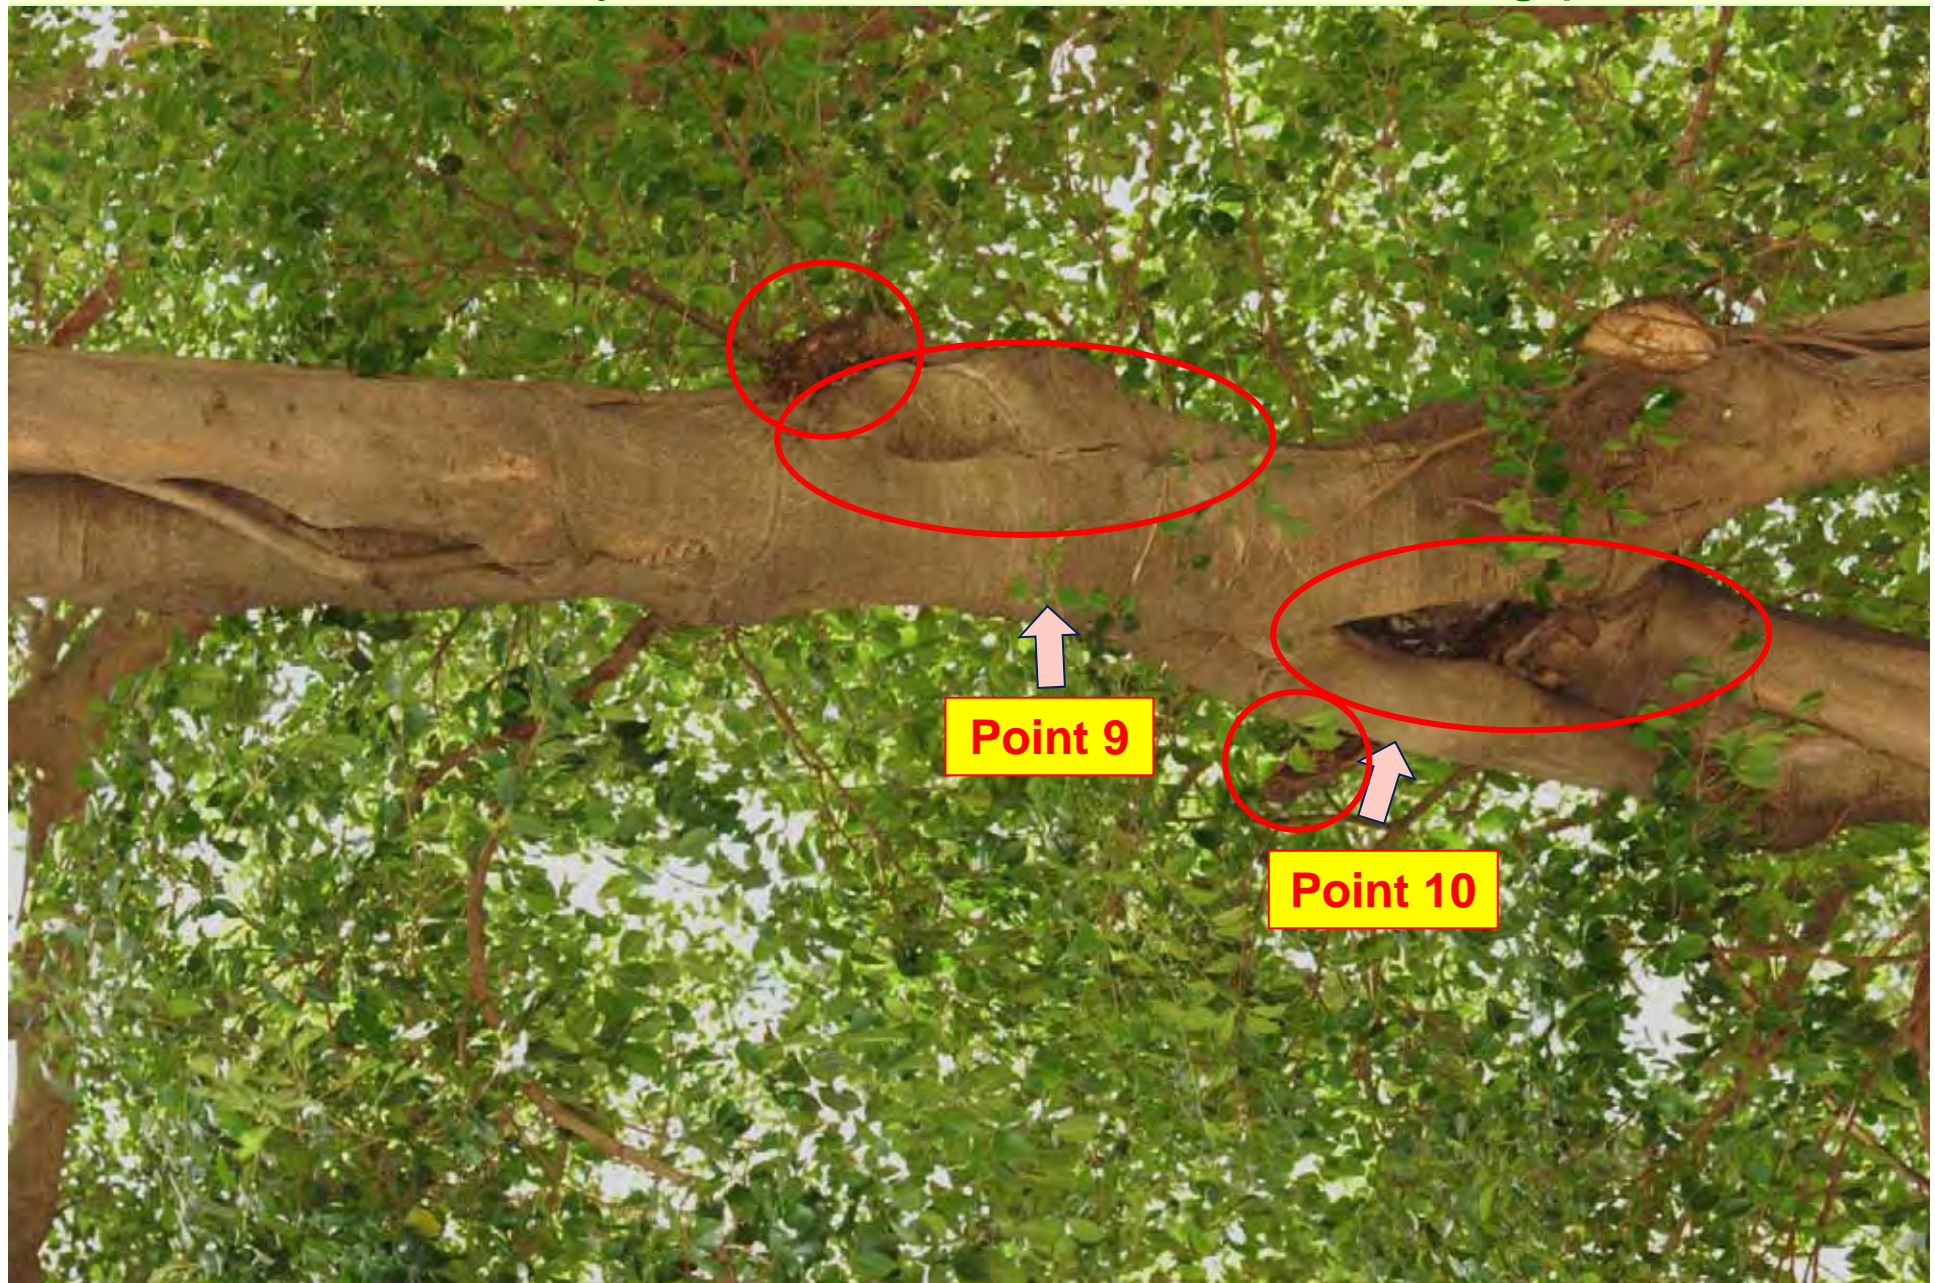
Photo T2-61. Stem C with cracks, seam, bulgewood, decayed wound, and decayed crotch. Arrows denote drilling positions.

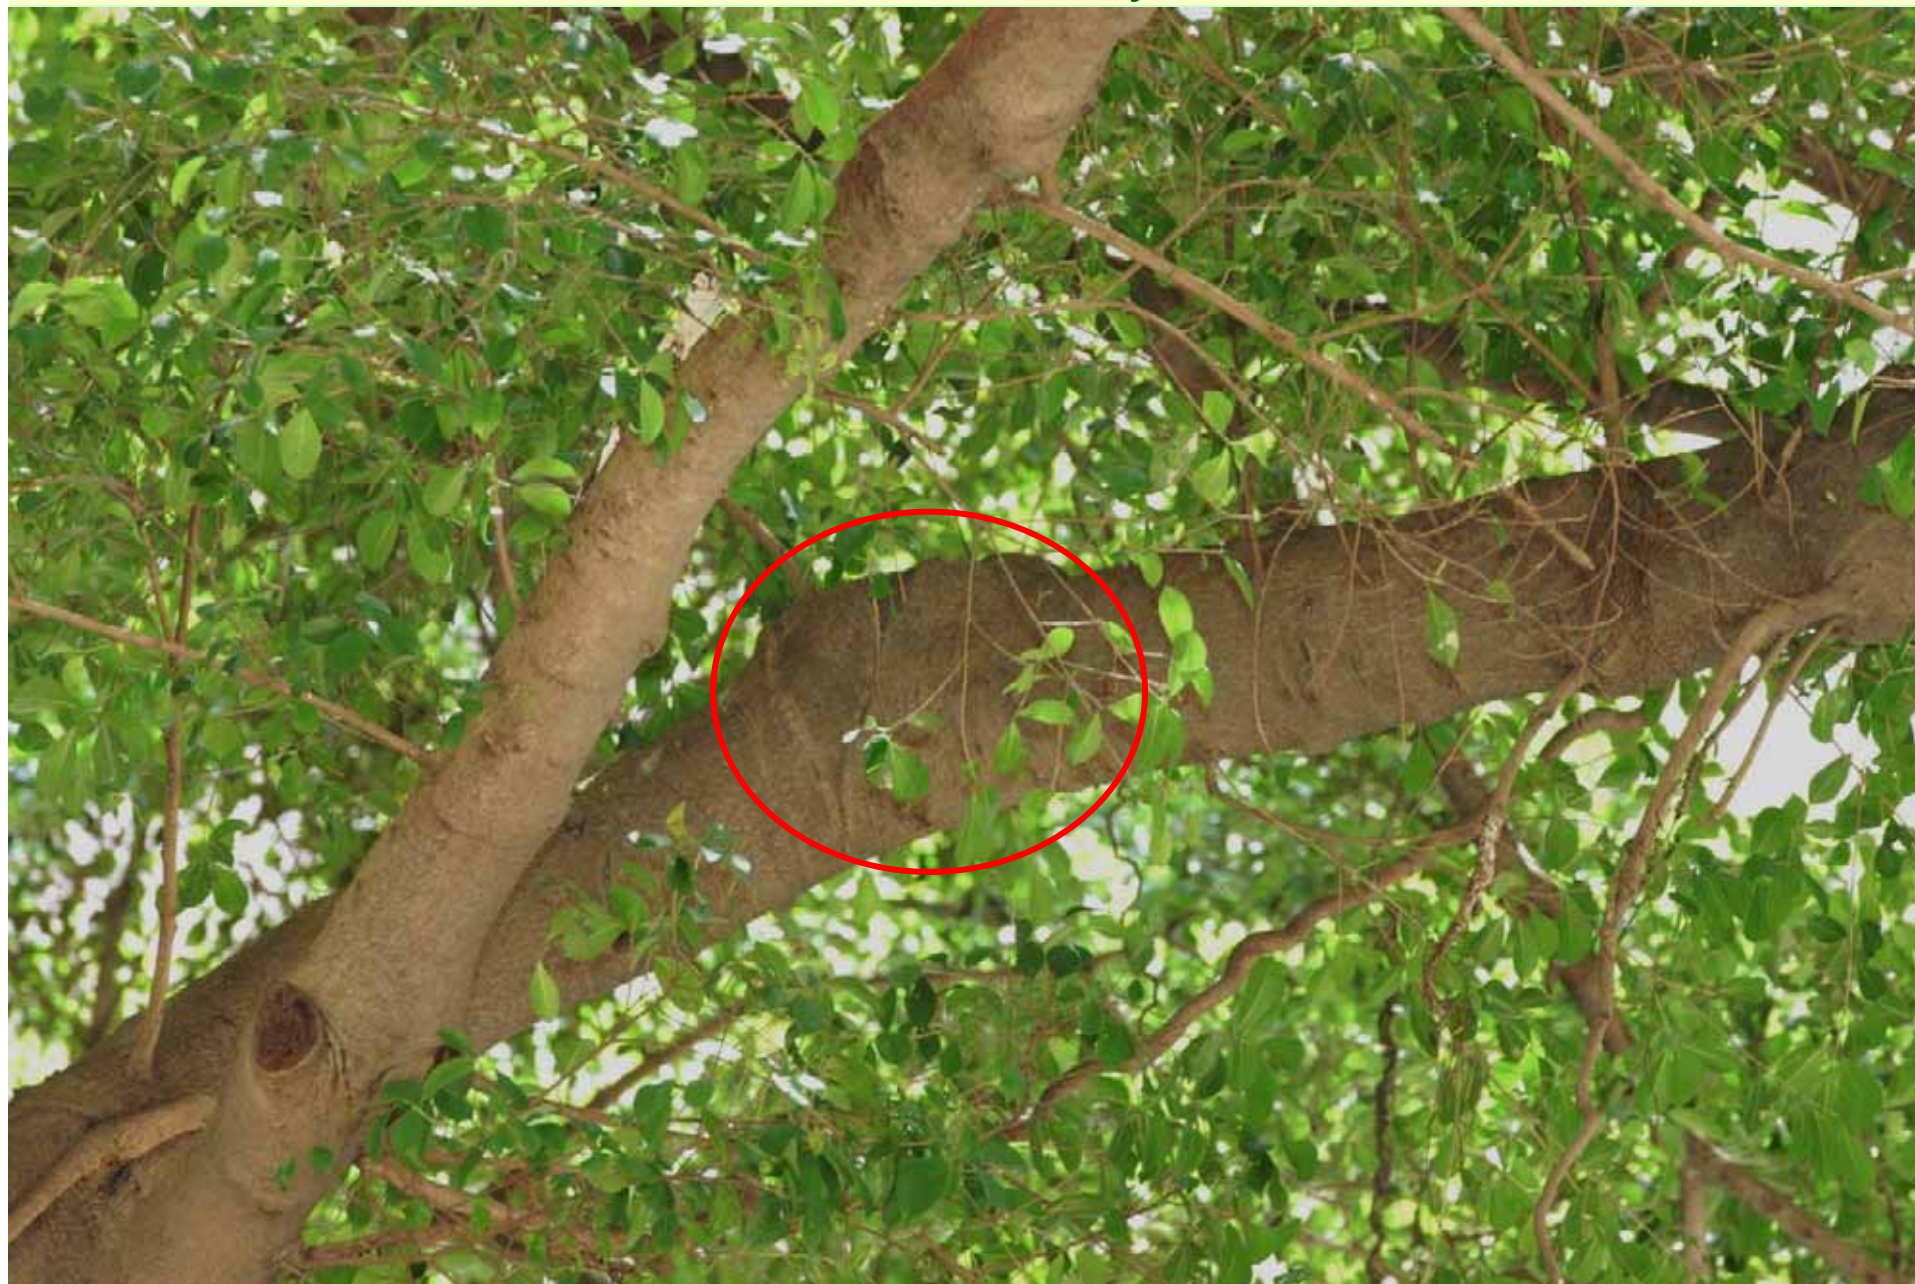
Photo T2-62. Bulgewood in Stem C branch indicating possible internal decay.

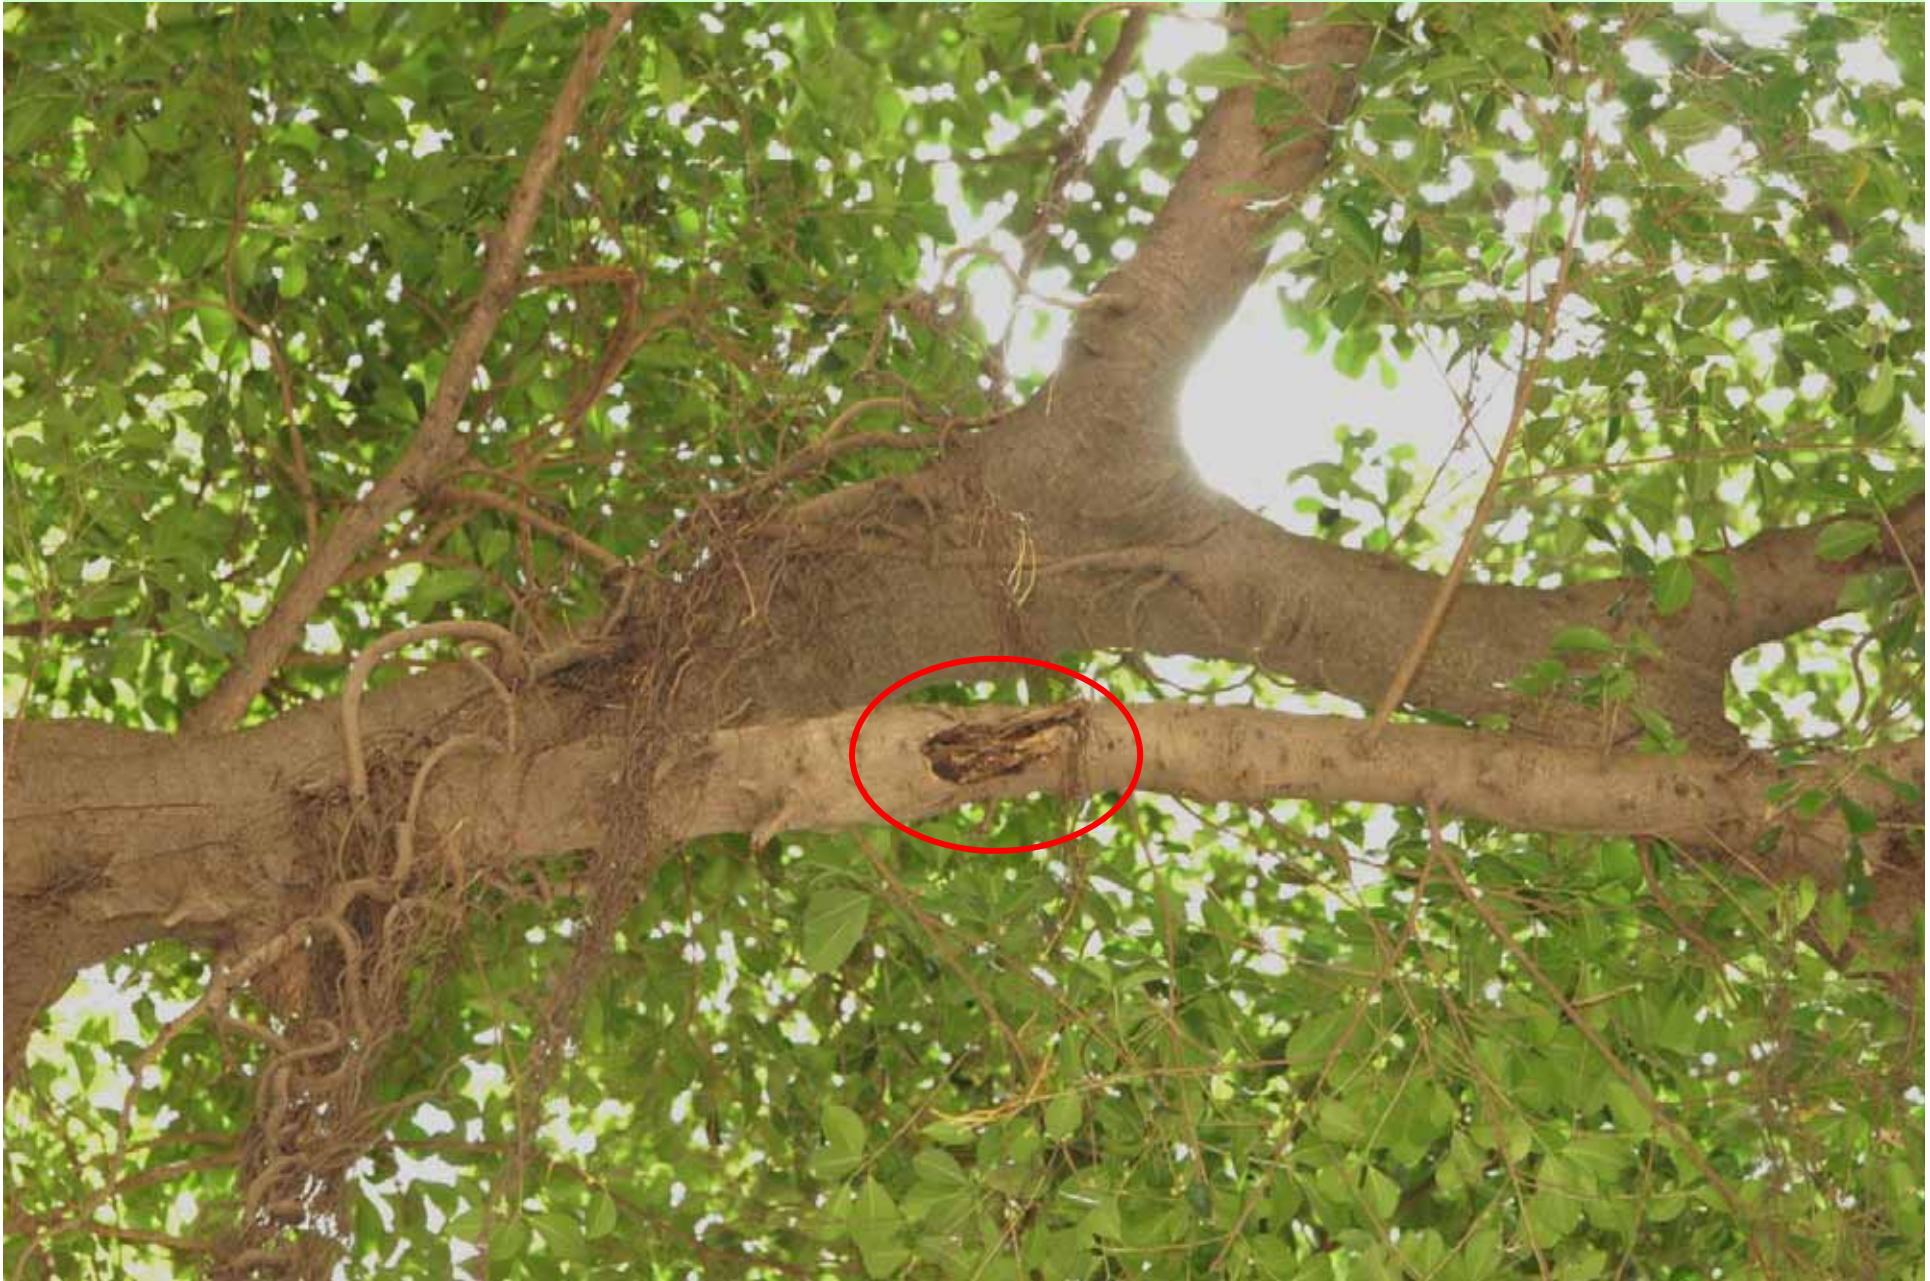
Photo T2-63. Decay of stub at stem C branch may extend into the parent branch.

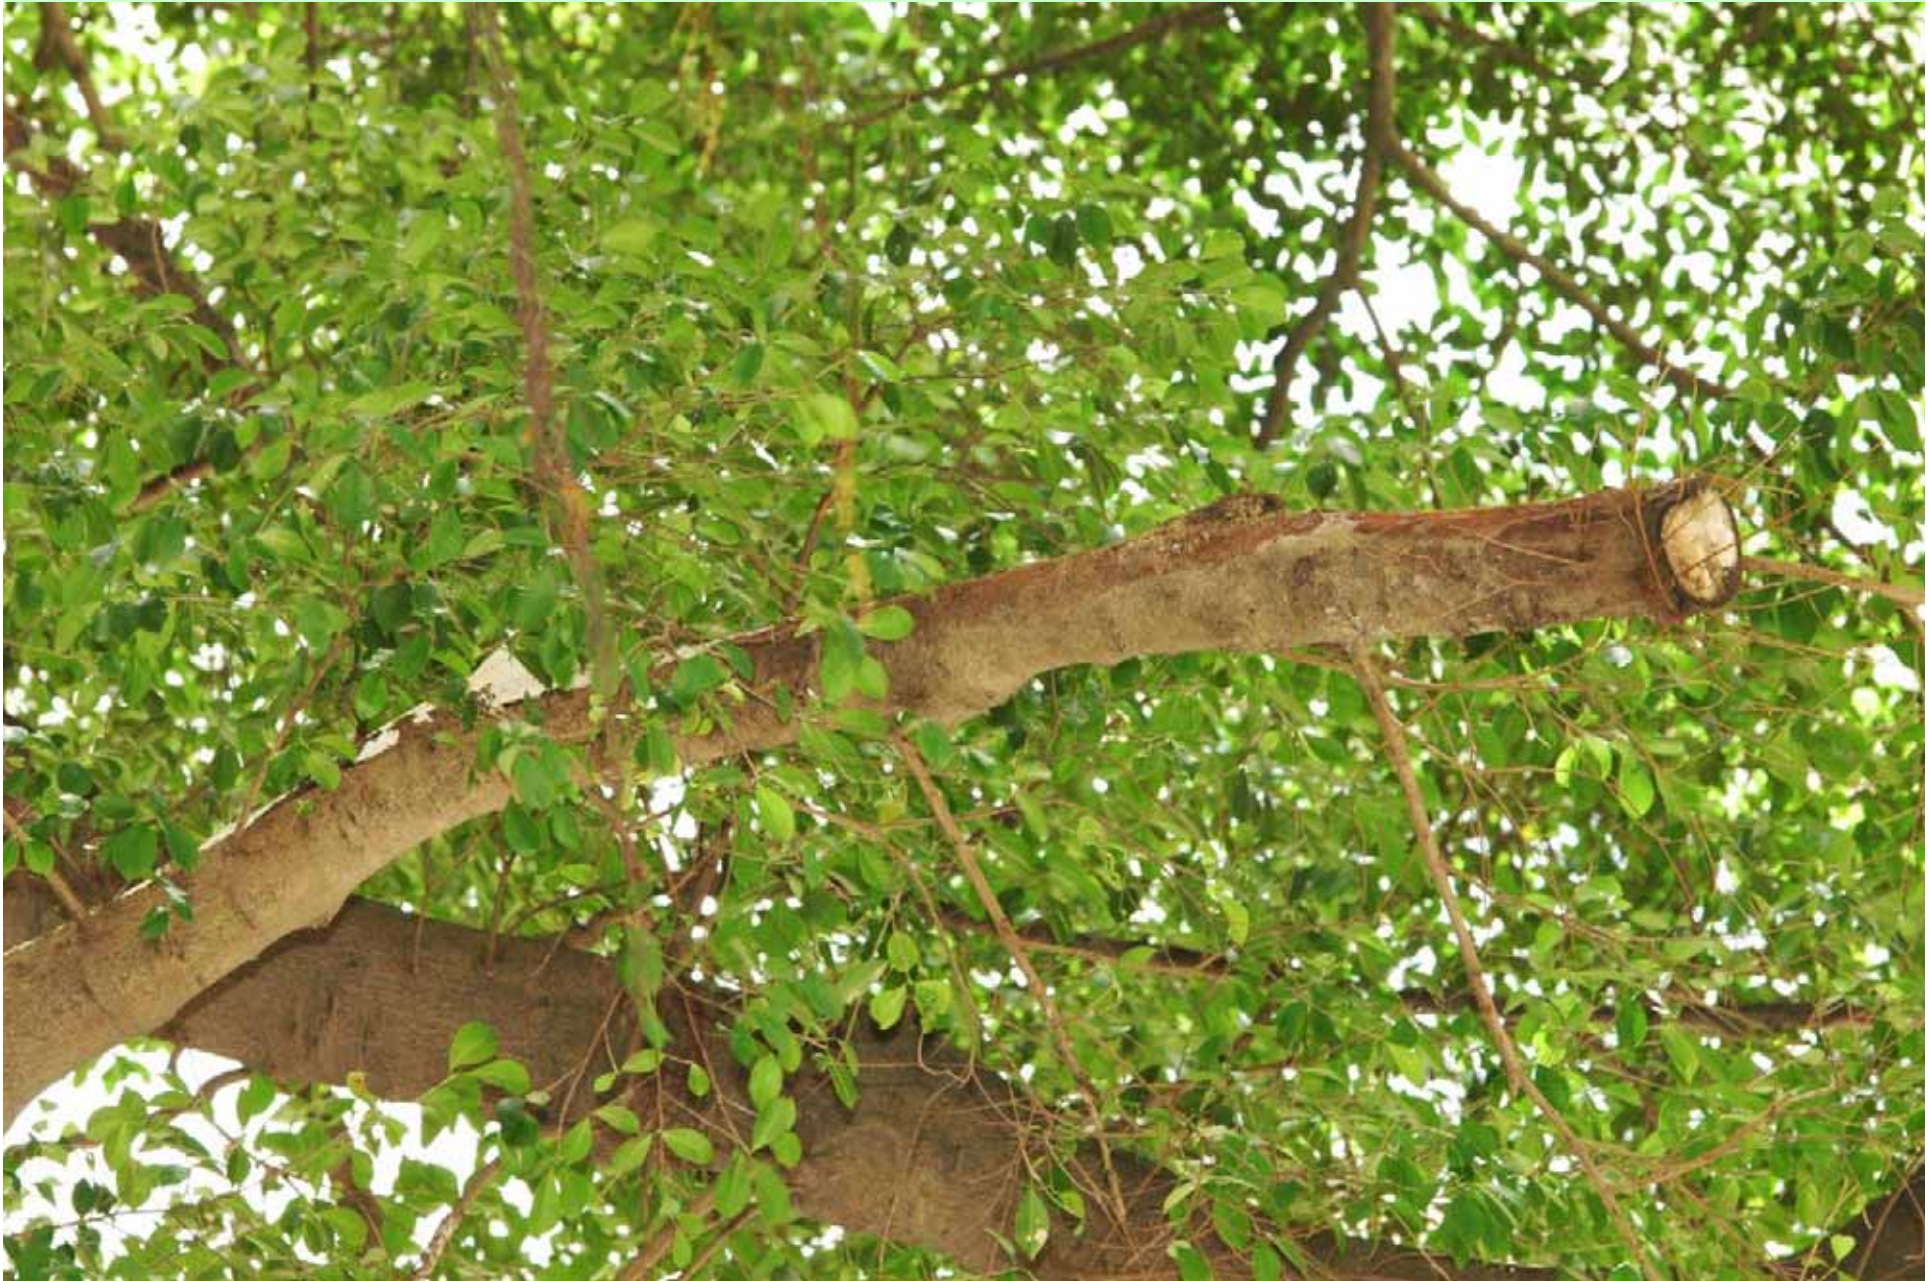
Photo T2-64. Tipped branch of stem C with longitudinal spread of decay from the wound and dead sprouts.

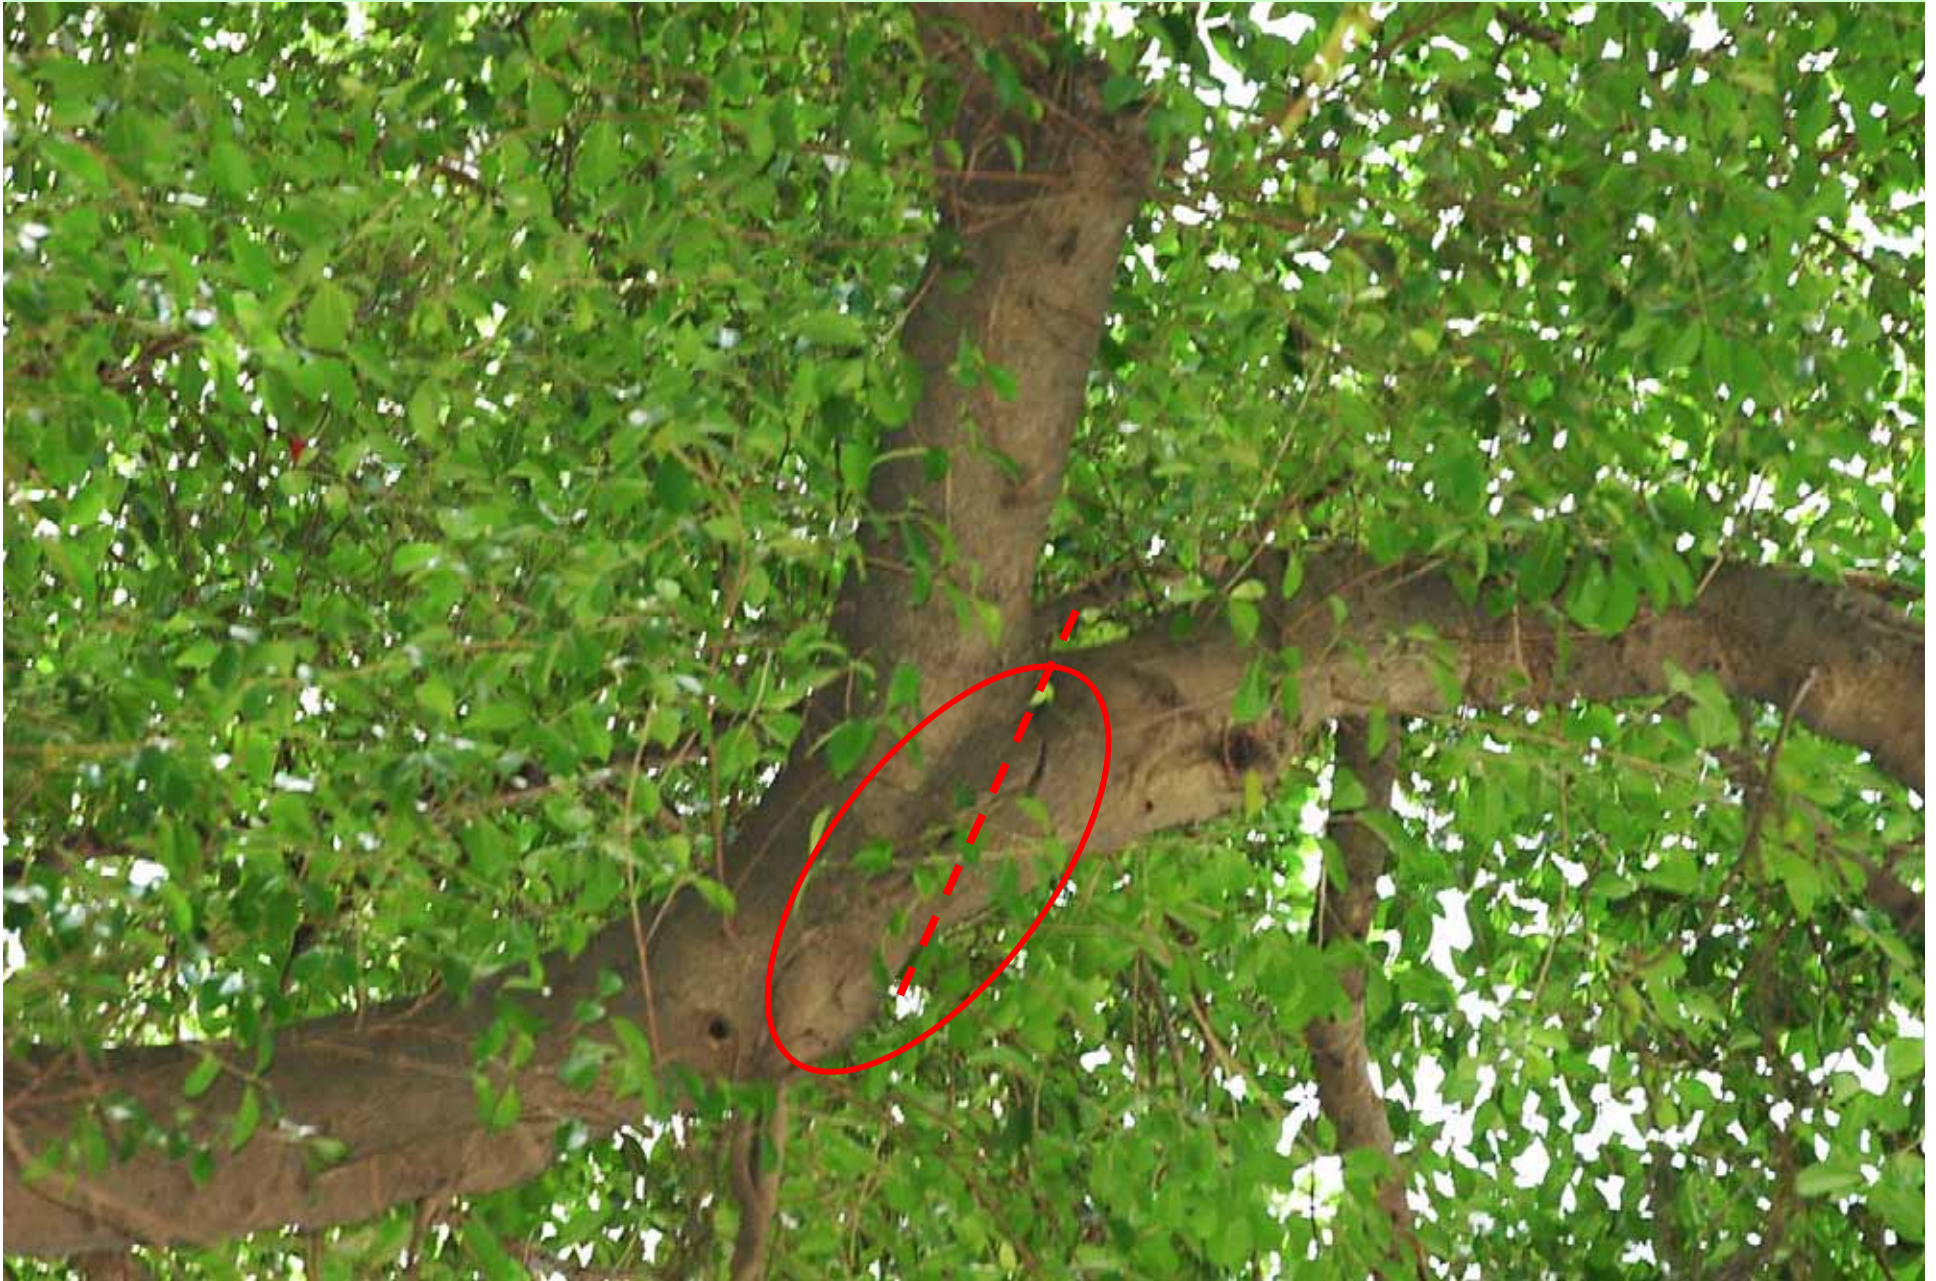
Photo T2-65. Stem C branch with crack at the crotch.

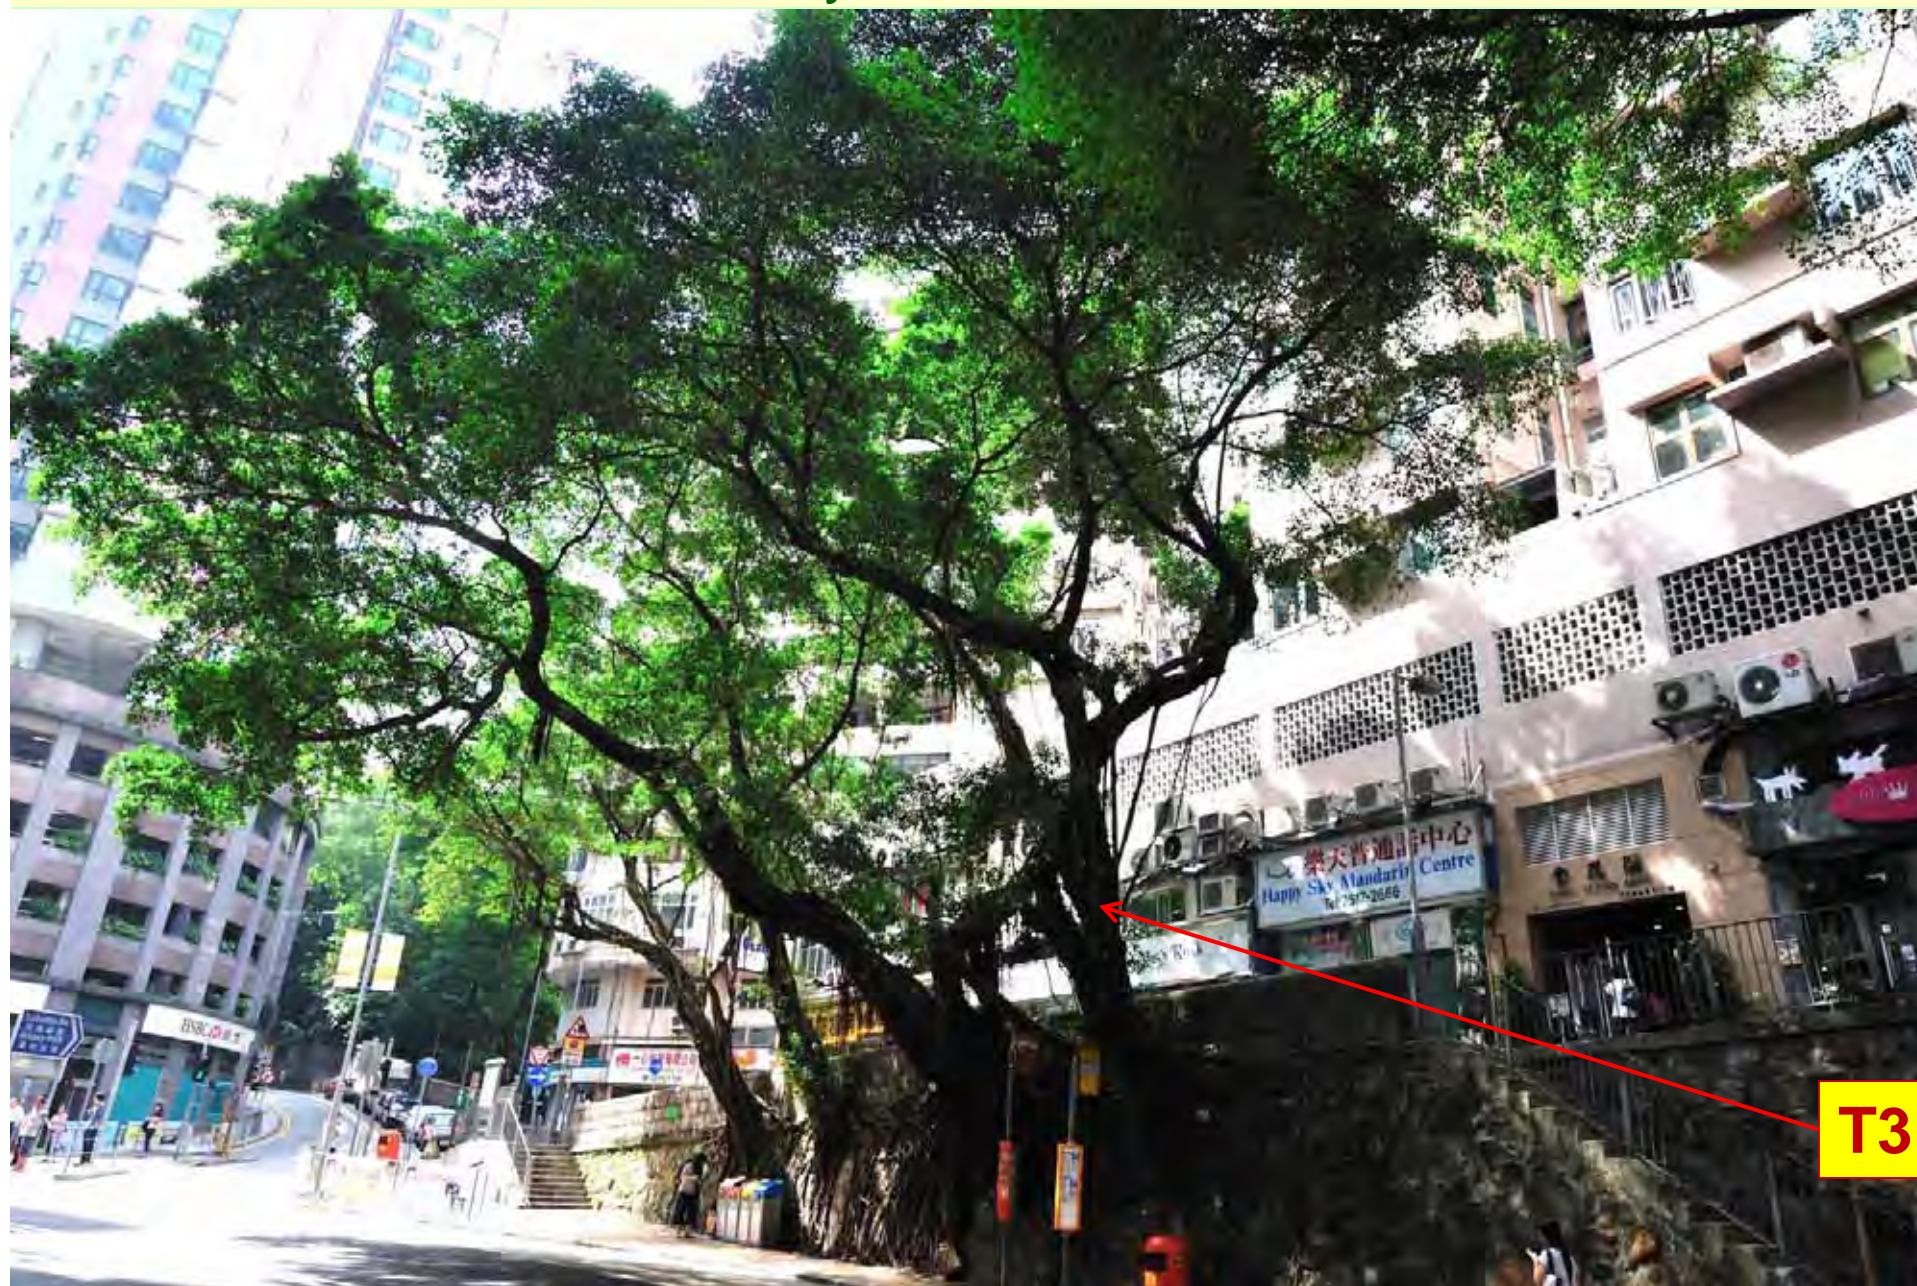
Photo T3-1. The tree in relation to its neighbours to the left, namely T4, T5 and T6.

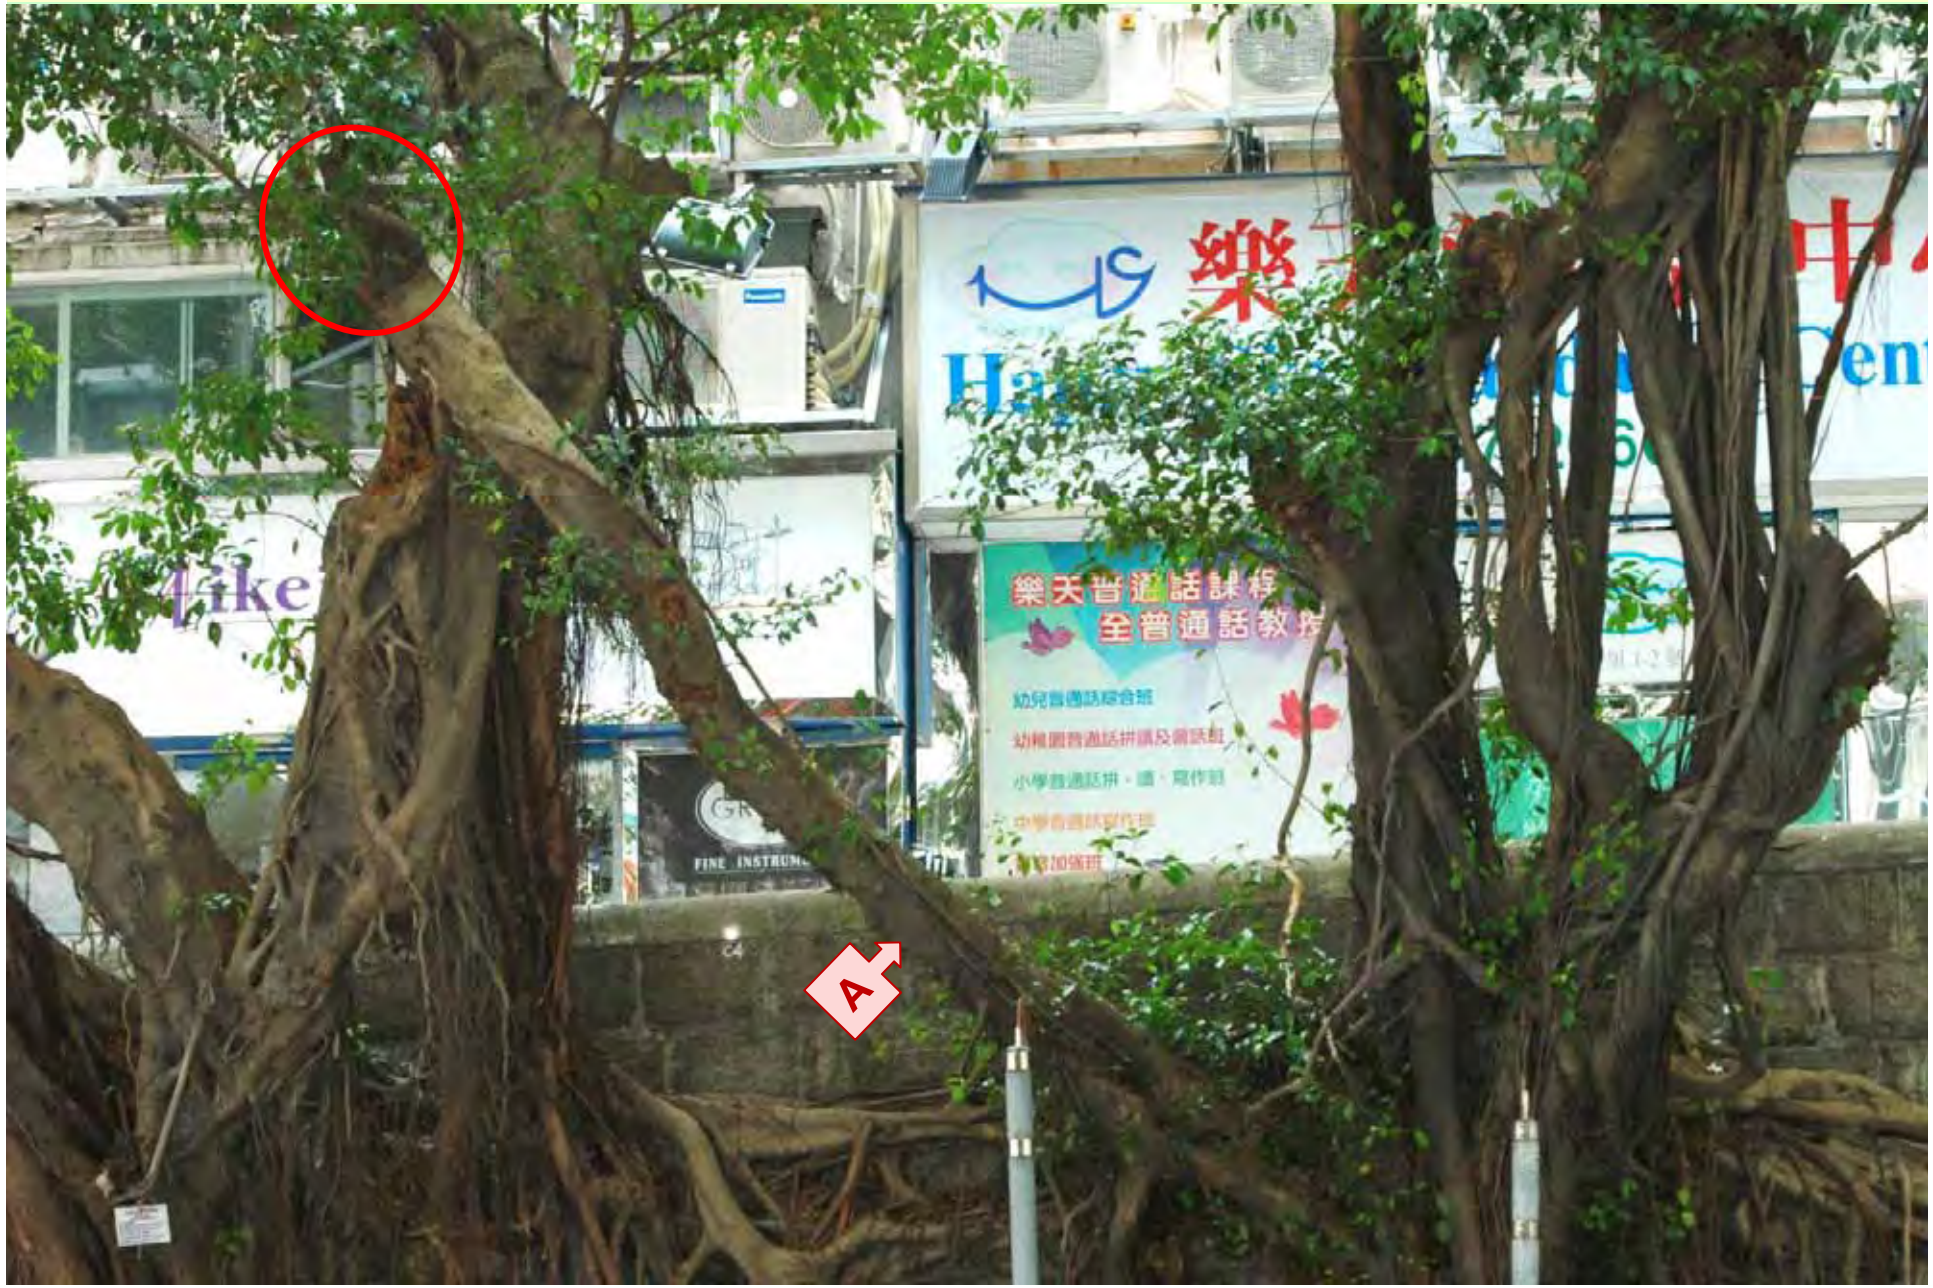
Photo T3-13. Truncated stem A that crosses with neighbour tree T4.
