Assessment of Wall Trees on Slope 11SW-A/R577 at Bonham Road

**Highways Department
HKSAR Government**

**C.Y. Jim
The University of Hong Kong
hrajcy@hku.hk**

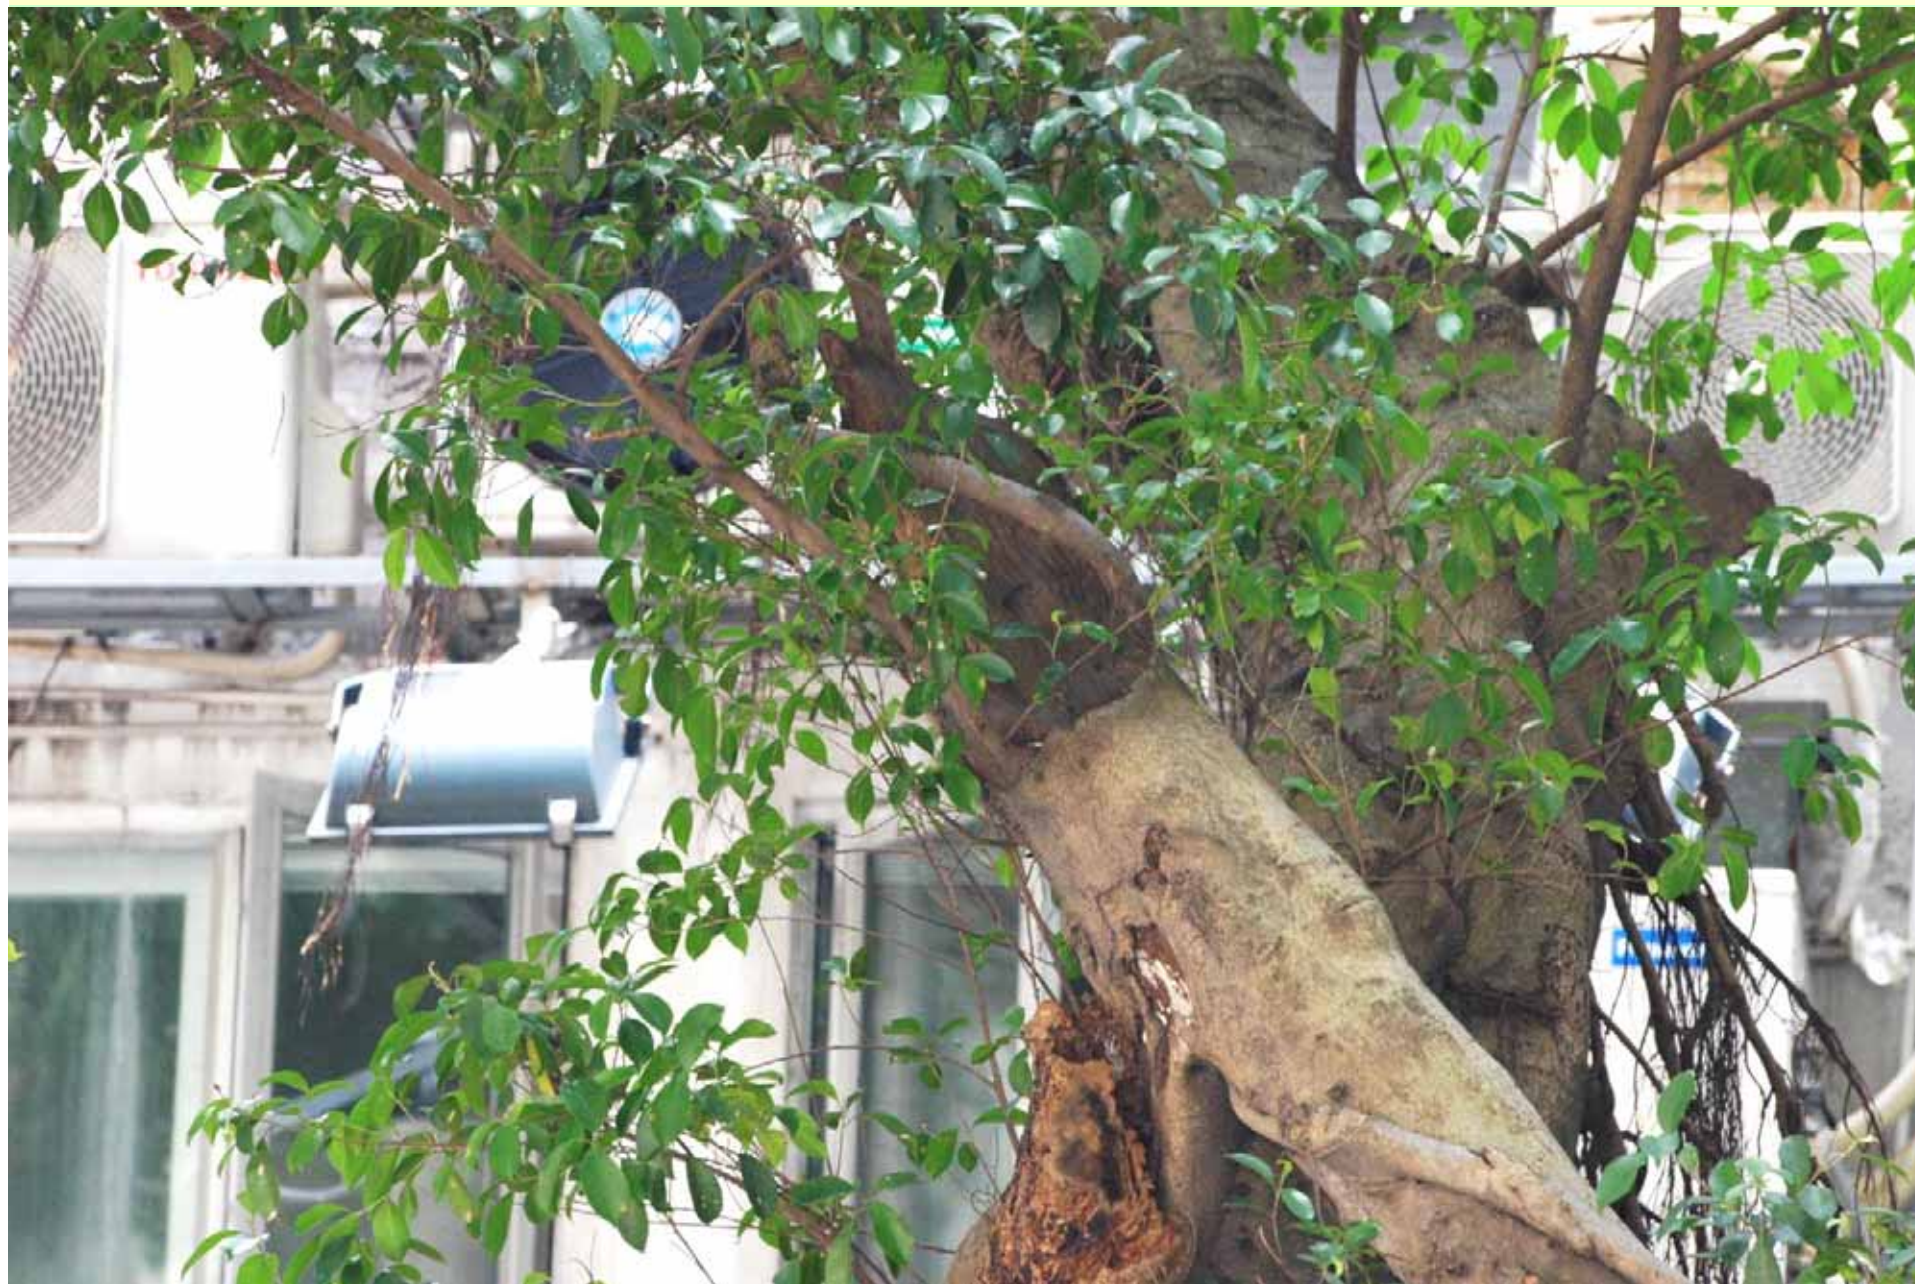
Photo T3-14. Close-up view of the decayed tip of truncated stem
A.

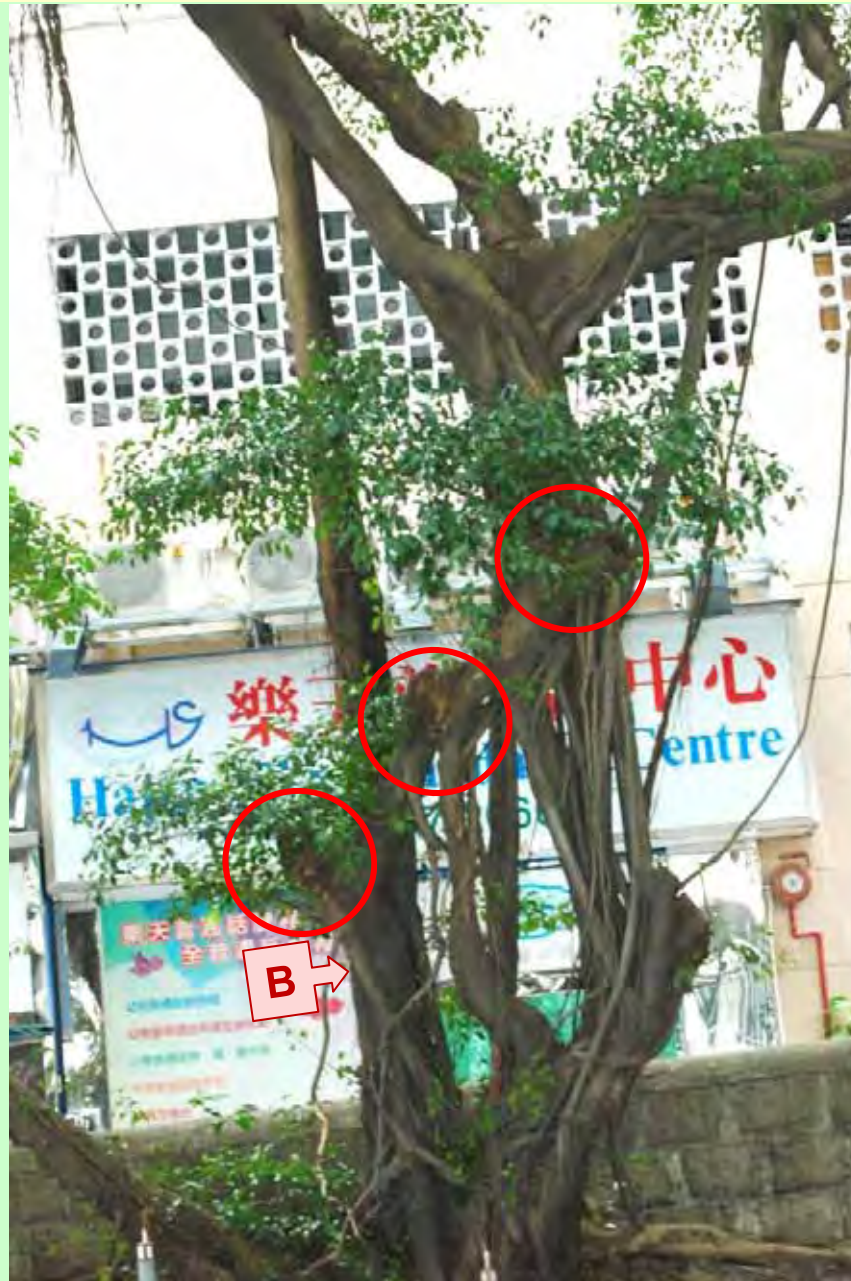
Photo T3-15. Wounds left by limb removal from stem B have developed decay and cavity.

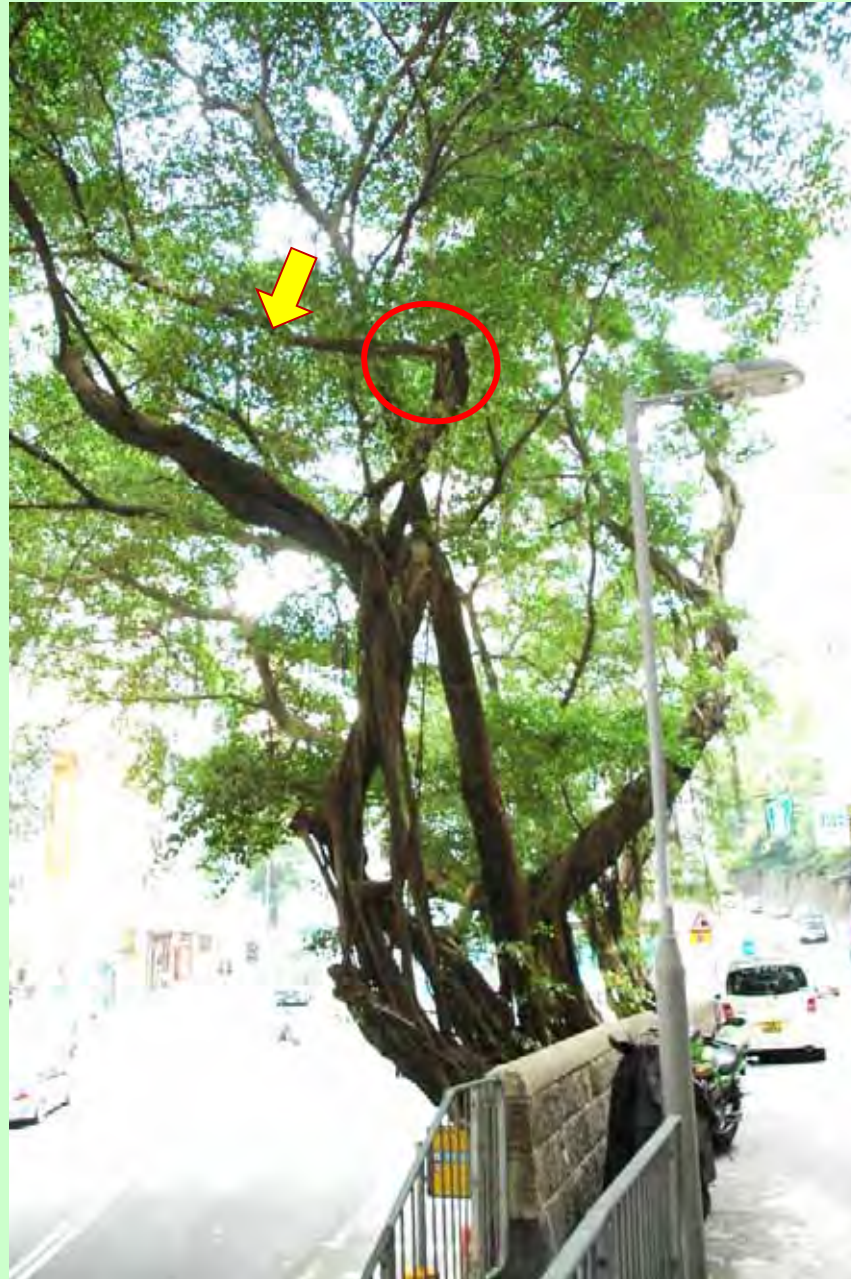
Photo T3-17. Long epicormic branch emerges with an elbow joint from a branch-cut wound.

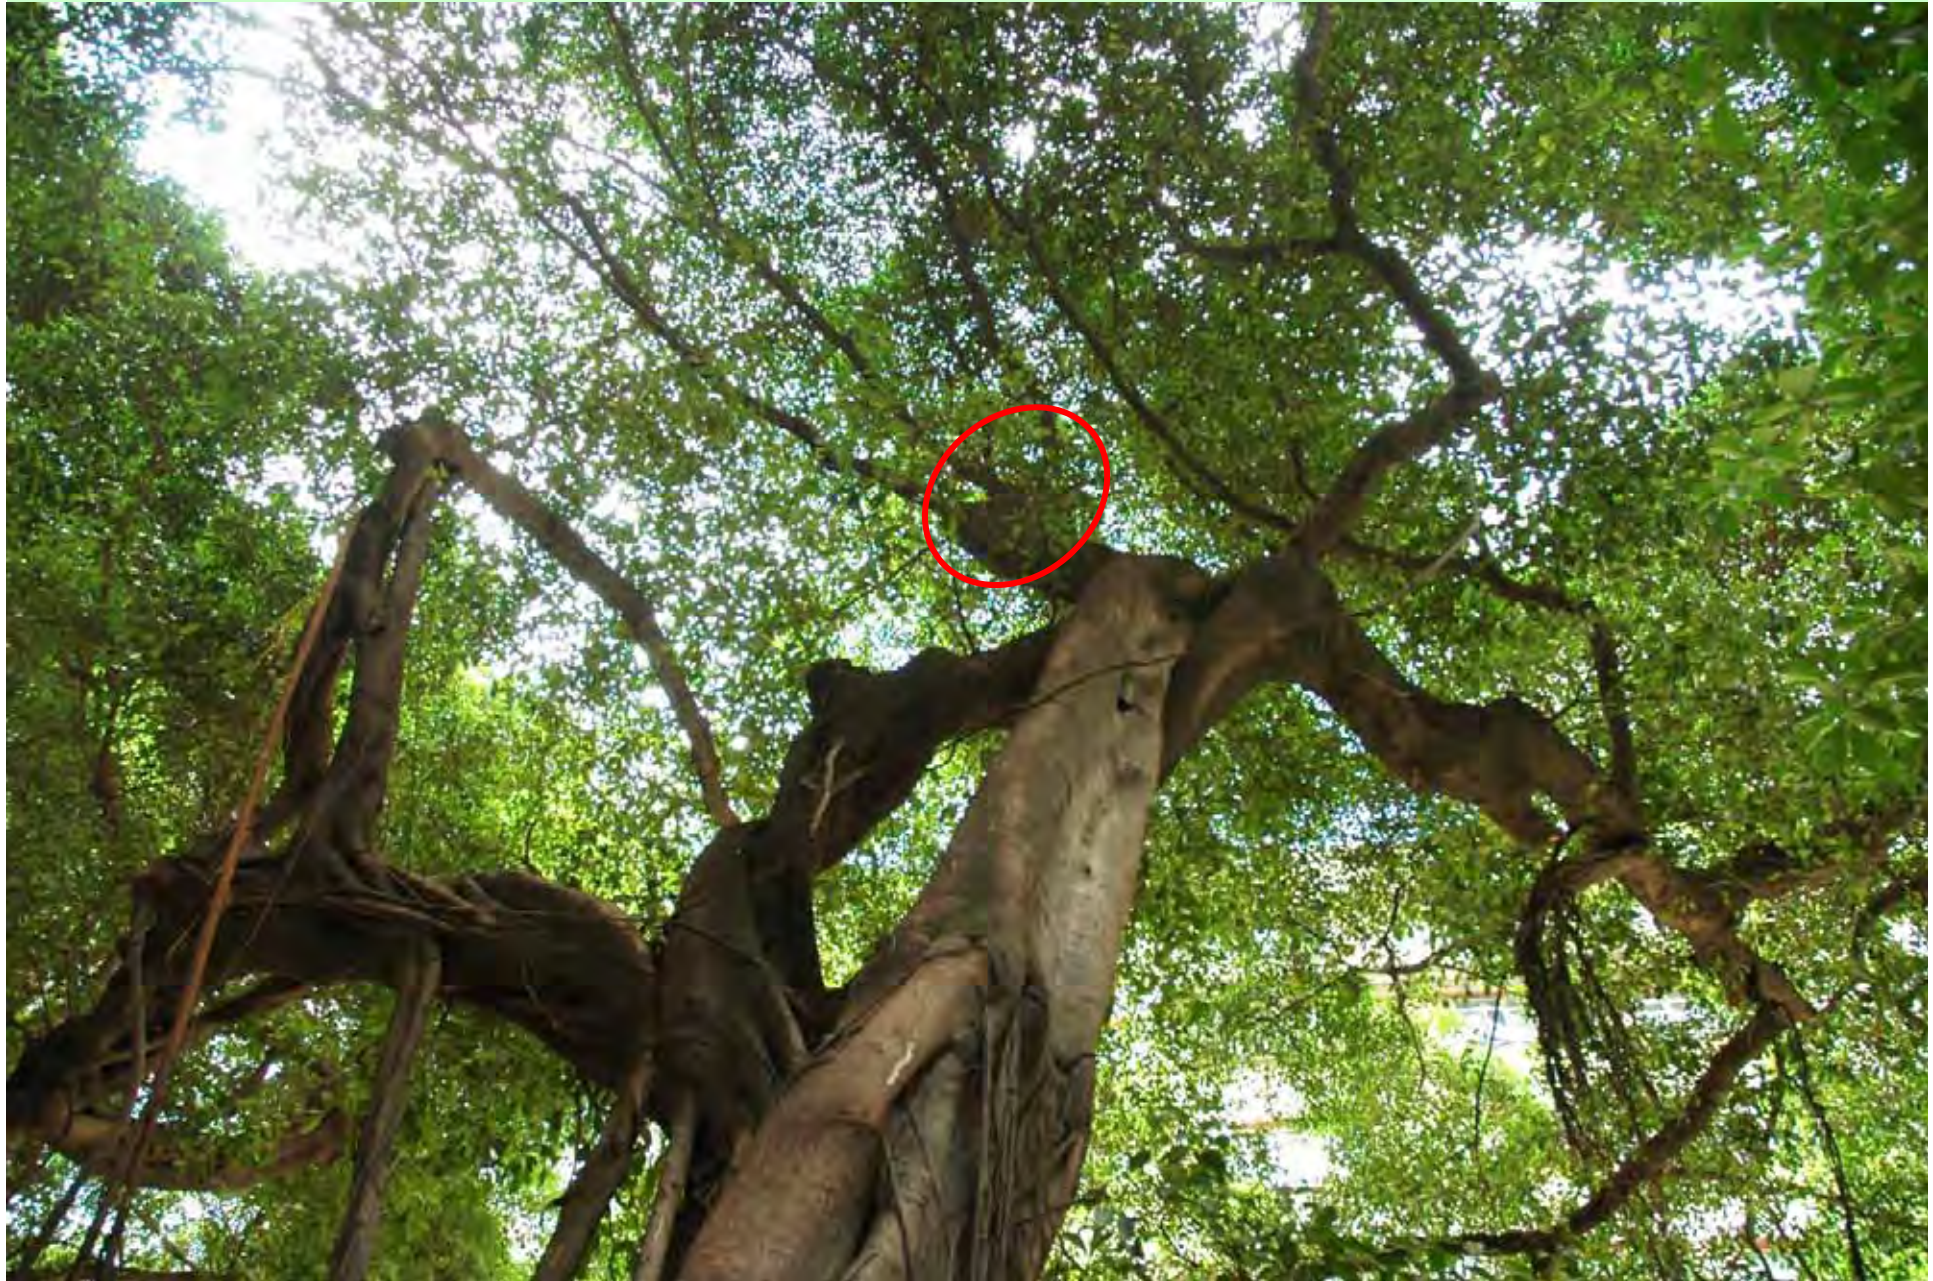
Photo T3-18. A top branch of stem B was tipped and has developed a series of long replacement epicormic branches.

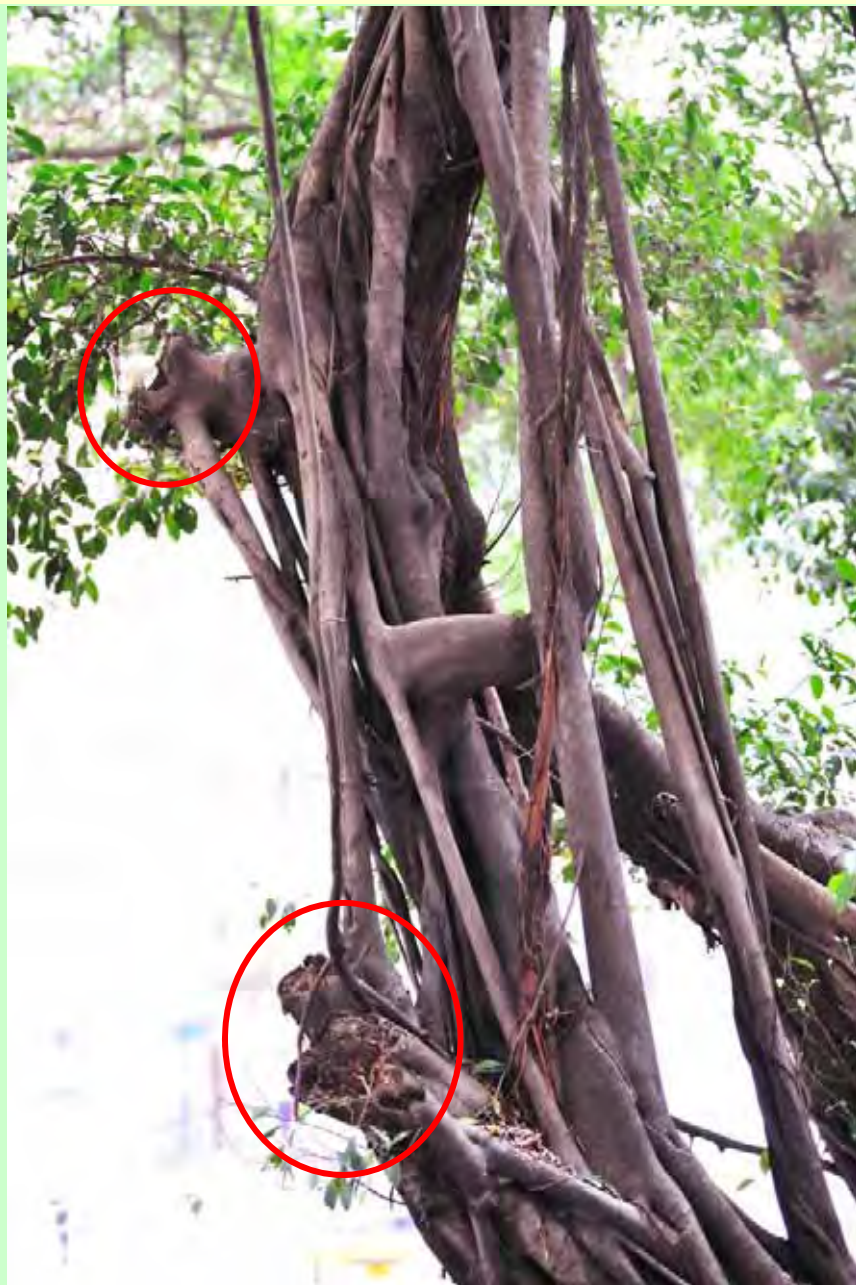
Photo T3-19. Decayed wounds at the stubs of truncated branches at stem B.

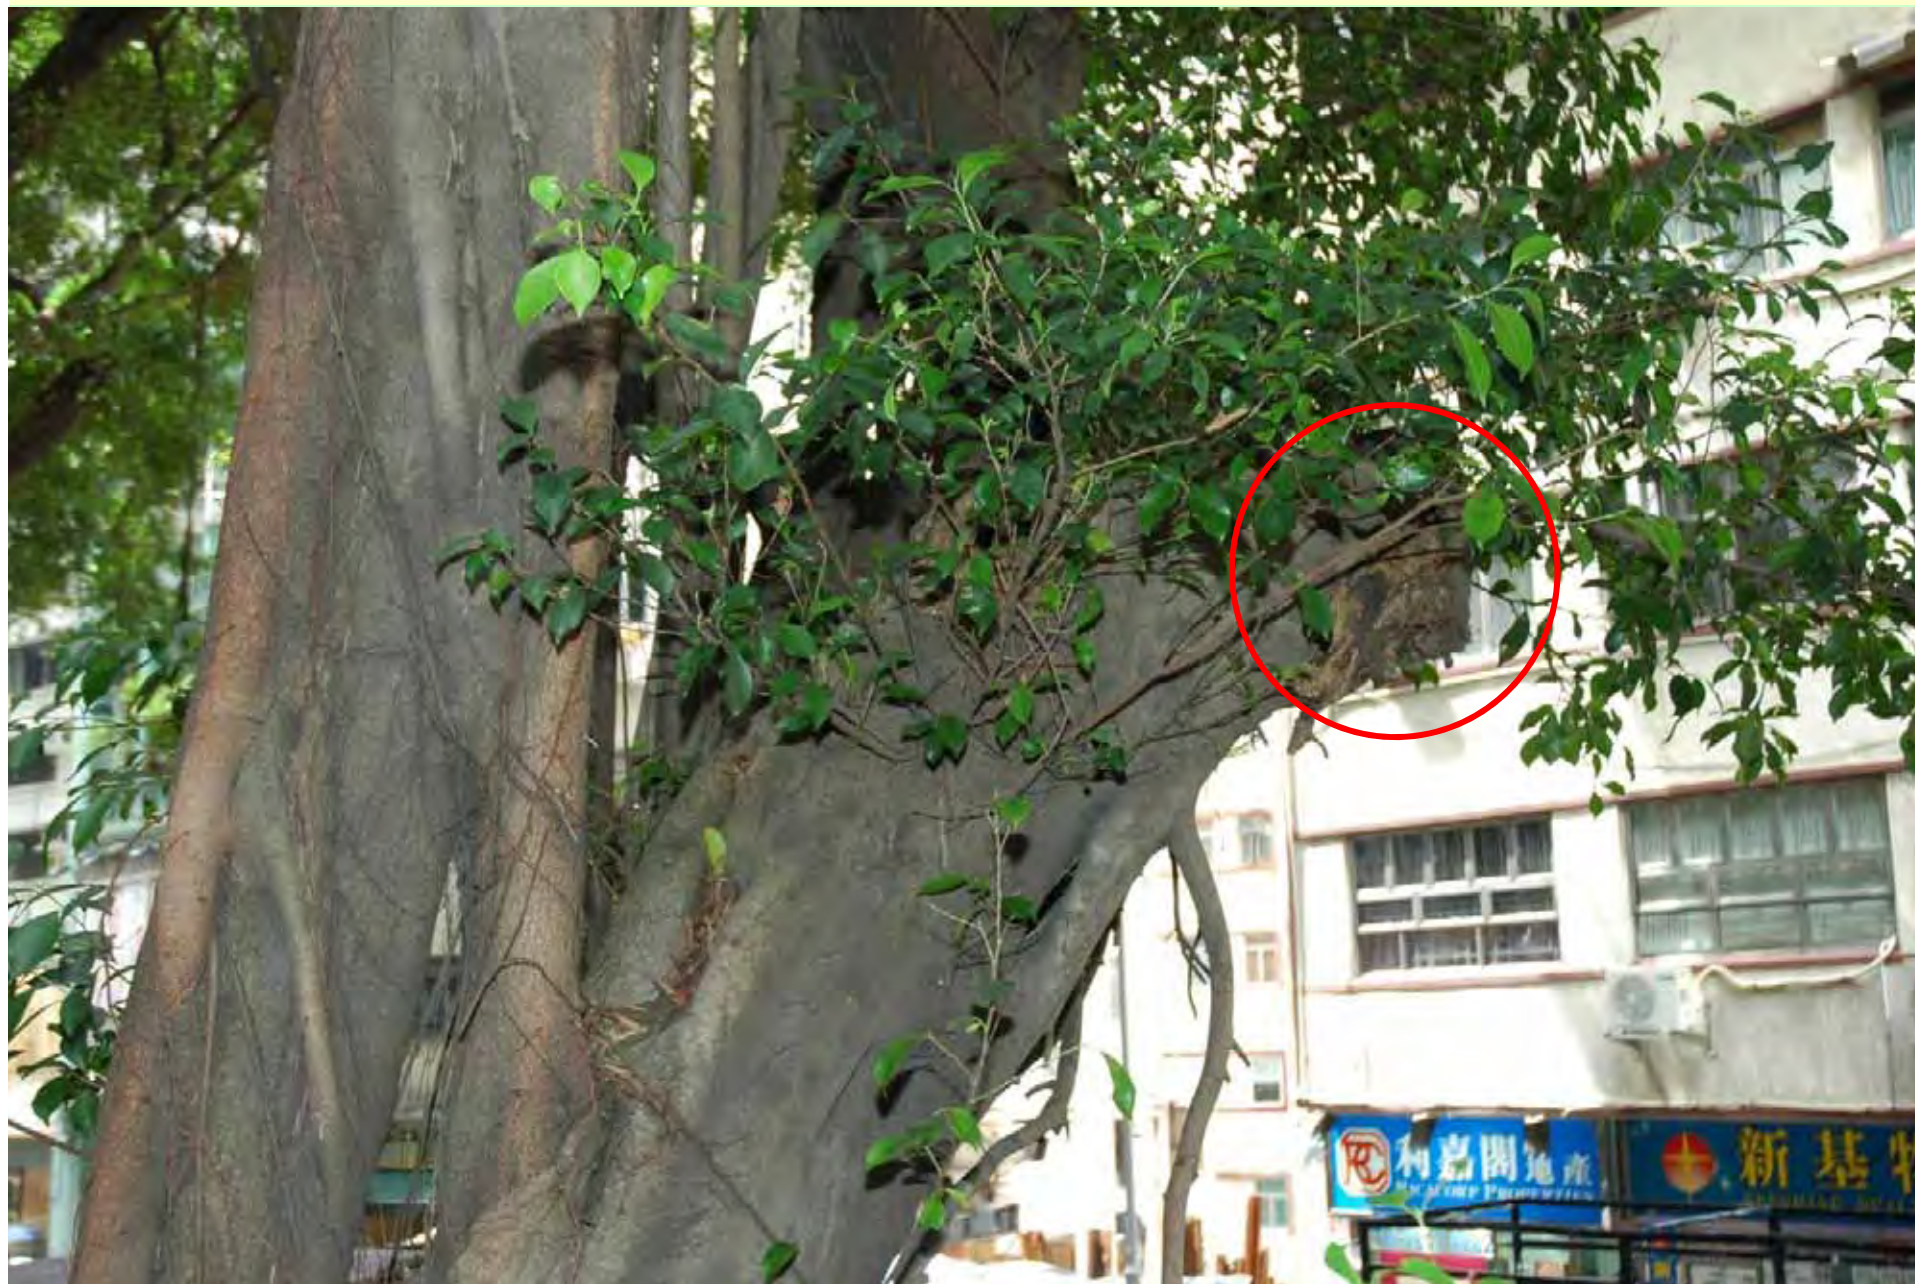
Photo T3-20. Truncated stem C with advanced decay at the large wound.

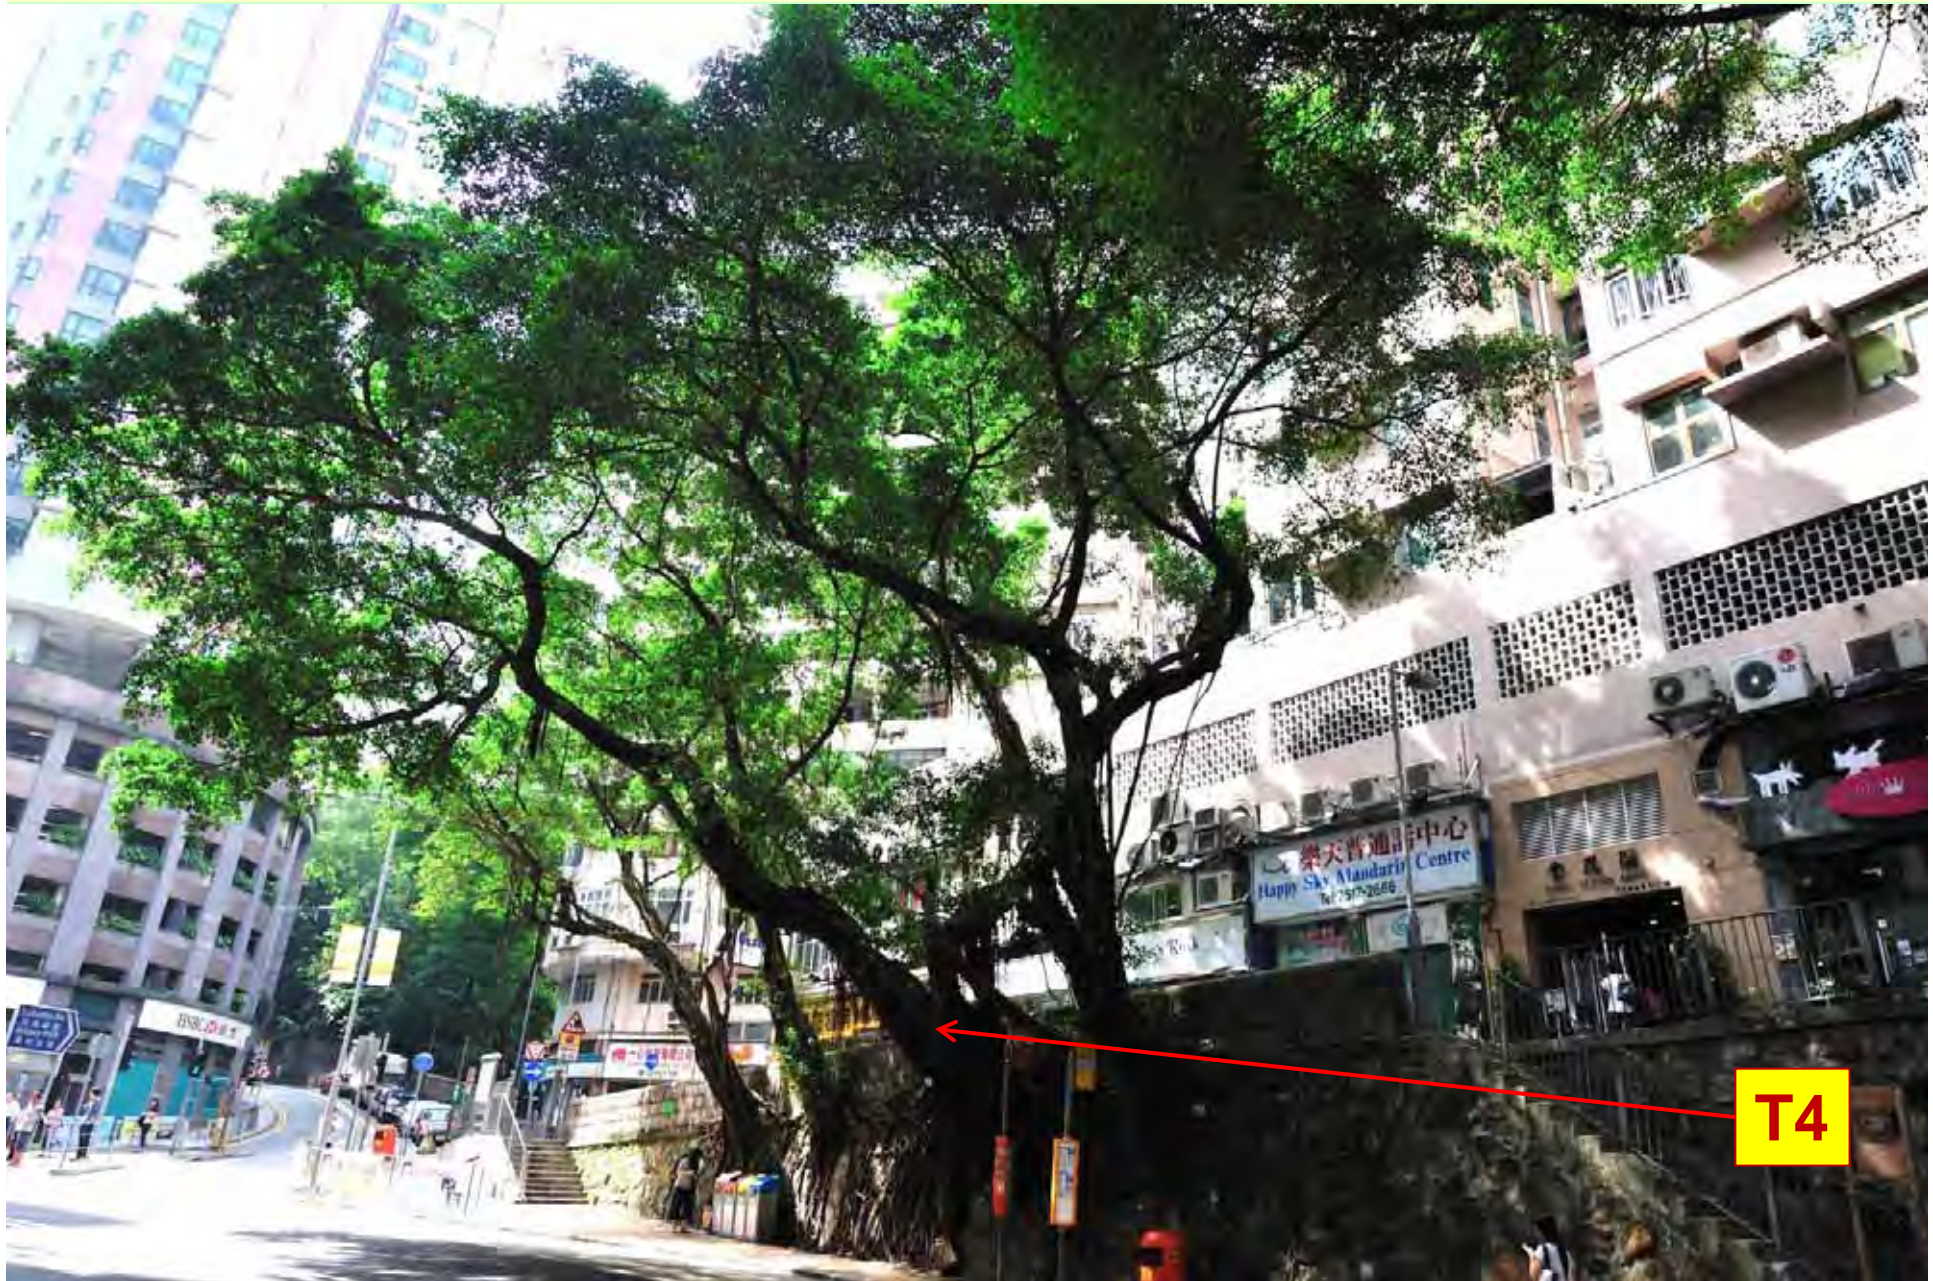
Photo T4-1. The tree in relation to its neighbours T5 and T6 (left), and T3 (right).

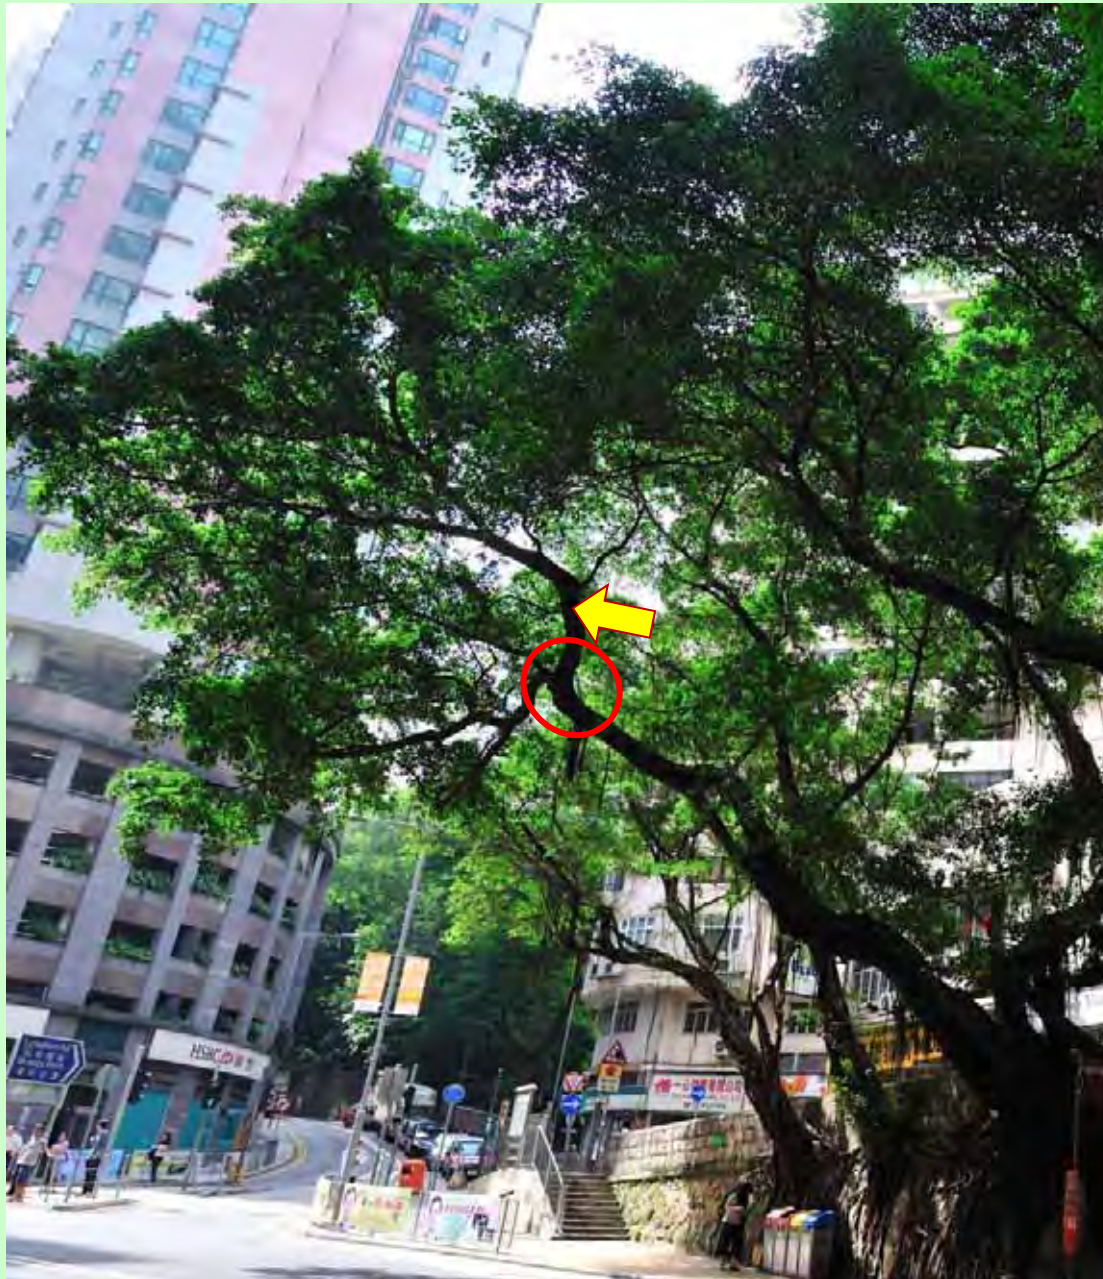
Photo T4-15. Truncated tip (circle) of Stem A with large replacement epicormic branch (arrow).

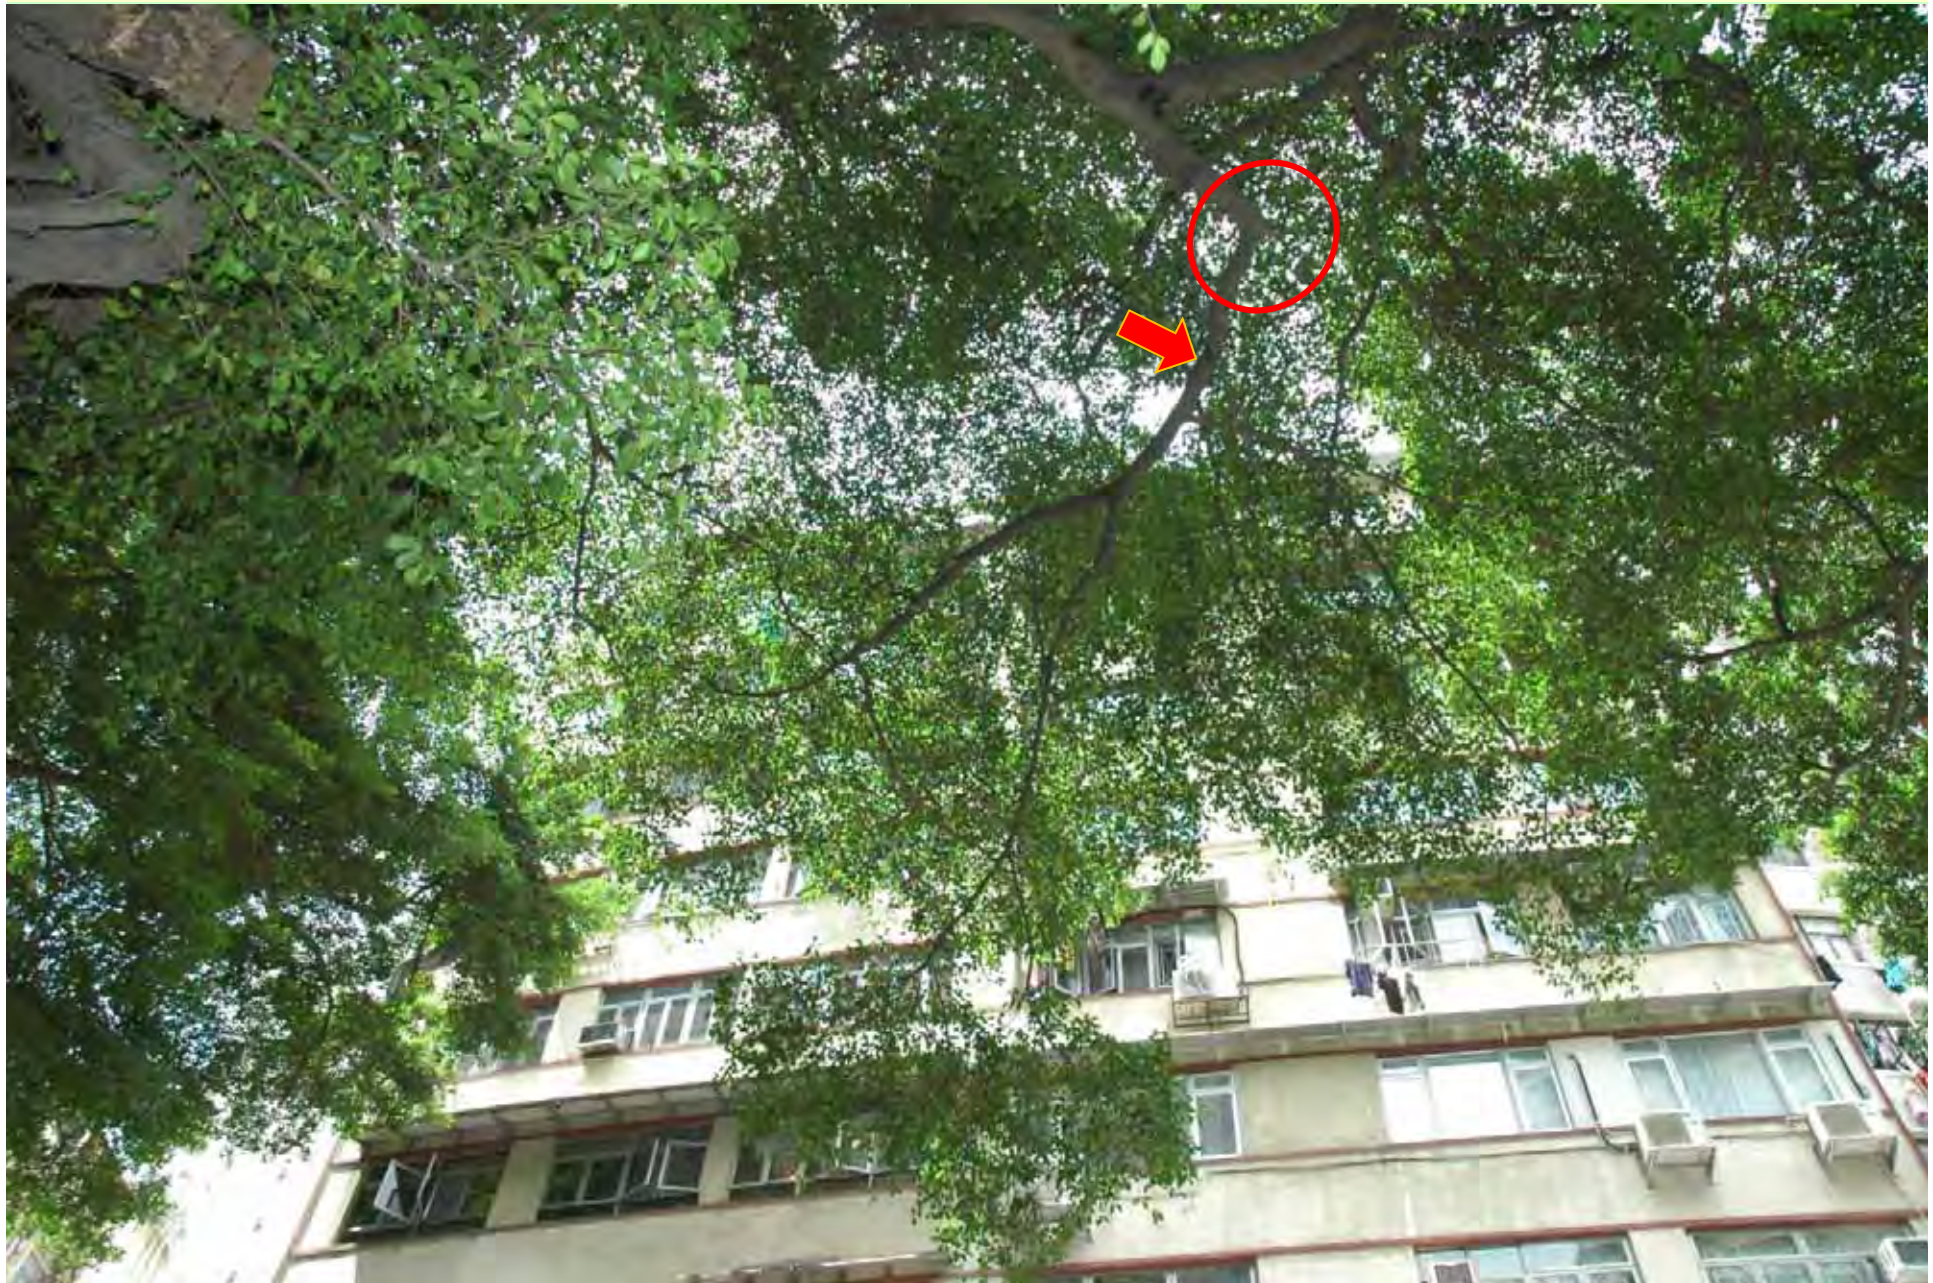
Photo T4-16. Tipped branch of Stem A with replacement epicormic branch with elbow joint.

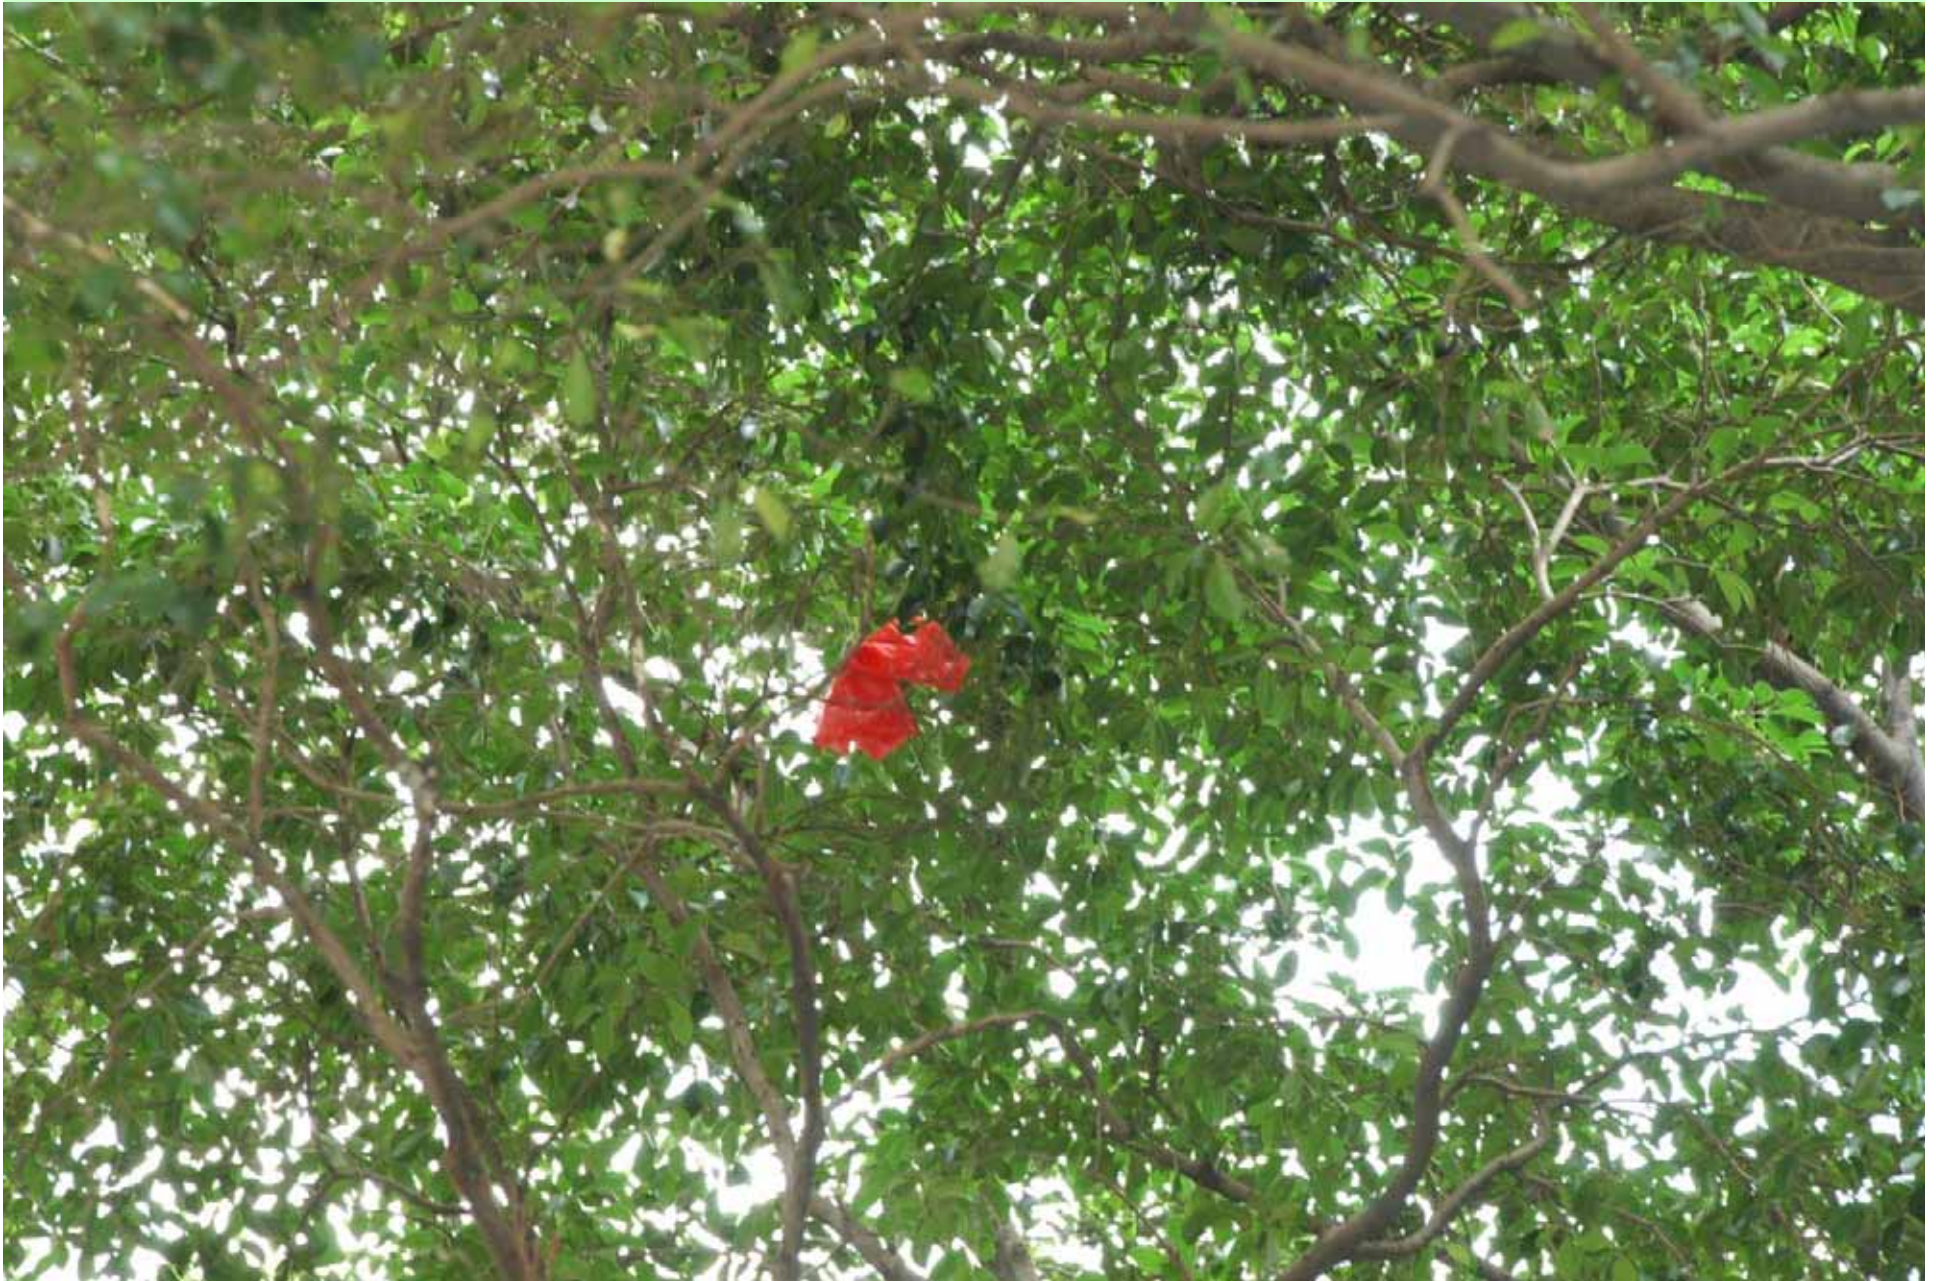
Photo T4-17. Hanging plastic rubbish trapped in the crown.

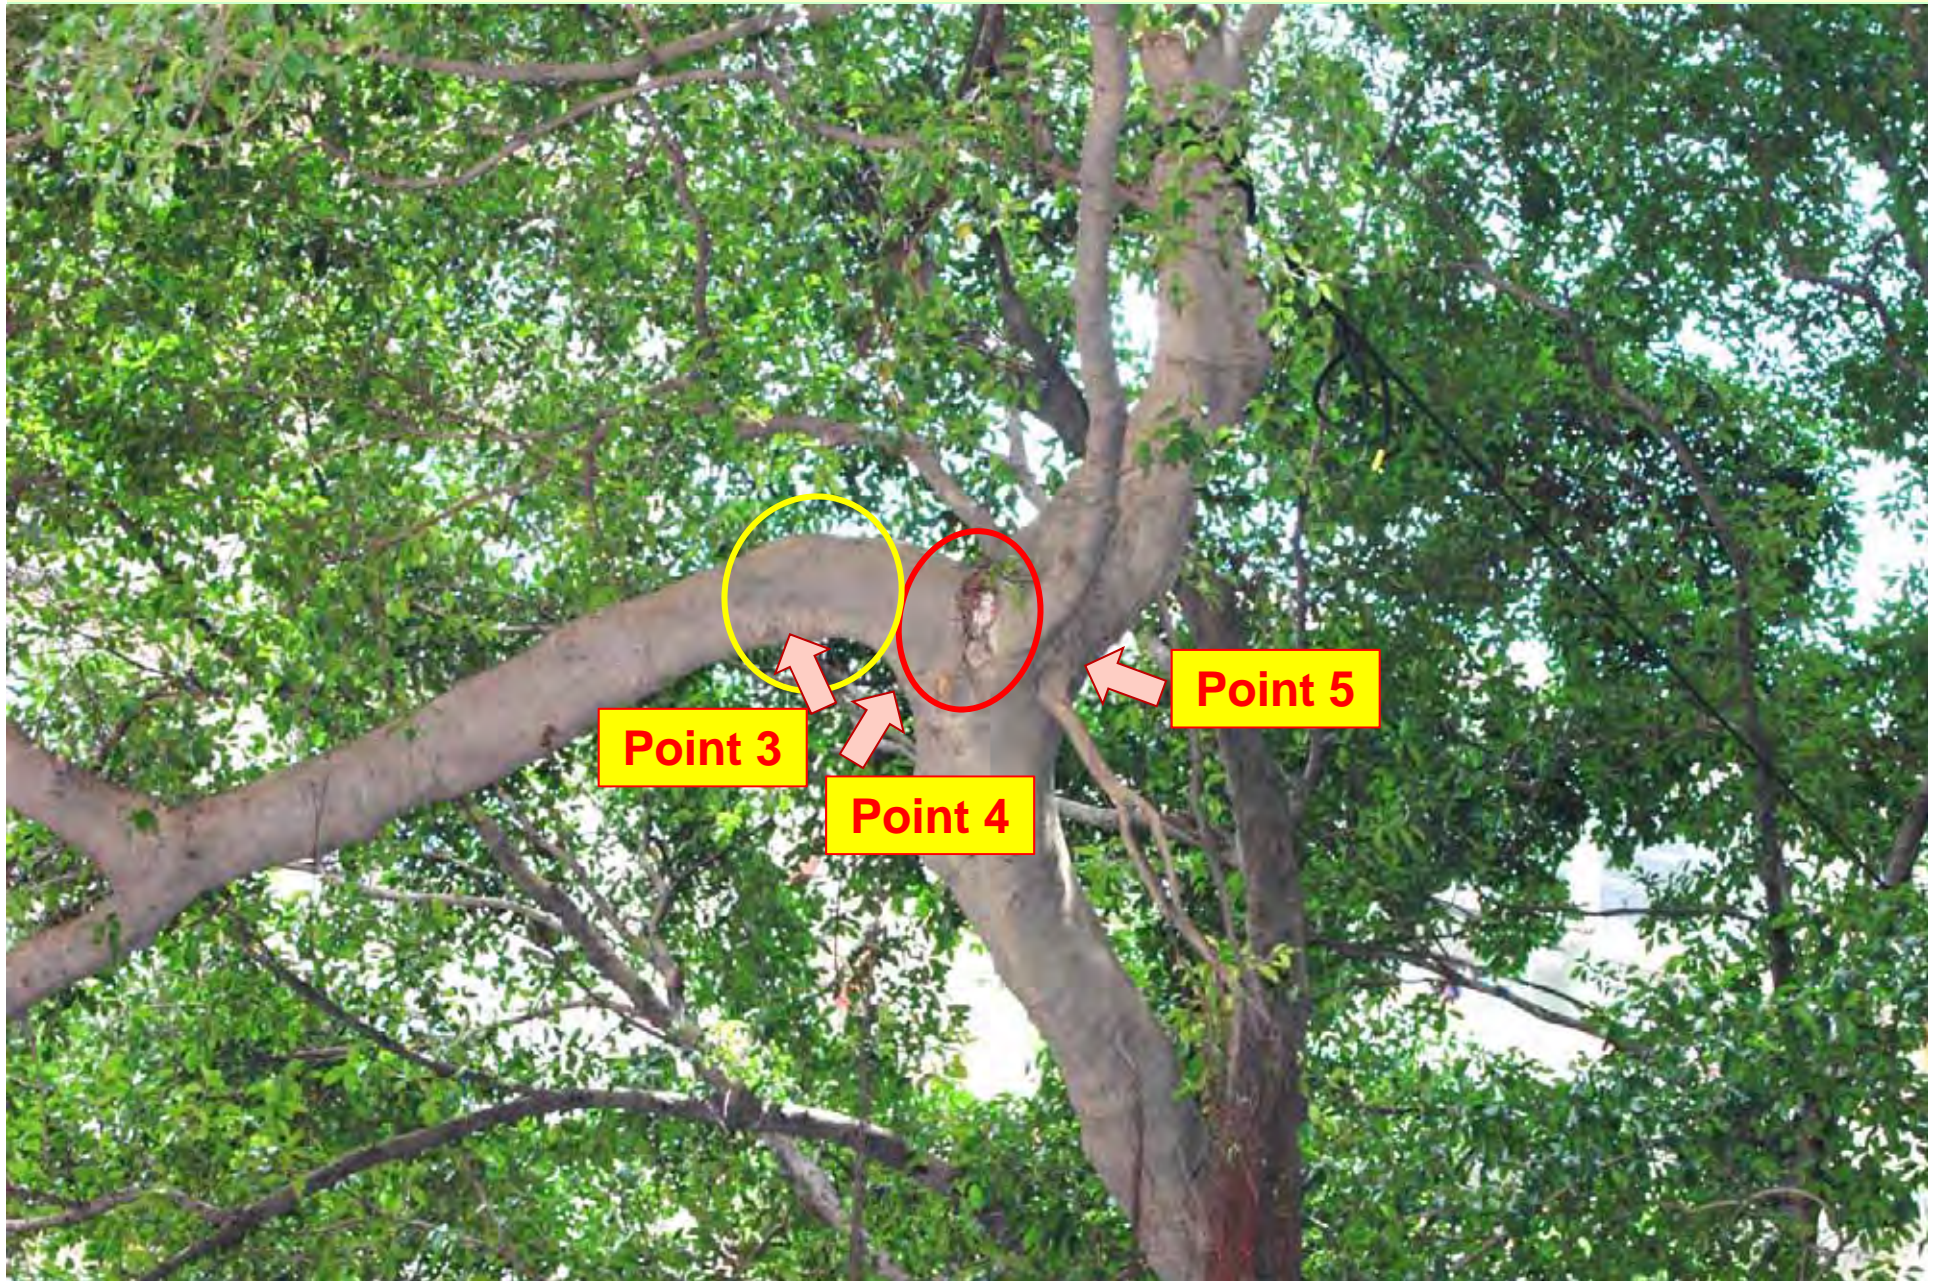
Photo T4-18. Basal curvature of stem A branch and decayed wound at crotch. Arrow indicates microdrilling position.
