Assessment of Wall Trees on Slope 11SW-A/R577 at Bonham Road

**Highways Department
HKSAR Government**

**C.Y. Jim
The University of Hong Kong
hrajcy@hku.hk**

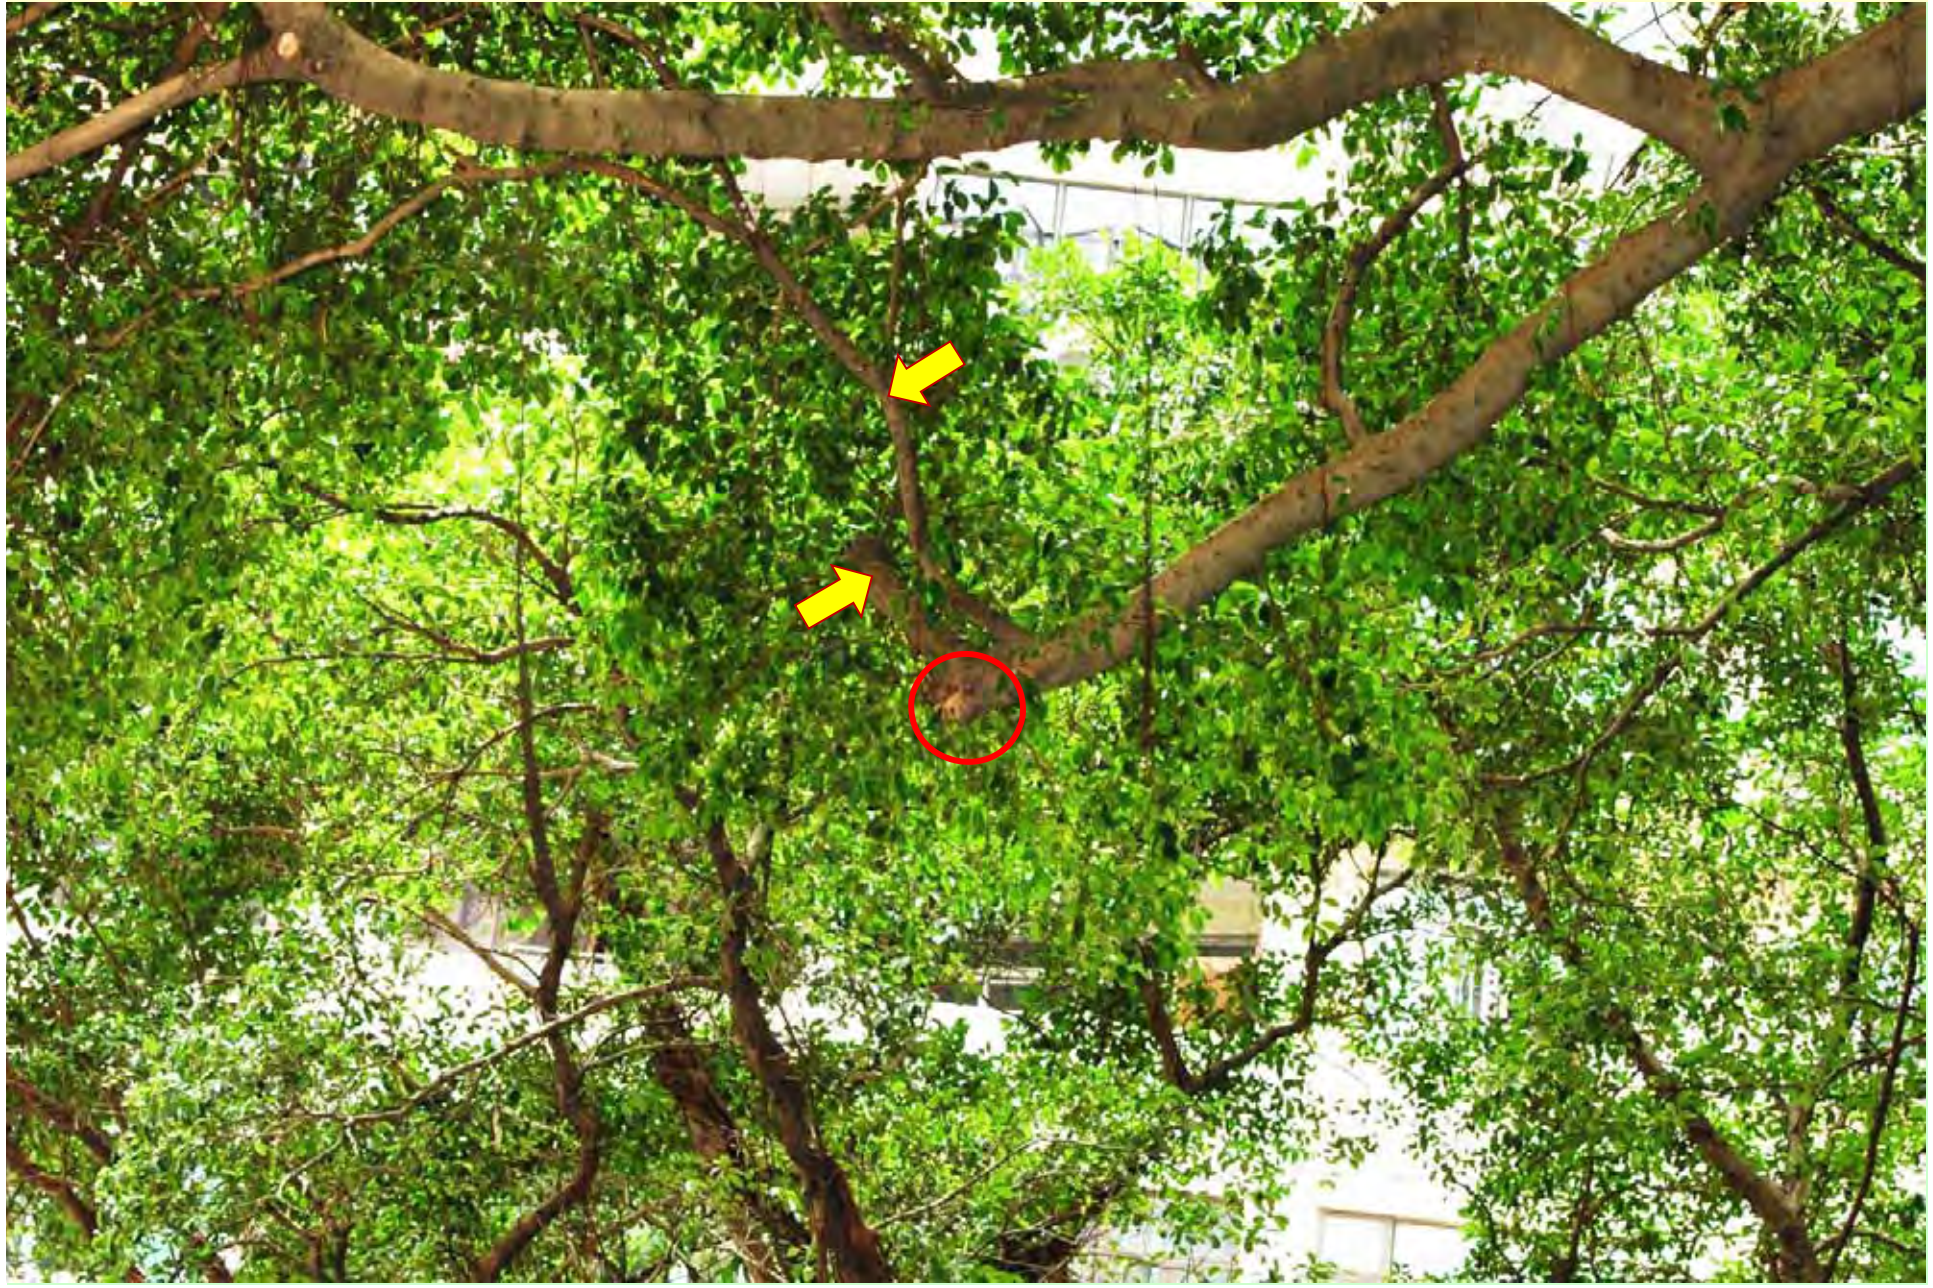
Photo T4-19. Truncated branch of stem A with decayed wound and two epicormic branches (arrows) with elbow joint (circle).

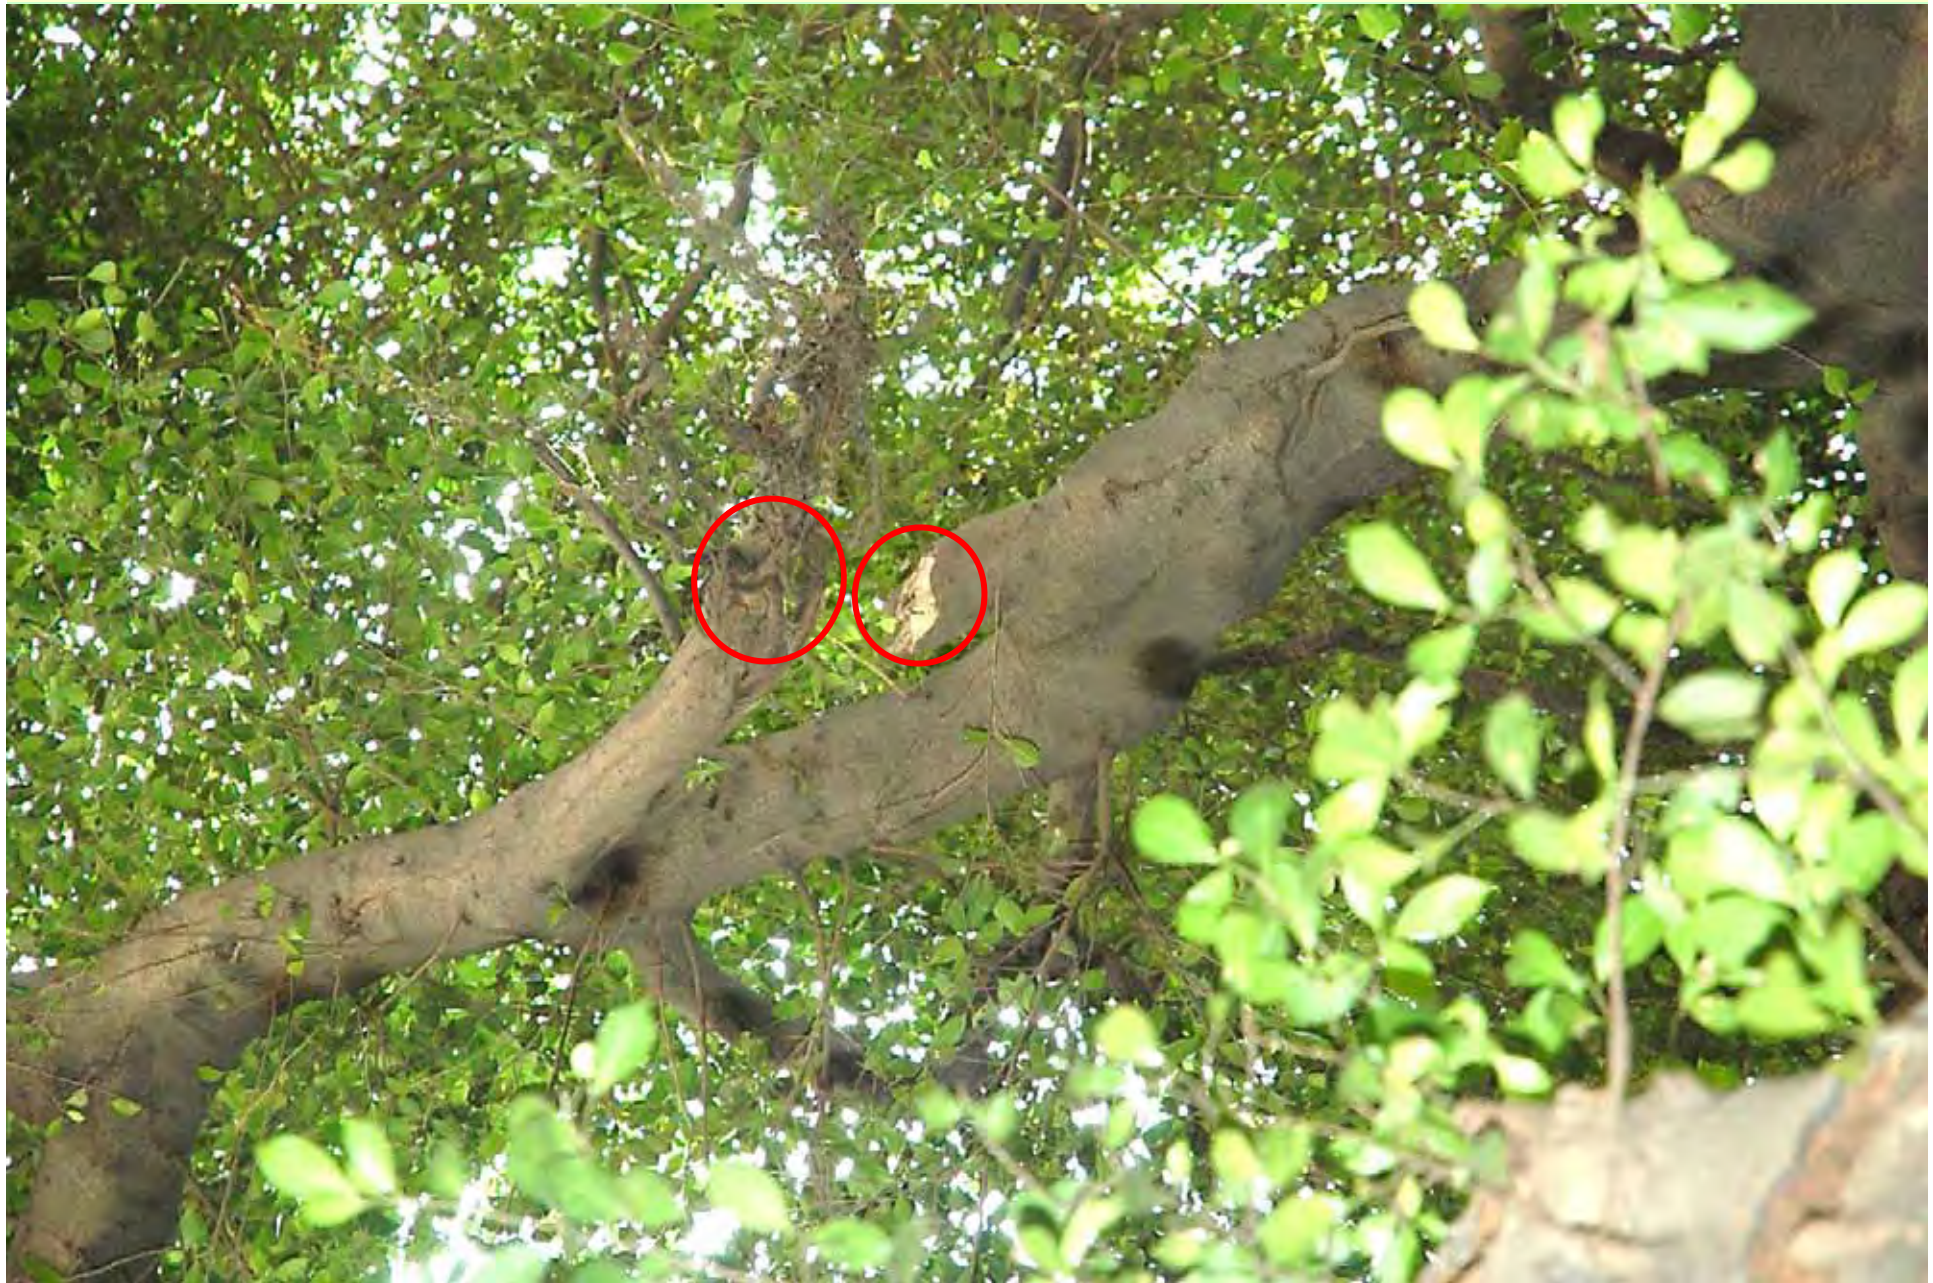
Photo T4-20. Stem A branch with fractured wound and nearby decayed stub.

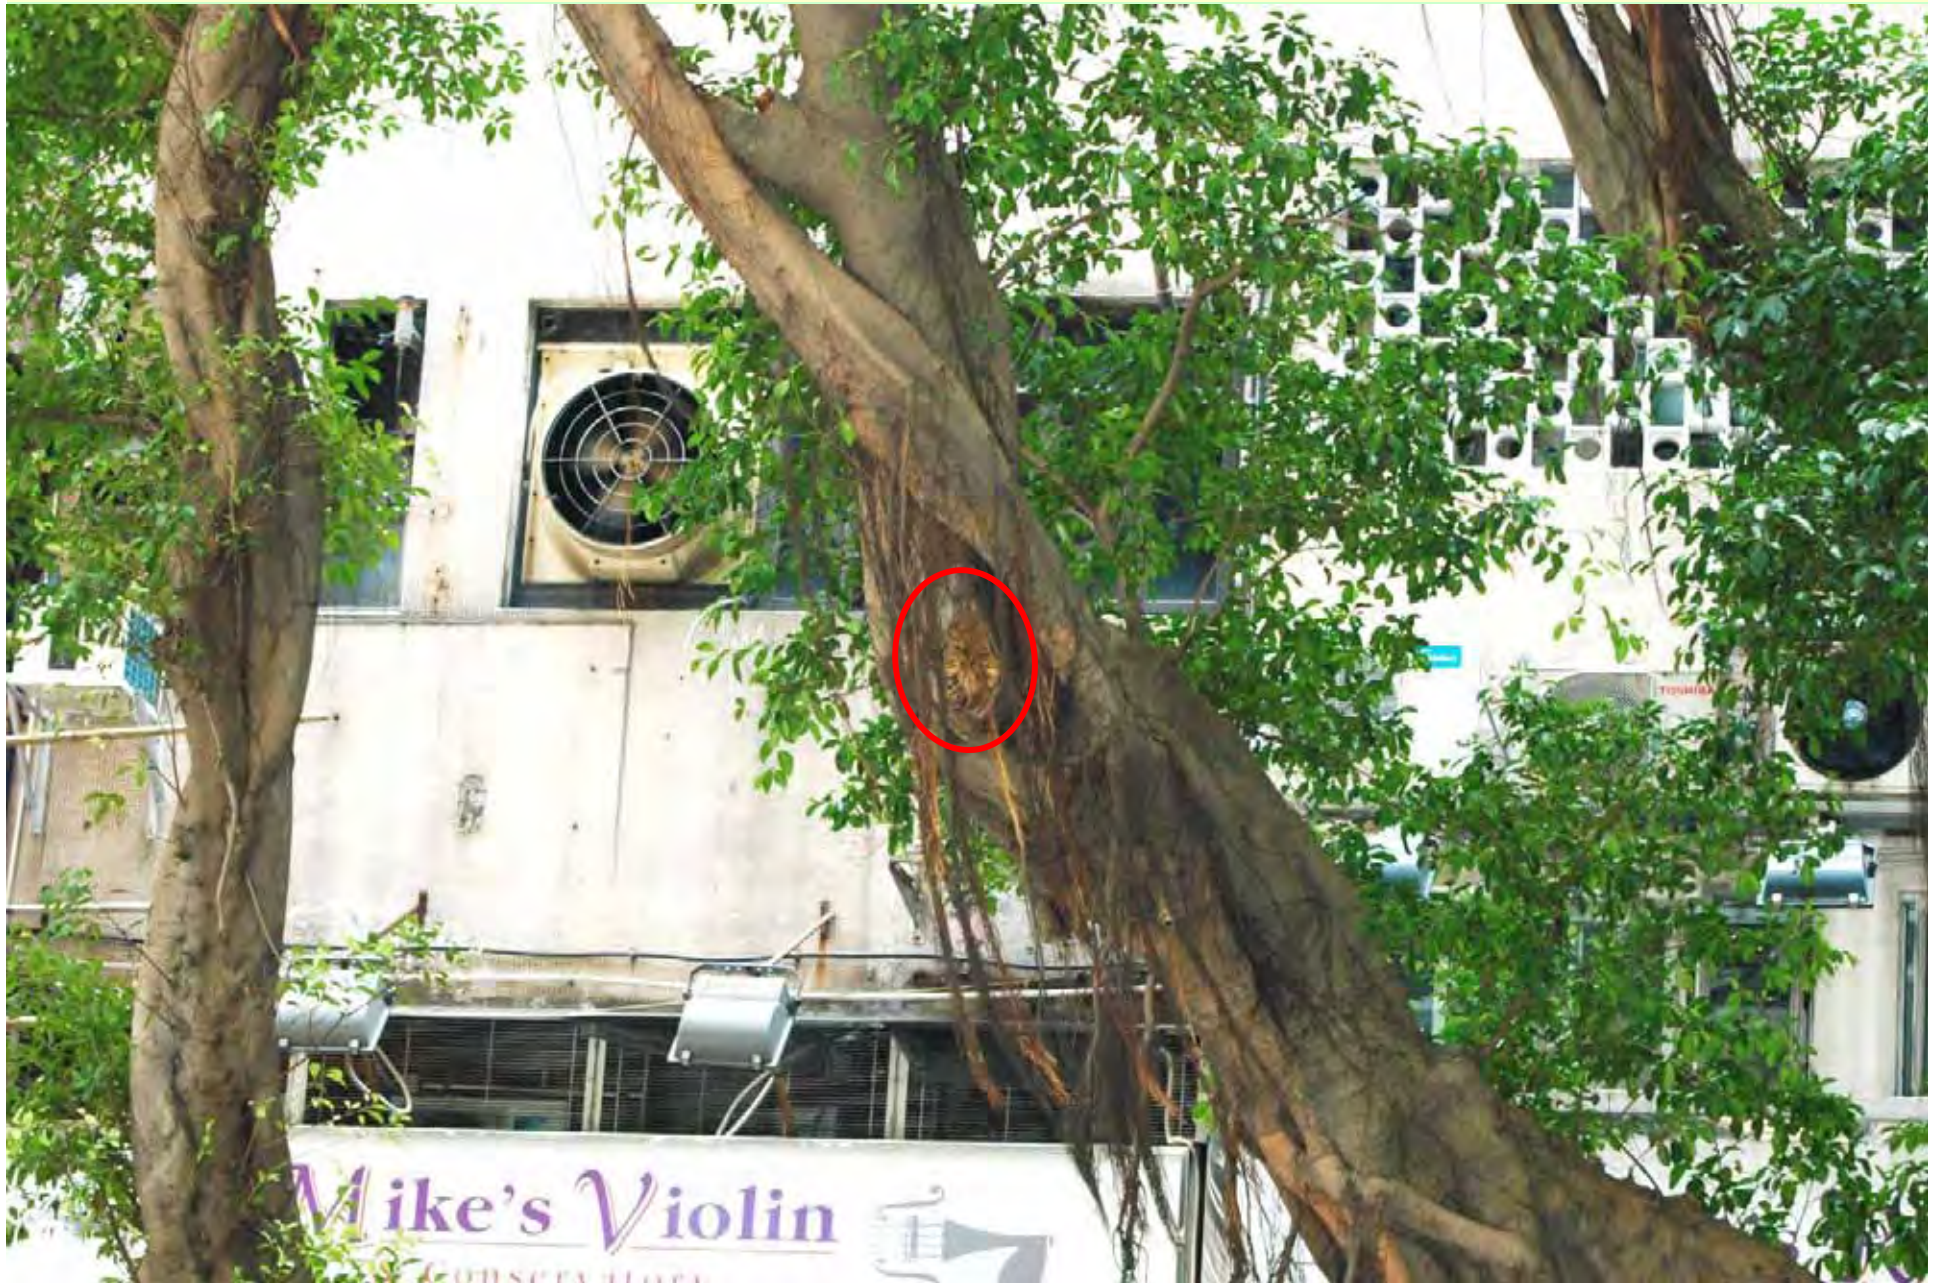
Photo T4-21. Stem A branch-removal wound with decay.

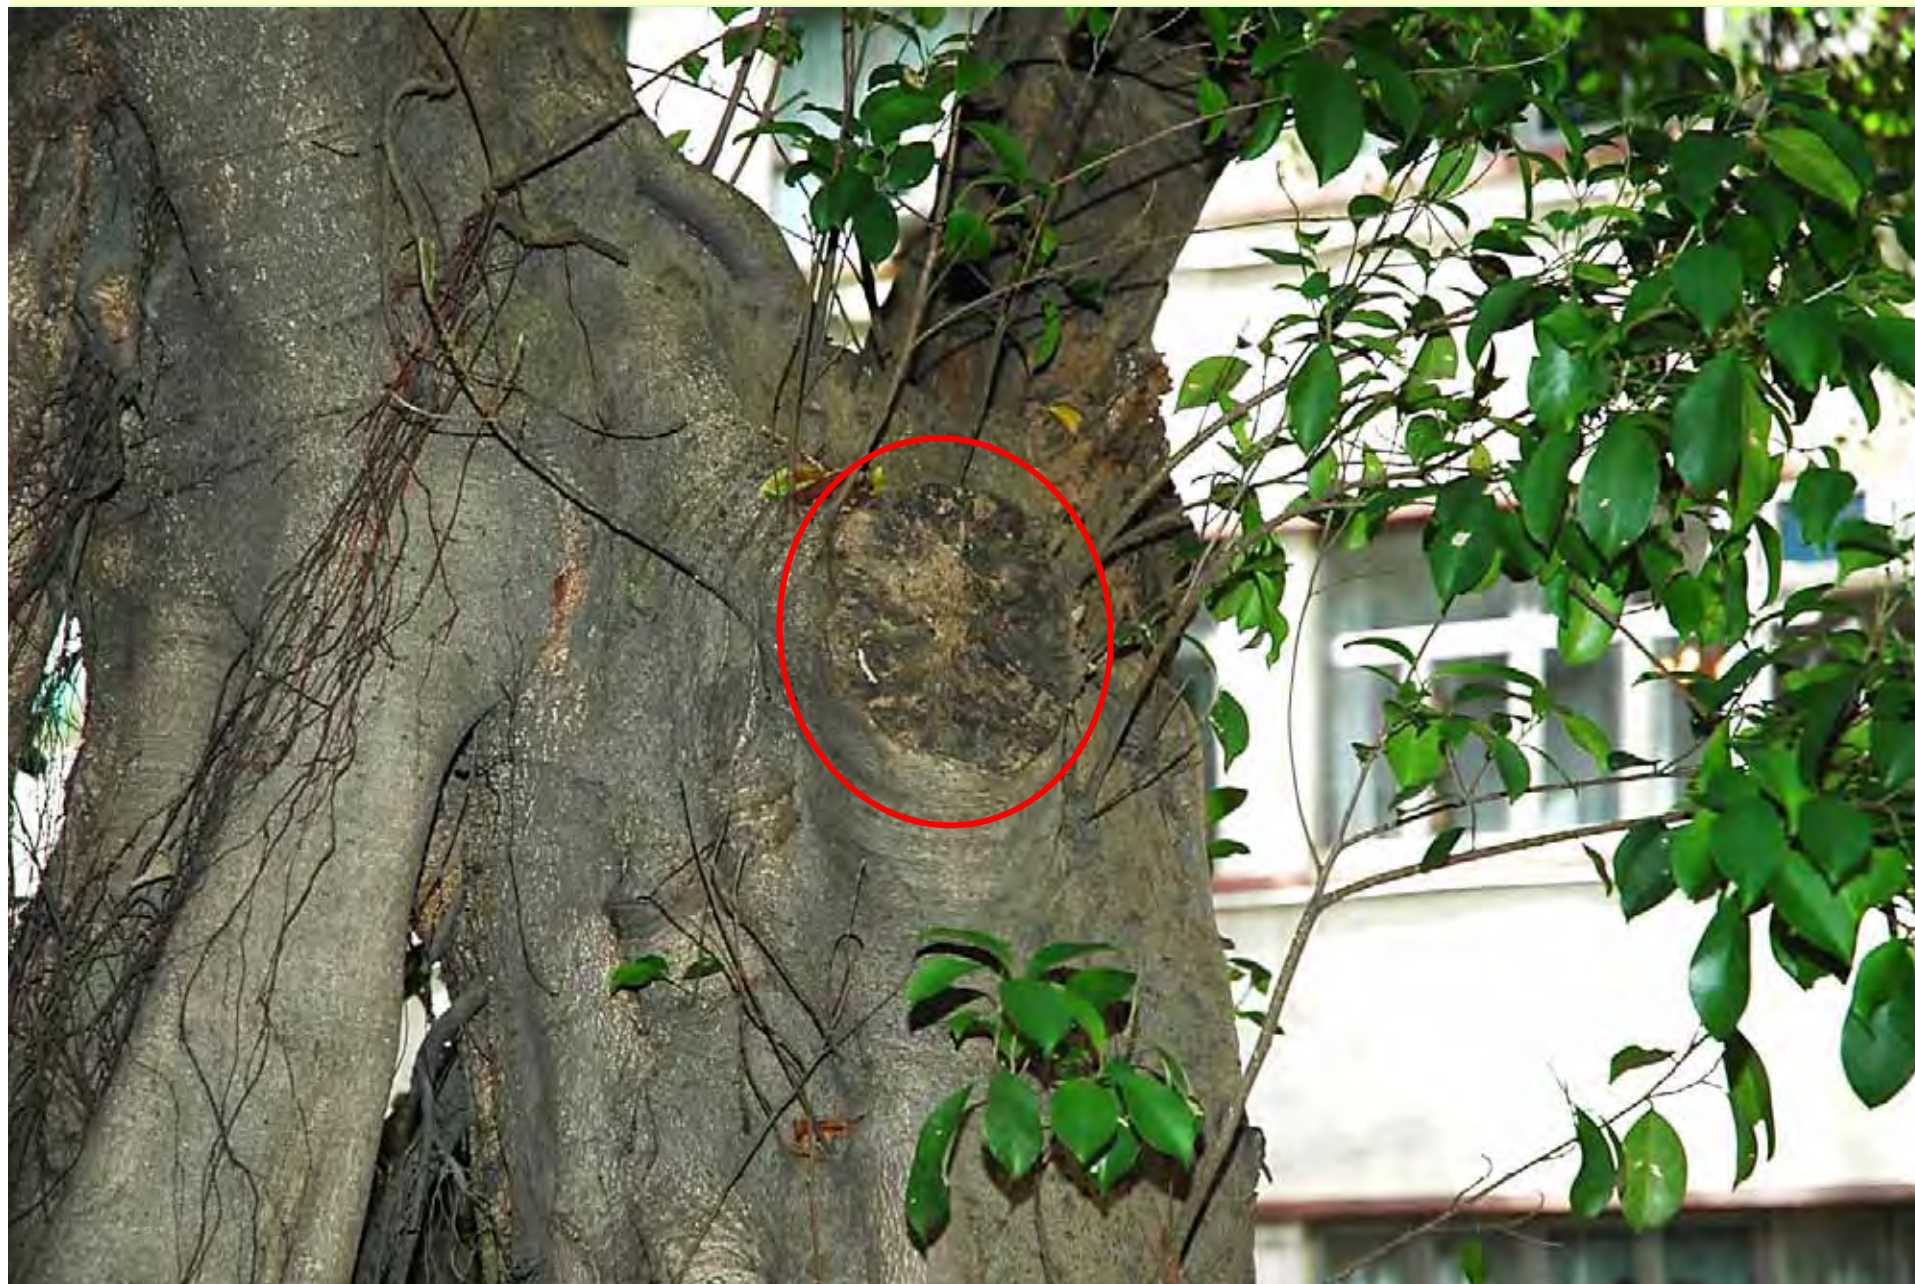
Photo T4-22. Stem A branch-removal wound with decay.

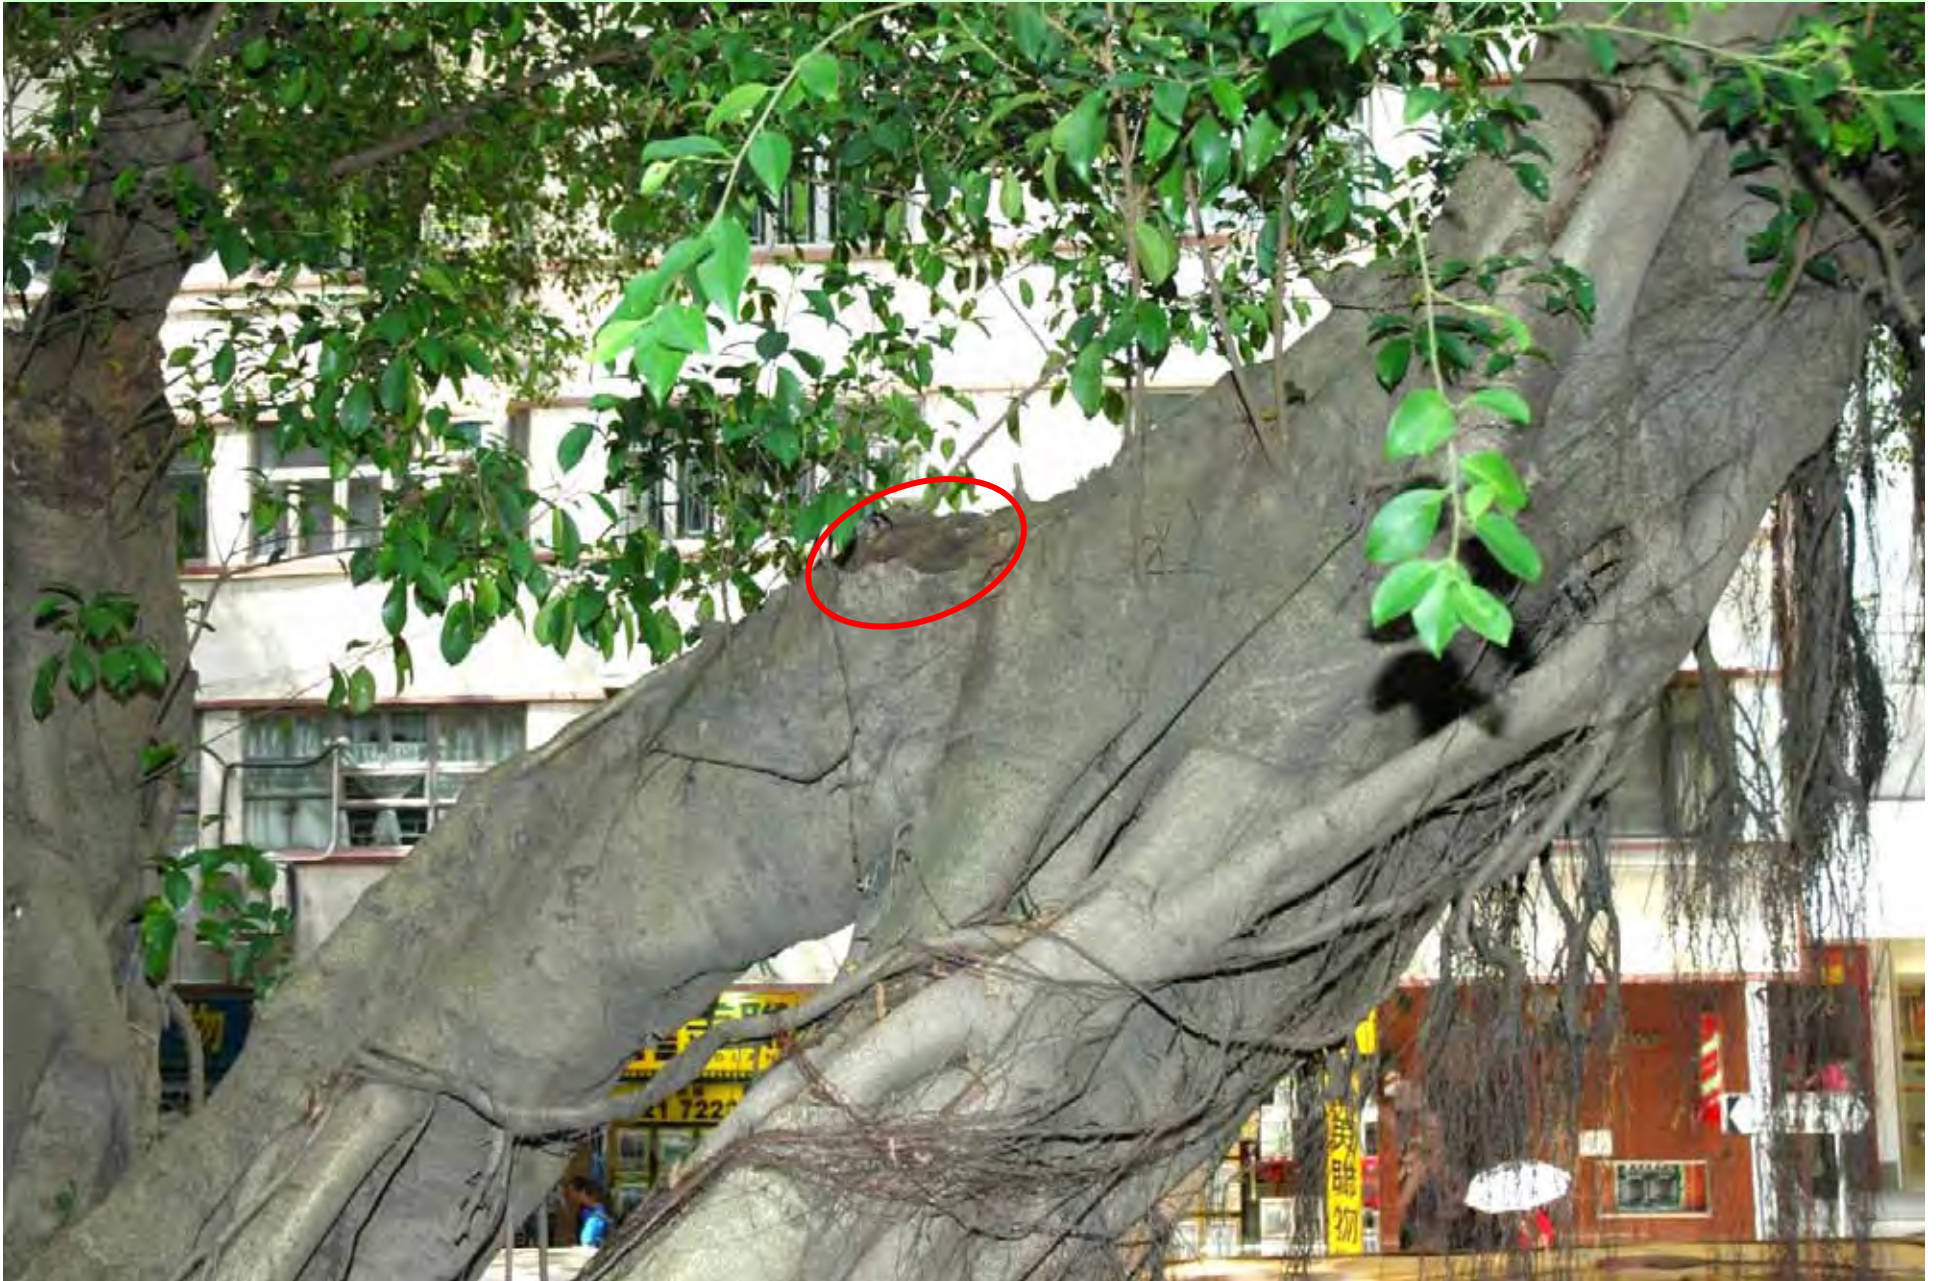
Photo T4-23. Stem A branch-removal wound with decay.

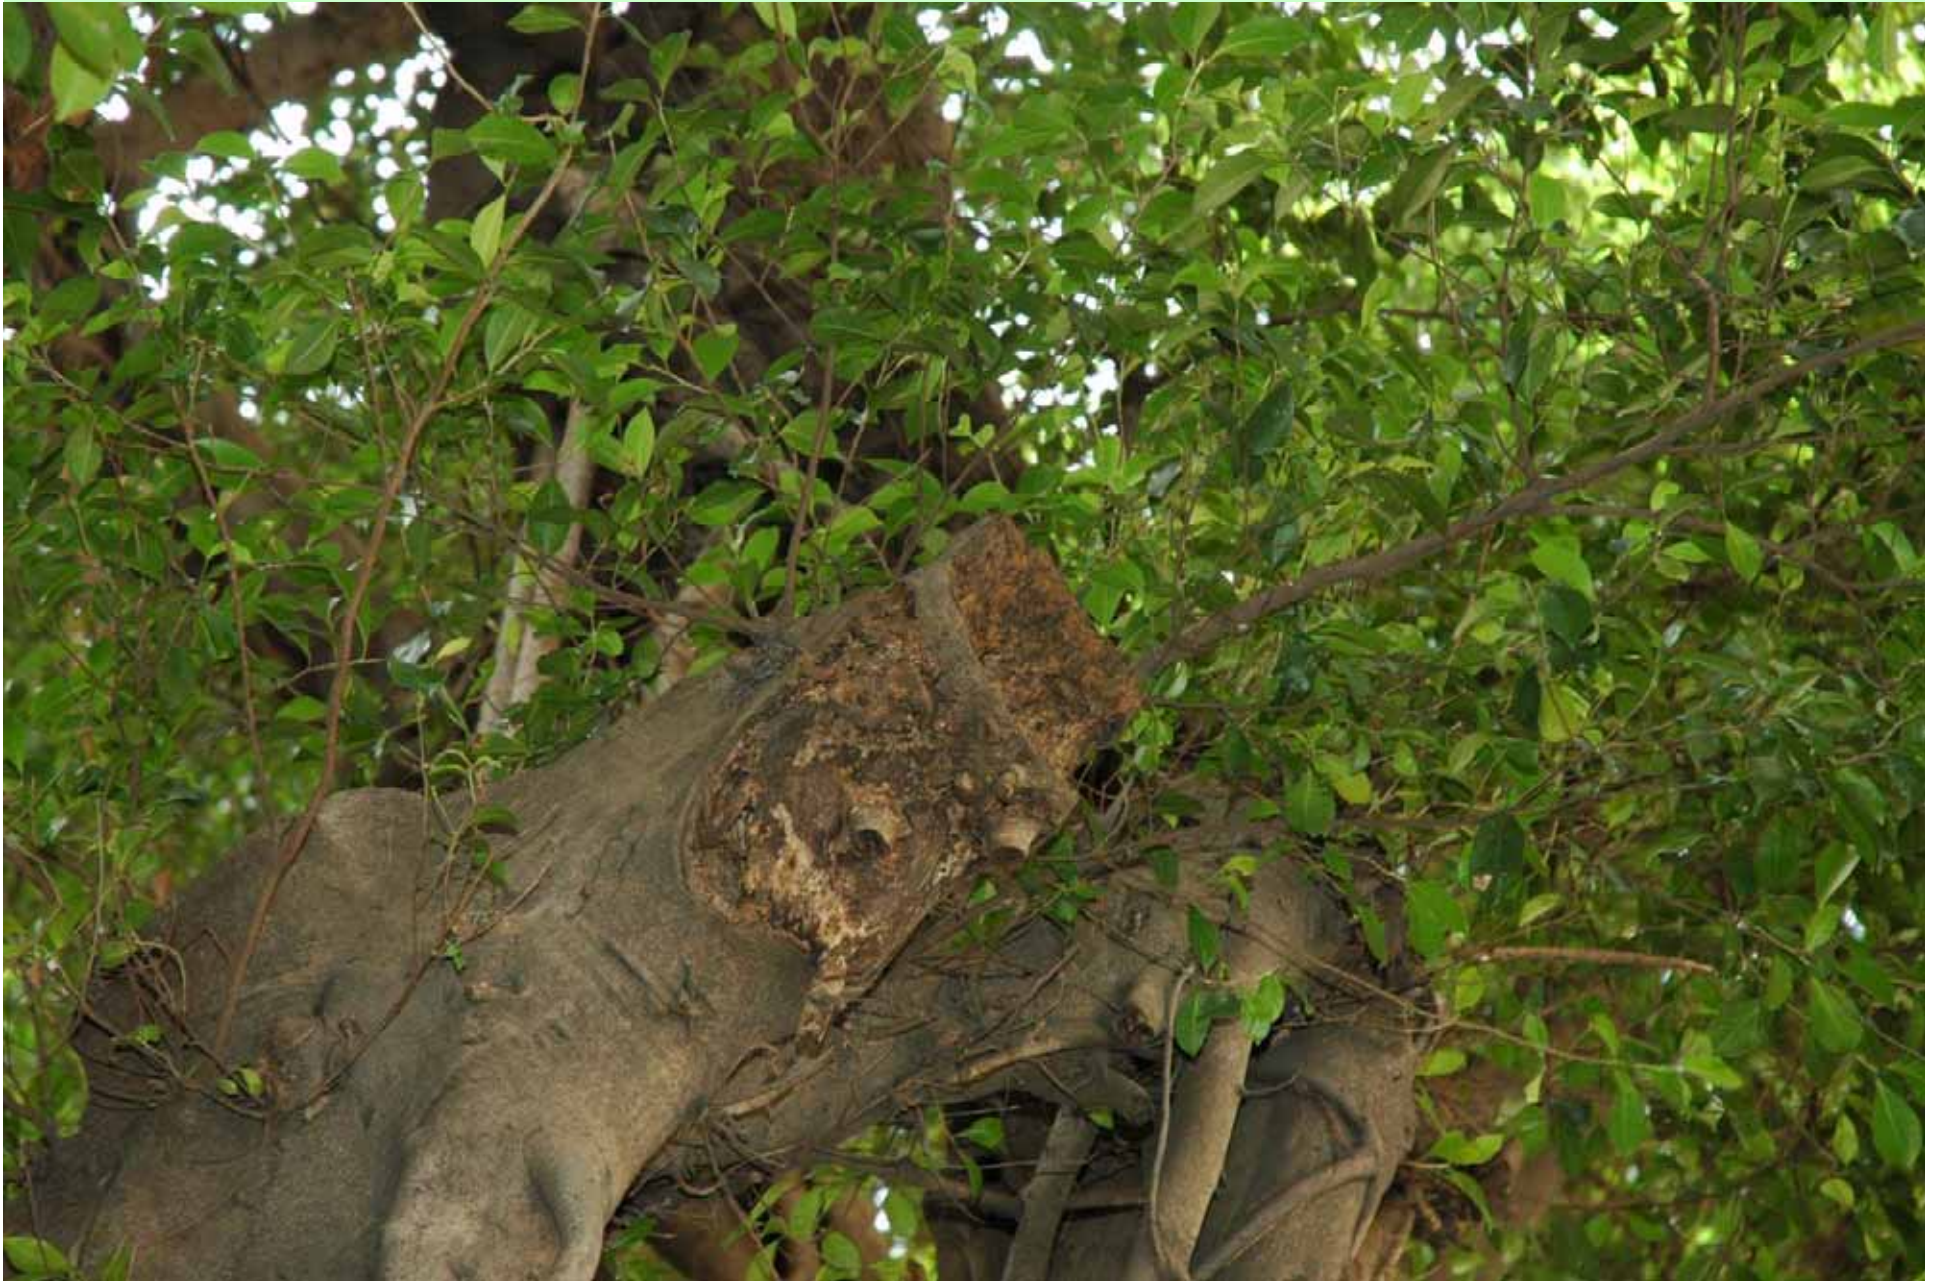
Photo T4-24. Stem A branch stub with advanced decay.

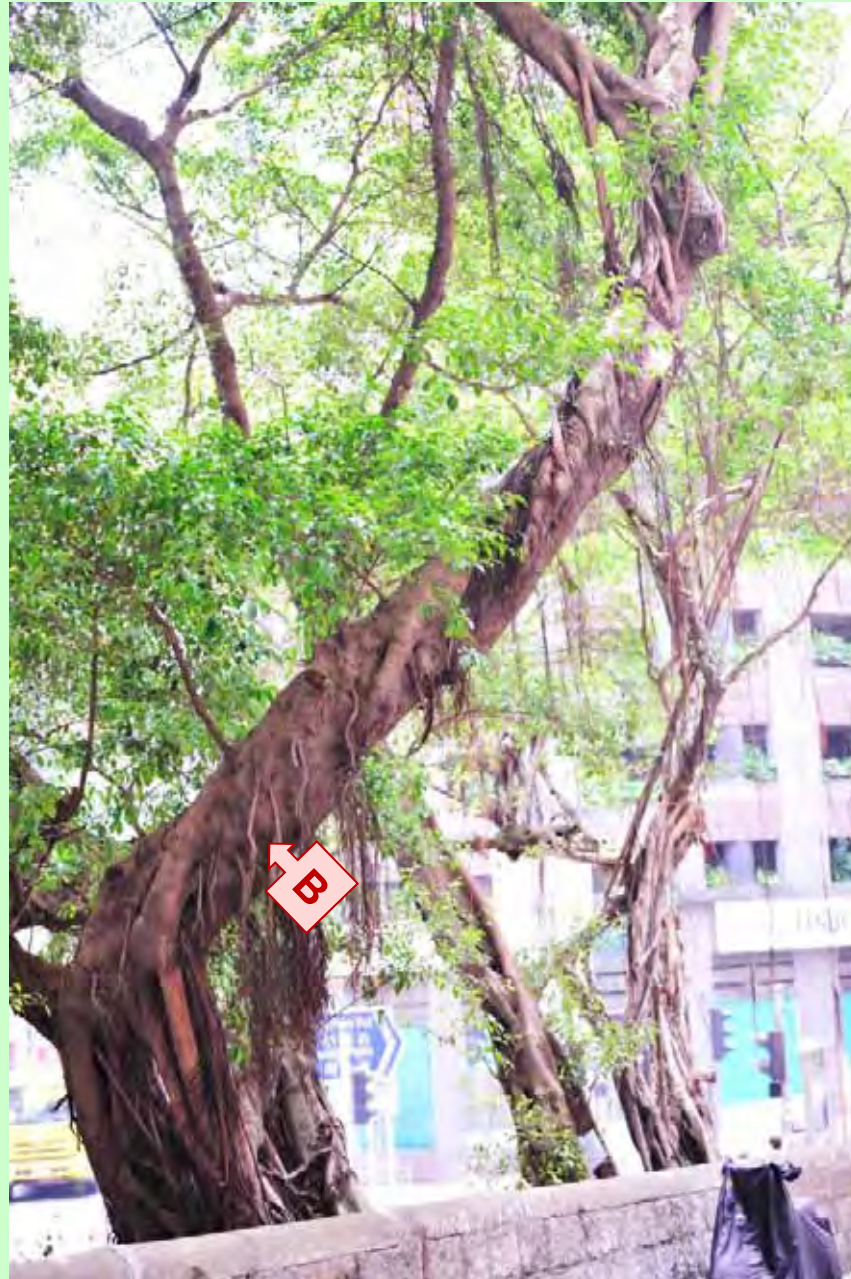
Photo T4-26. Stem B curving backwards towards St Stephen's Lane.

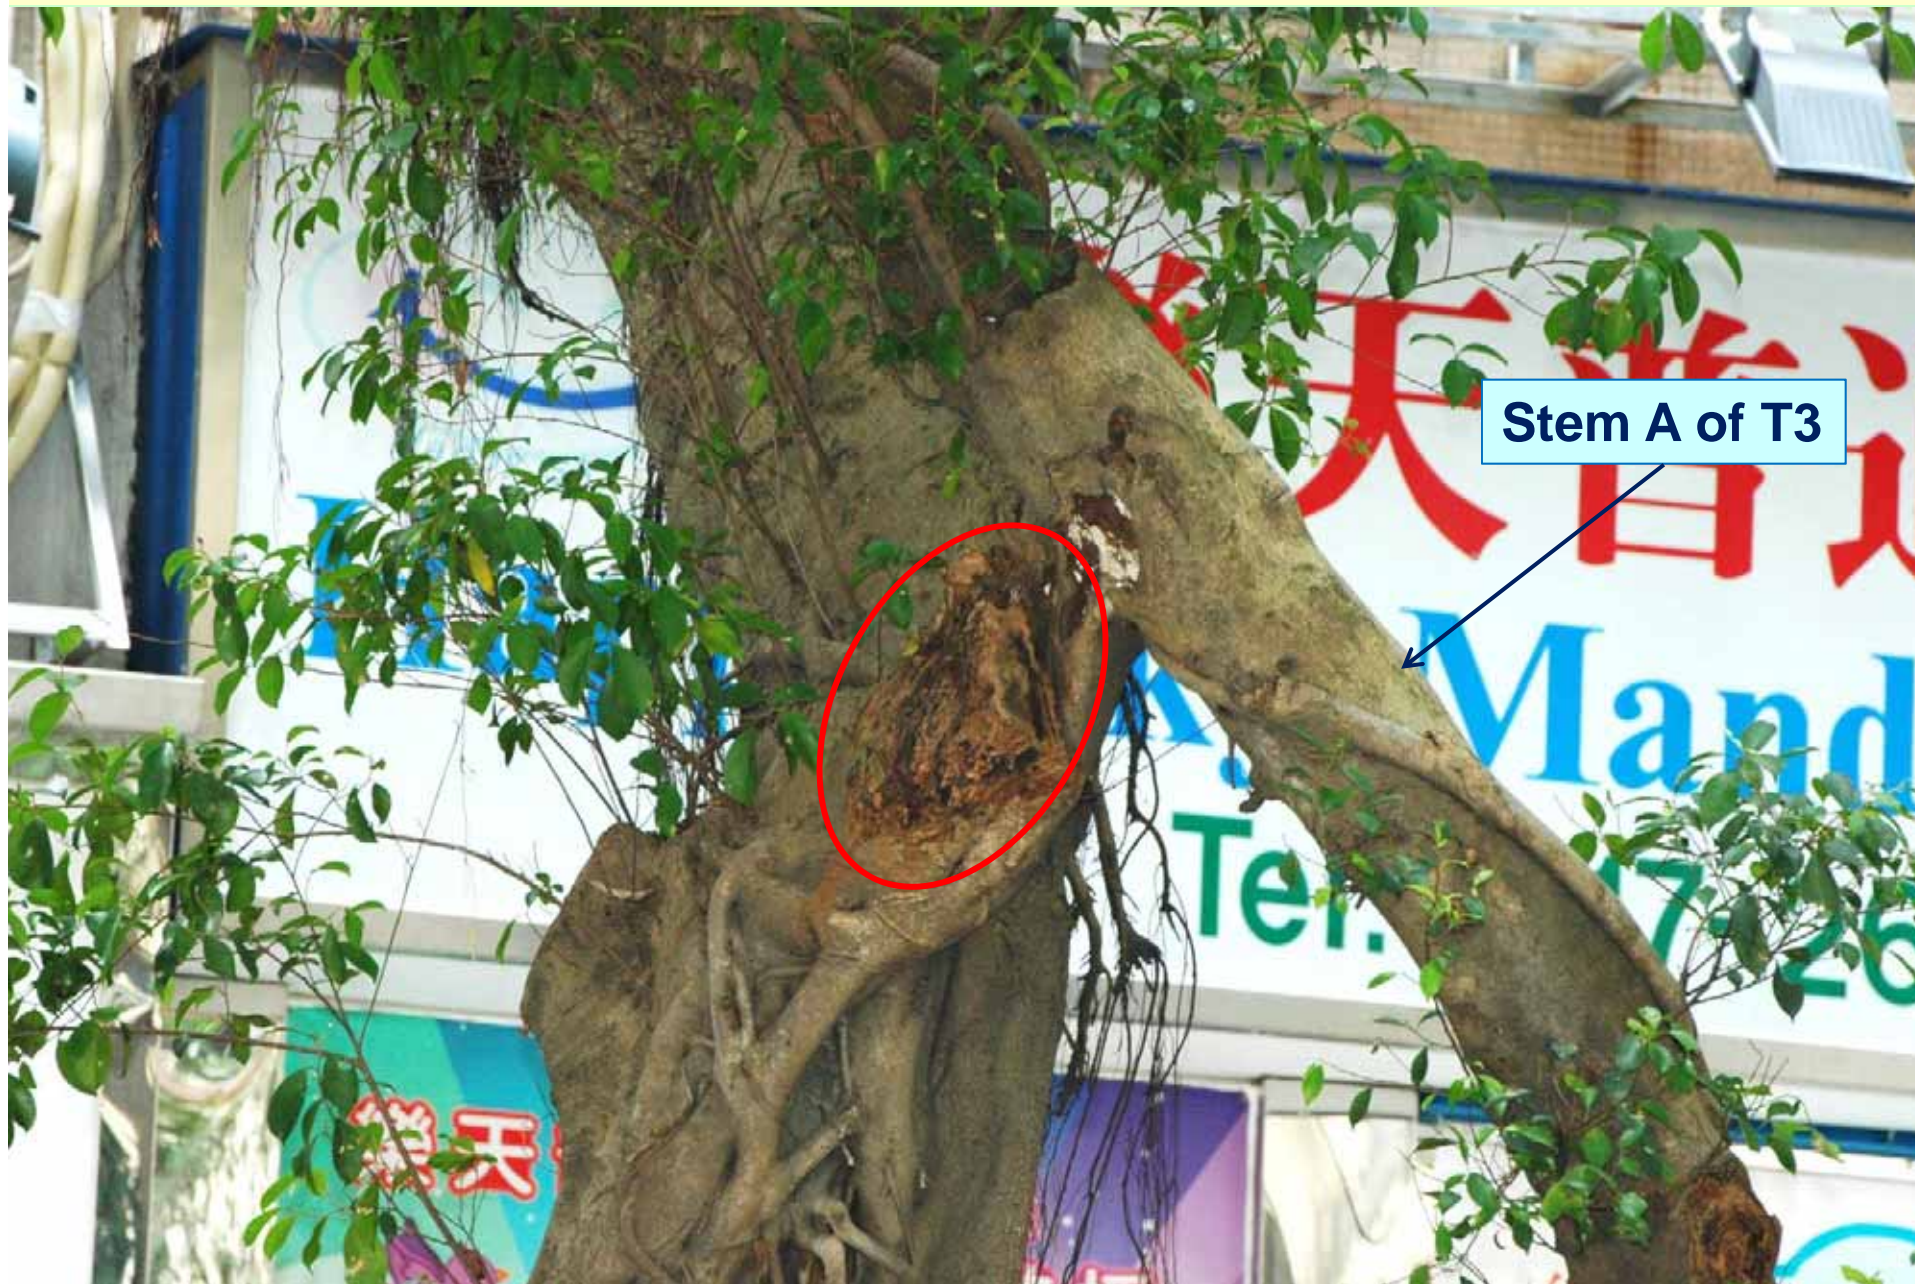
Photo T4-27. Stub of stem B with advanced decay, near stem A of T3.

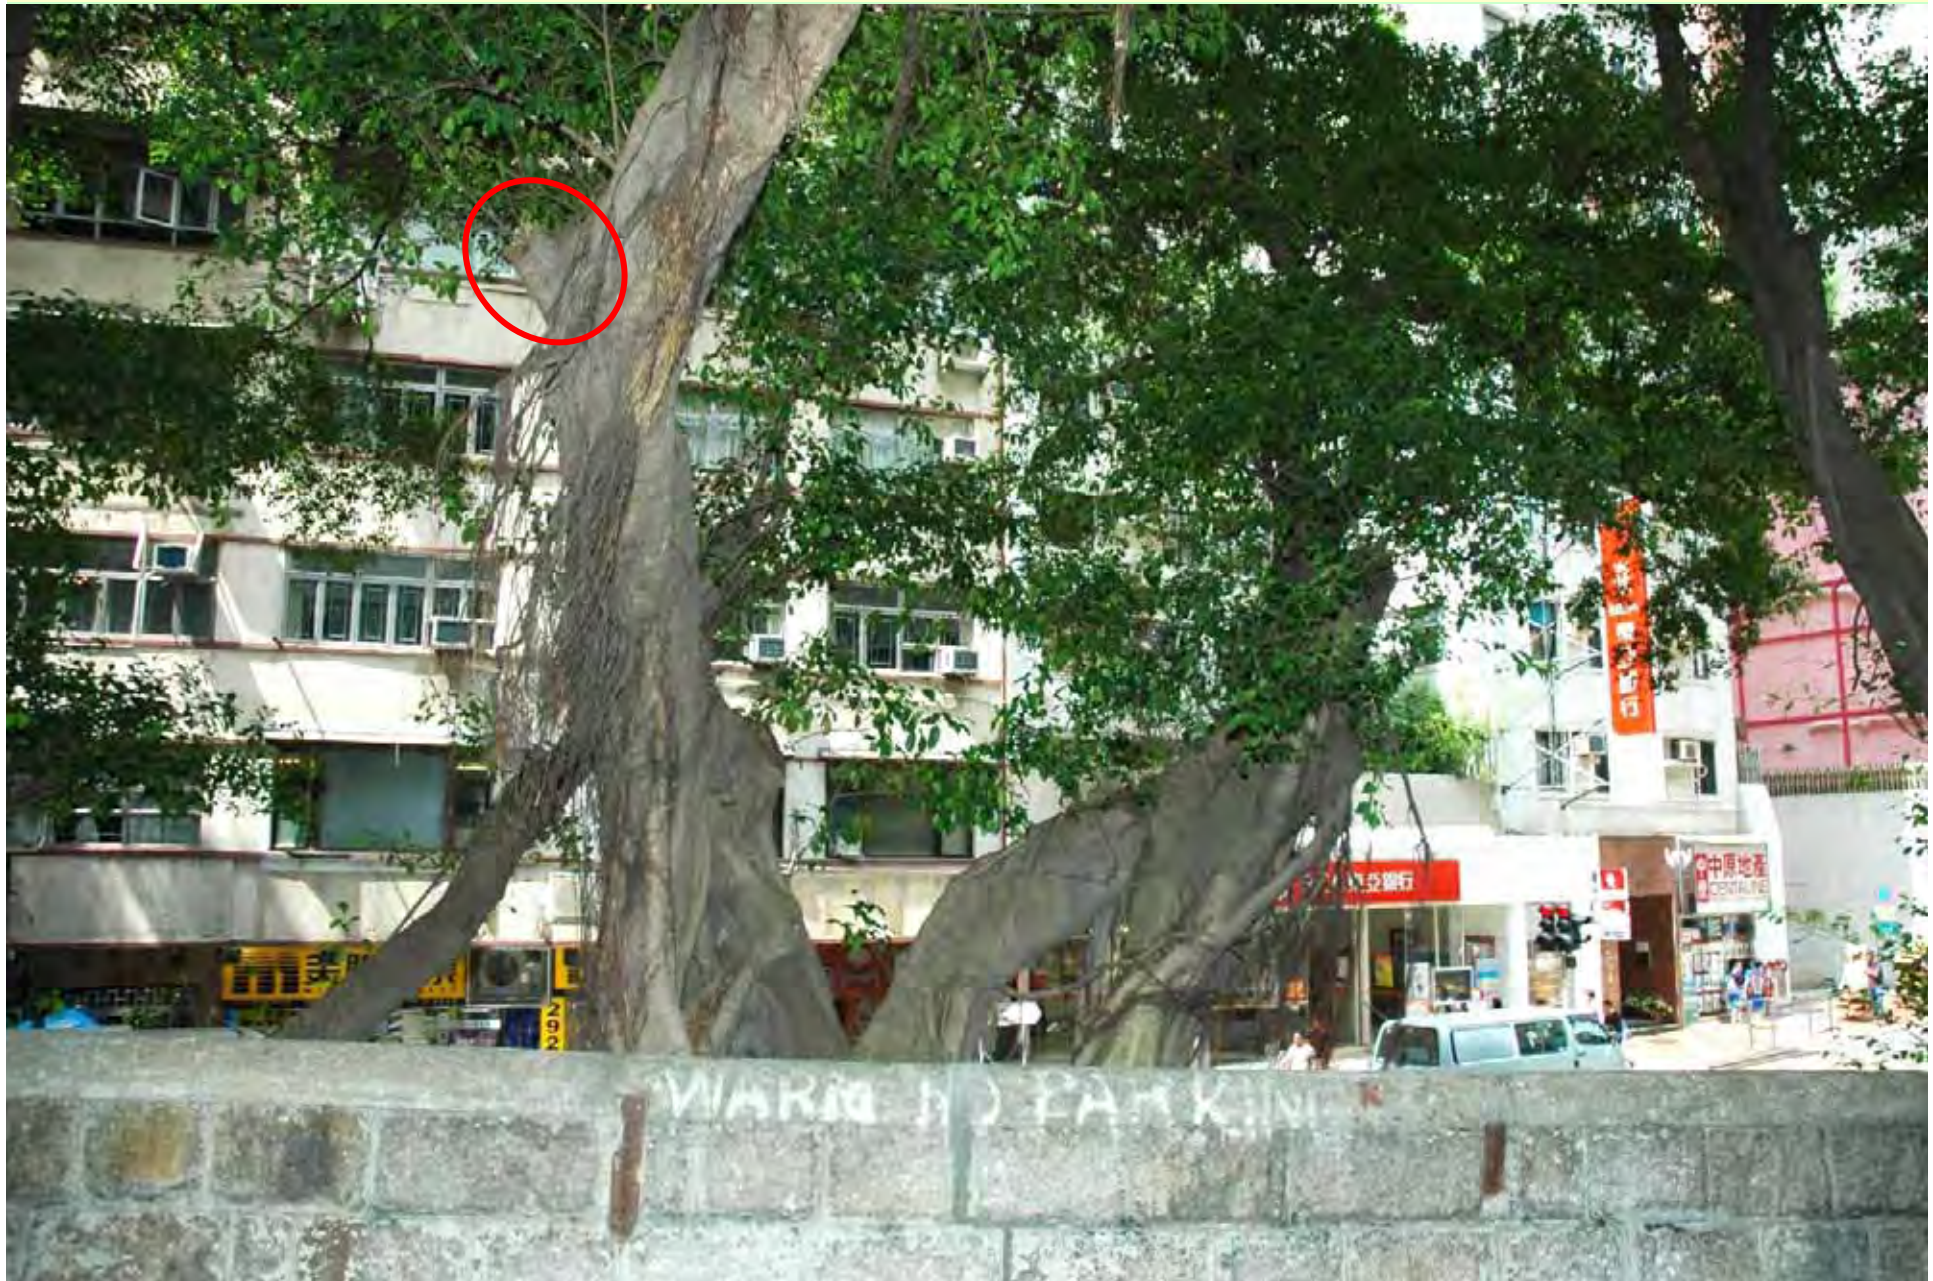
Photo T4-28. Branch stub of stem B with decay.
