Assessment of Wall Trees on Slope 11SW-A/R577 at Bonham Road

**Highways Department
HKSAR Government**

**C.Y. Jim
The University of Hong Kong
hrajcy@hku.hk**

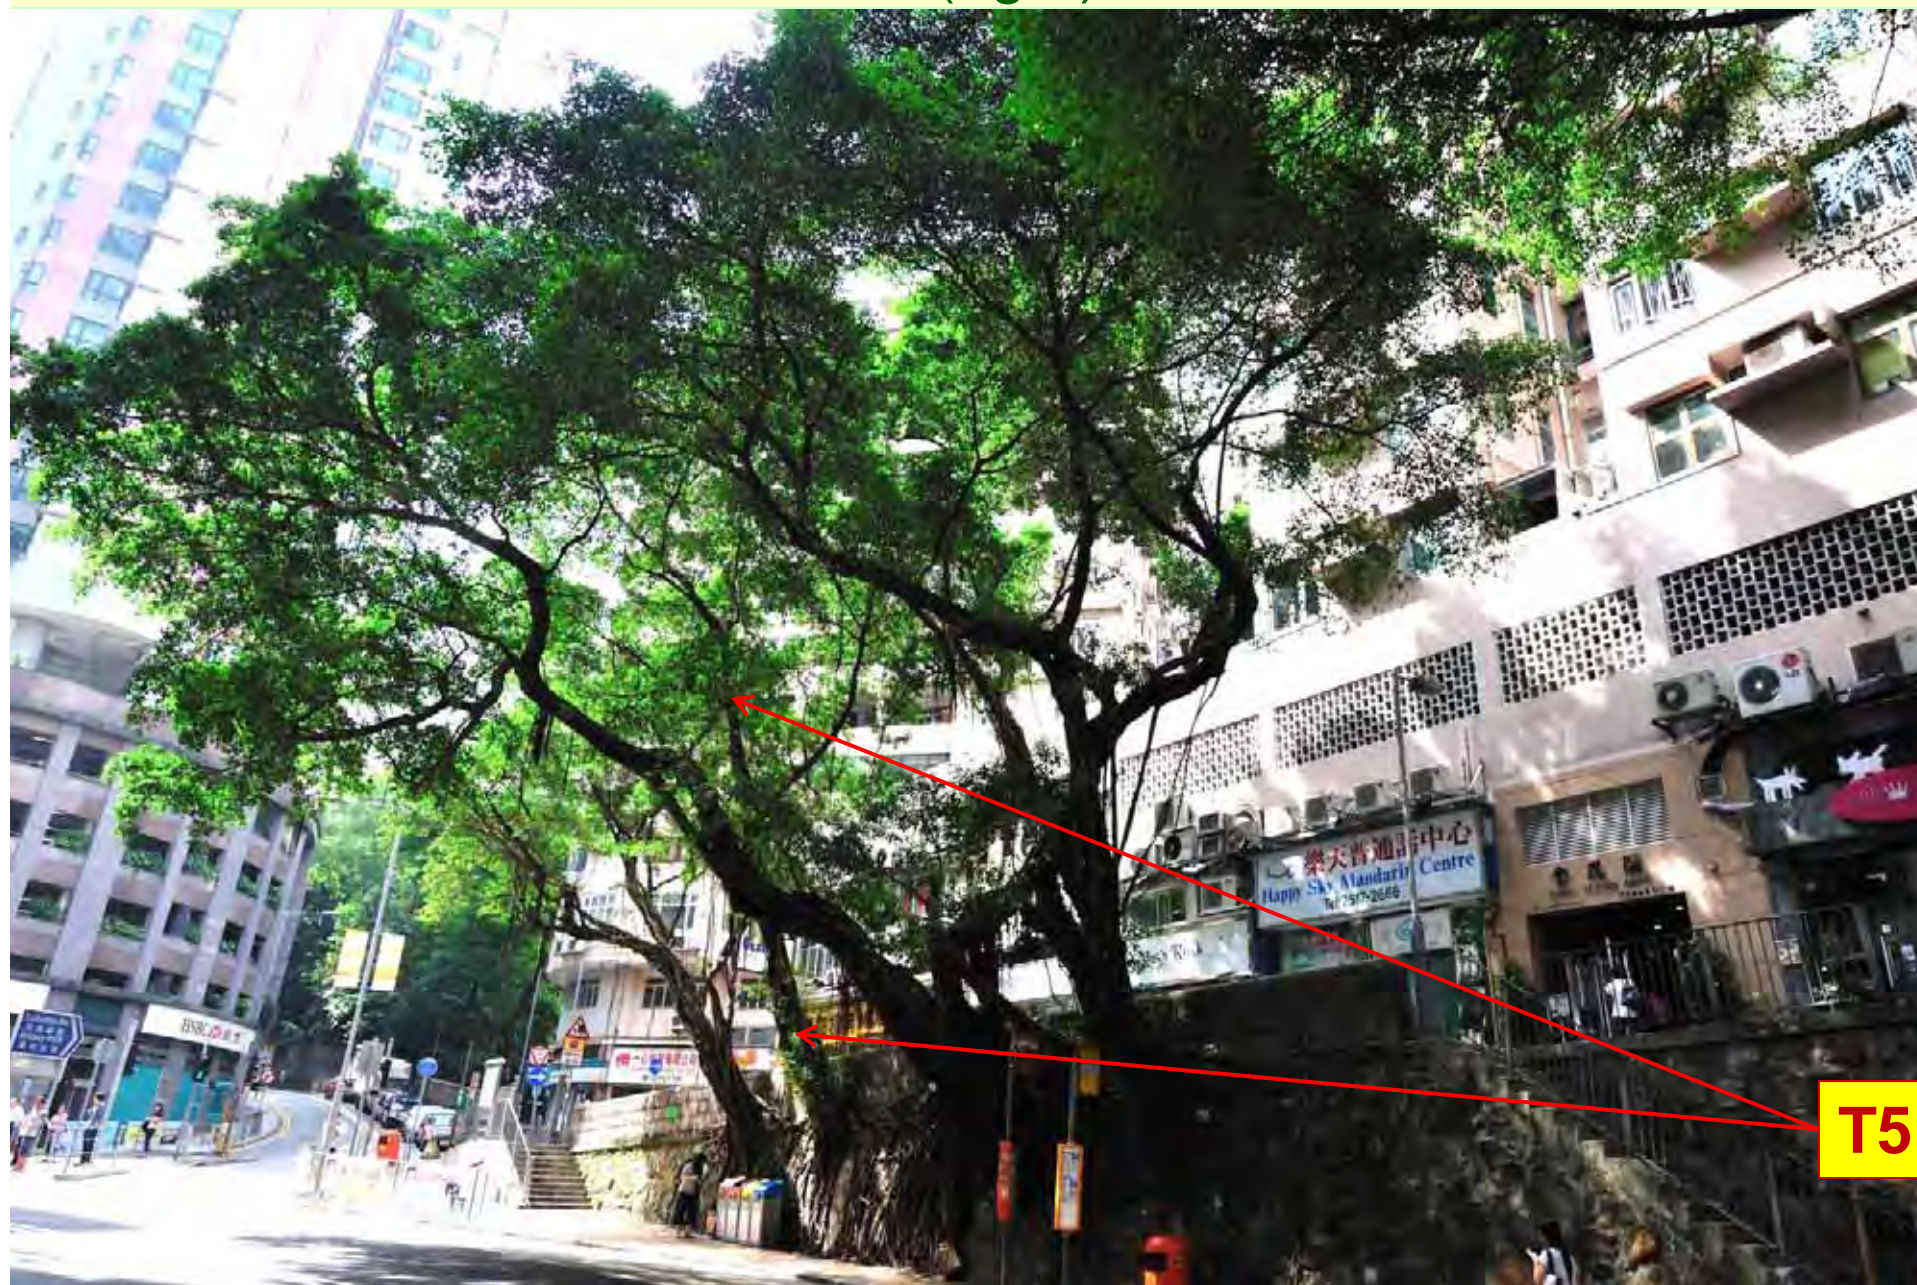
Photo T5-1. The tree in relation to neighbours T6 (left) and T4 and T3 (right)

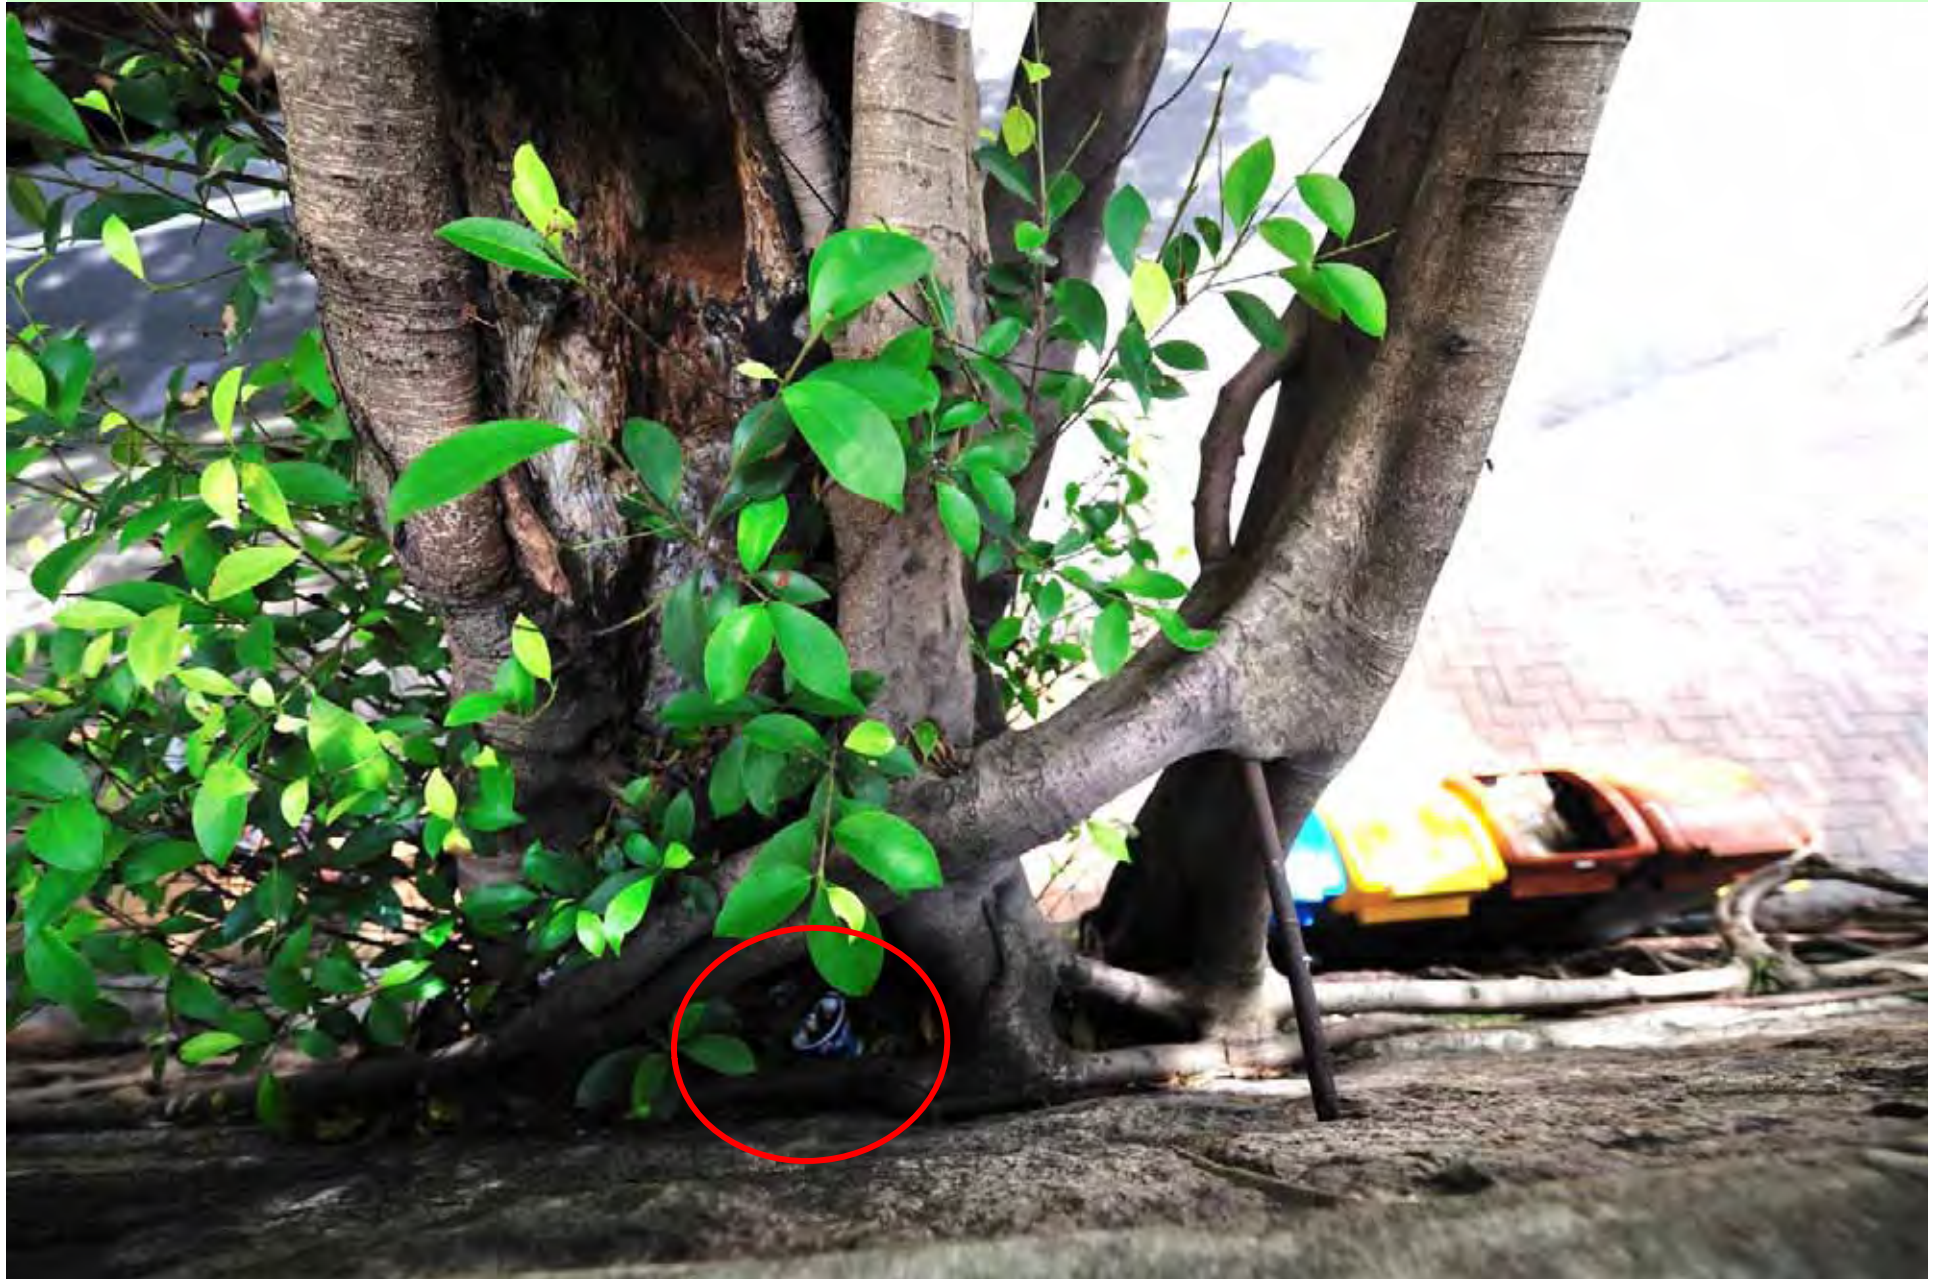
Photo T5-7. Relationship between tree and wall crest, viewed from the south. Rubbish accumulation in the gap.

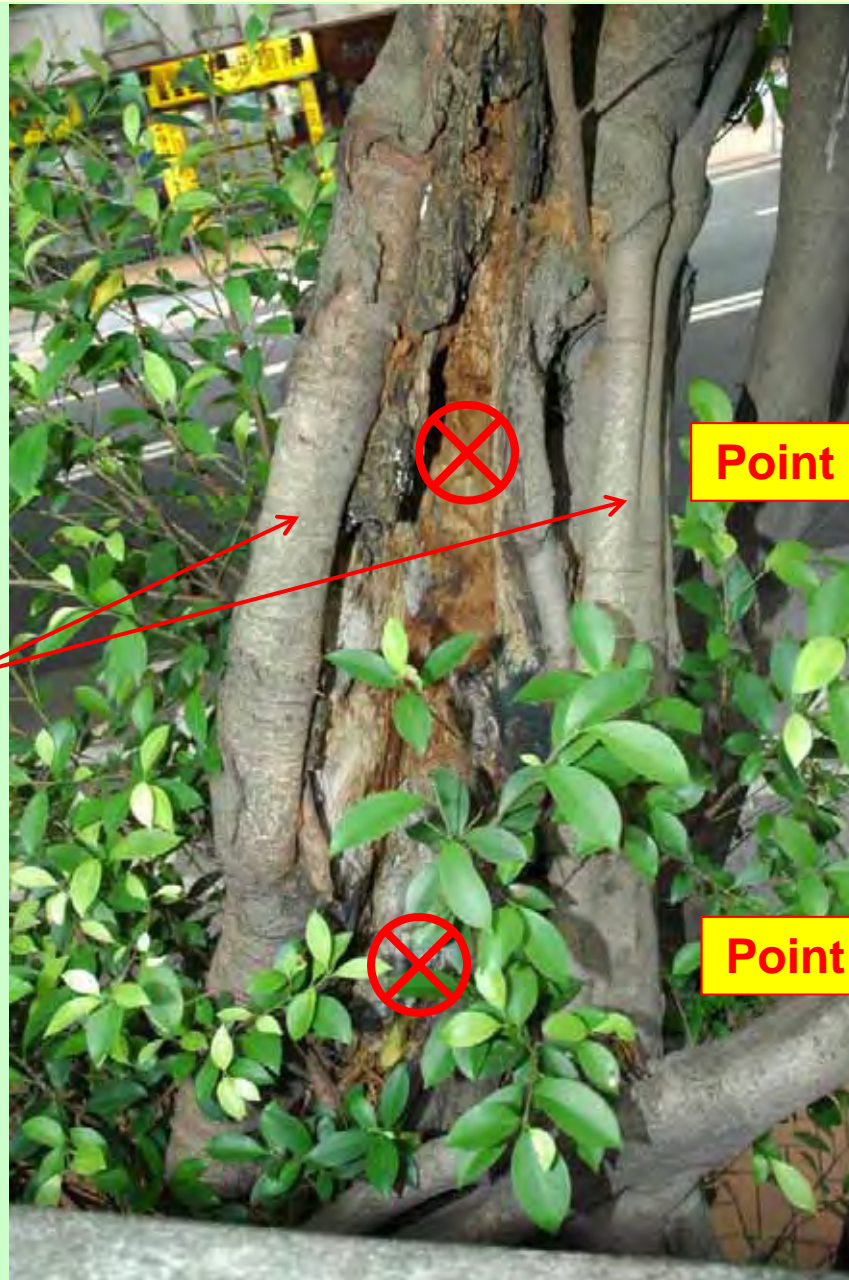
Photo T5-8. Large cavity with decay extending from trunk base upwards. Crosses denote drilling positions.

**Strong response
wood
development at
edge of cavity**

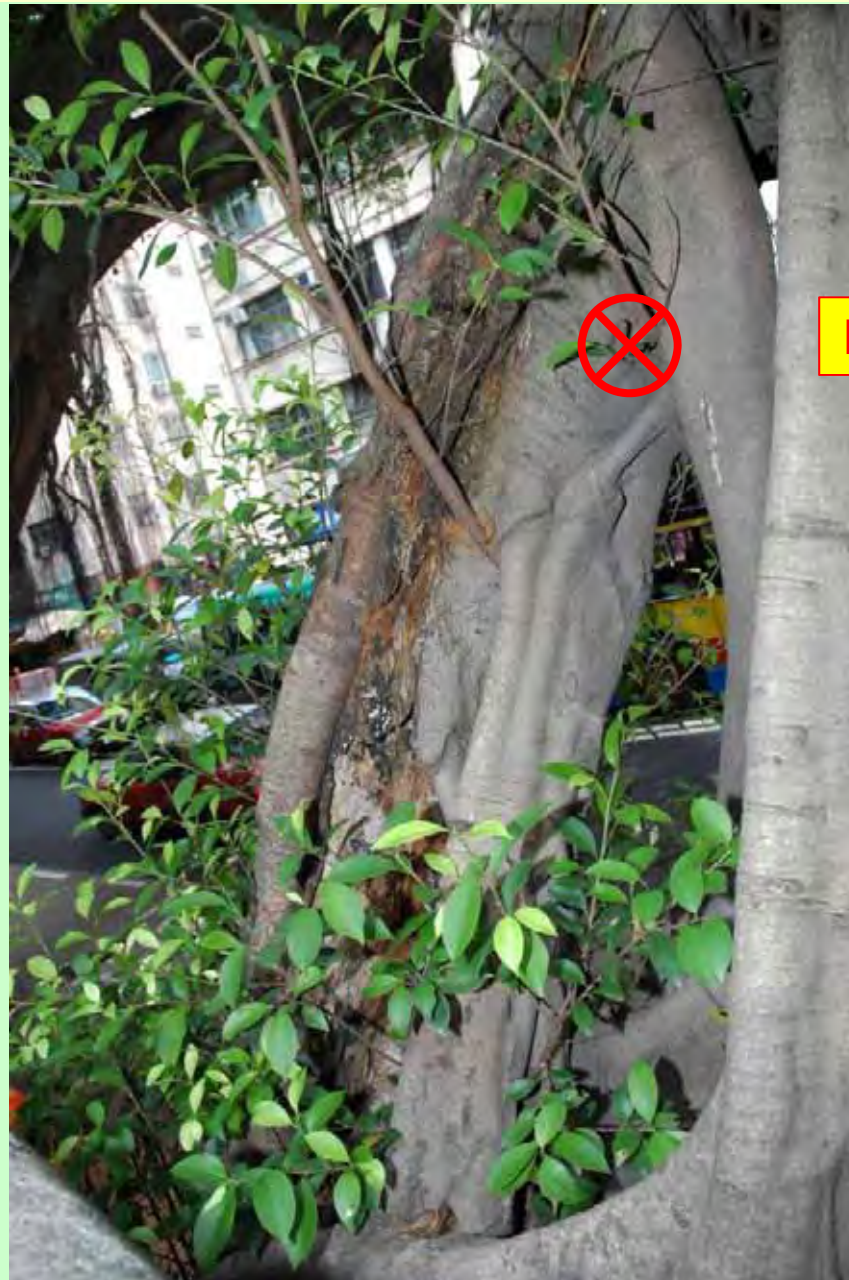
Photo T5-9. Upper end of the trunk cavity with upward extension of wood decay. Cross denotes drilling position.

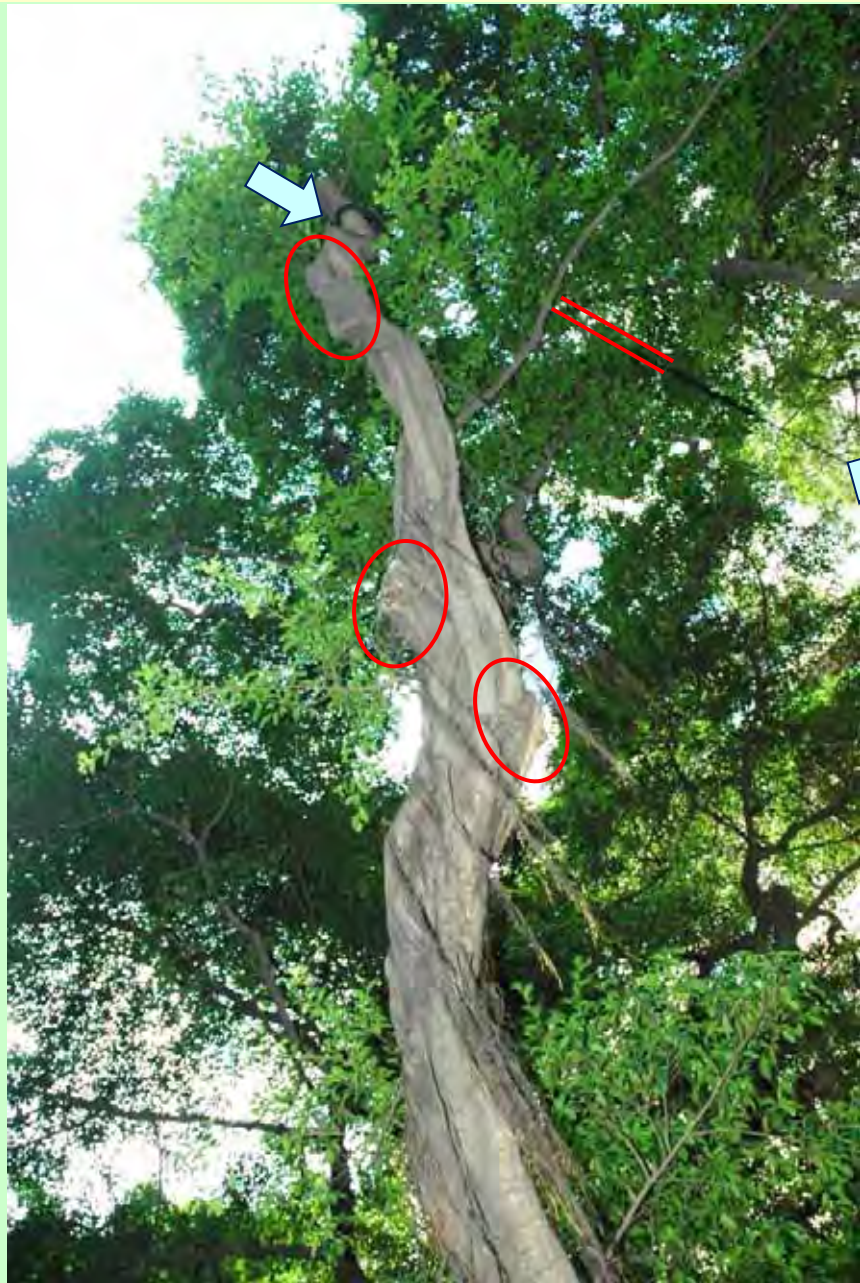
Photo T5-10. Several limbs were removed from the trunk. Cobra cable bracing linked to T4.

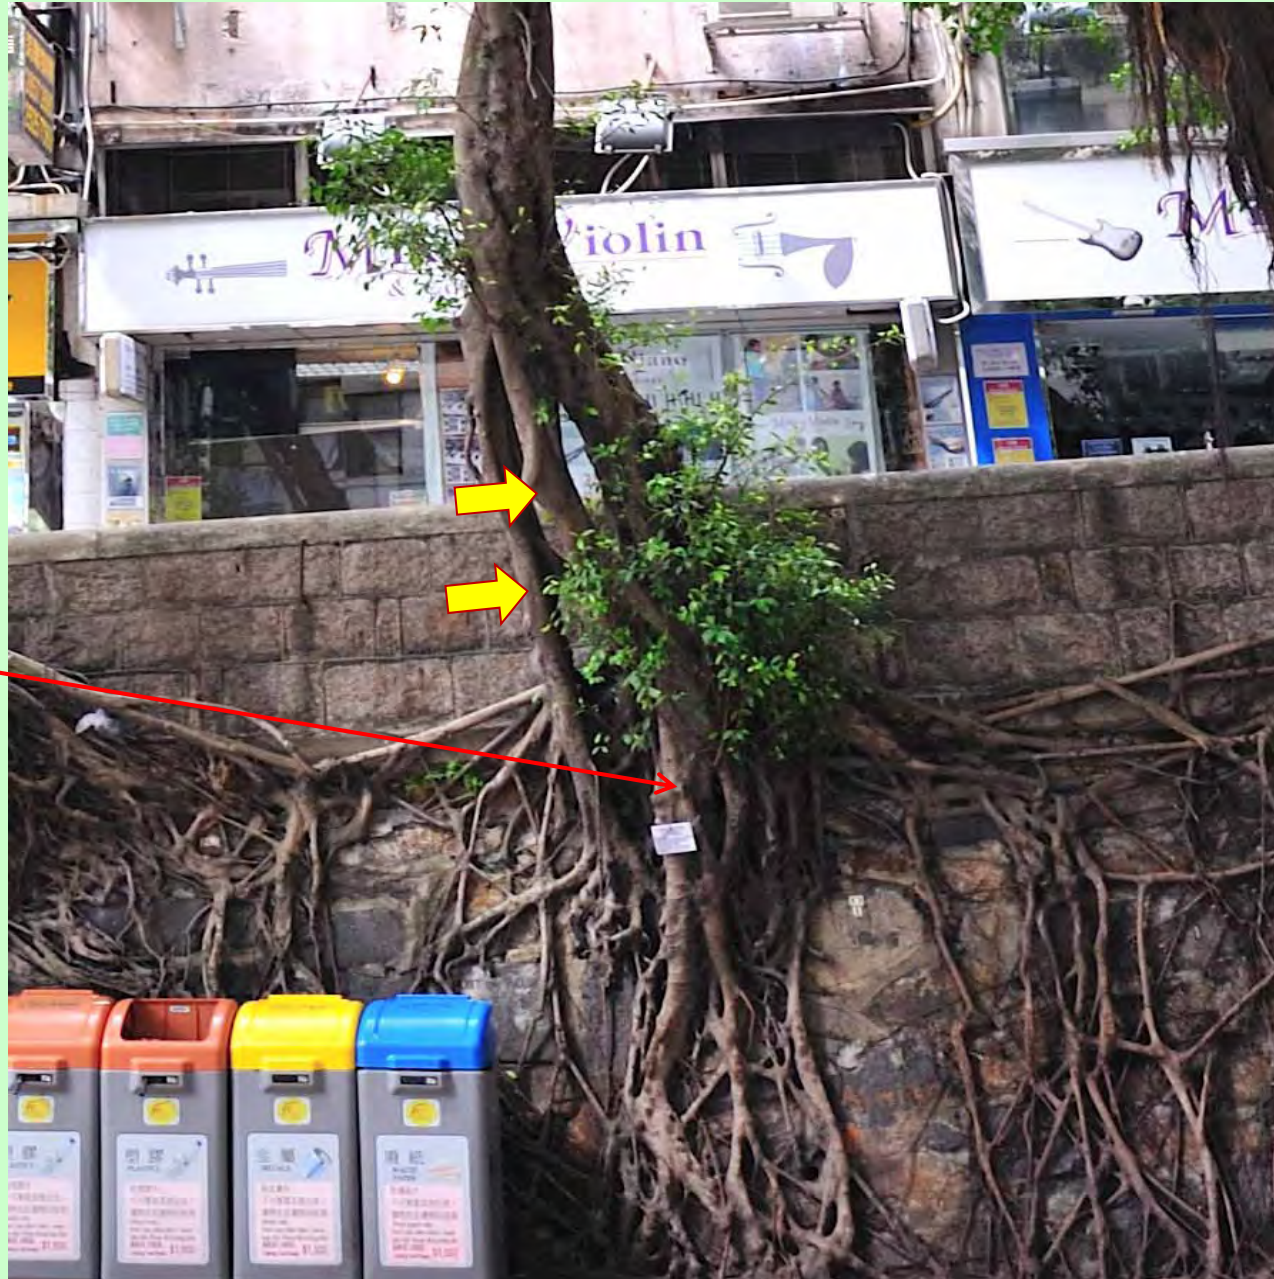
Photo T5-11. Reinforcement of decayed and hollowed trunk base by two strong lignified aerial roots and thickened root prop.

Notably thickened root prop

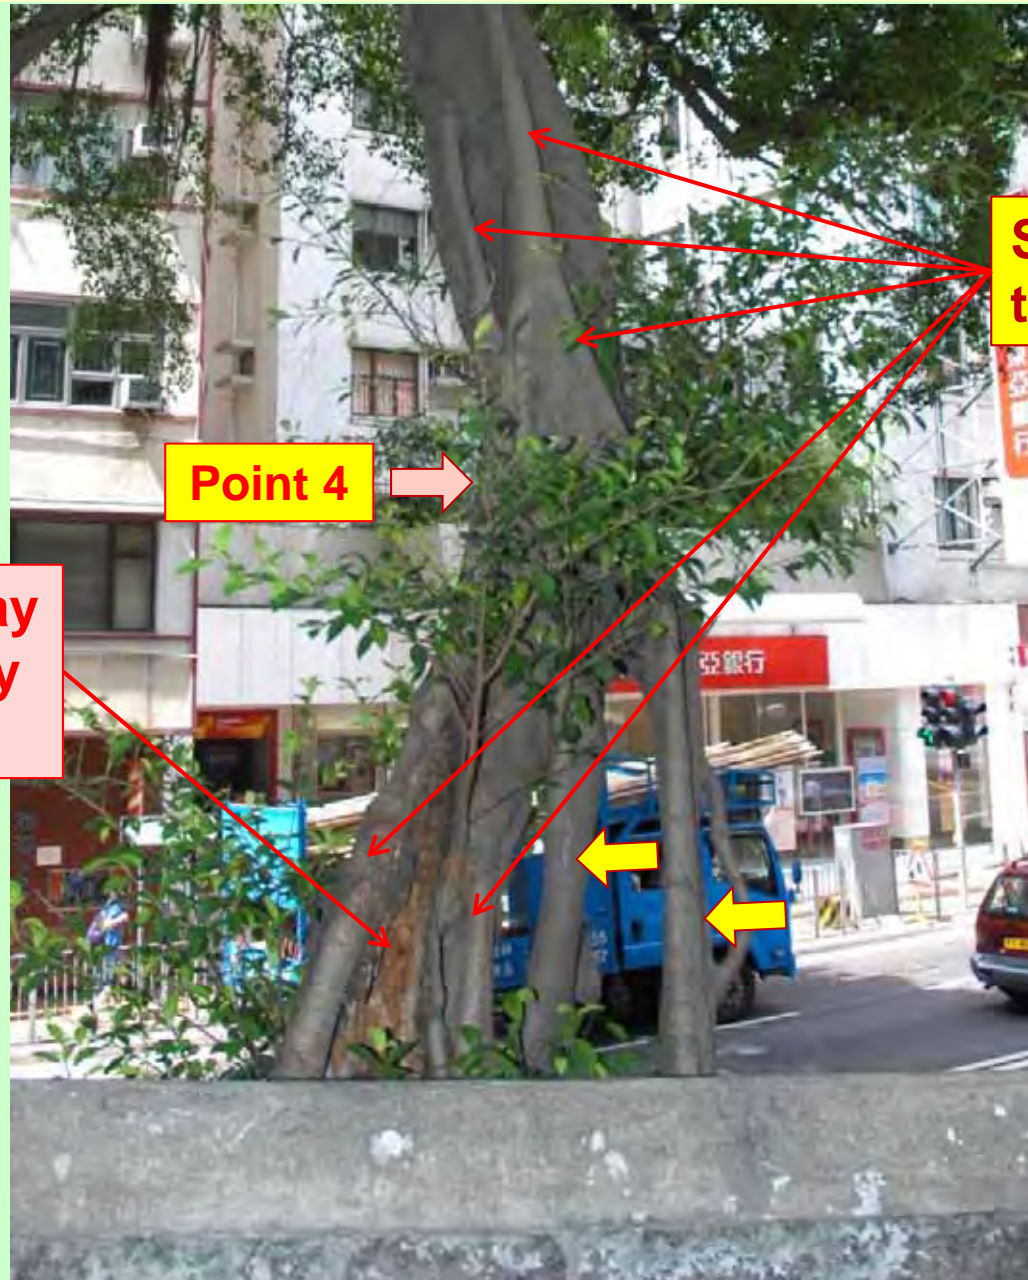
Photo T5-12. Reinforcement of decayed trunk base by two strong lignified aerial roots (arrows). Pink arrow denotes drilling position.

Advanced decay and large cavity at trunk base

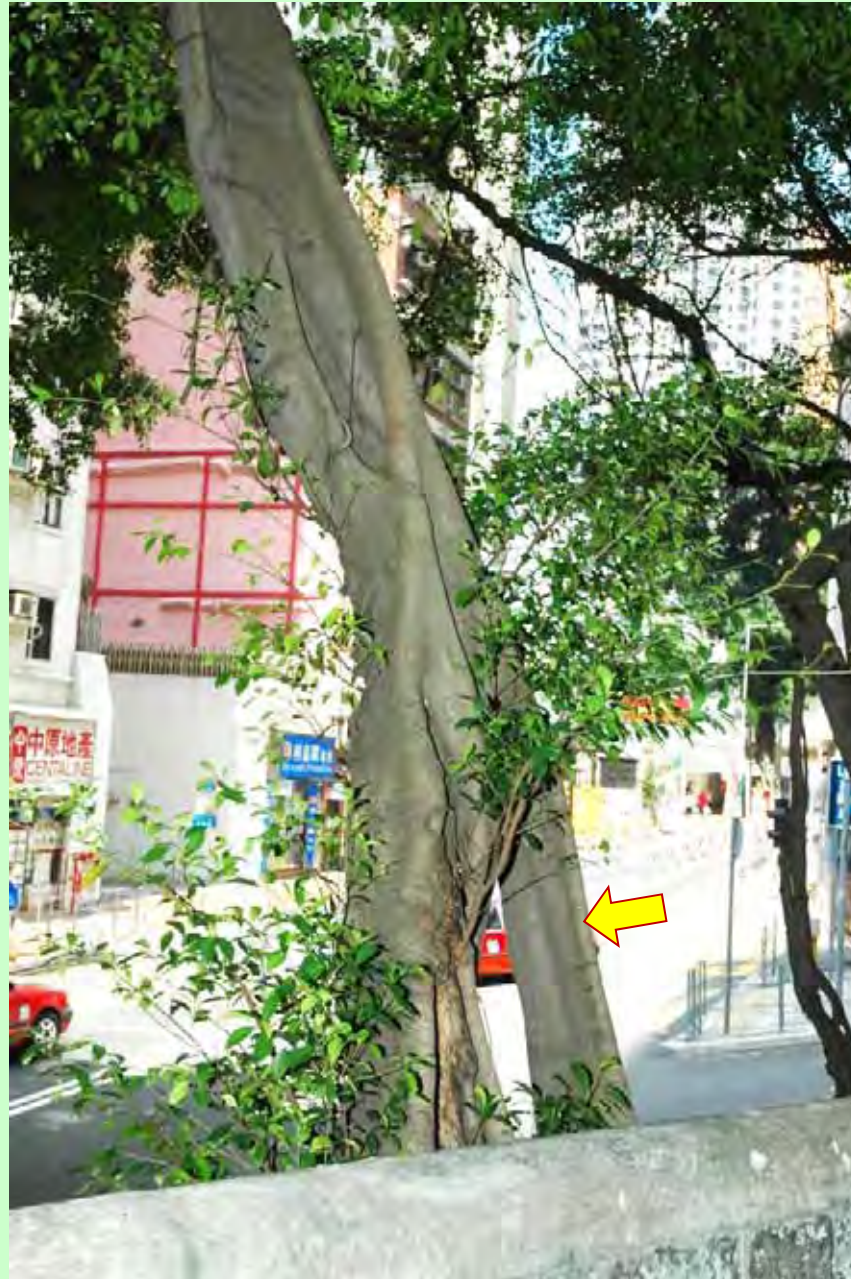
Strong response tension wood

Photo T5-13. Significant response wood development in lignified aerial root to compensate for trunk decay and cavity formation.

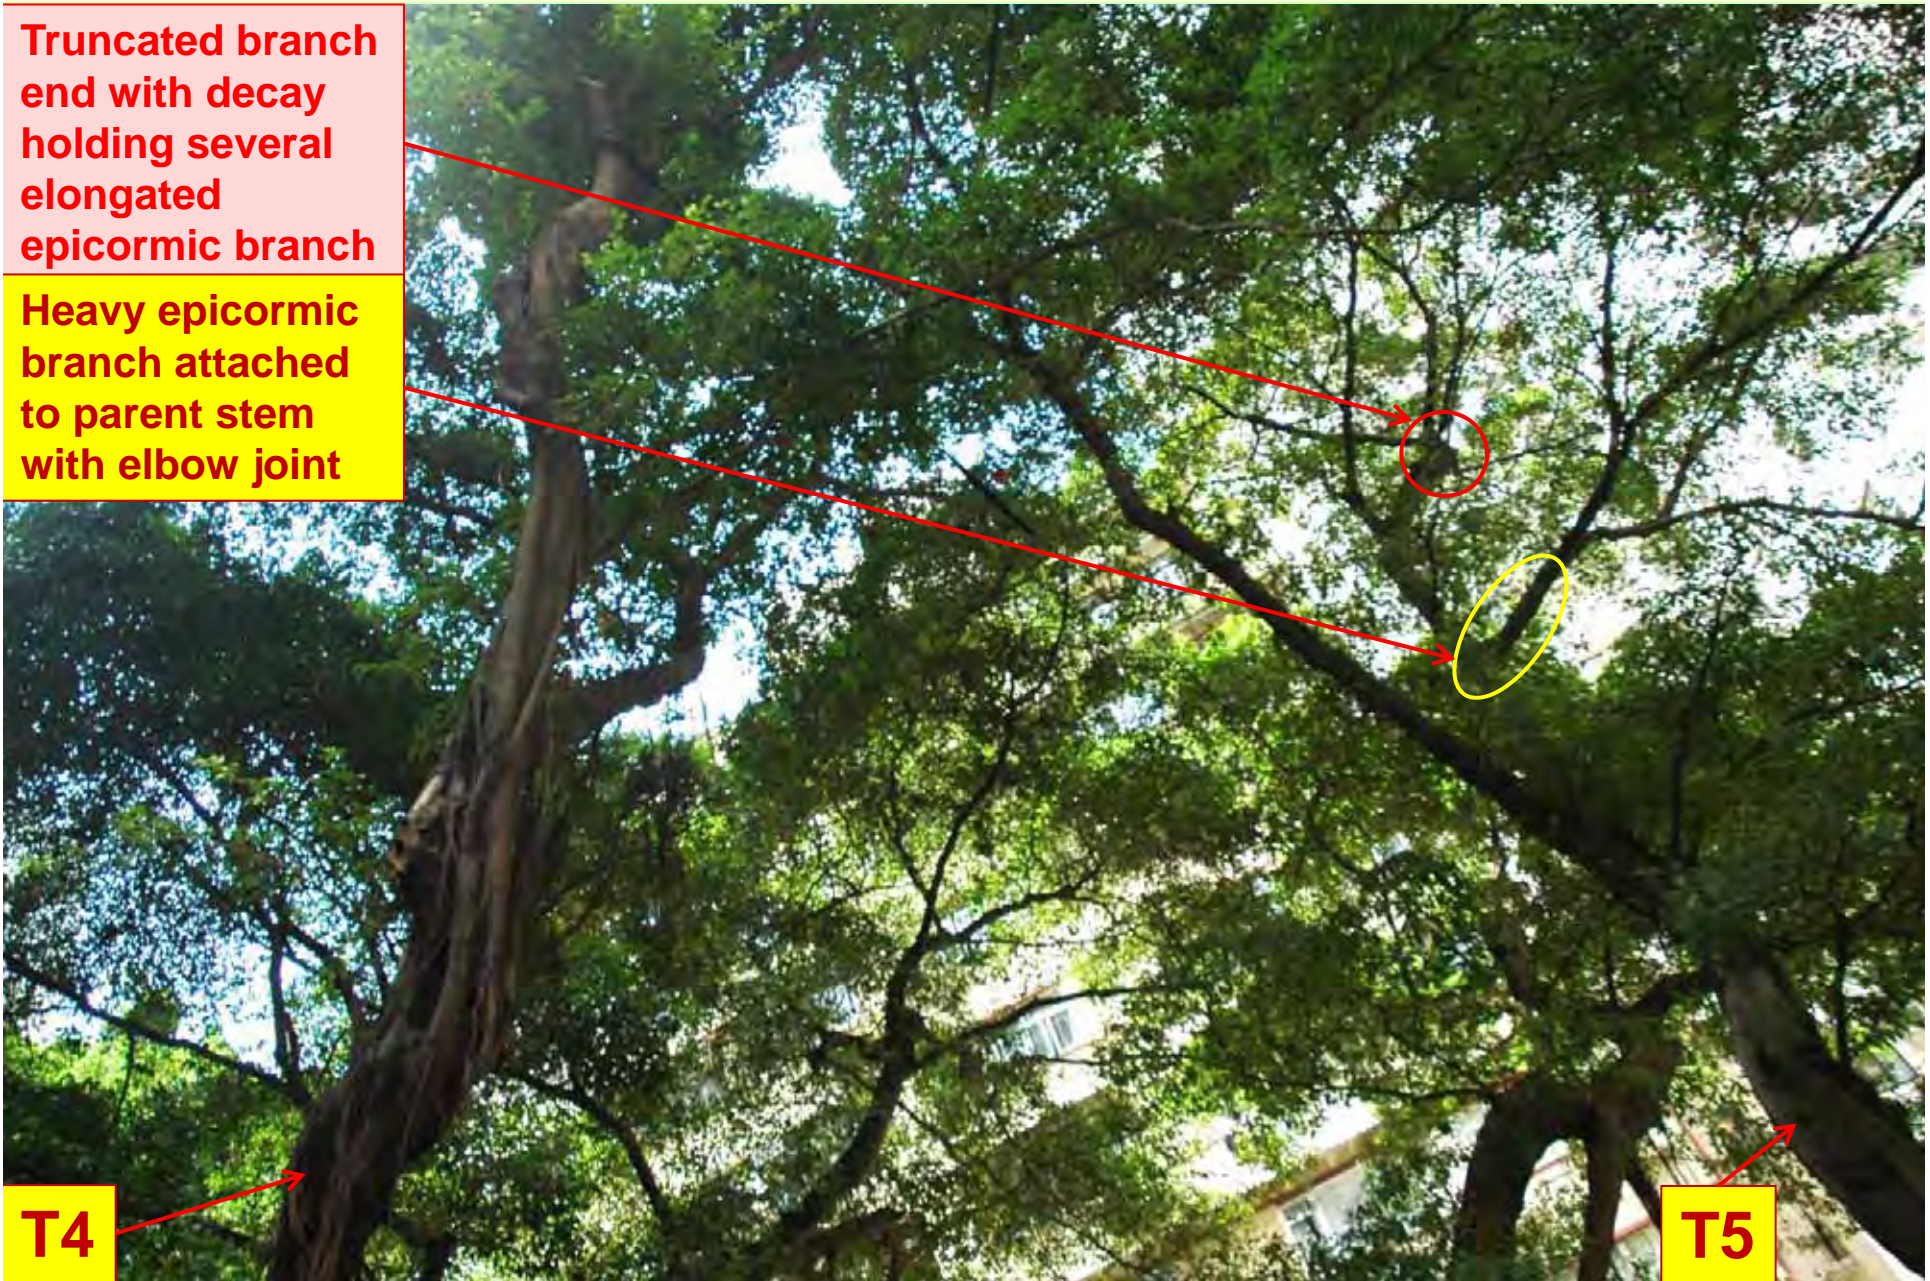
Photo T5-14. Narrow crown trapped between T4 and T6.
Truncated branch & elbow joint holding long epicormic branches.

Truncated branch
end with decay
holding several
elongated
epicormic branch

Heavy epicormic
branch attached
to parent stem
with elbow joint

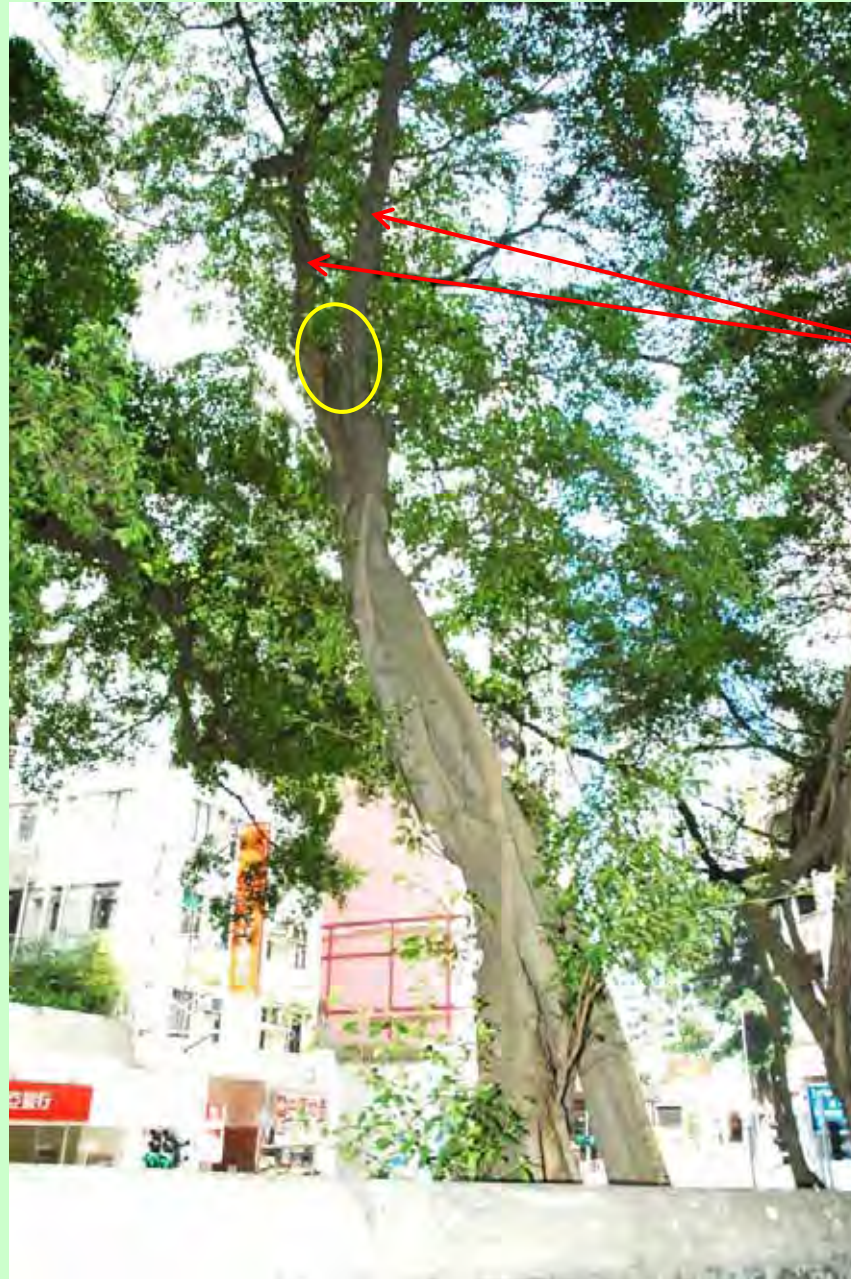
Photo T5-15. The limited crown development with only two rather upright limbs with V-crotch (circle) and few branches.

**Upright
limbs with
intervening
V-crotch**

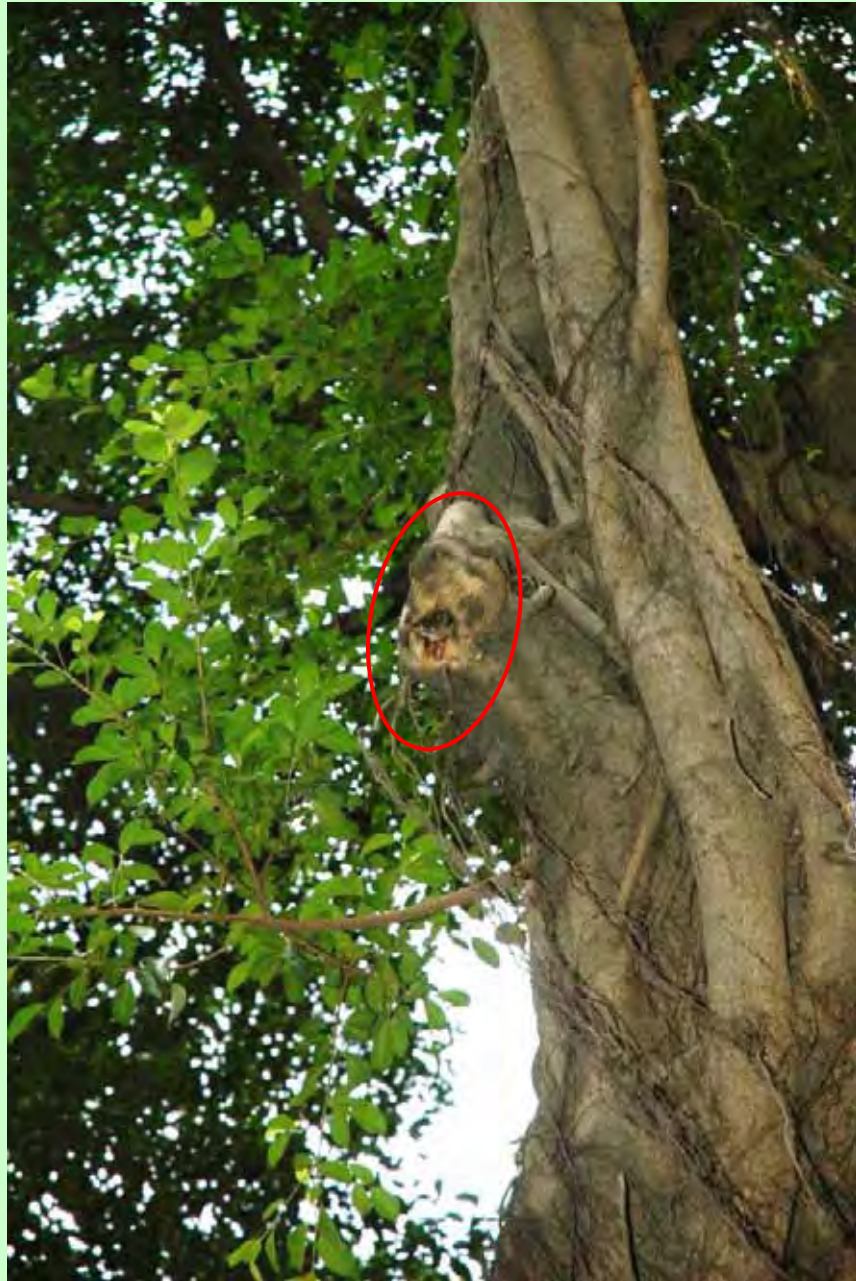
Photo T5-16. Branch stub on trunk with decay.

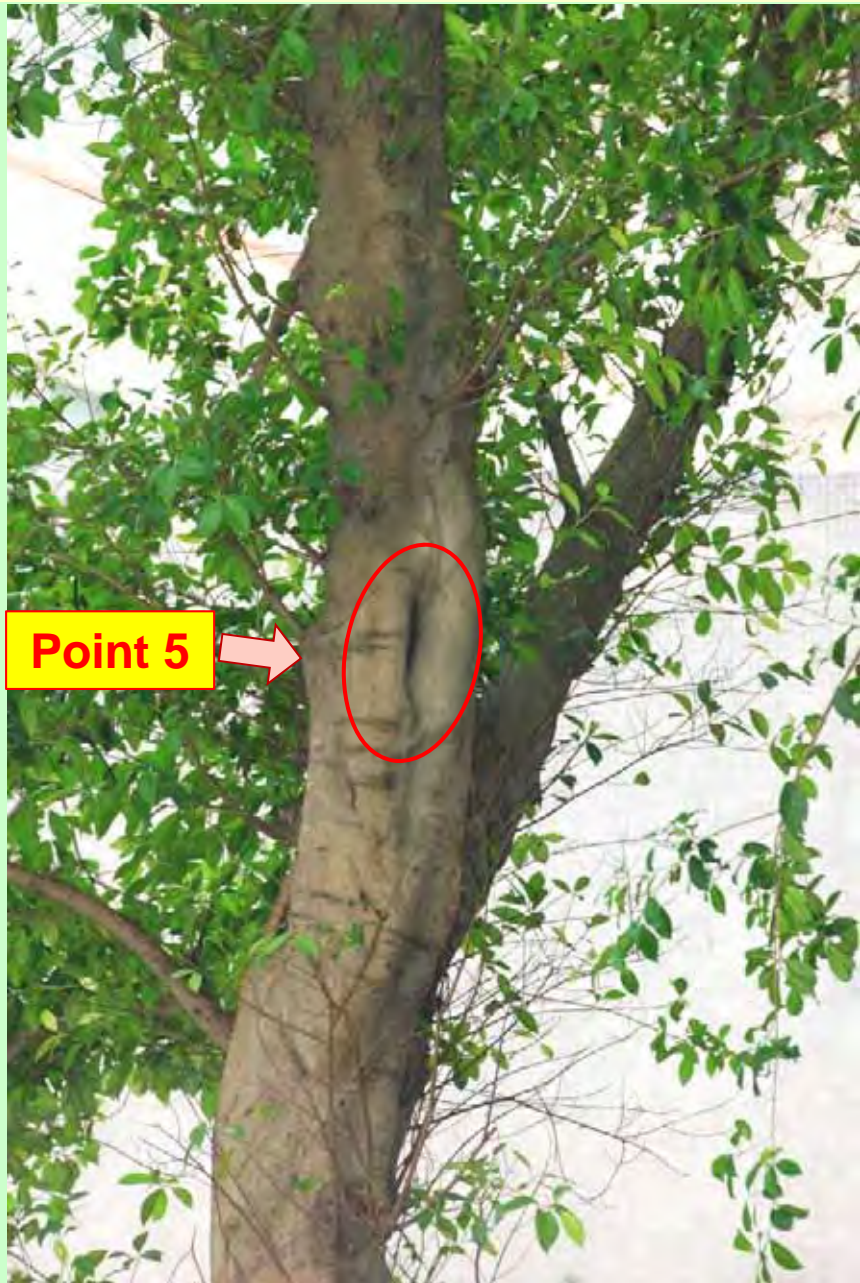
Photo T5-17. Seam and slight bulge on heavy limb with possible internal decay. Arrow denotes drilling position.

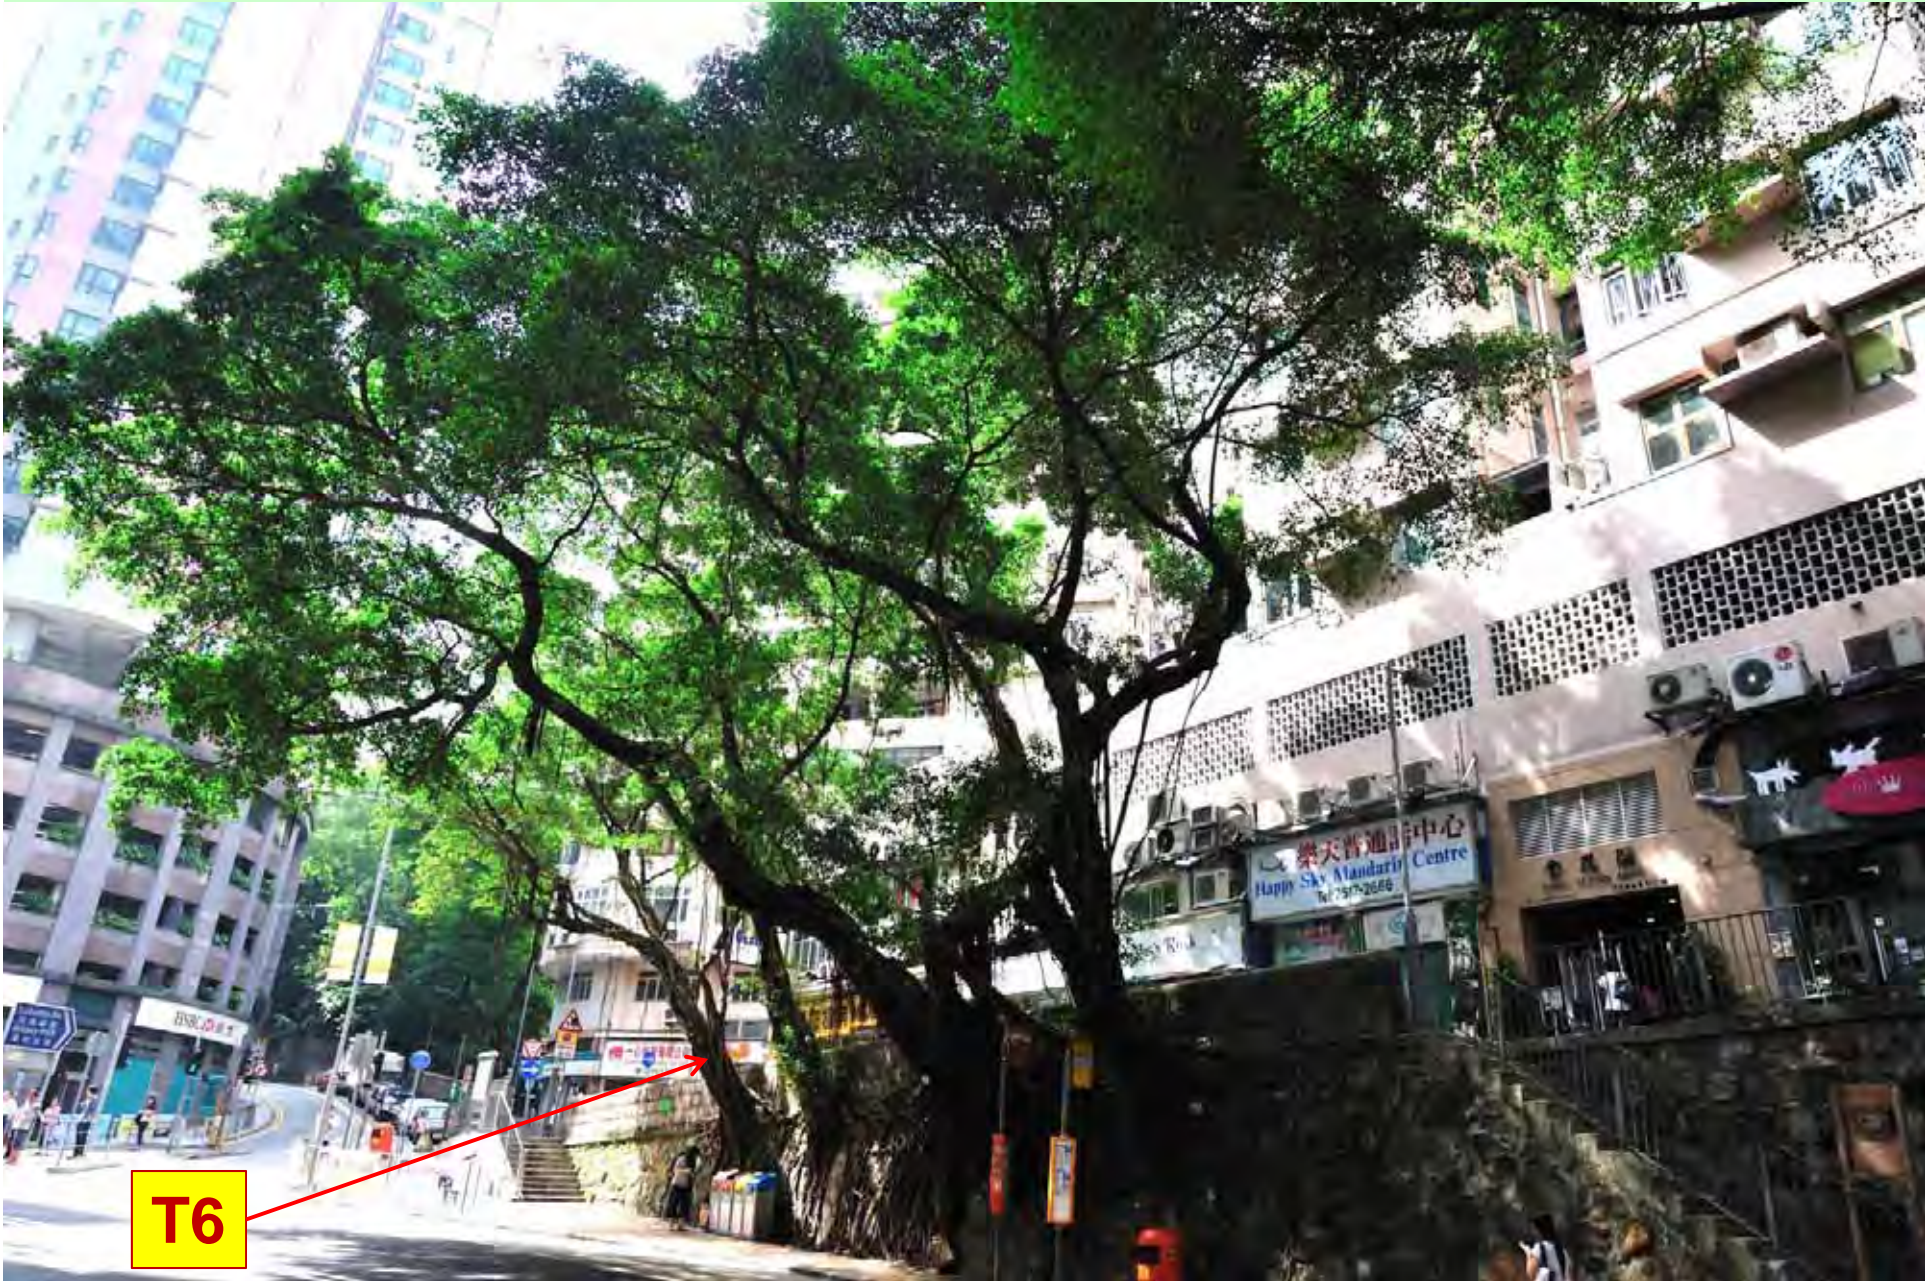
Photo T6-1. The tree in relation to its neighbours to the right, namely T5, T4 and T3.
