Assessment of Wall Trees on Slope 11SW-A/R577 at Bonham Road

**Highways Department
HKSAR Government**

**C.Y. Jim
The University of Hong Kong
hrajcy@hku.hk**

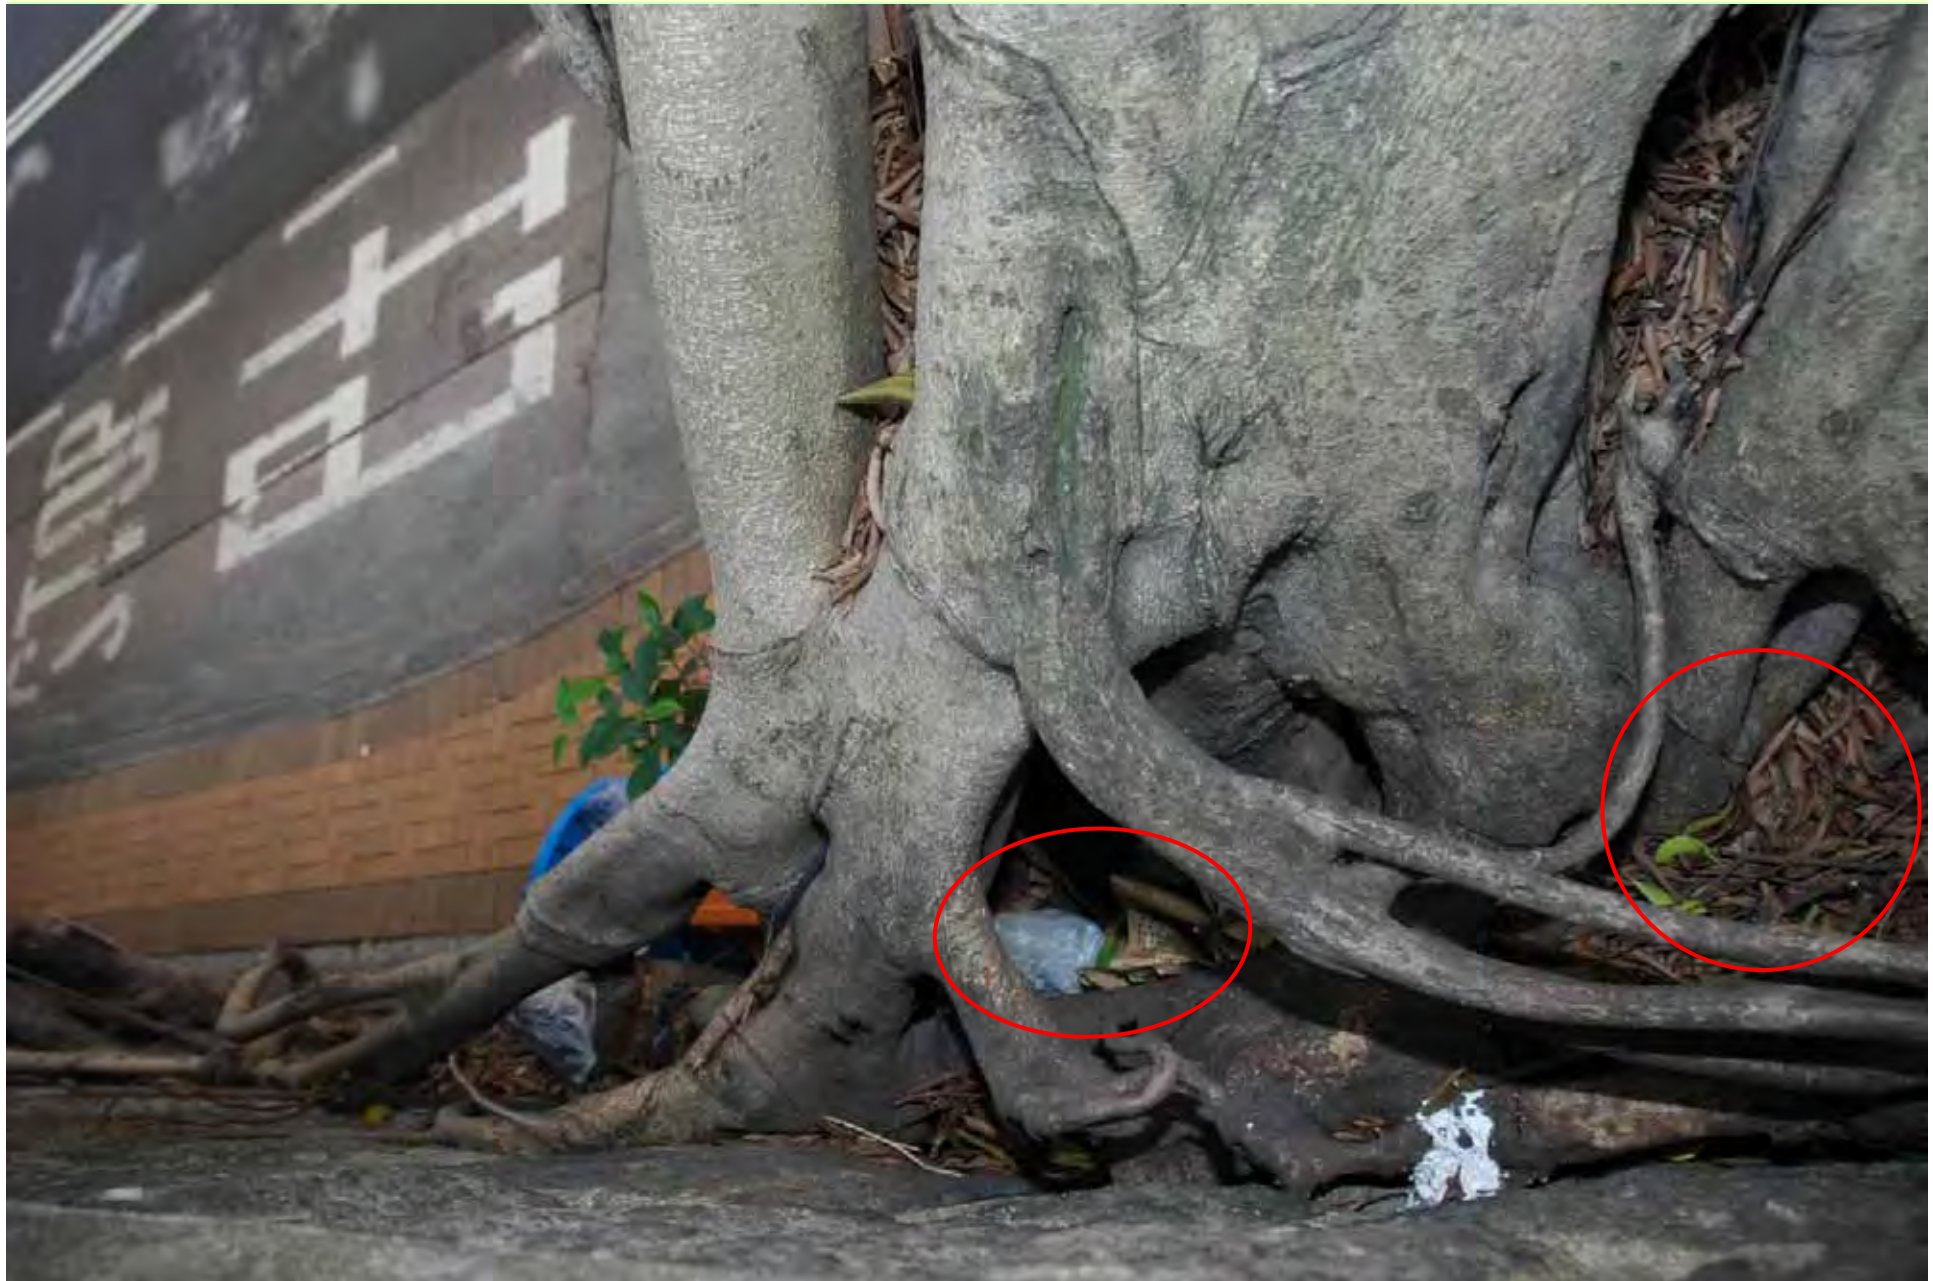
Photo T6-8. The organic litter and rubbish accumulated in the gap between the trunk and the wall can be regularly removed.

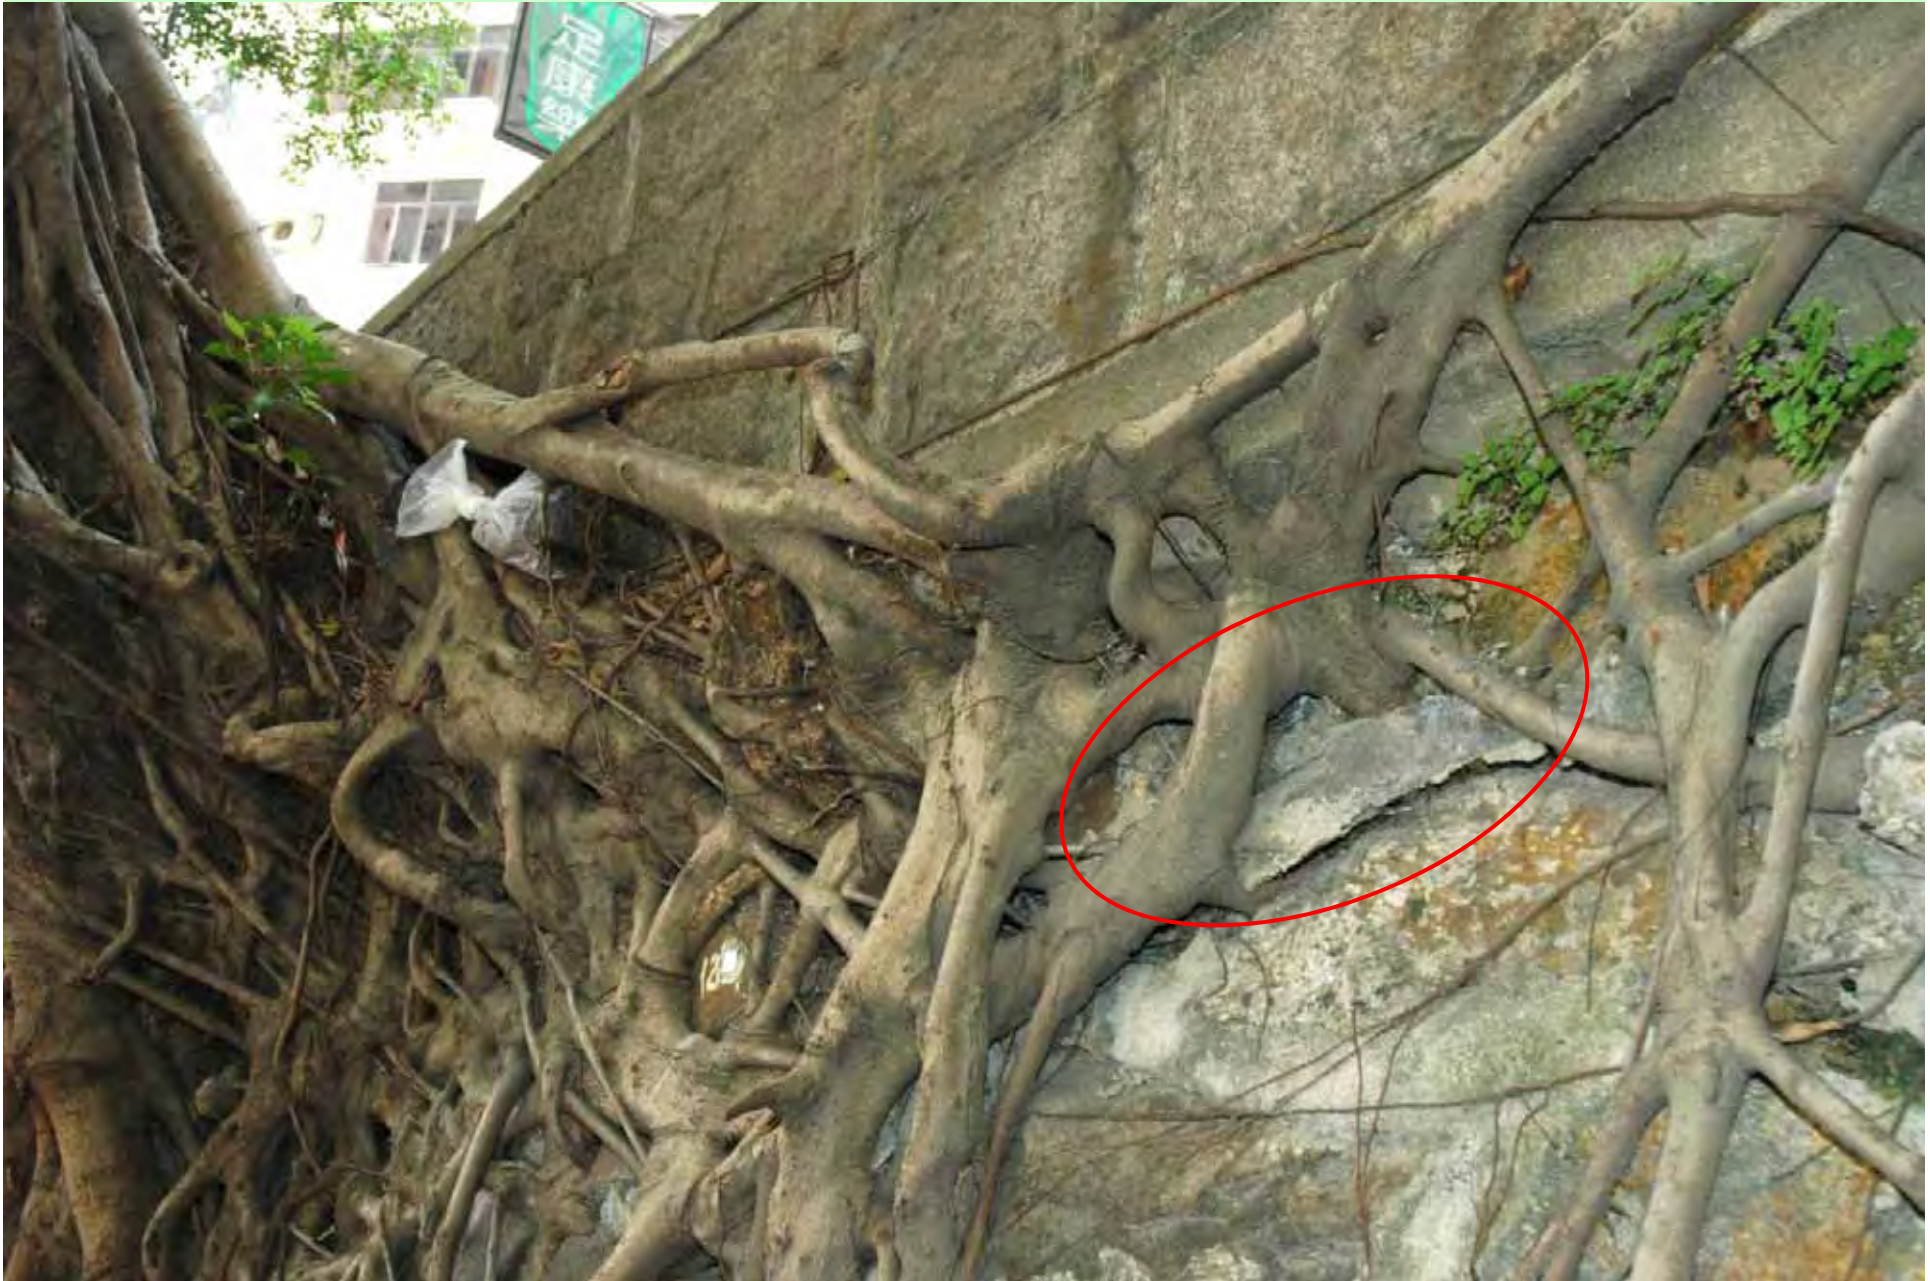
Photo T6-9. Surface root mass on the west side with loosened mortar. Litter accumulation in surface roots.

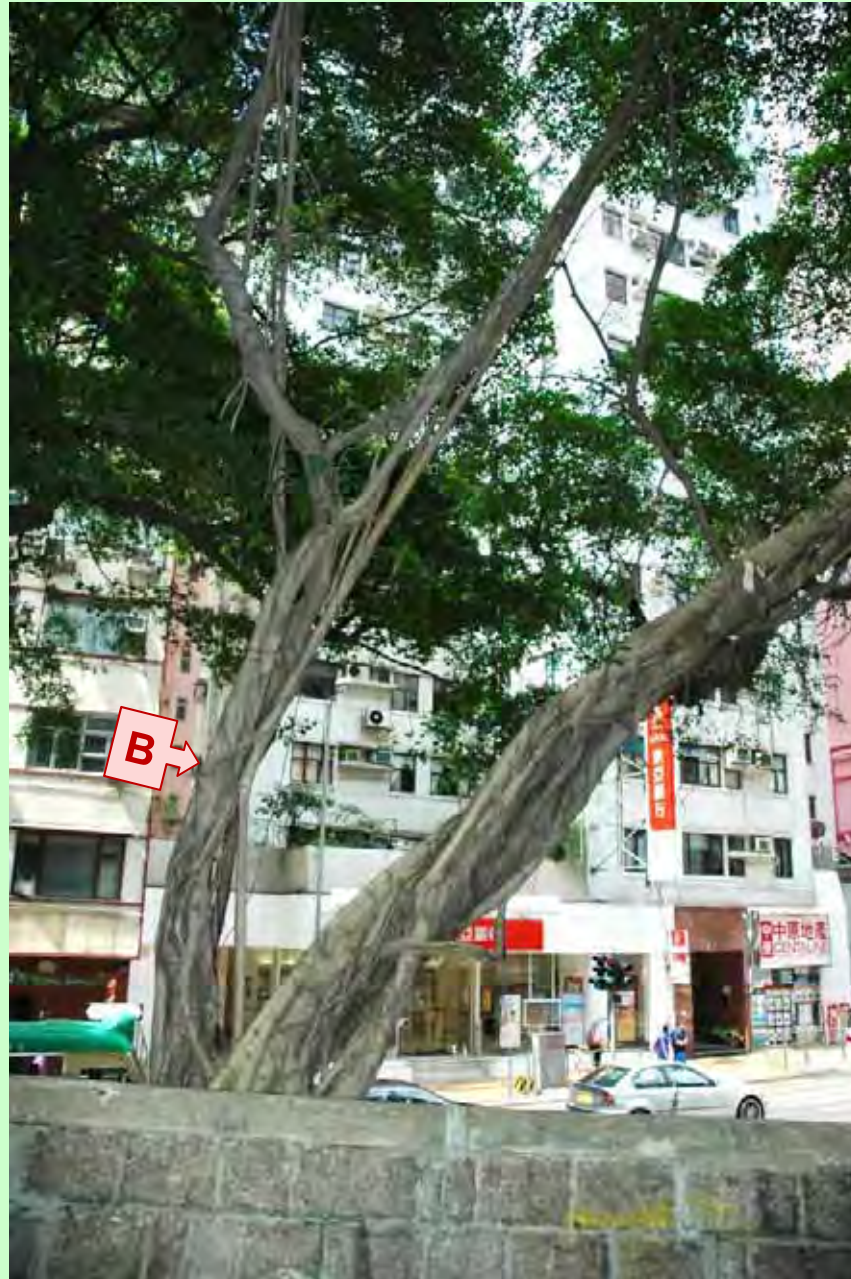
Photo T6-12. Stem B and its branches are well reinforced by lignified aerial roots. Notable loss of lower branches.

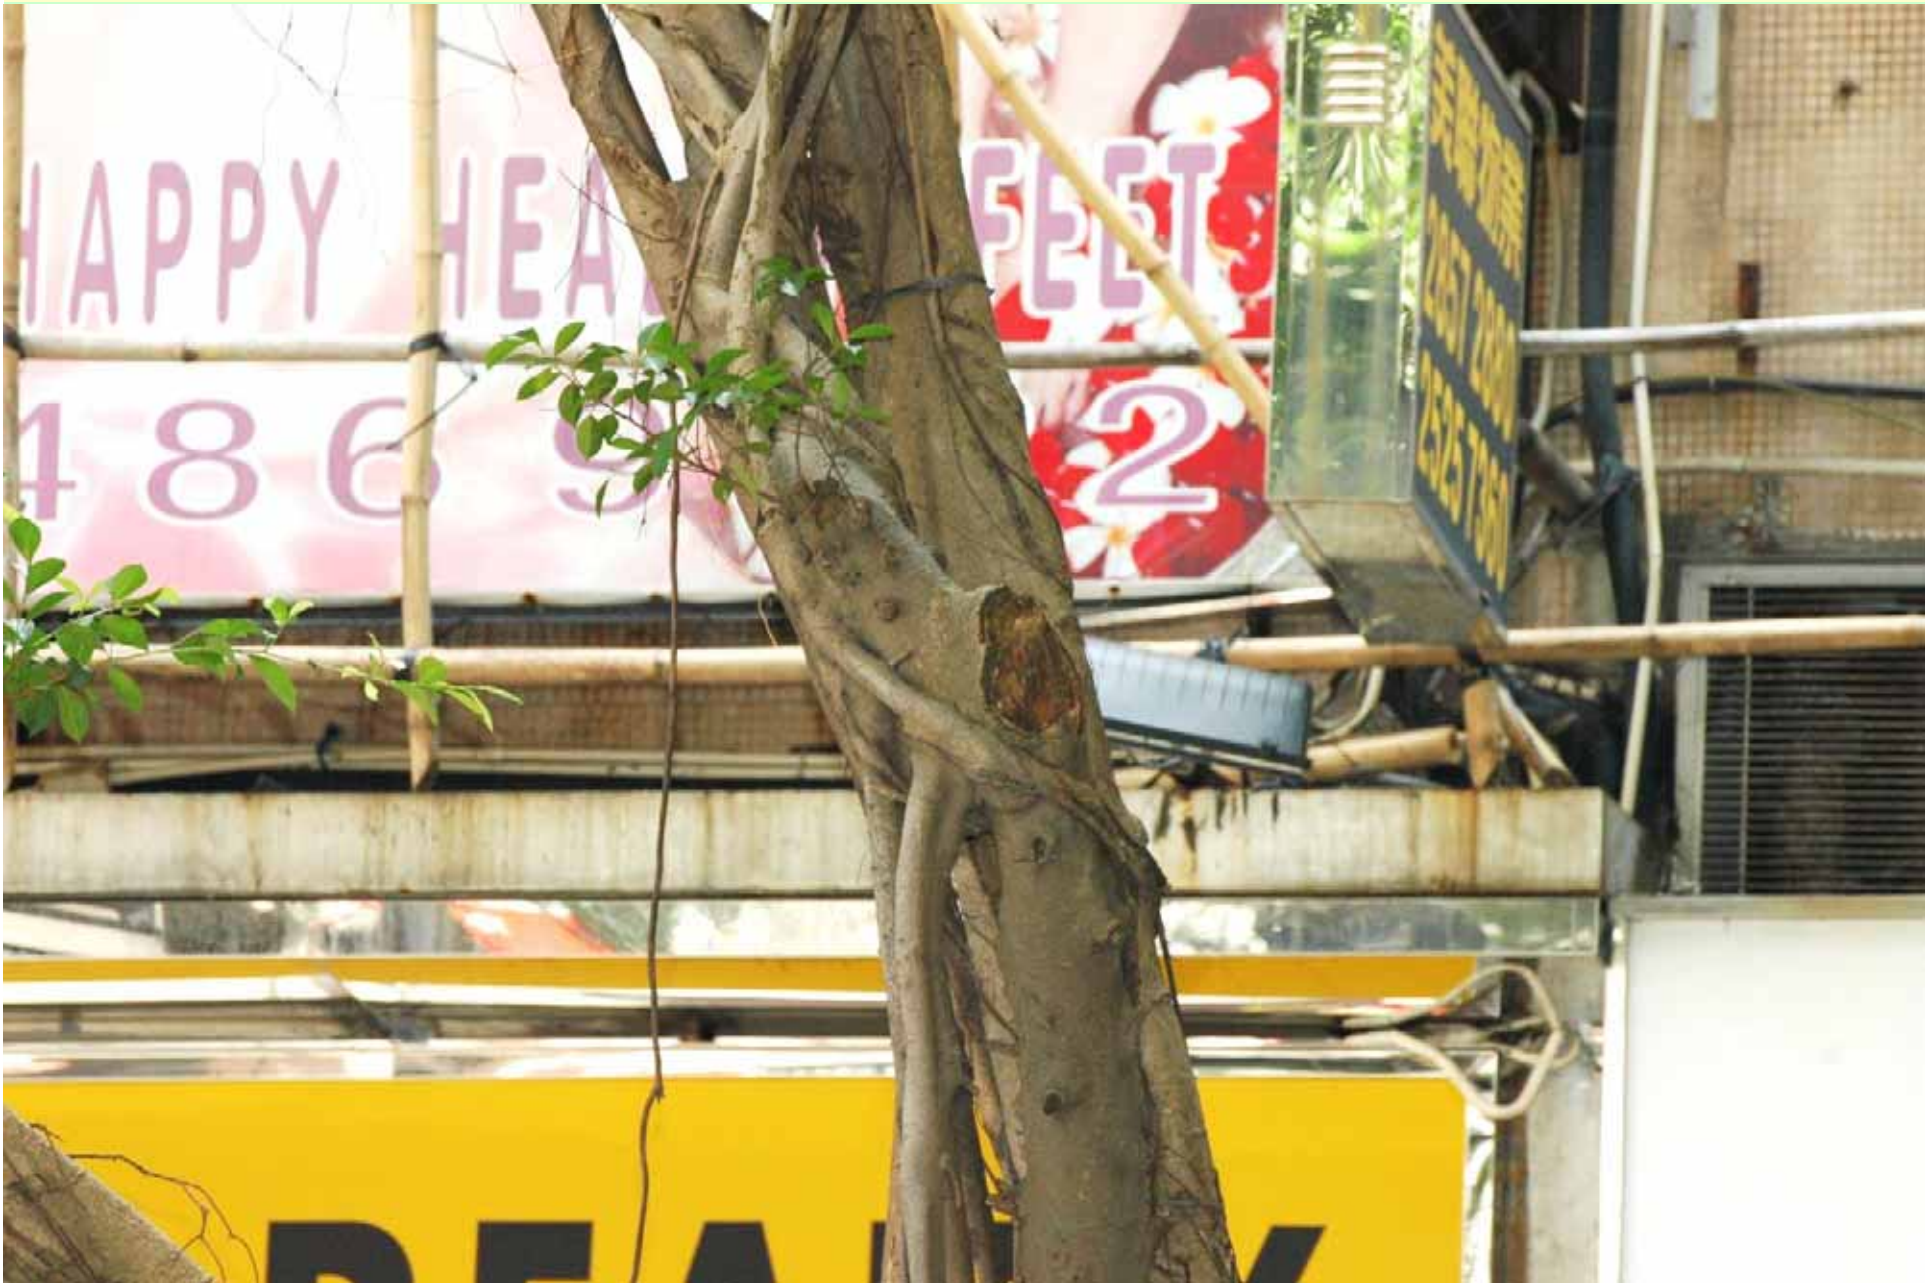
Photo T6-13. Stem B with branch removal wound and decay.
