## Supplementary Note

### **Maintenance Efforts on Stonewall Trees on Slope no. 11SW-A/R577 Bonham Road, Hong Kong**

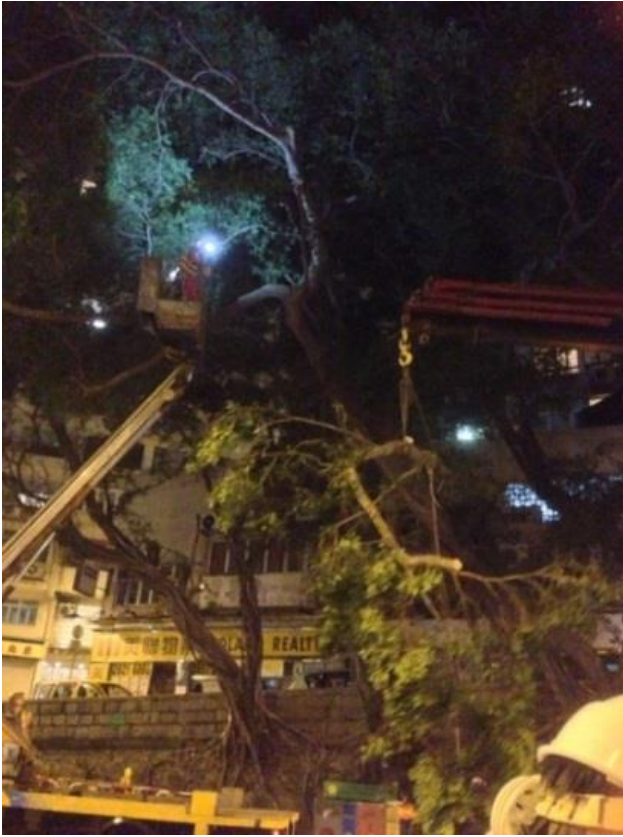
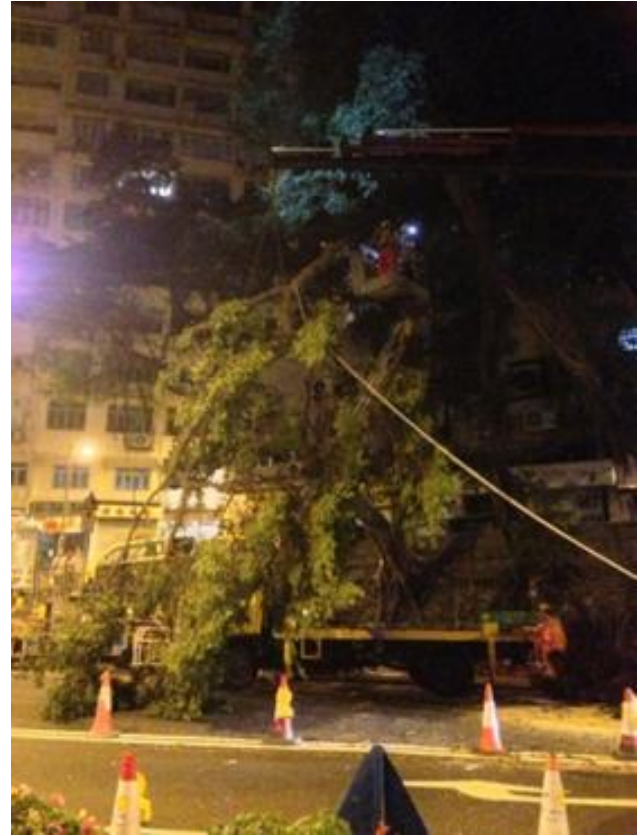
Photos of the pruning operation of T4 and T5 on 17 May 2013

5. In the absence of feasible mitigation measures to support T4 and T5 so as to address their alarming risks to public safety, a substantial pruning operation to the tree T4 (about 60%) and the tree T5 (about 25%) had been carried out on 17 May 2013 (Photos of the pruning operation are attached for reference). Subsequently, pruning of T1, T2, T3 and T6 (about 5-10%) had also been conducted in June 2013.
