Assessment of Wall Trees on Slope 11SW-A/R577 at Bonham Road

**Highways Department
HKSAR Government**

**C.Y. Jim
The University of Hong Kong
hrajcy@hku.hk**

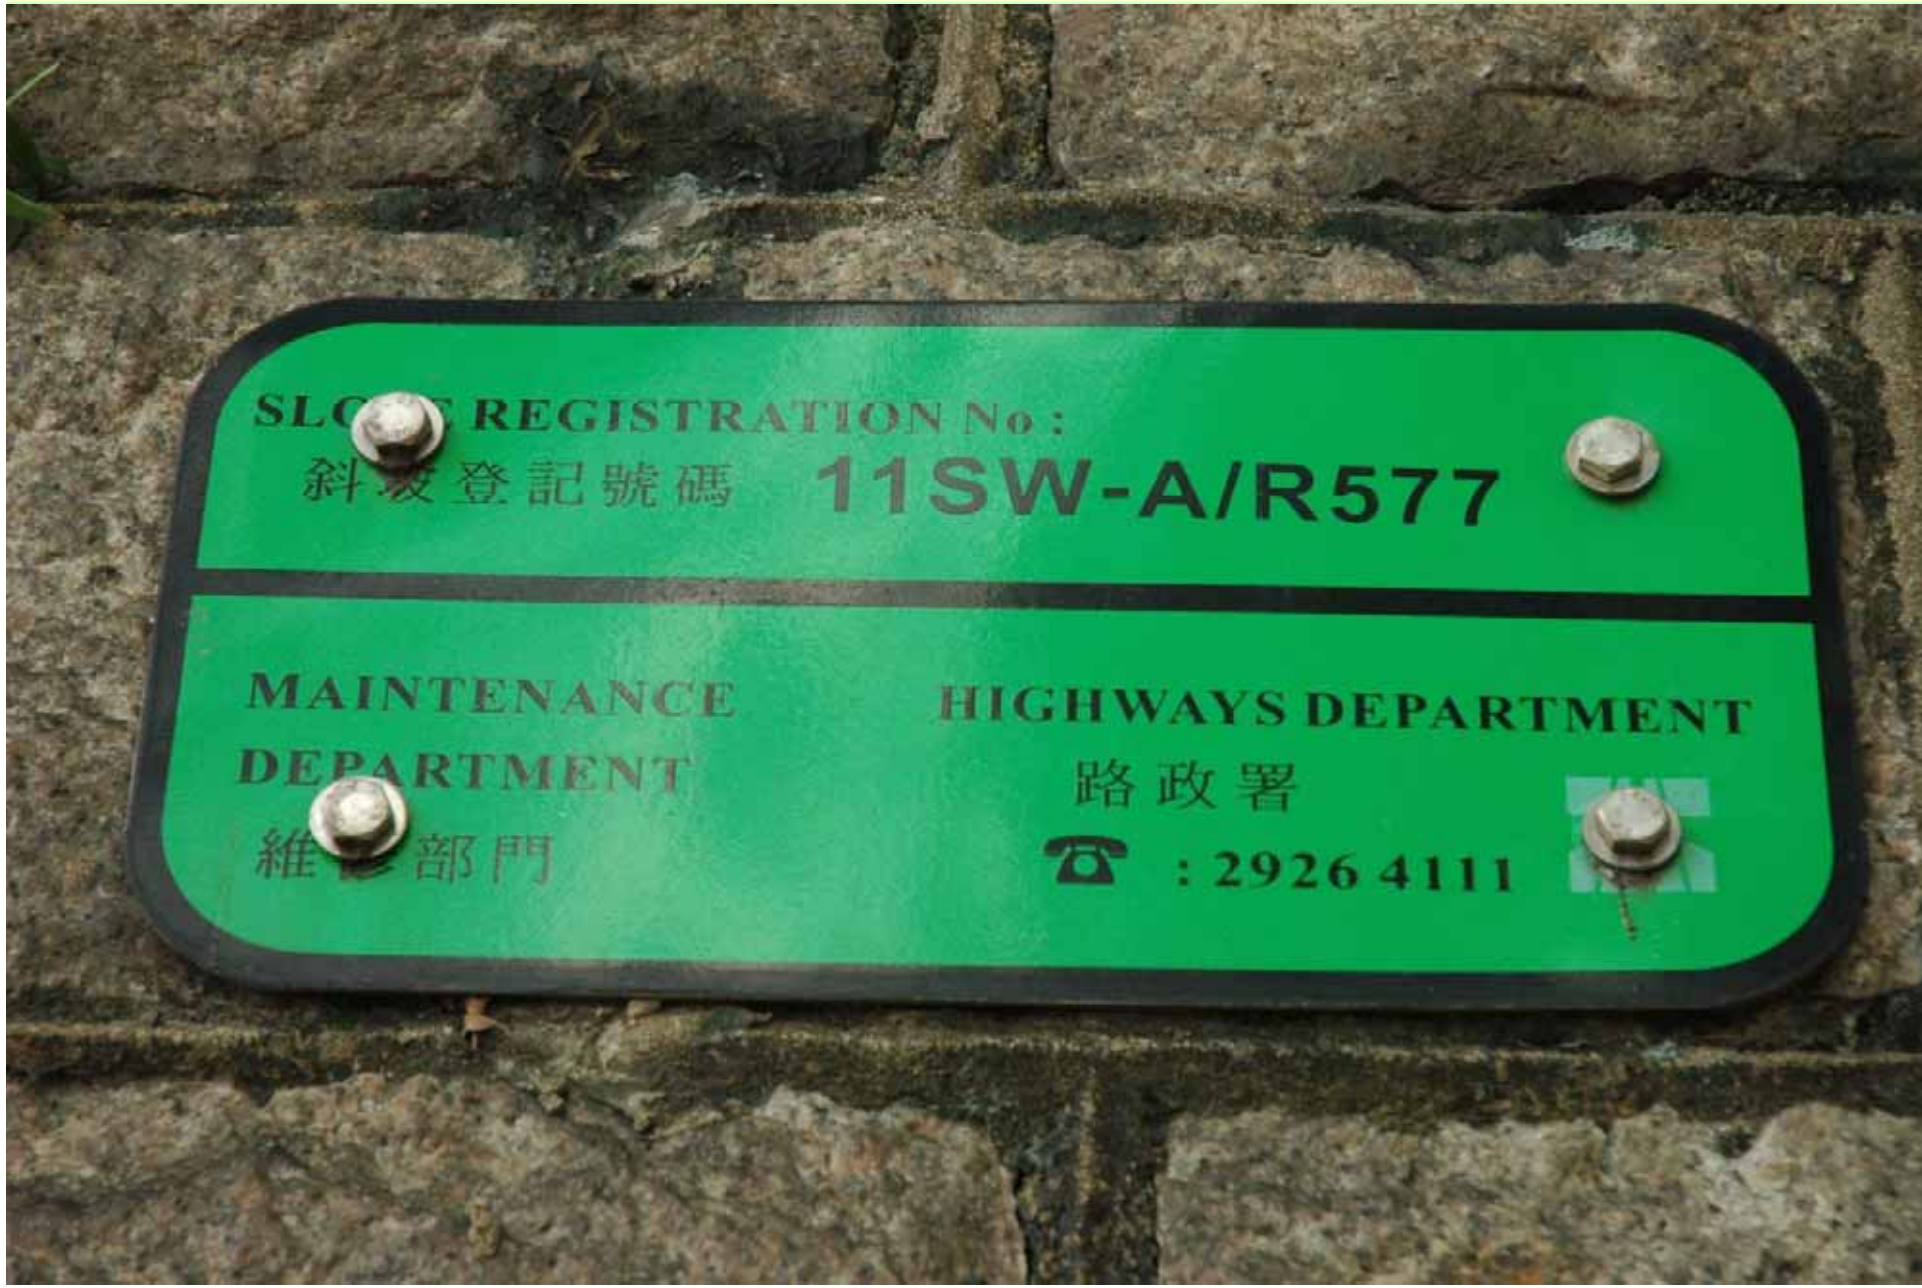
Photo T0-2. The old stone wall together with its stonewall trees are maintained by the Highways Department.

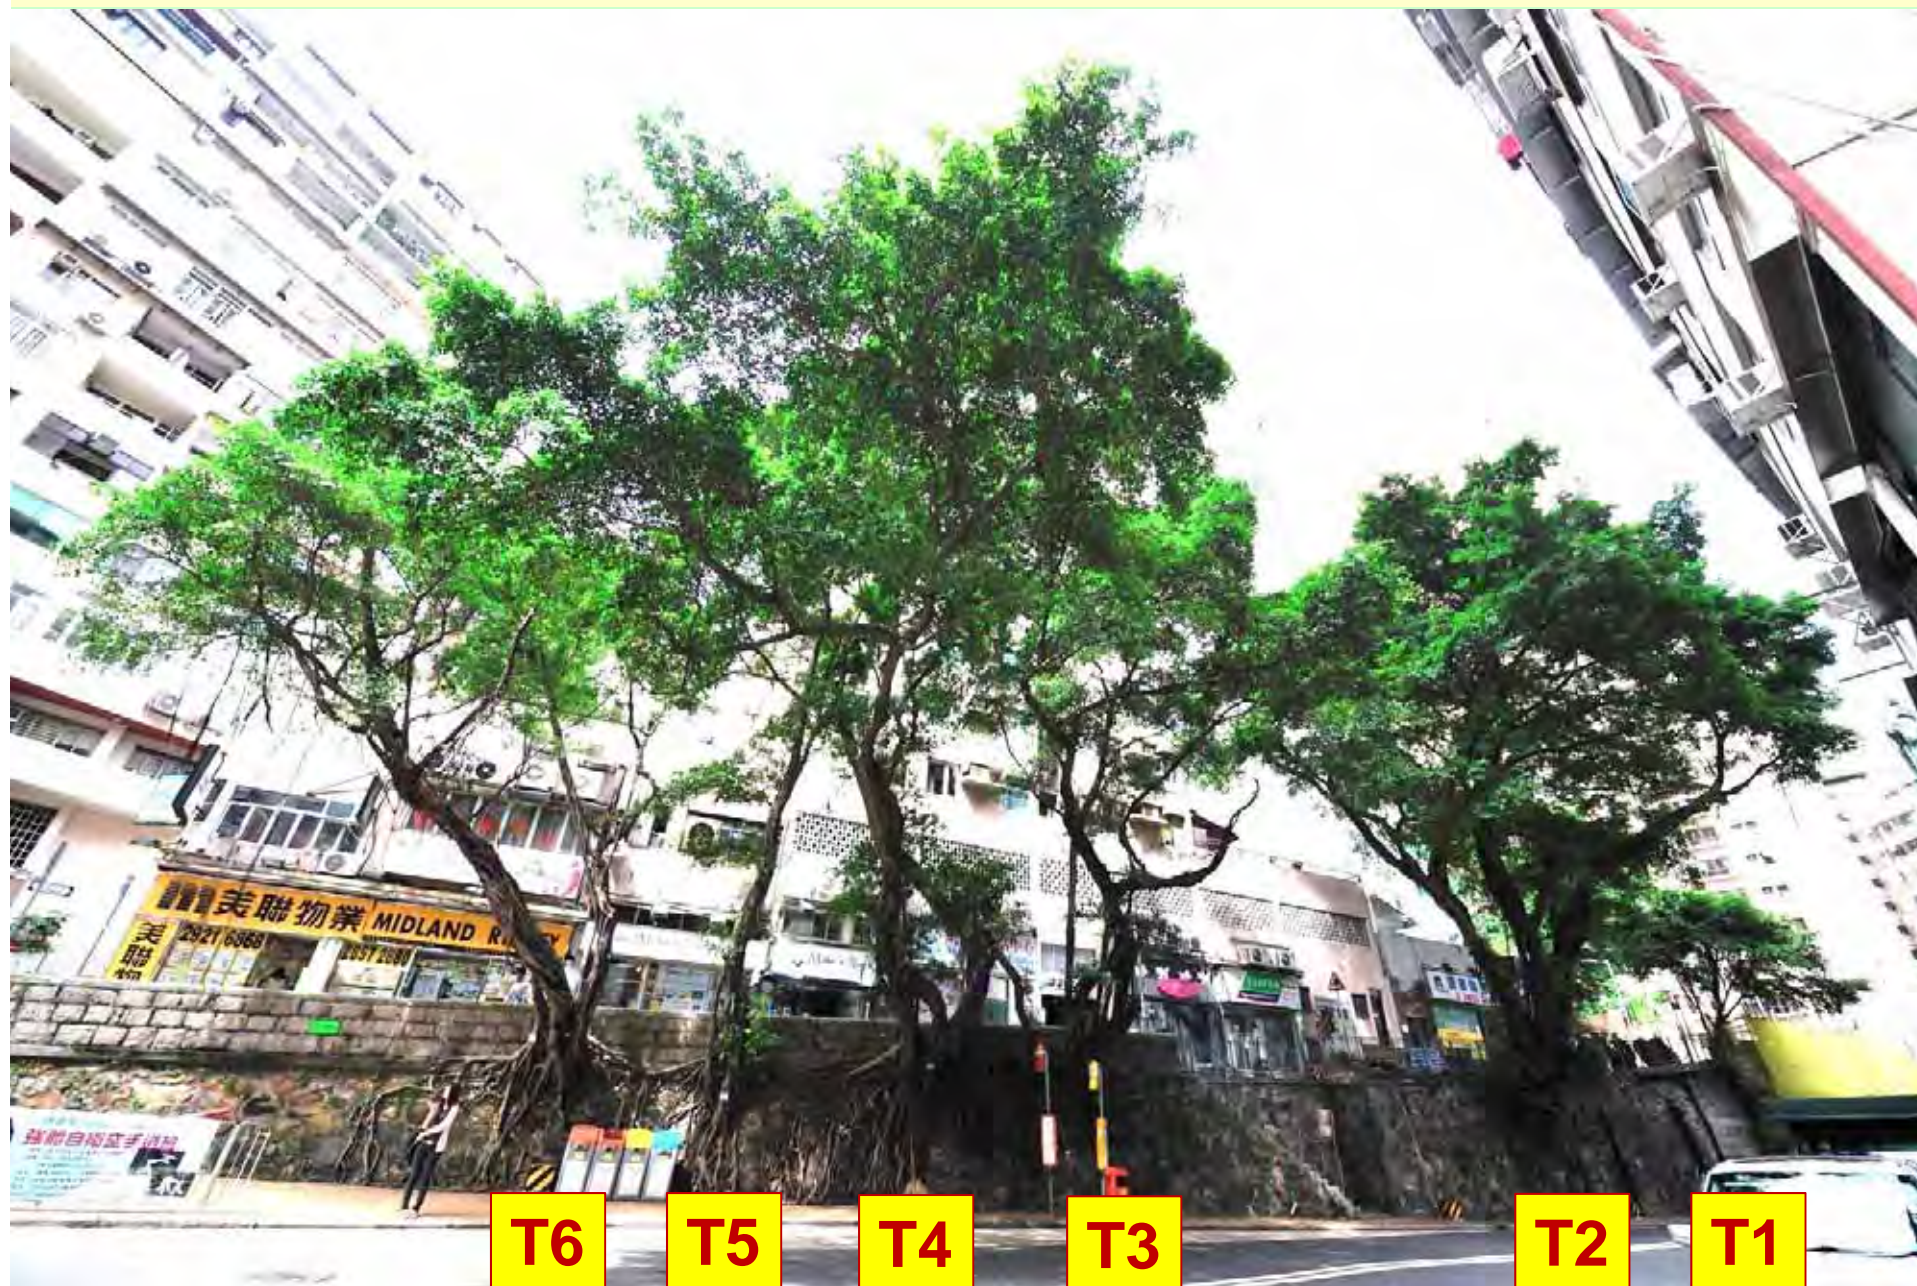
Photo T0-3. The six stone wall trees viewed from the east side at Bonham Road.

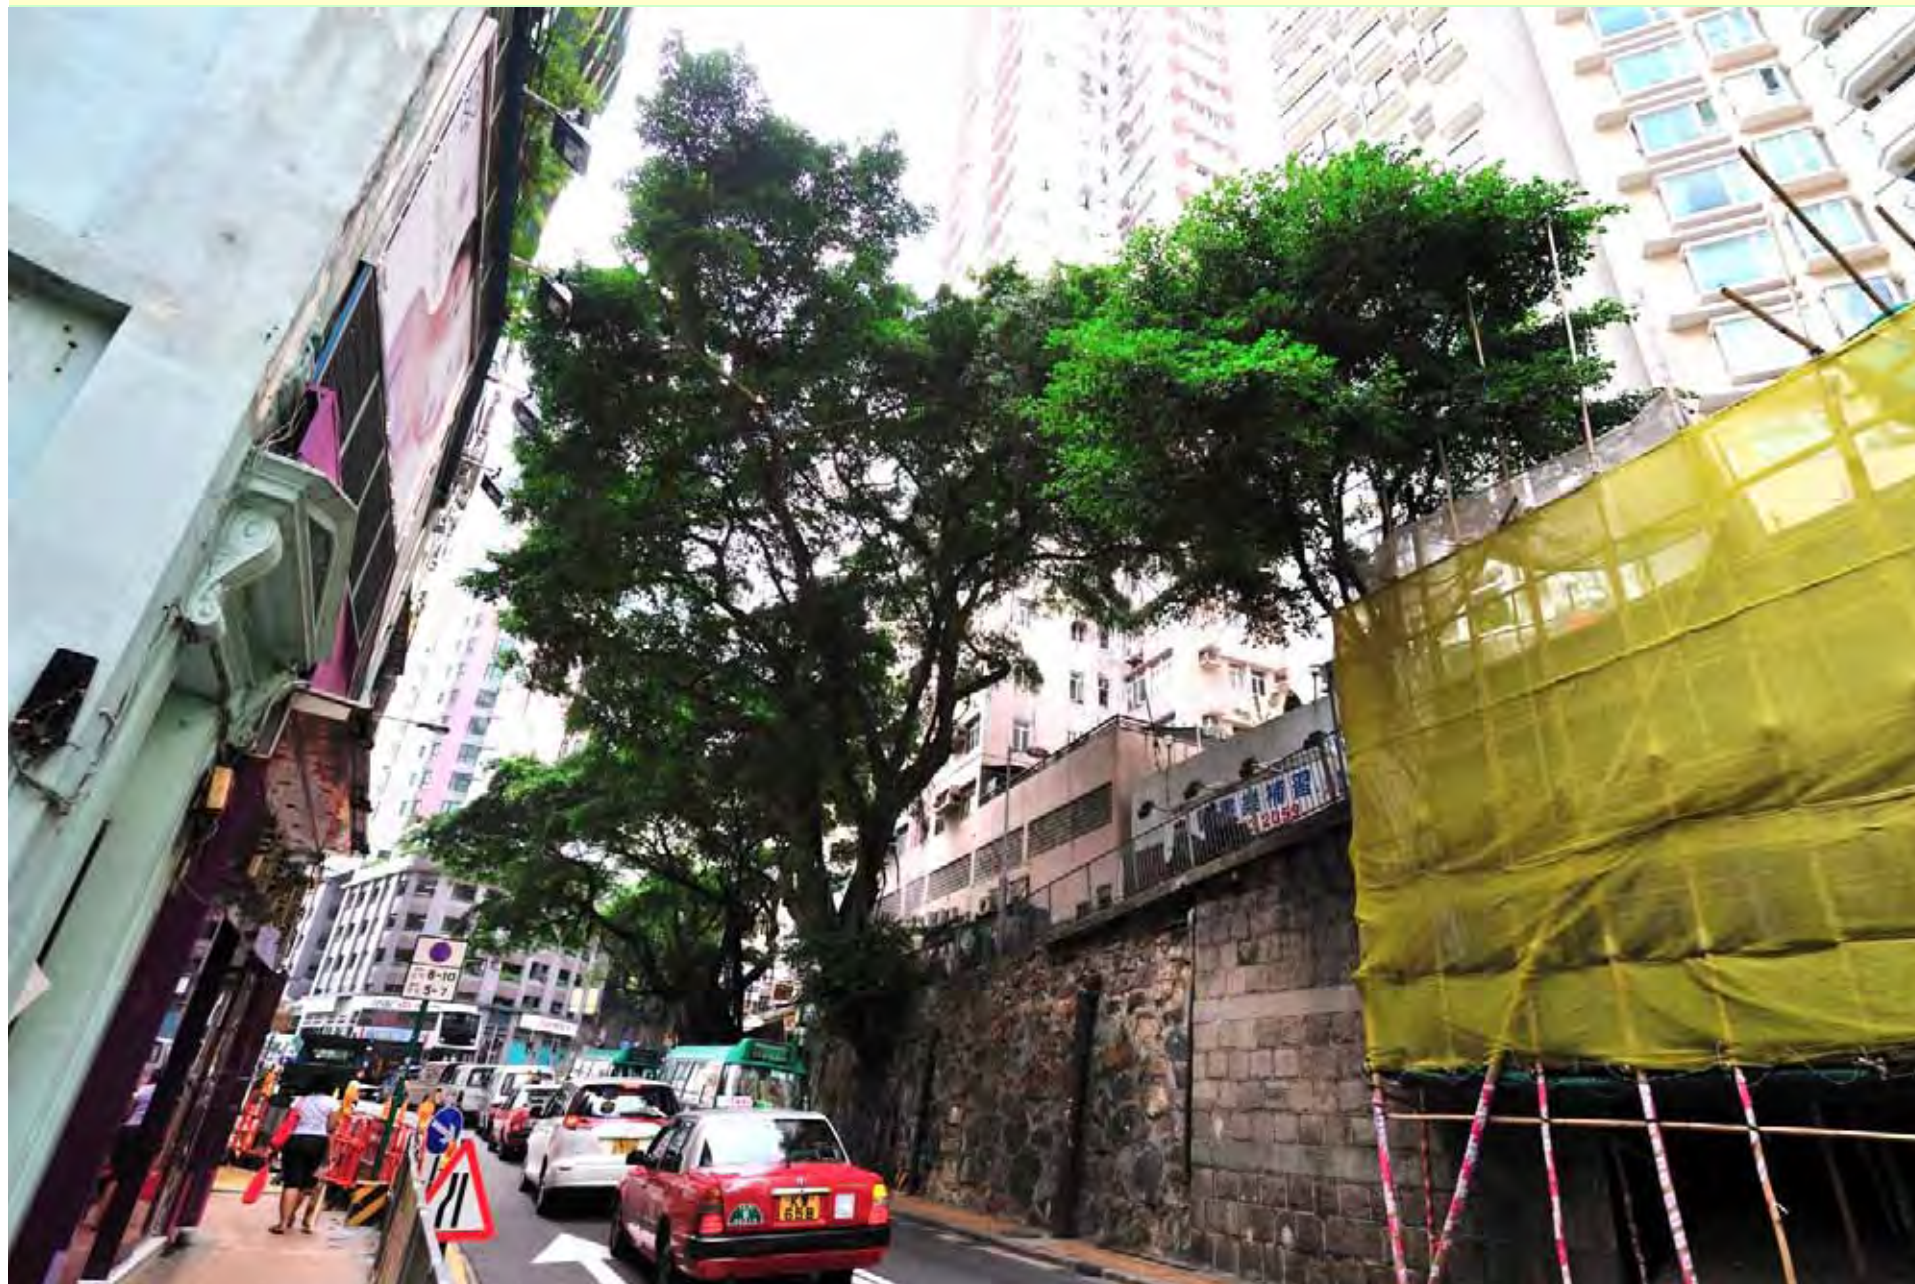
Photo T0-4. The six stonewall trees viewed from the west side at Bonham Road.

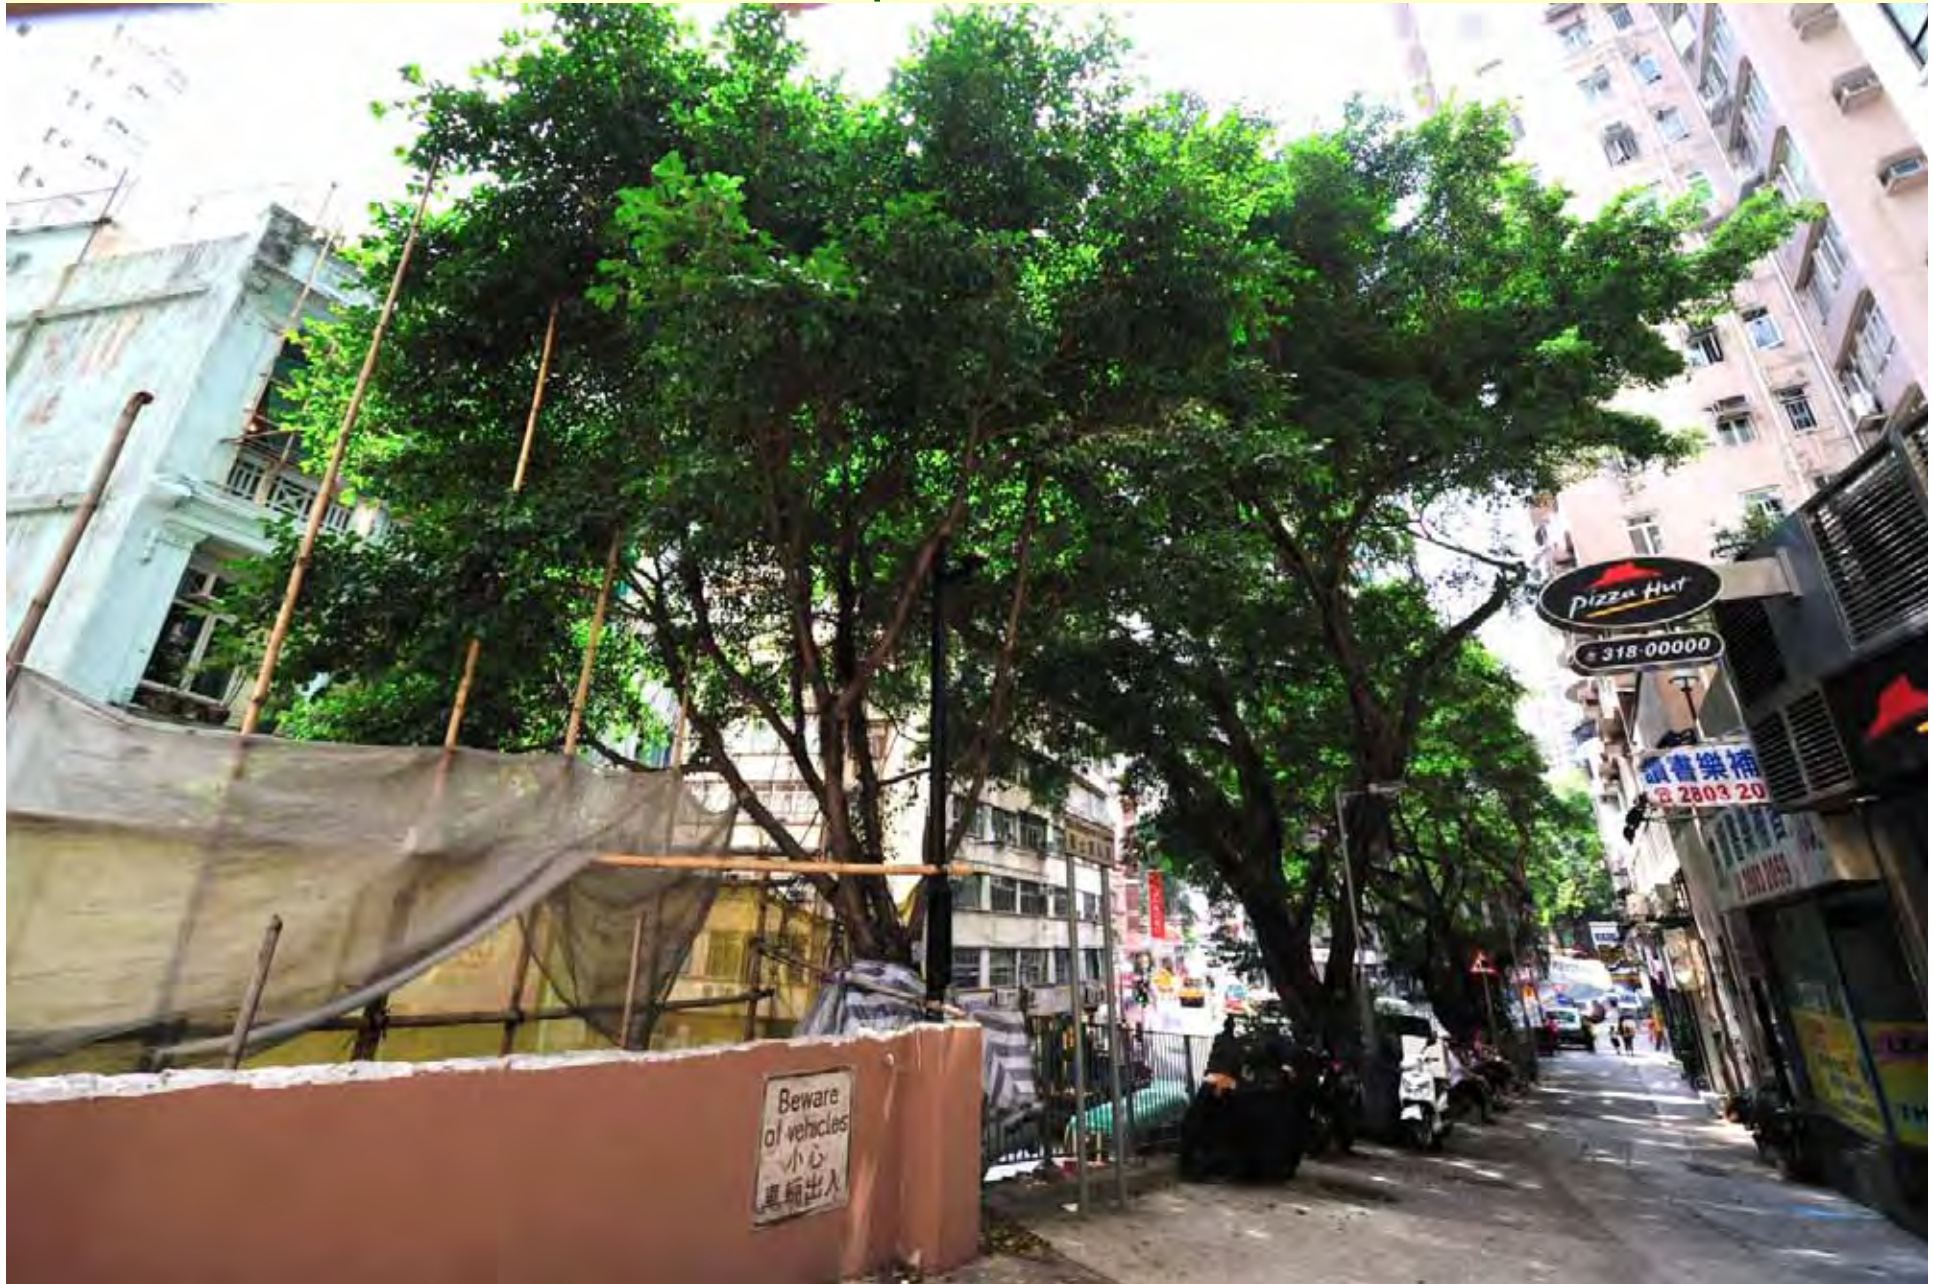
Photo T0-5. The six stonewall trees viewed from the west side at St Stephen's Lane.

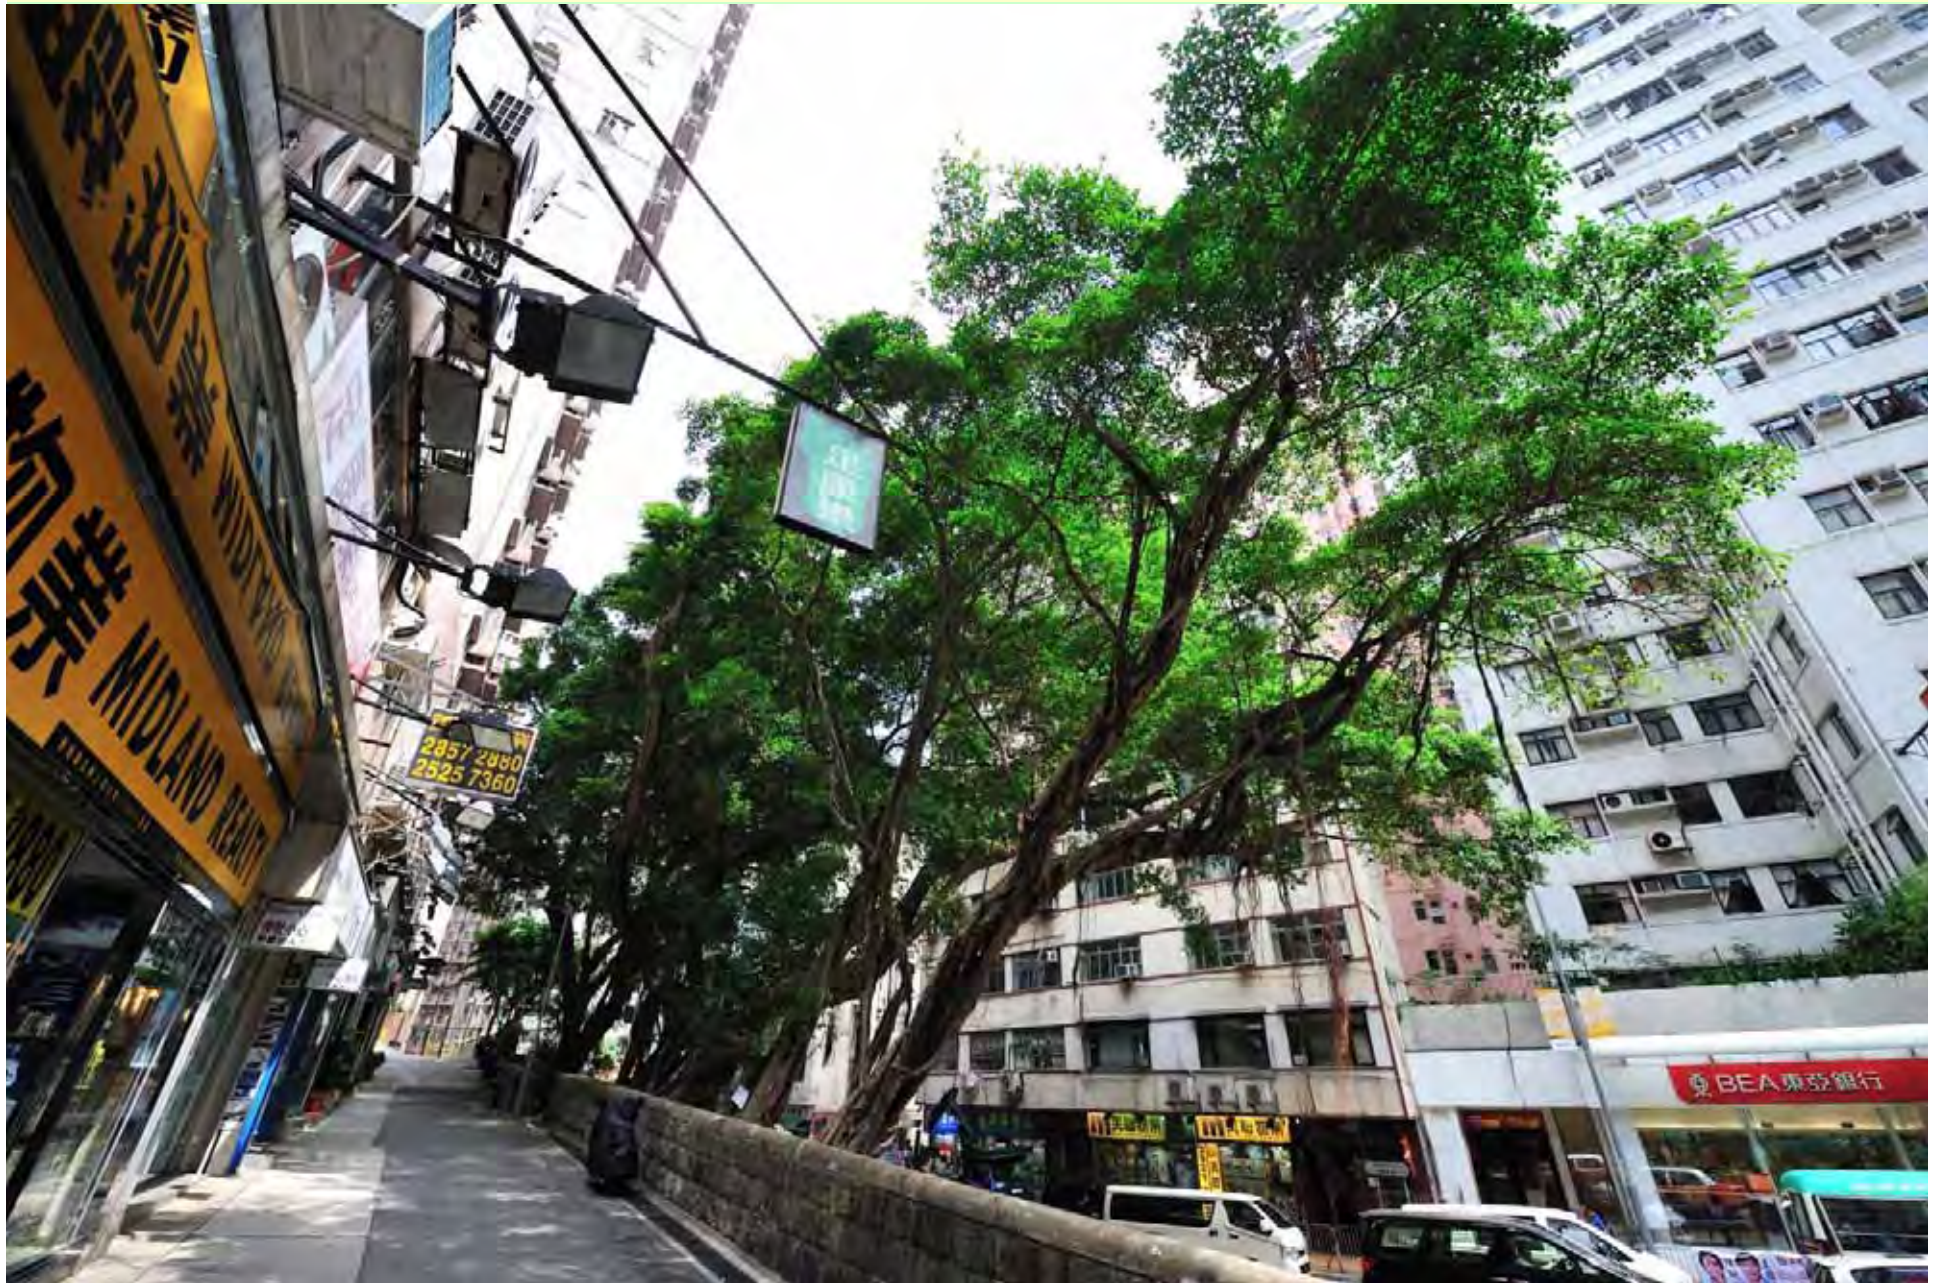
Photo T0-6. The six stonewall trees viewed from the east side at St Stephen's Lane.

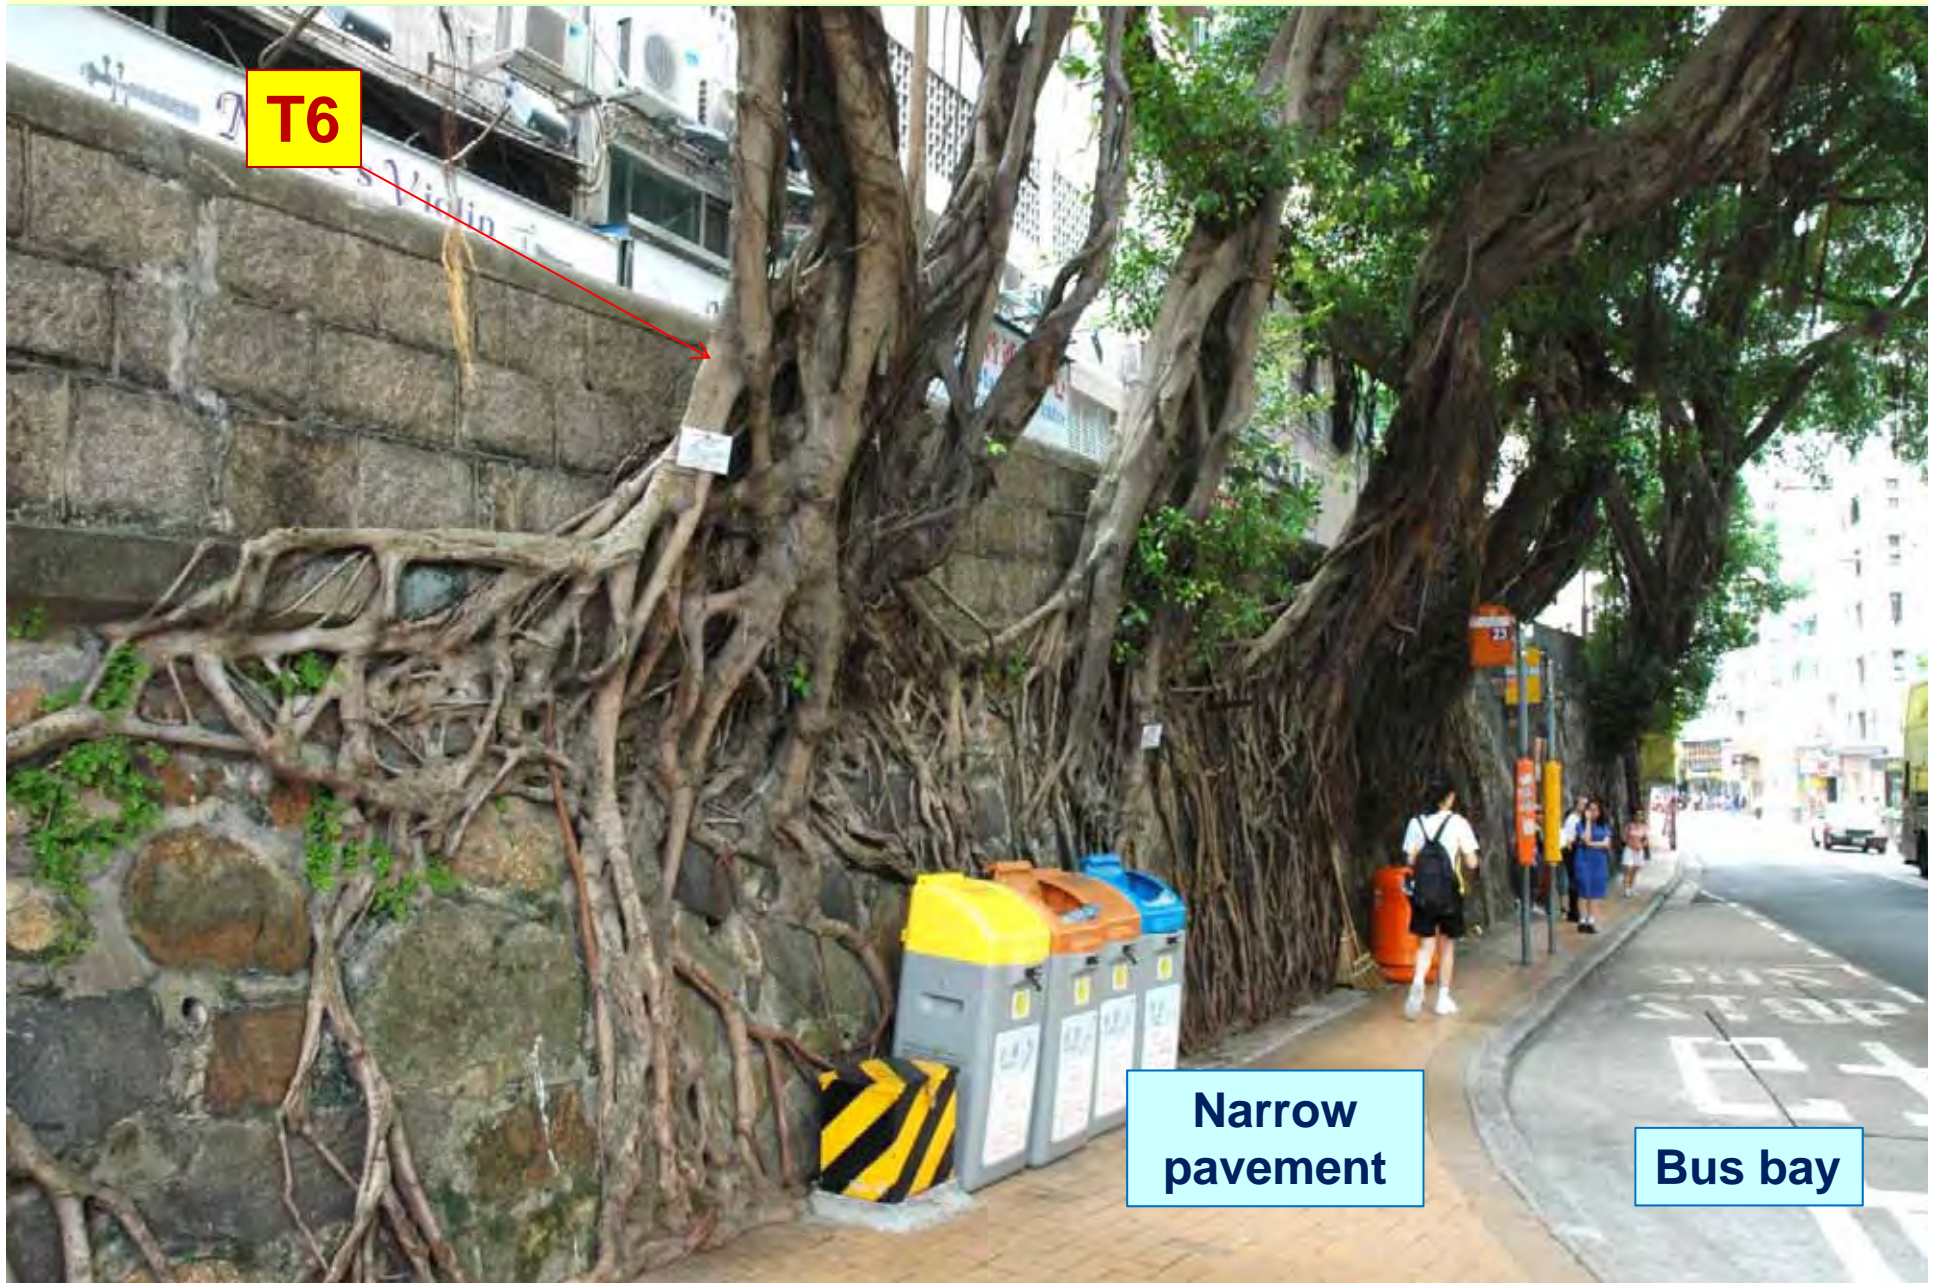
Photo T0-8. The old masonry wall viewed from the east, being shorter at the east side and taller towards the west.

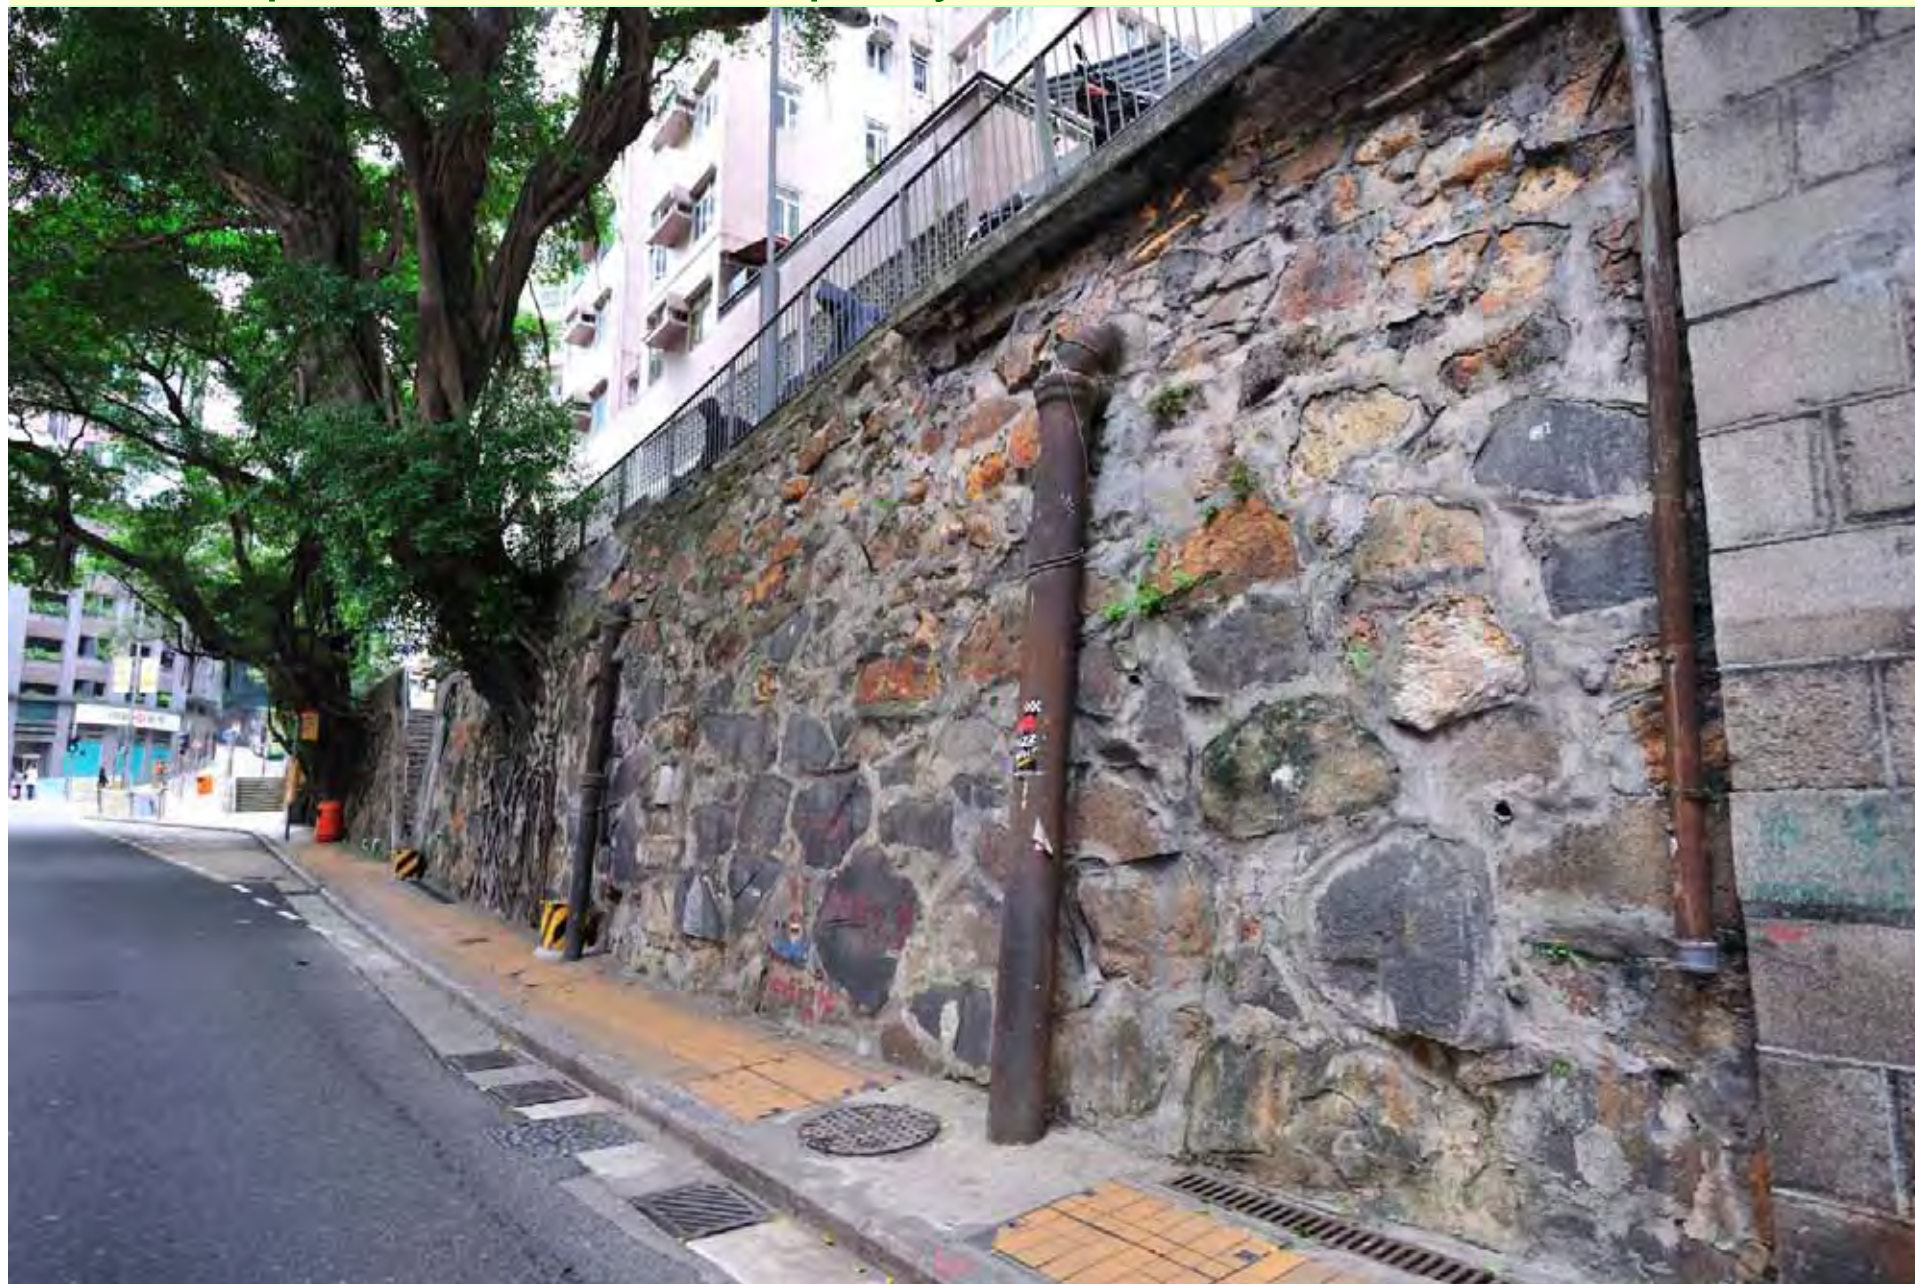
Photo T0-9. The stone wall viewed from the west, with irregularly shaped and sized and partly-weathered volcanic stones..

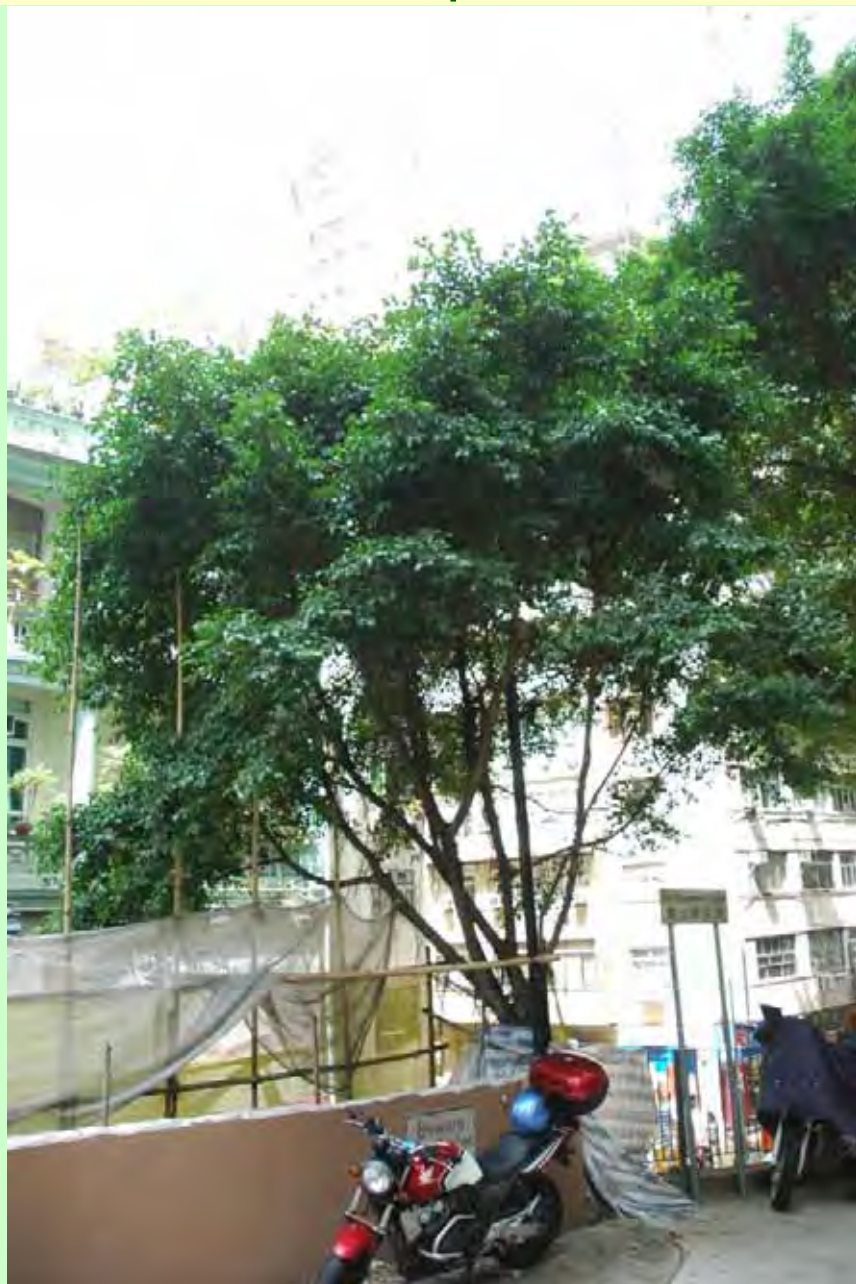
Photo T1-3. The young tree with compact crown viewed from the west at St Stephen's Lane.

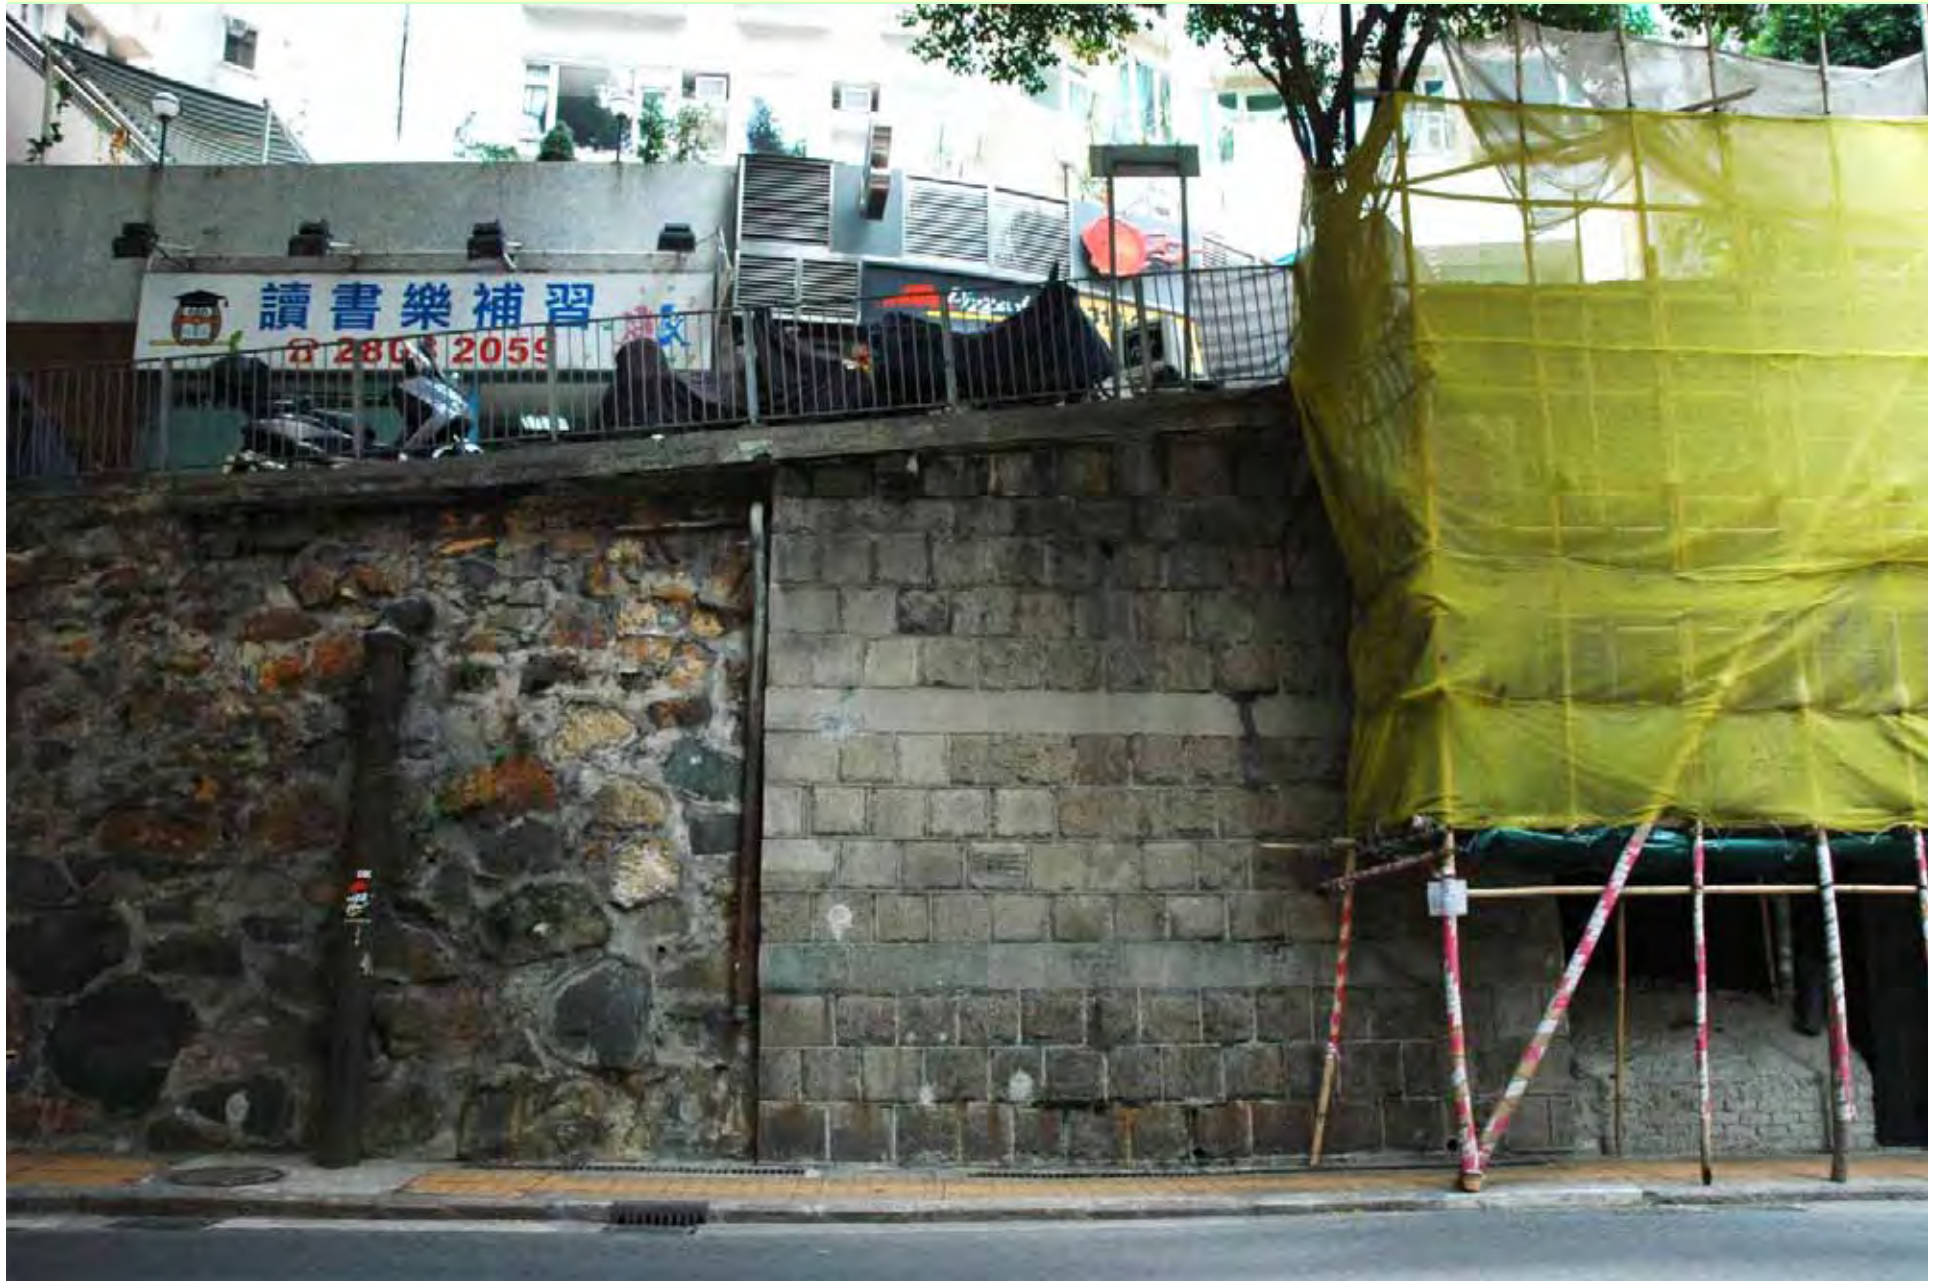
Photo T1-4. The wall section has regular squared-dressed granite blocks, contrasting with volcanic rubble boulders of the main wall.

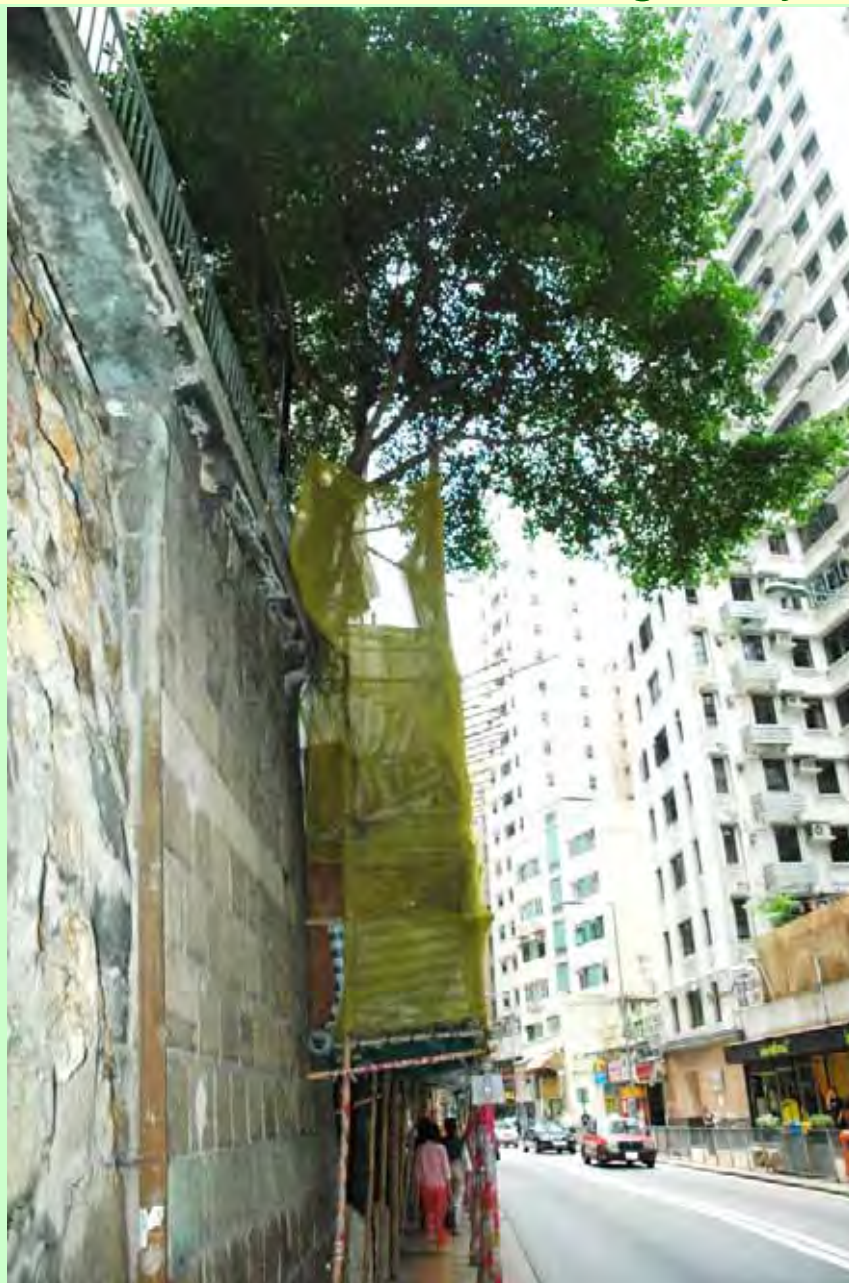
Photo T1-5. The young Chinese Banyan with a small crown hangs well above the carriageway.
