Assessment of Wall Trees on Slope 11SW-A/R577 at Bonham Road

**Highways Department
HKSAR Government**

**C.Y. Jim
The University of Hong Kong
hrajcy@hku.hk**

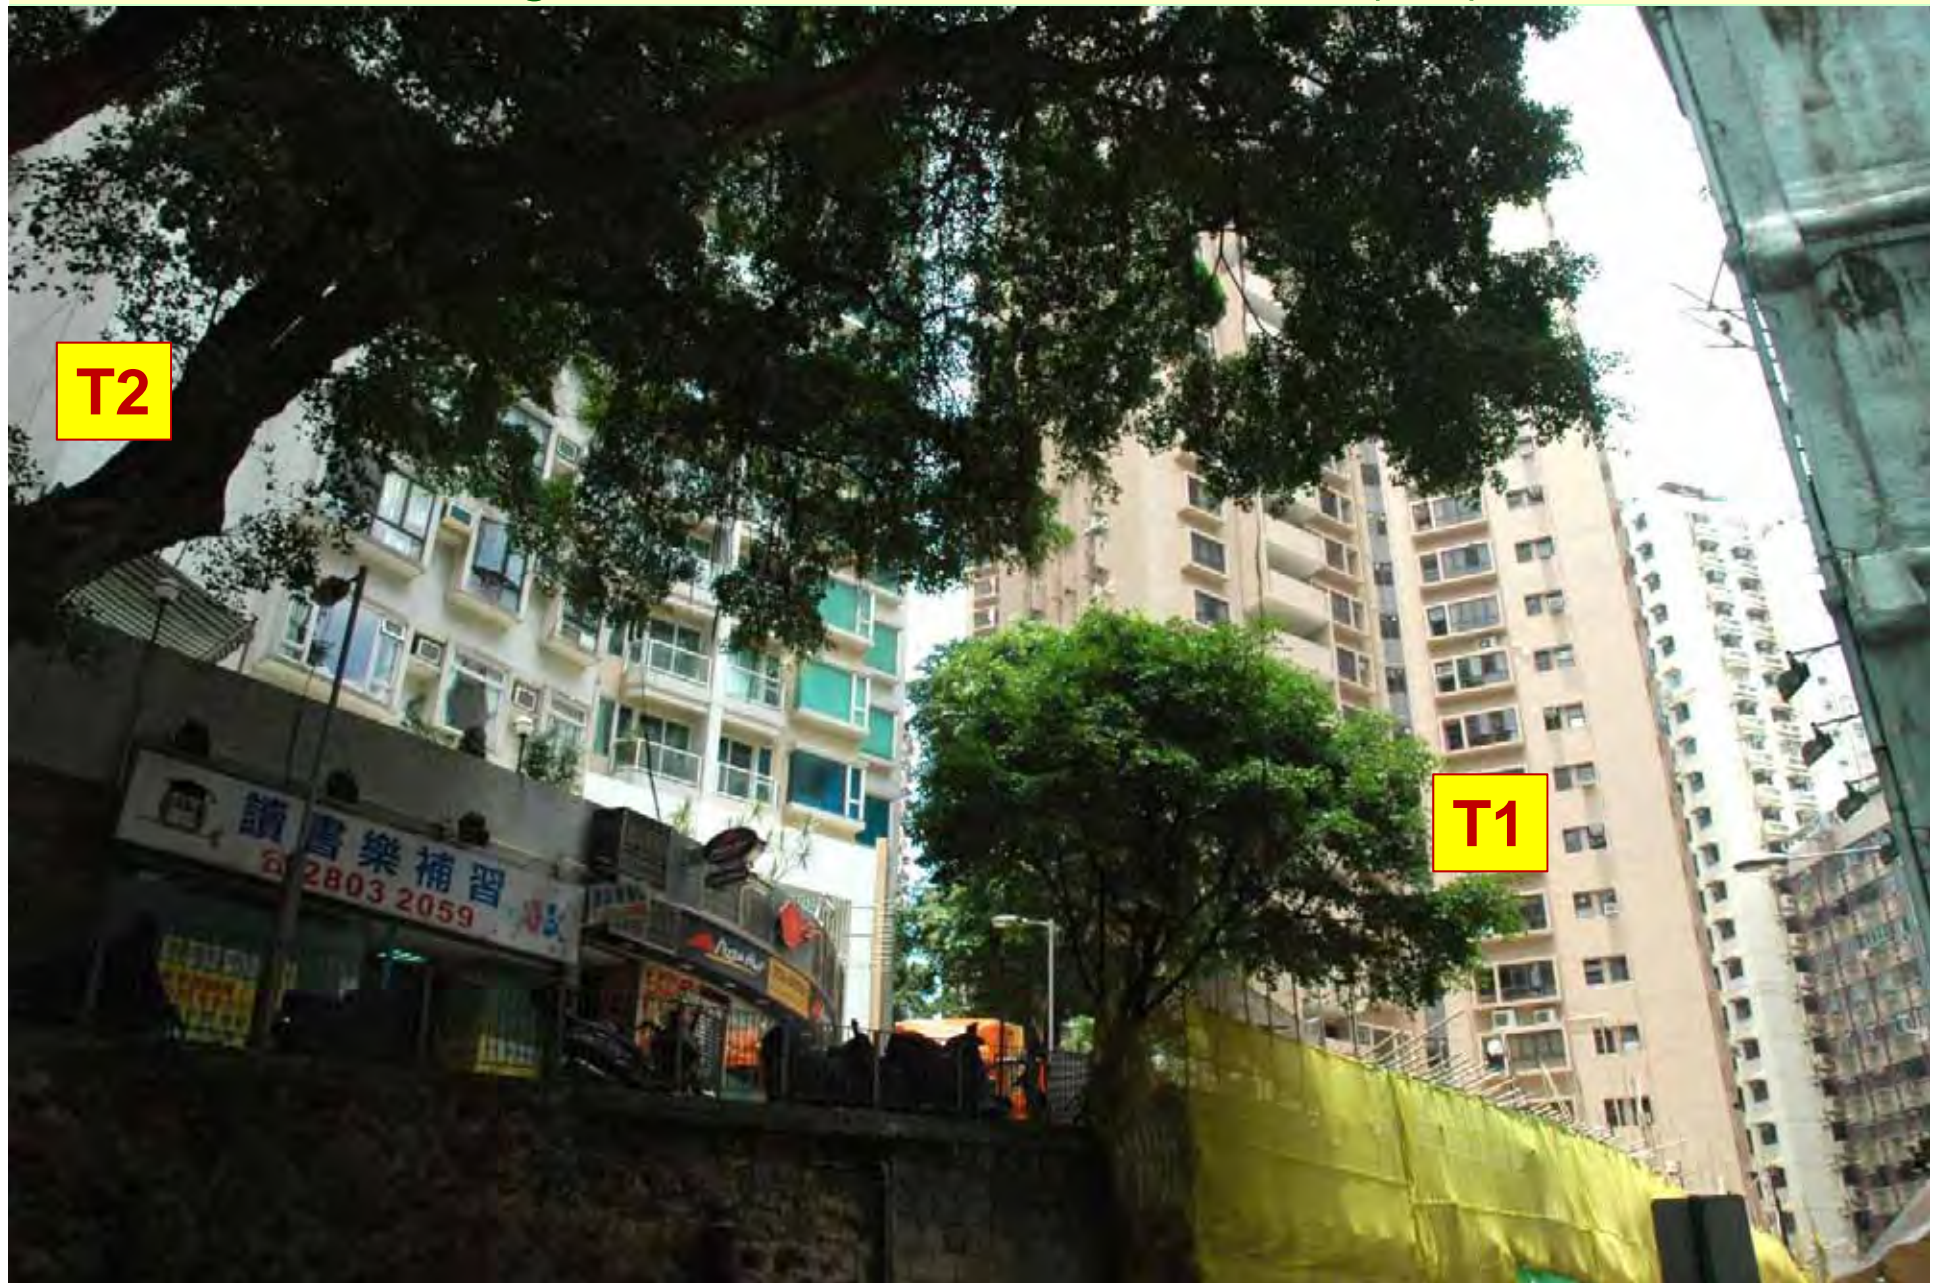
Photo T1-6. The small tree is overshadowed by its large neighbour T2 situated to its east (left).

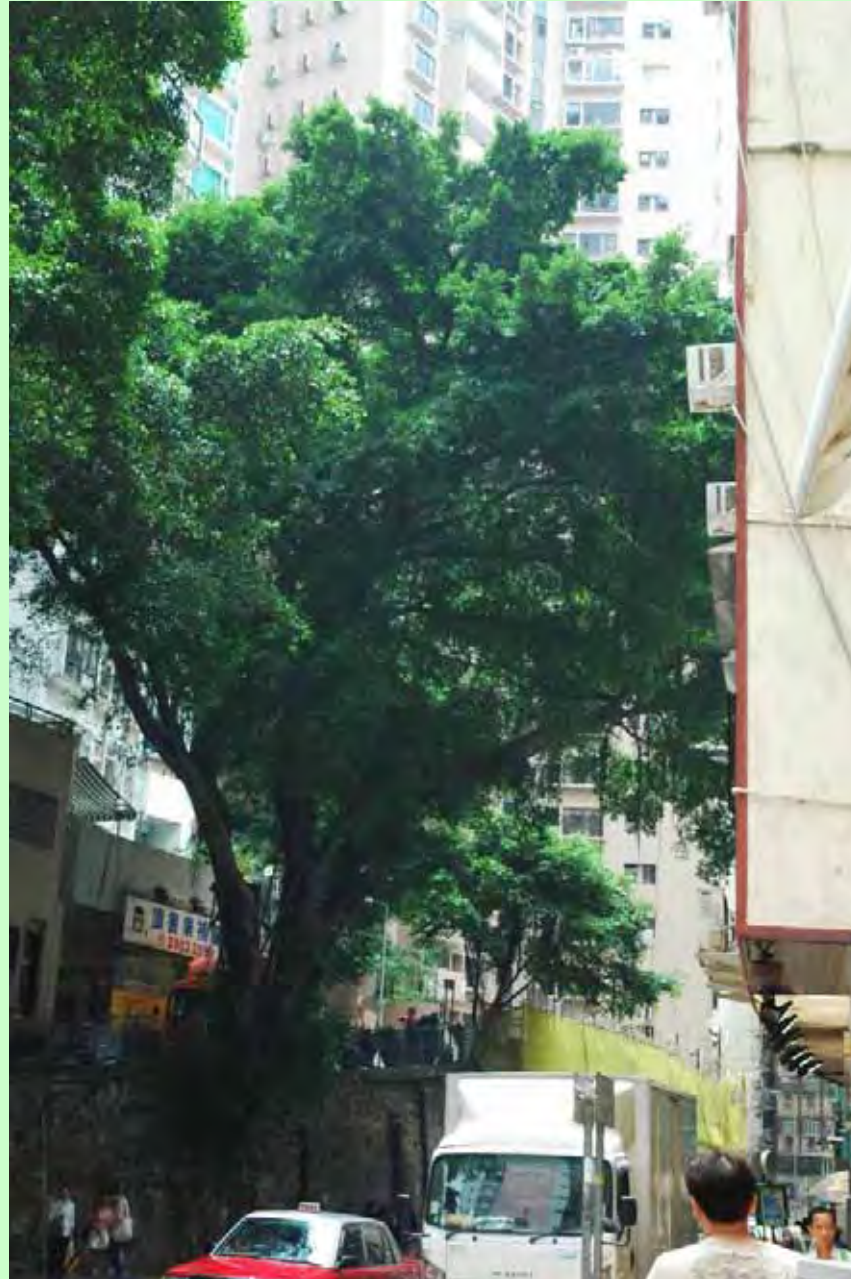
Photo T2-2. The dense and sprawling crown of the large stonewall tree that hangs above Bonham Road.

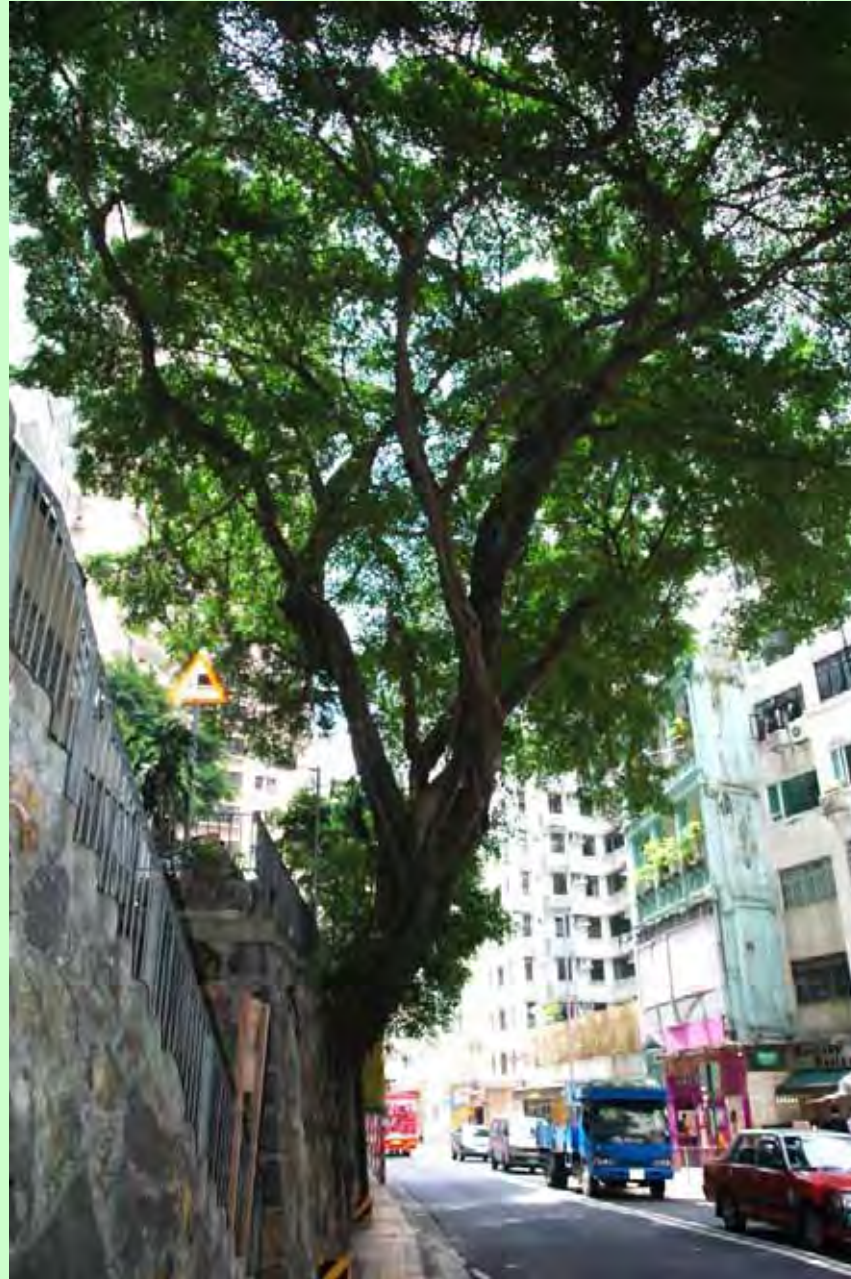
Photo T2-3. The large upright tree anchors at the crest of the west side of the old stone wall, hanging above the carriageway.

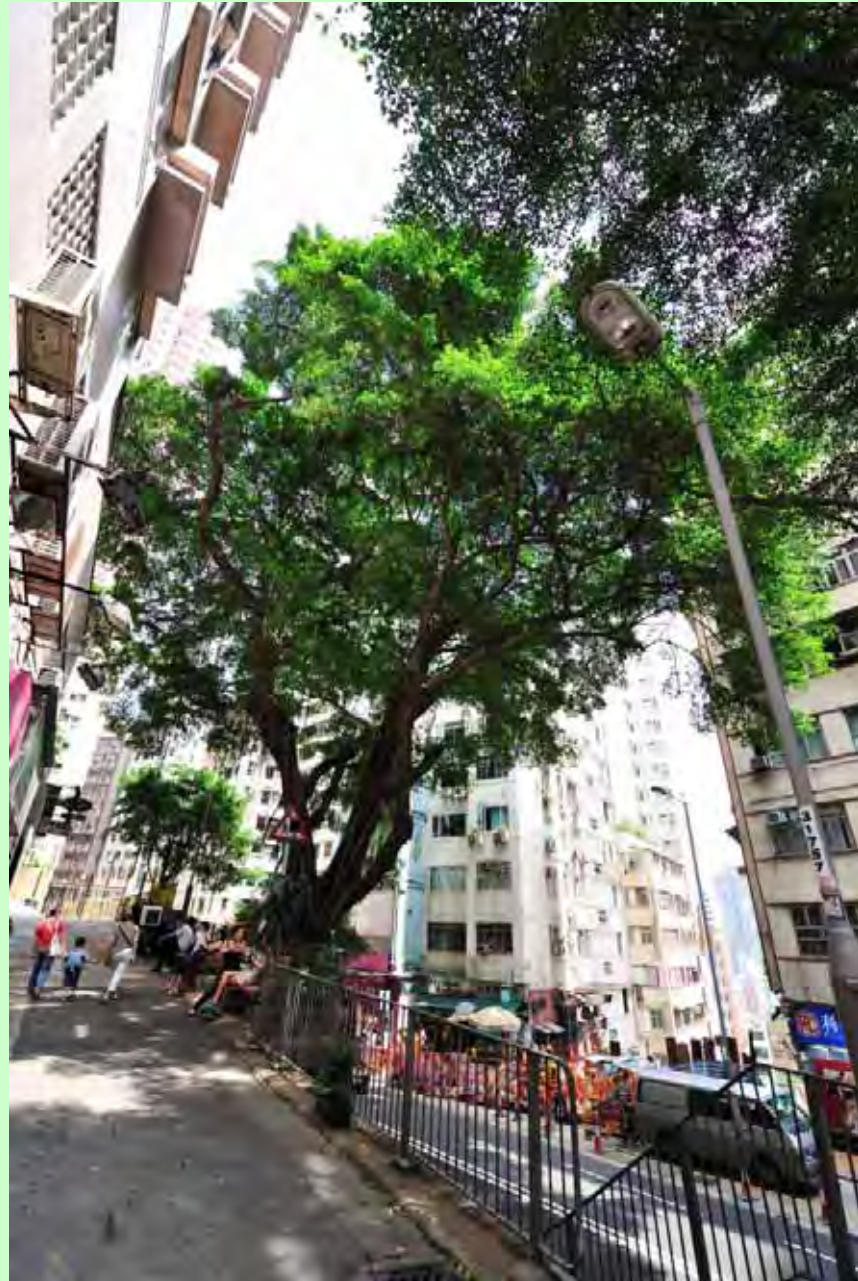
Photo T2-4. The crown extends southwards above St Stephen's Lane, supported by rather upright multiple trunks.

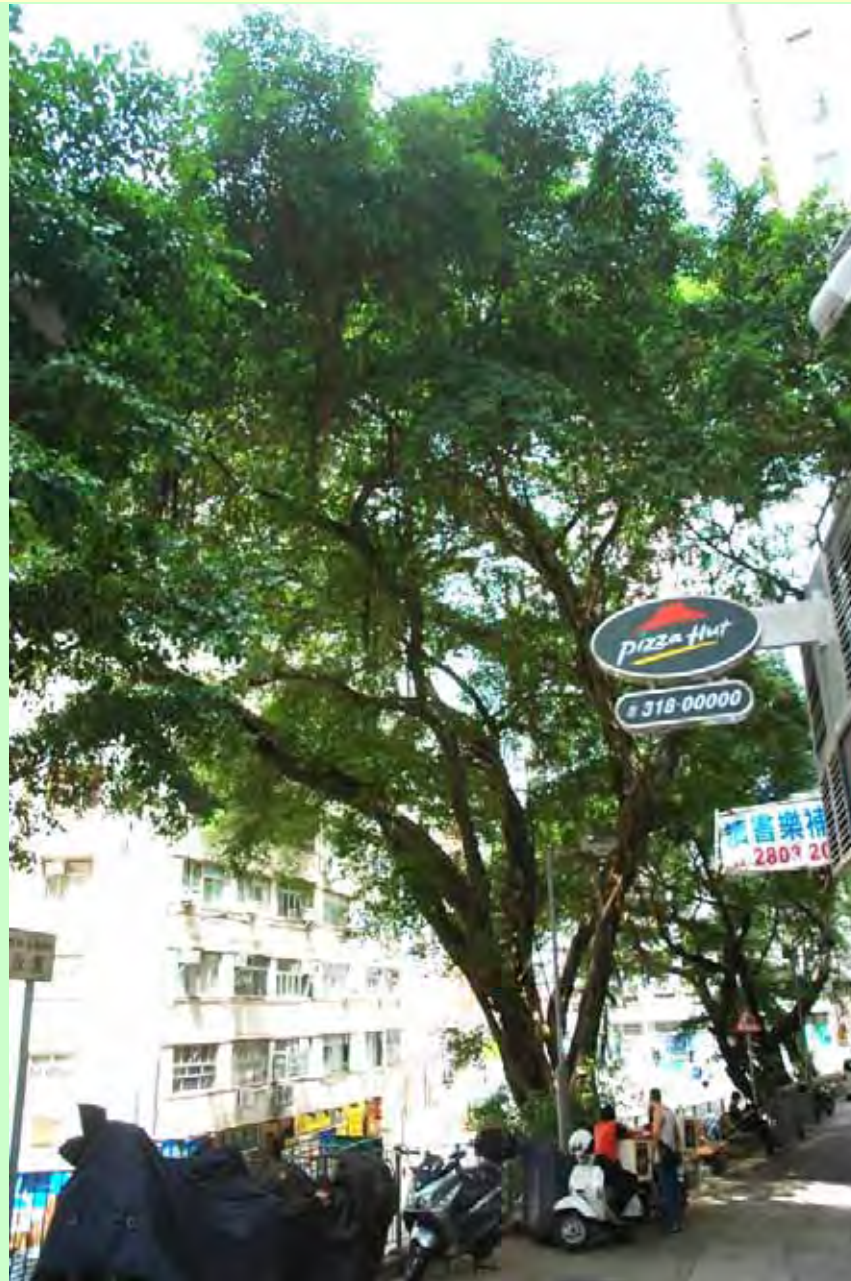
Photo T2-5. The tree viewed from the west side at St Stephen's Lane.

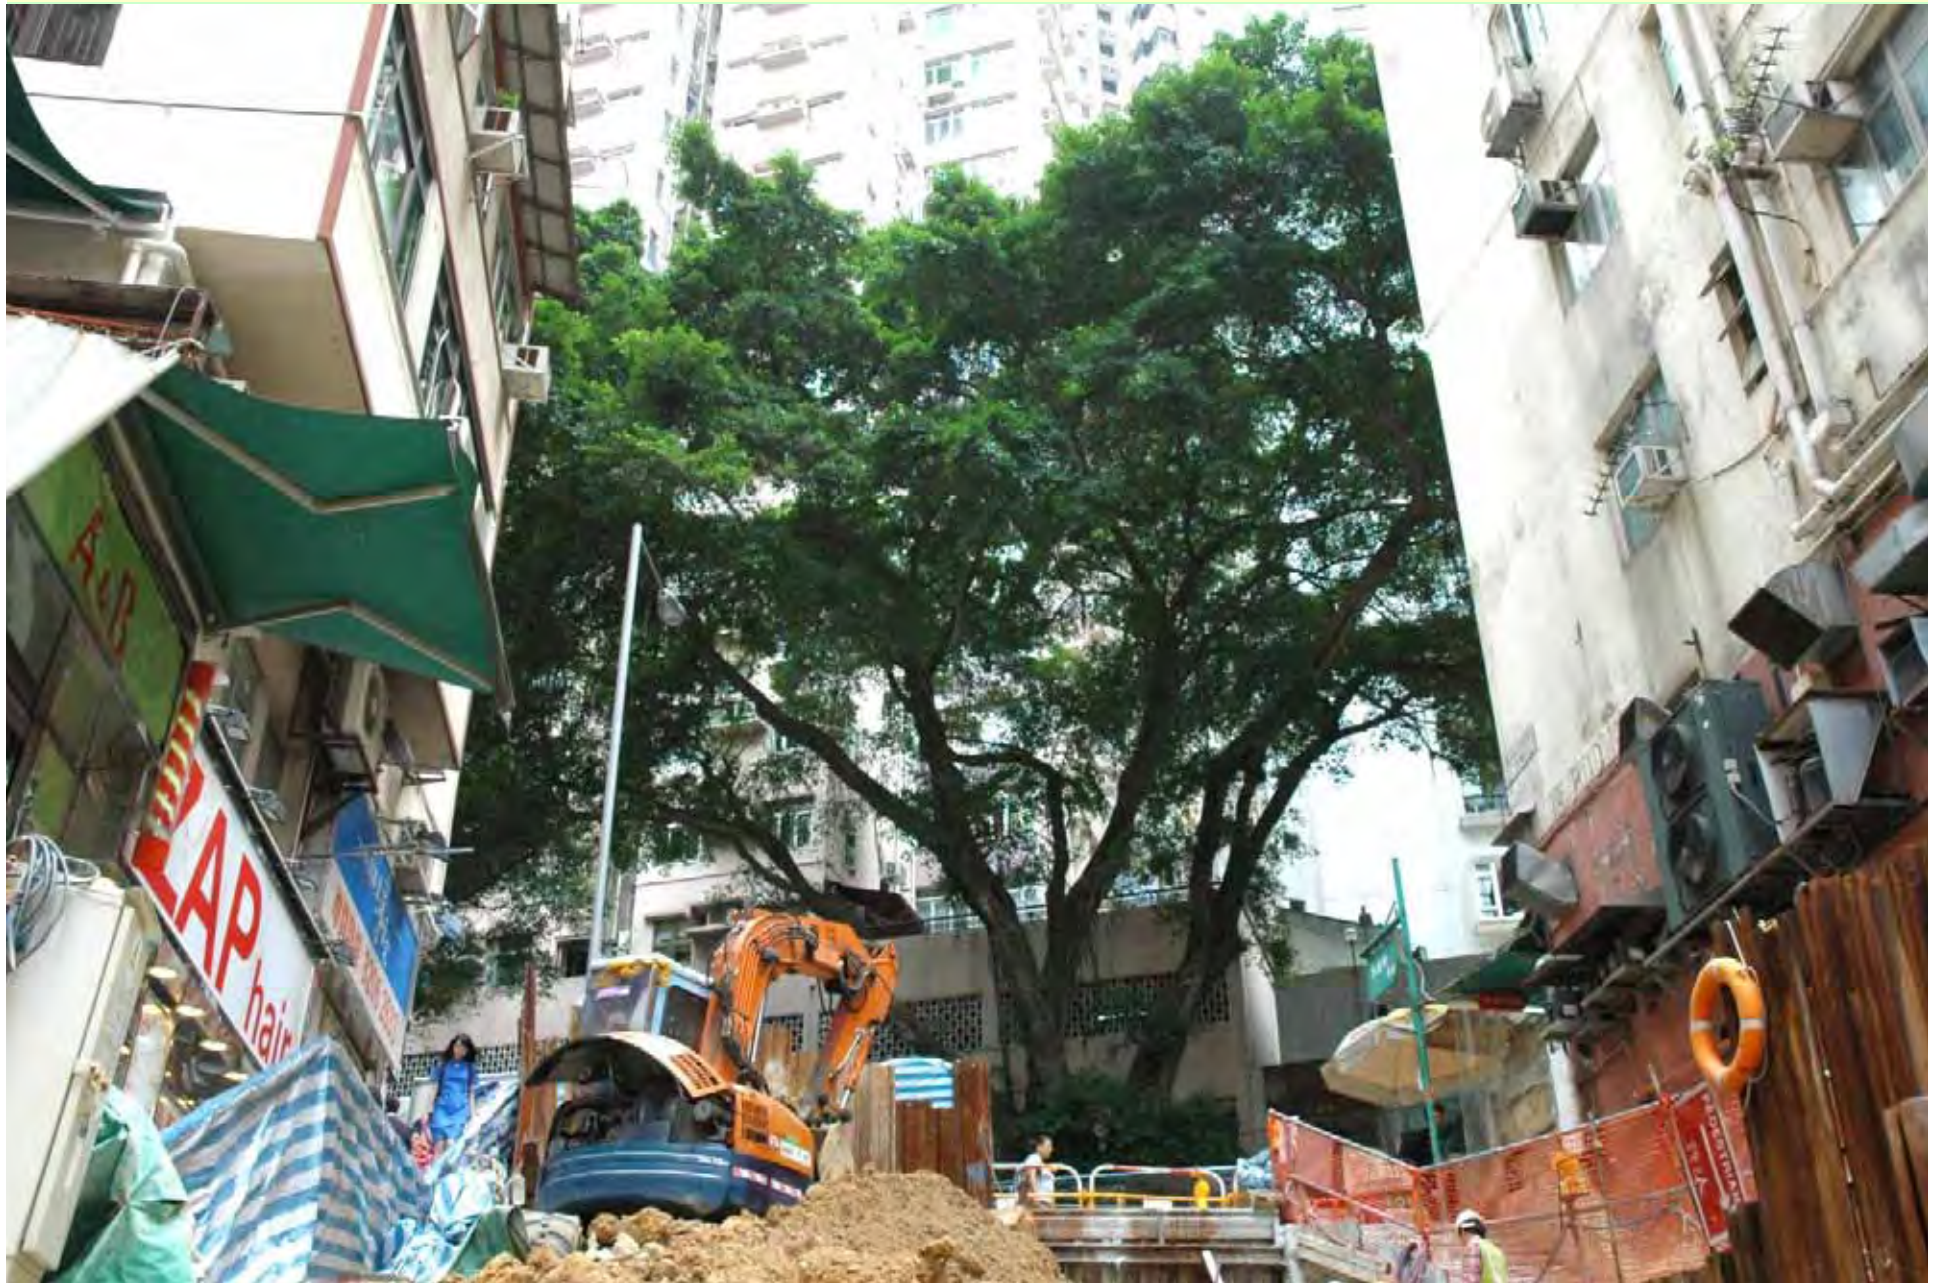
Photo T2-6. Broad east-west crown spread viewed from Centre Street; notable loss of low branches and foliage.

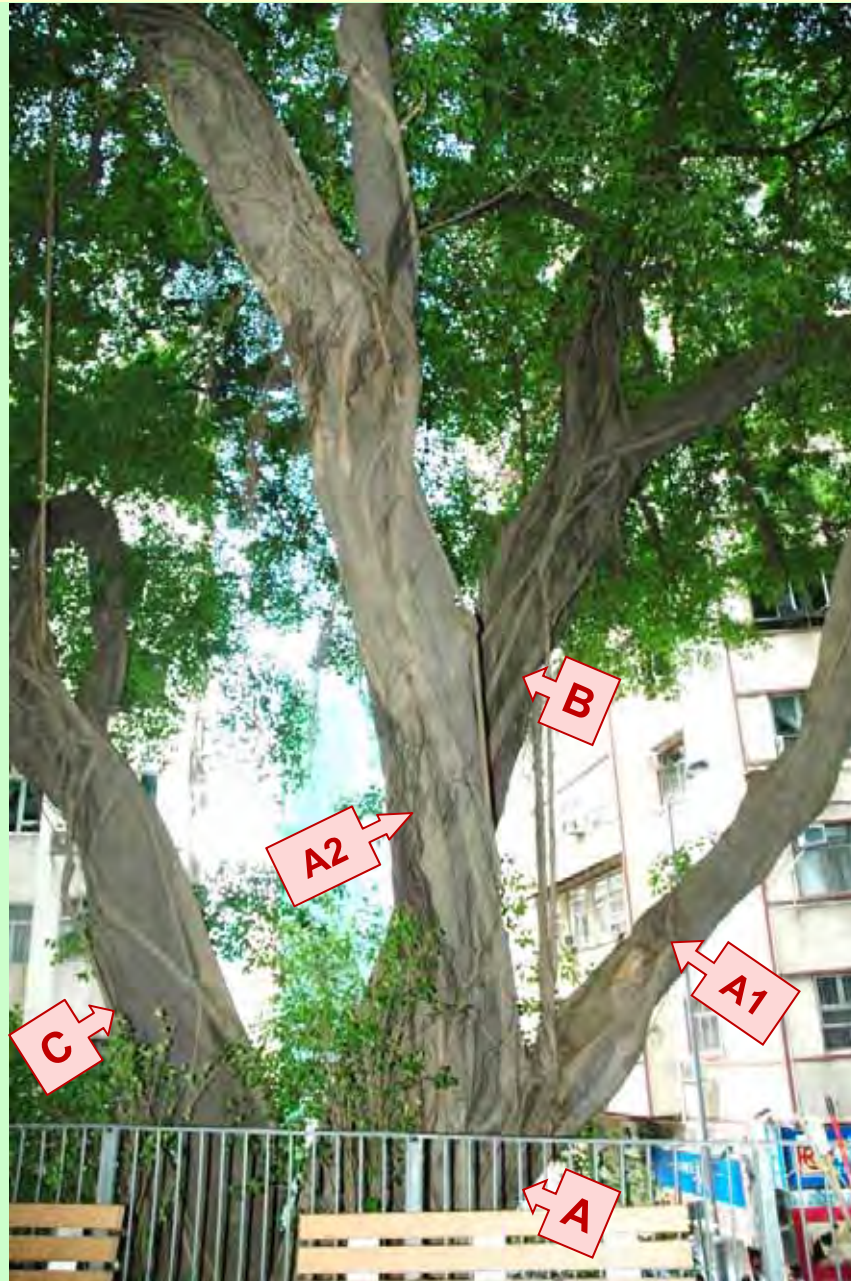
Photo T2-9. The three stout trunks viewed from the south (St Stephen's Lane).

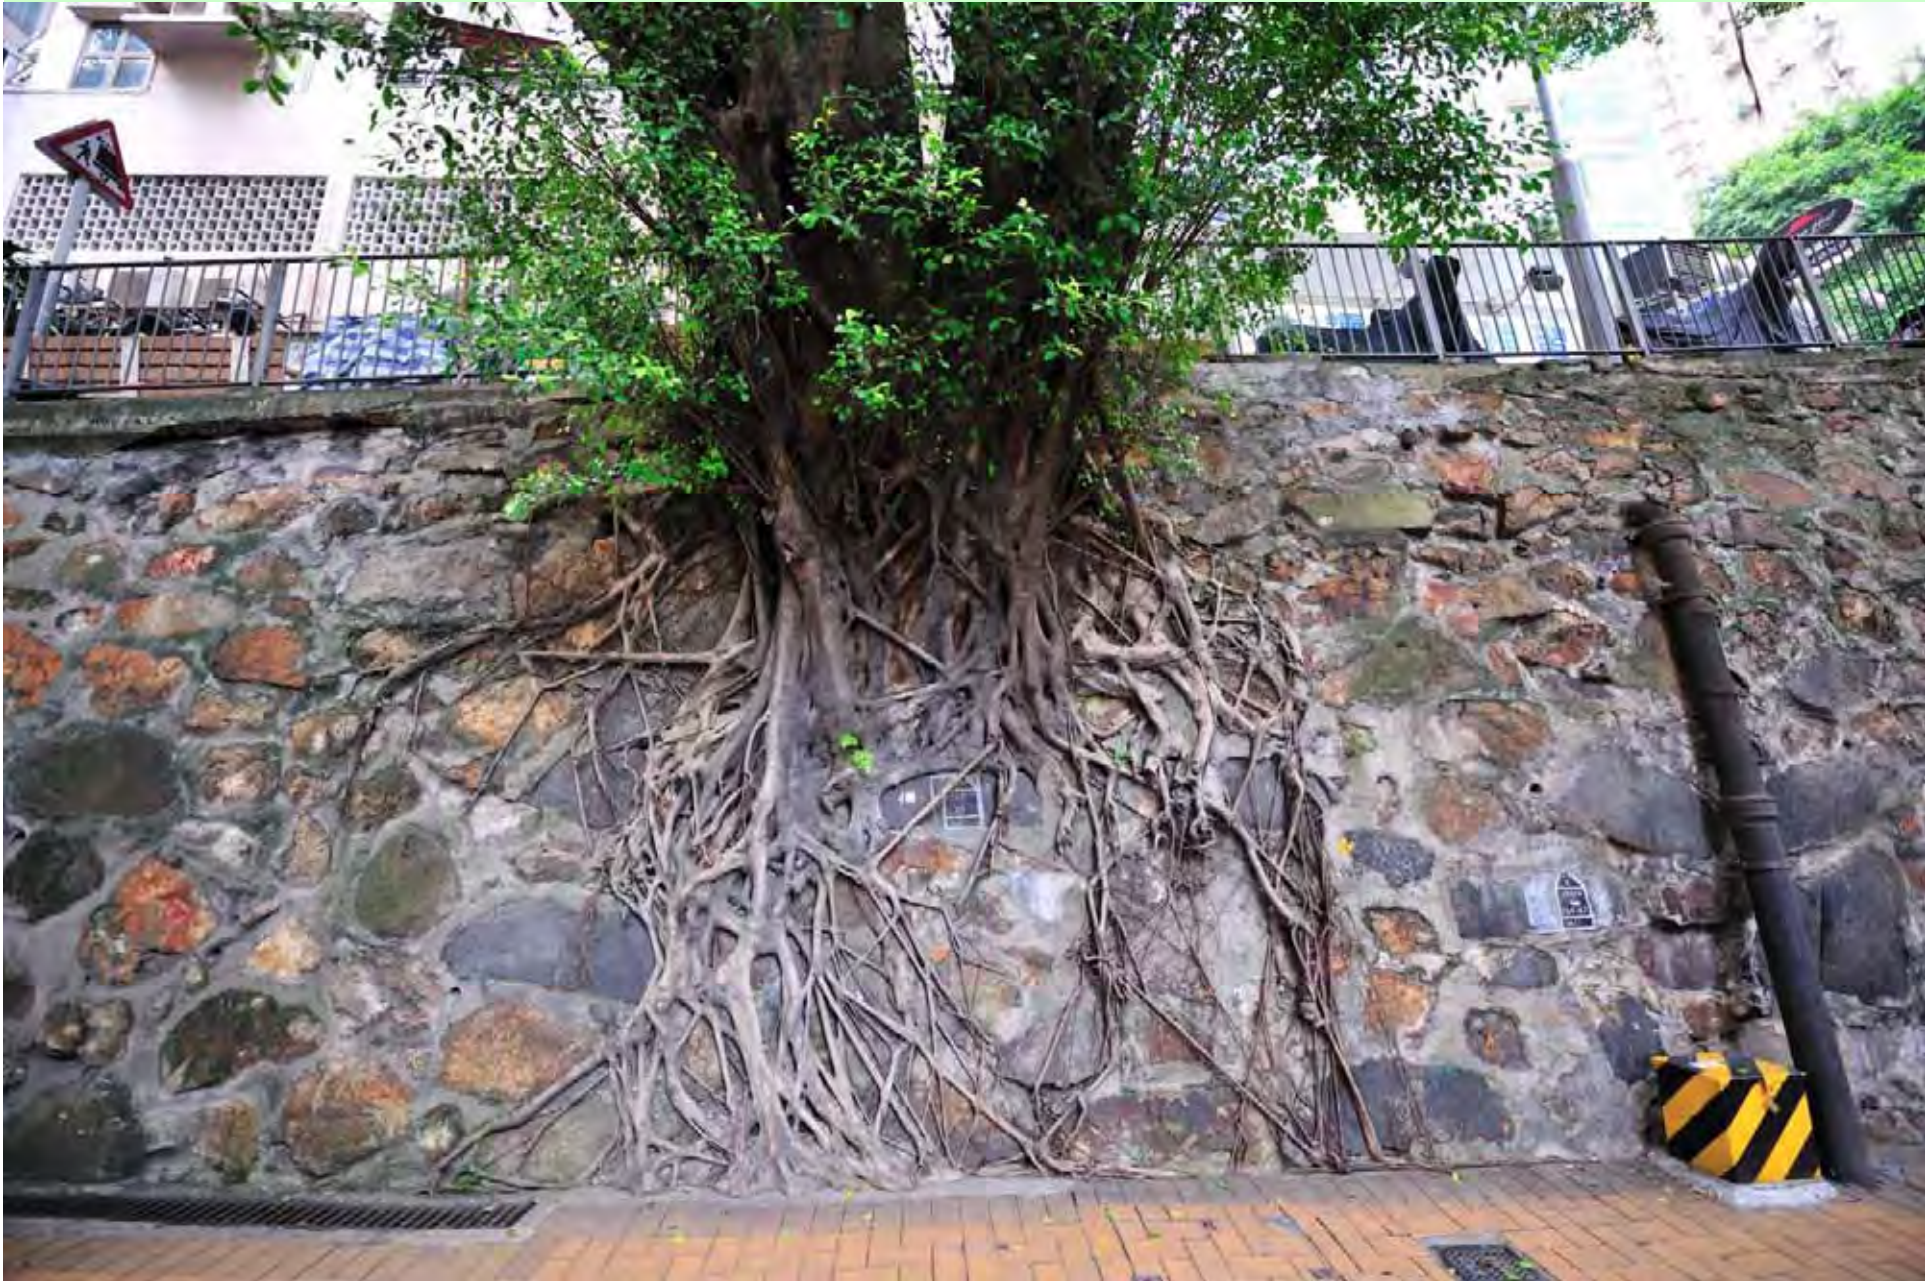
Photo T2-10. Limited spread of surface roots on the stone wall face.

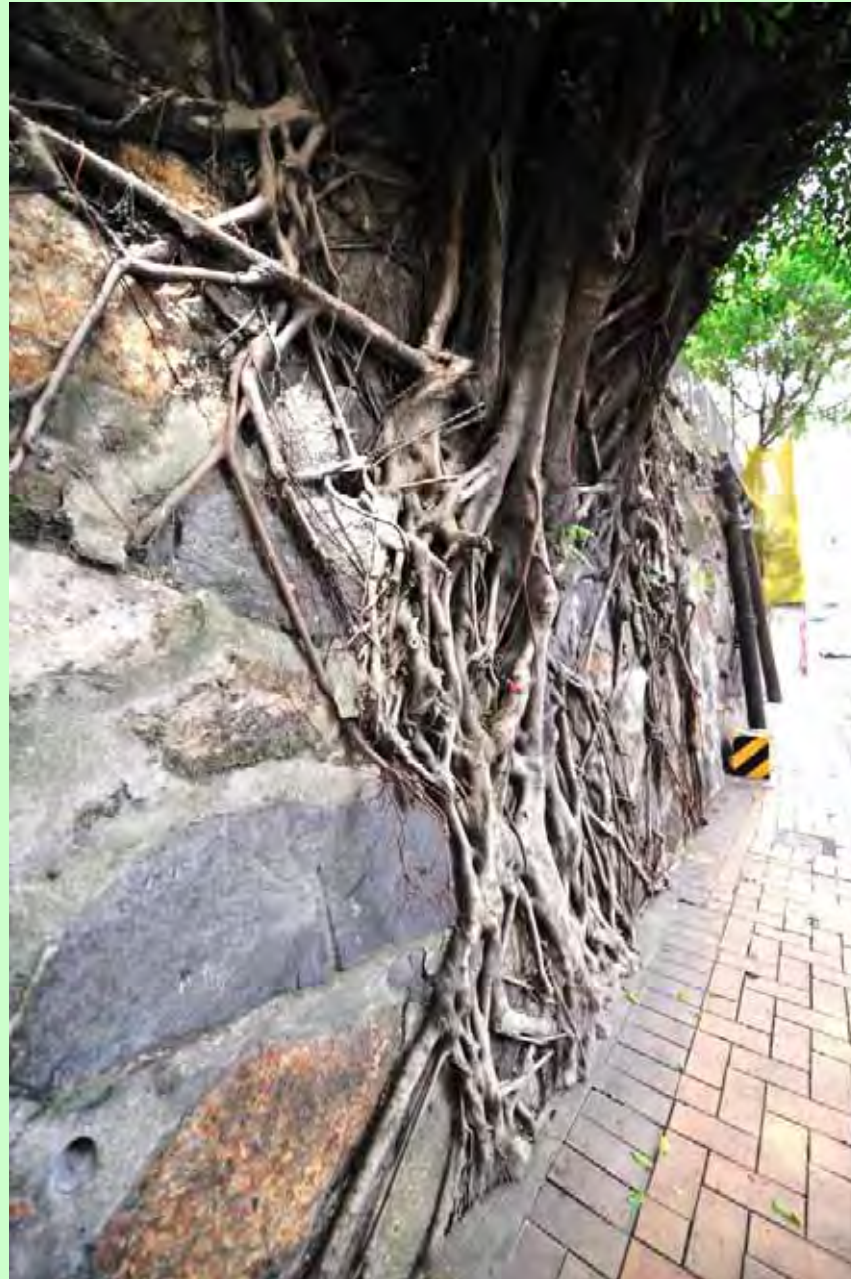
Photo T2-11. Restriction to root penetration at wall toe.

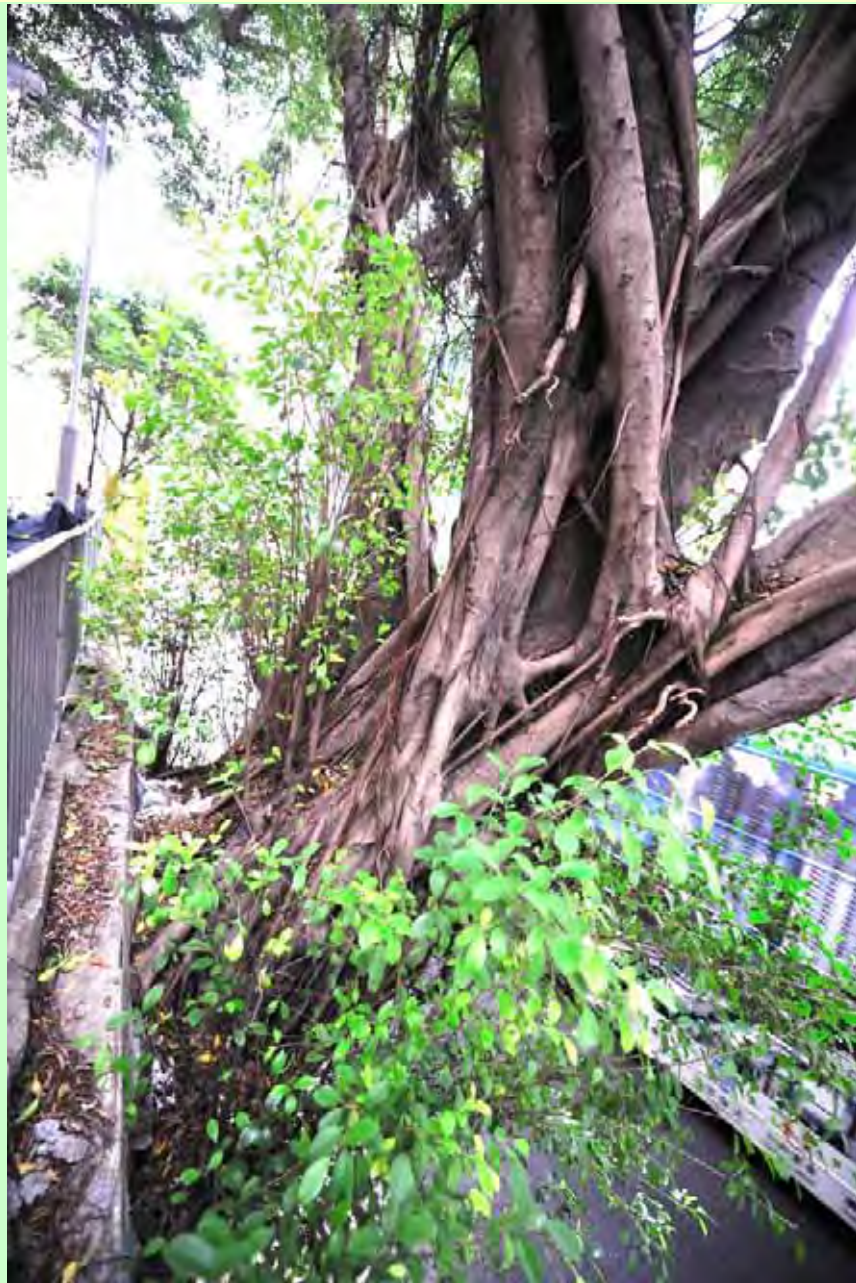
Photo T2-12. Relationship between tree and wall crest, viewed from the east.

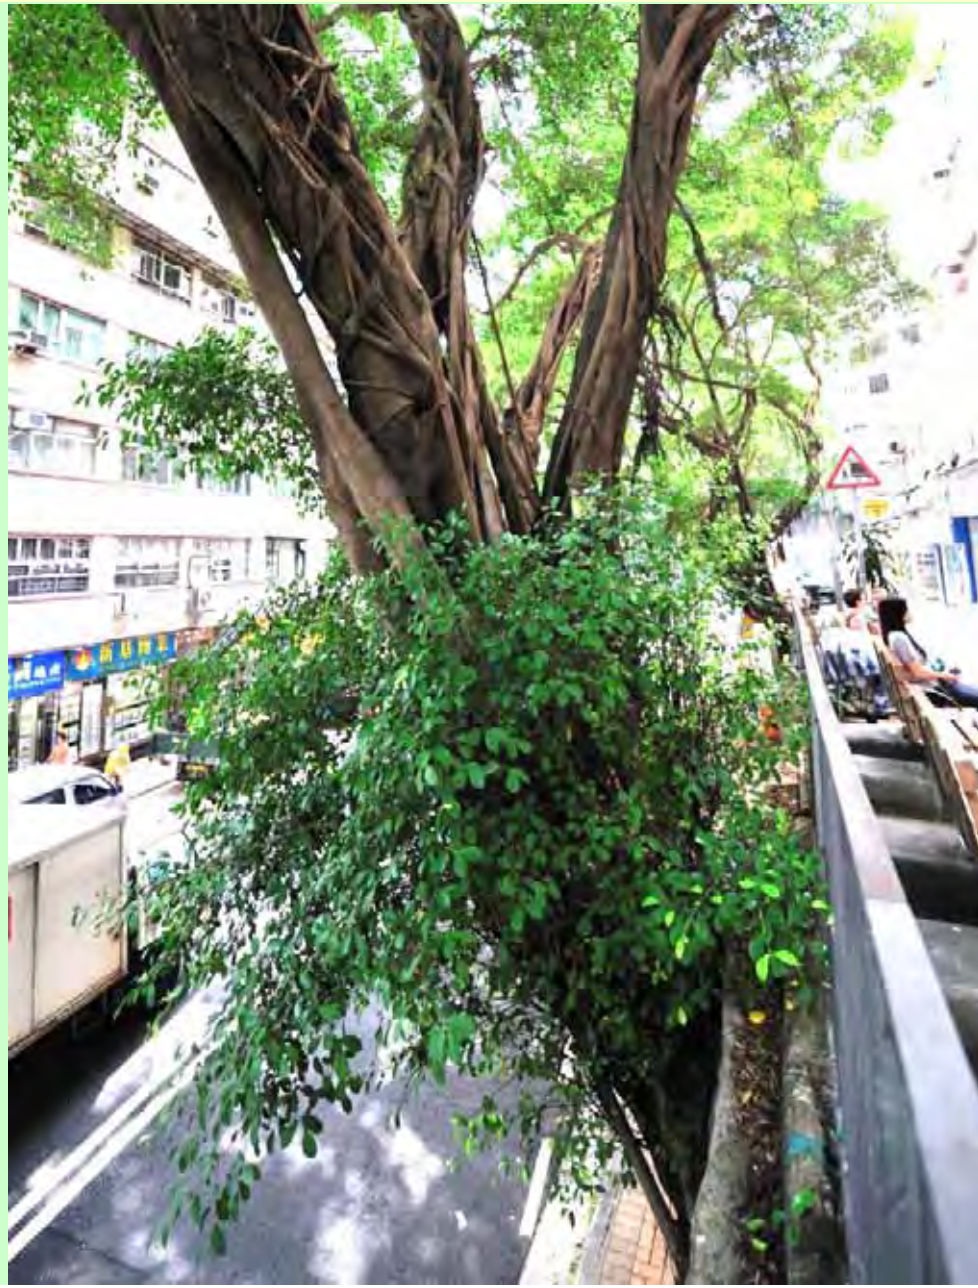
Photo T2-13. Relationship between tree and wall crest, viewed from the west.

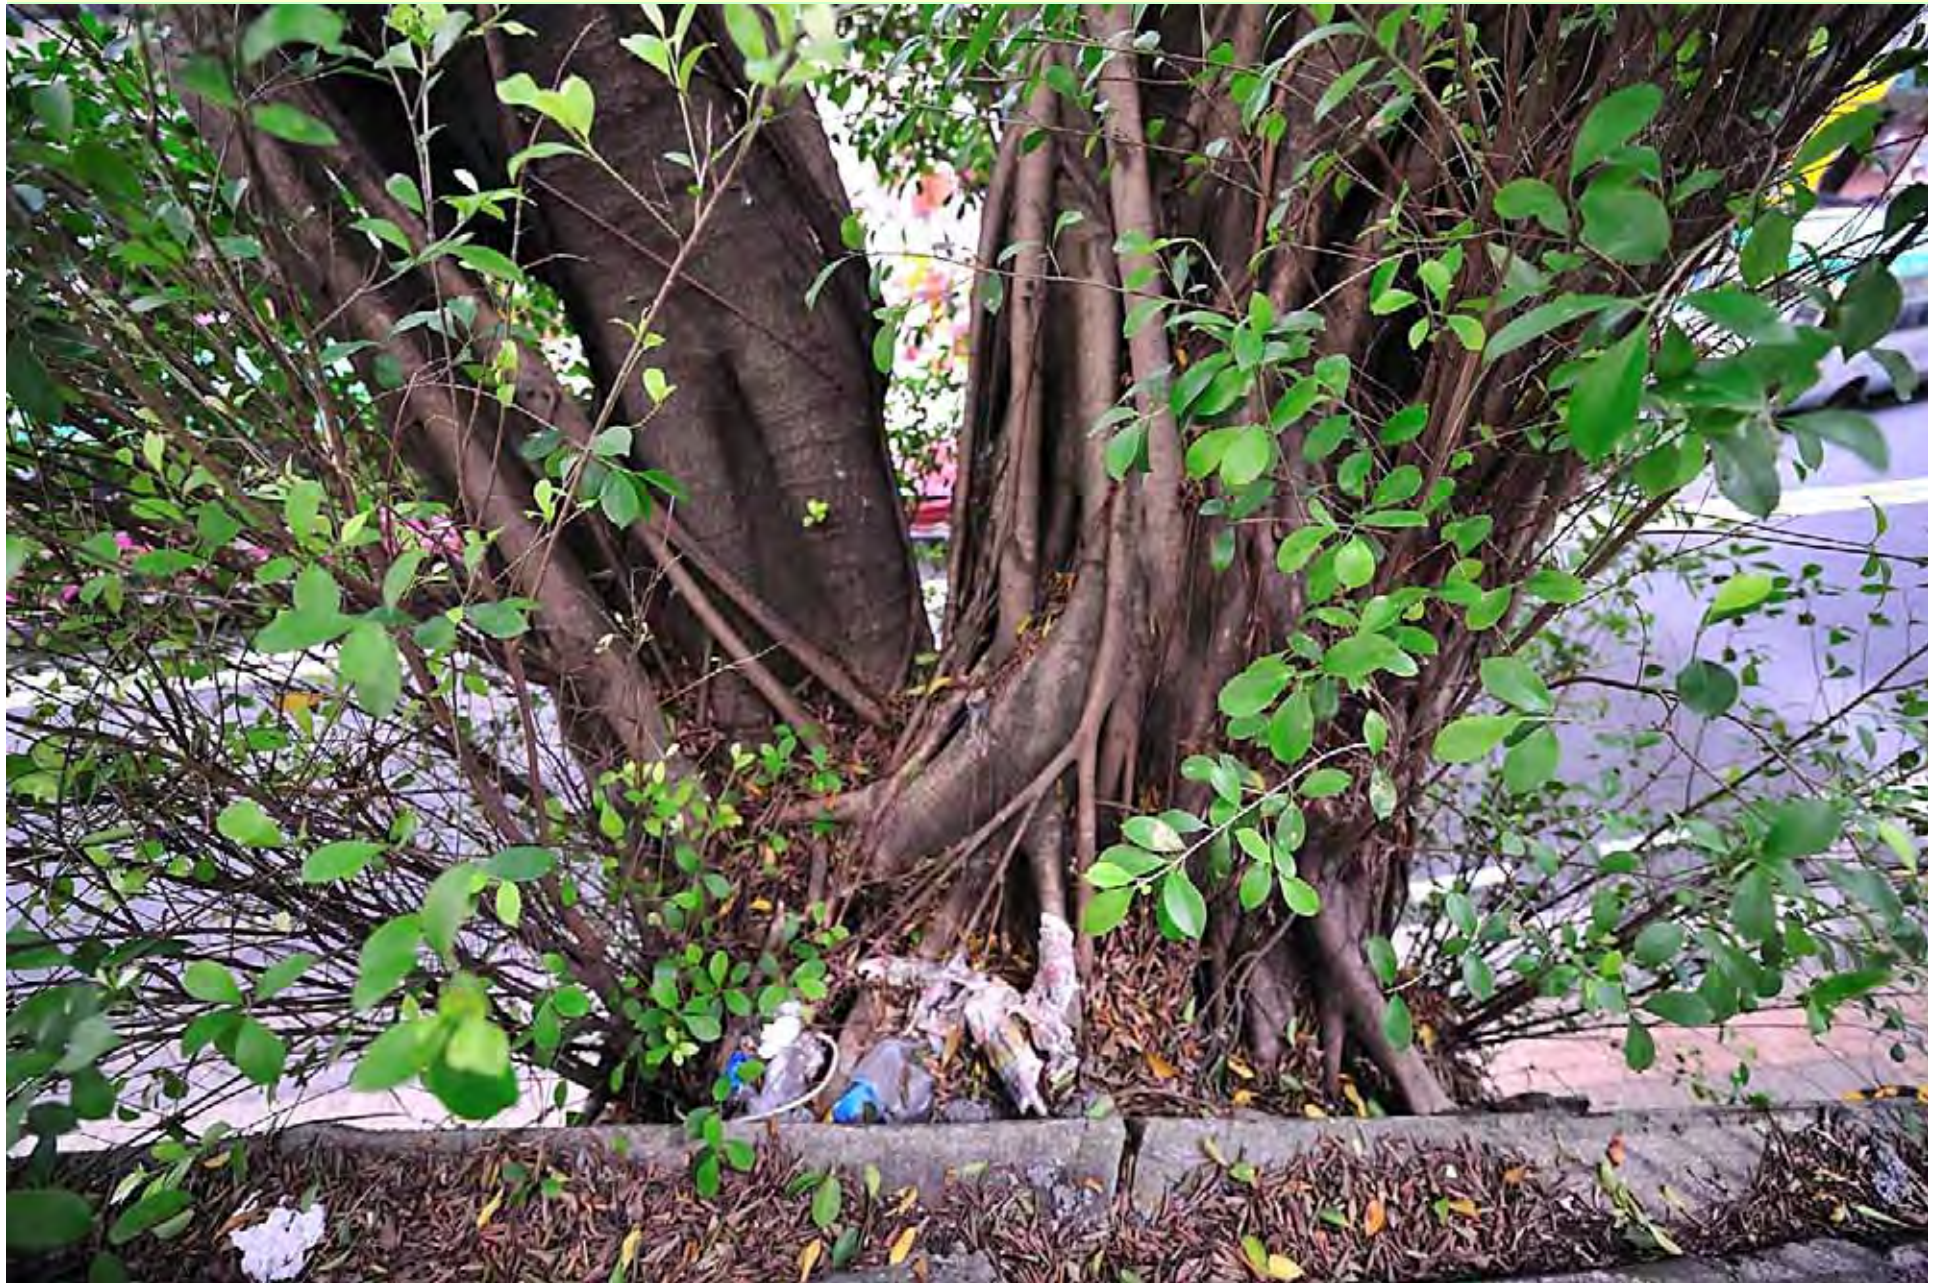
Photo T2-14. Relationship between tree and wall crest, viewed from the south. Rubbish accumulation.

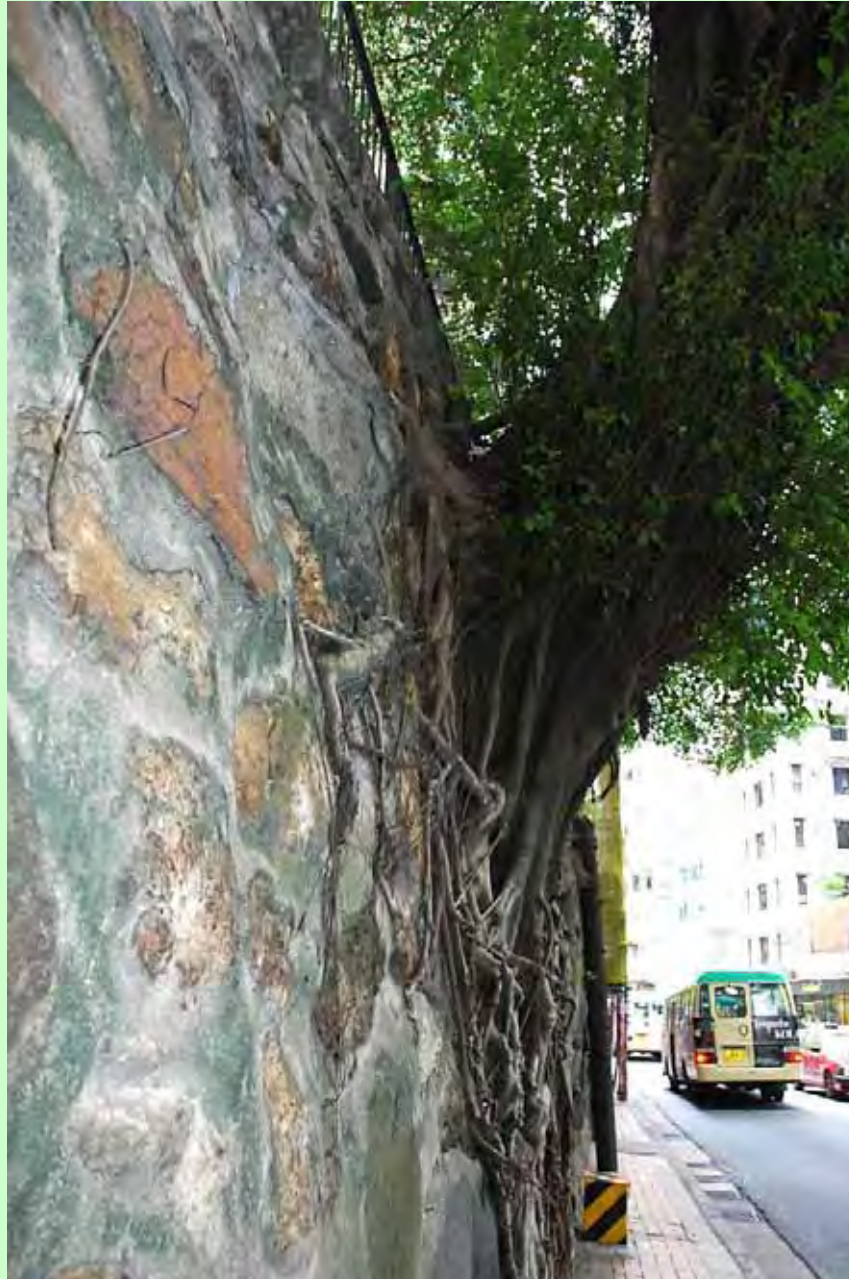
Photo T2-15. East side of surface root spread indicating slightly bulging surface of masonry blocks and cement sealing of joints.

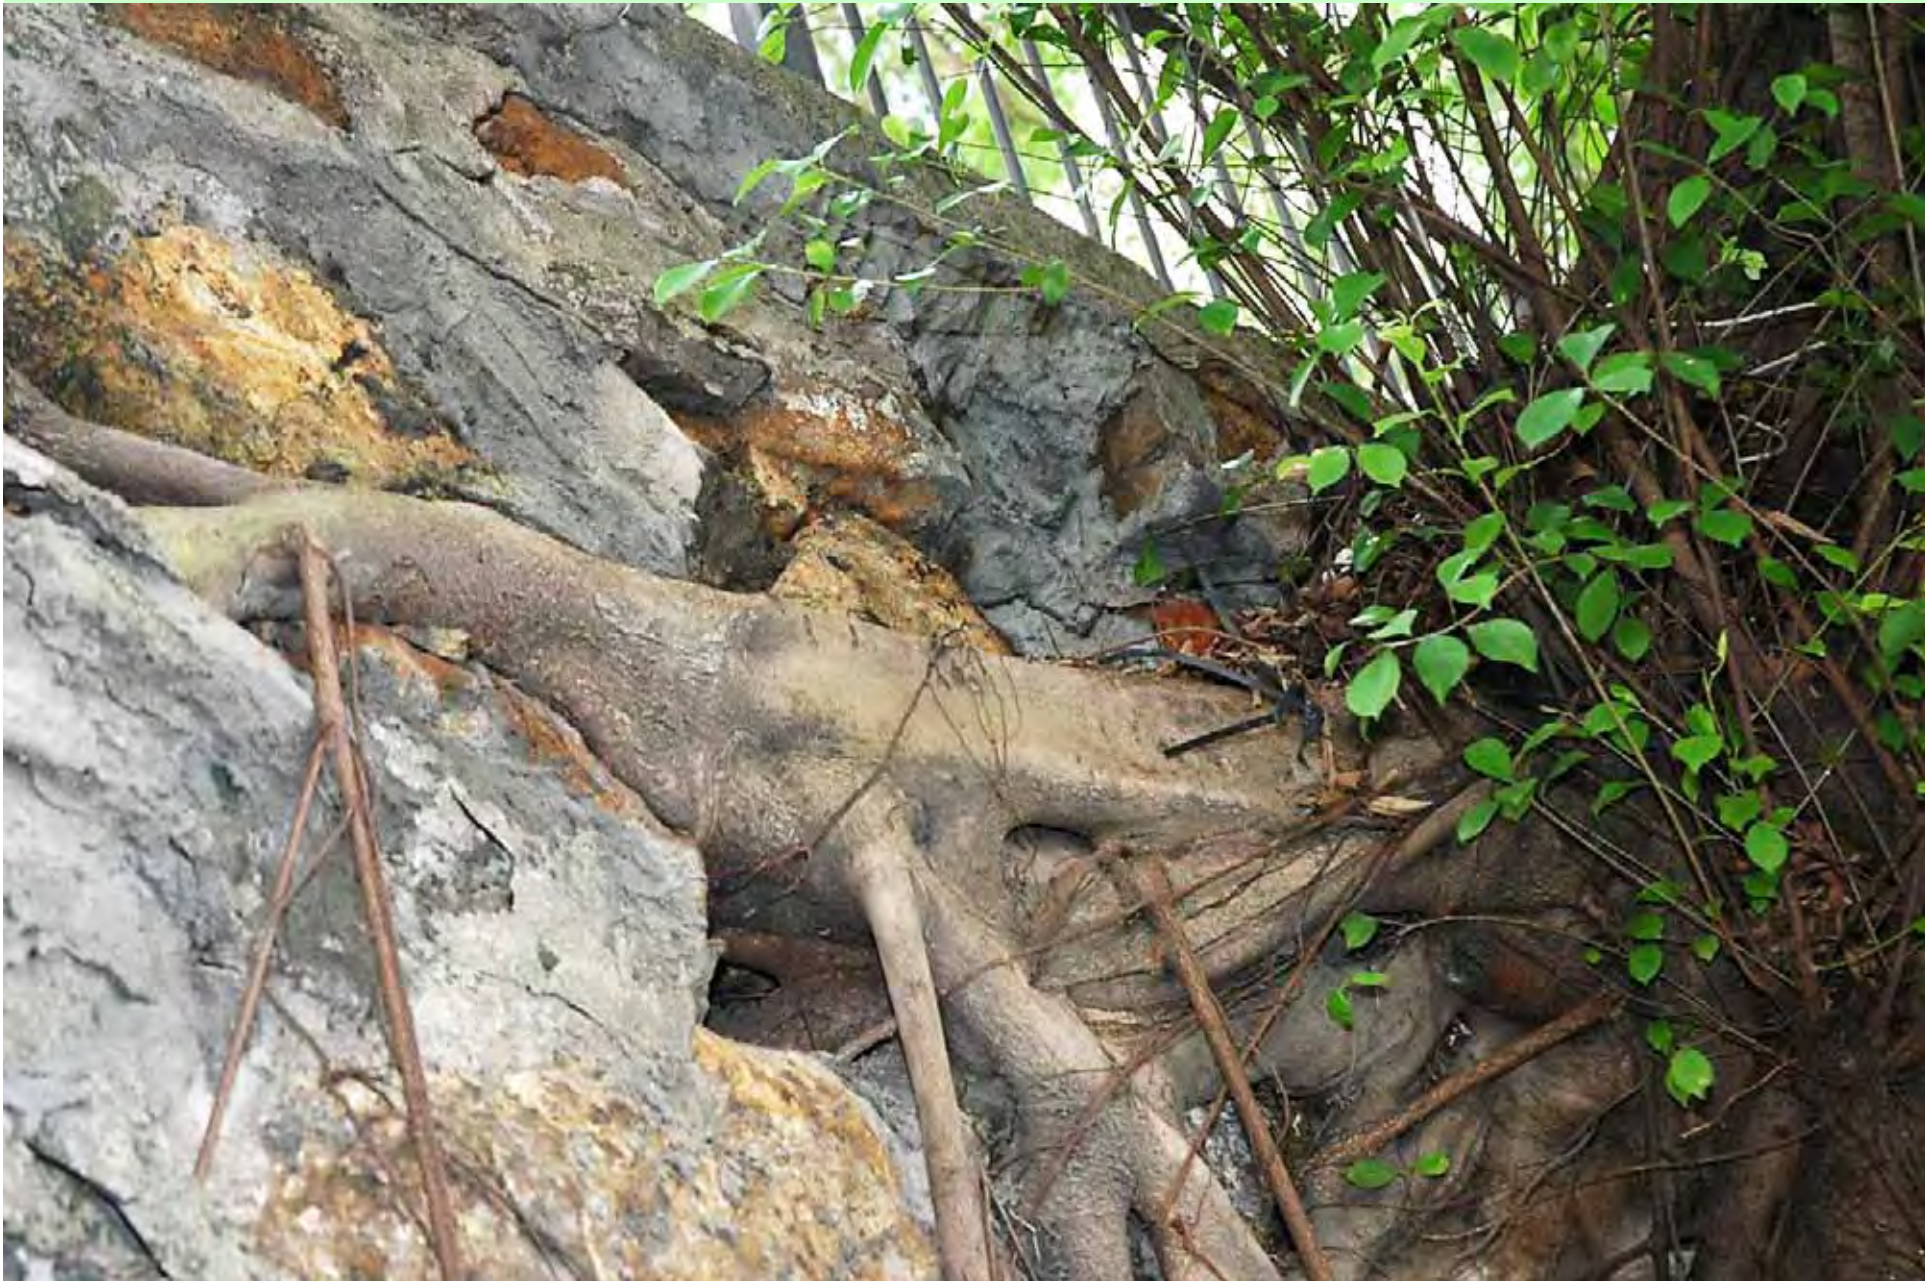
Photo T2-16. East side of the surface root spread near trunk base indicating displacement and omission of masonry blocks.
