Assessment of Wall Trees on Slope 11SW-A/R577 at Bonham Road

**Highways Department
HKSAR Government**

**C.Y. Jim
The University of Hong Kong
hrajcy@hku.hk**

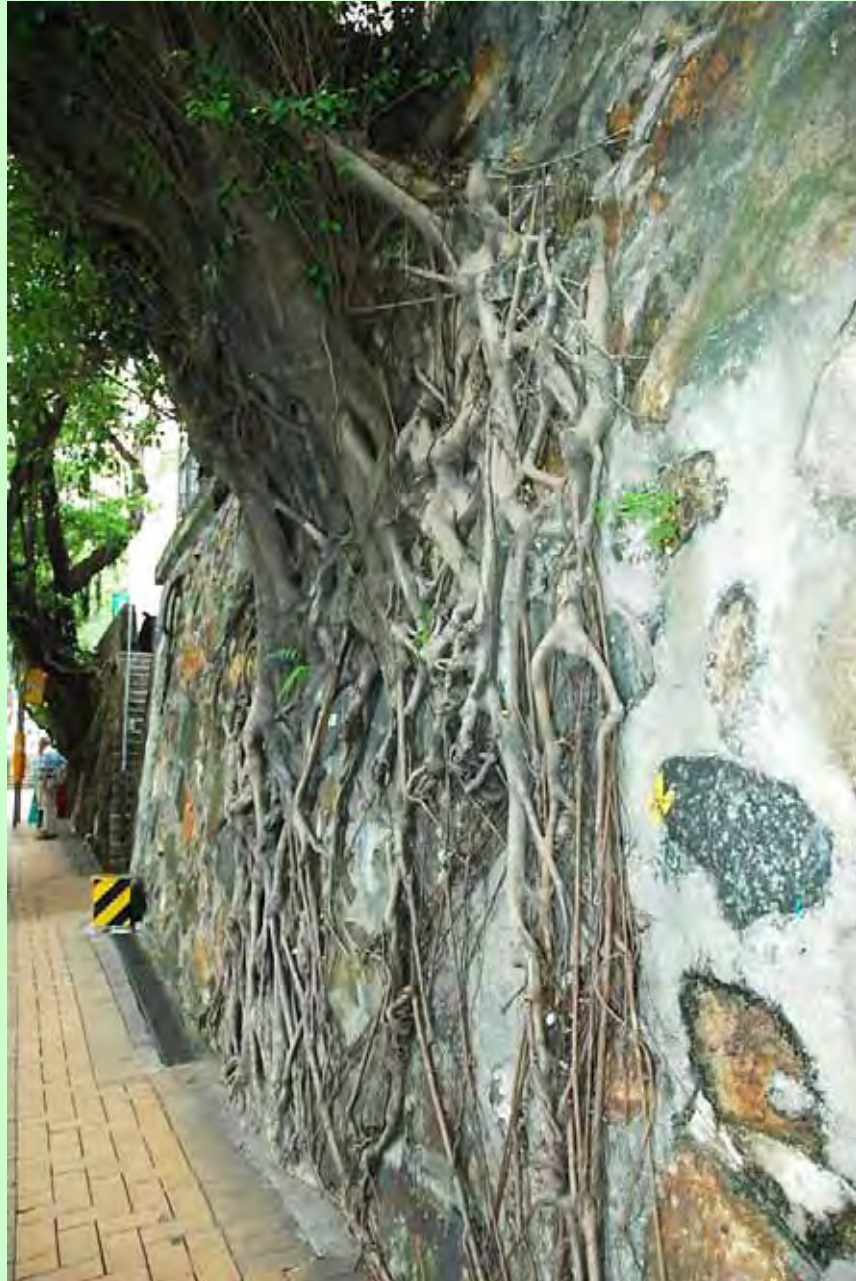
Photo T2-17. West side of the surface root spread indicating extensive buttering of joints by cement.

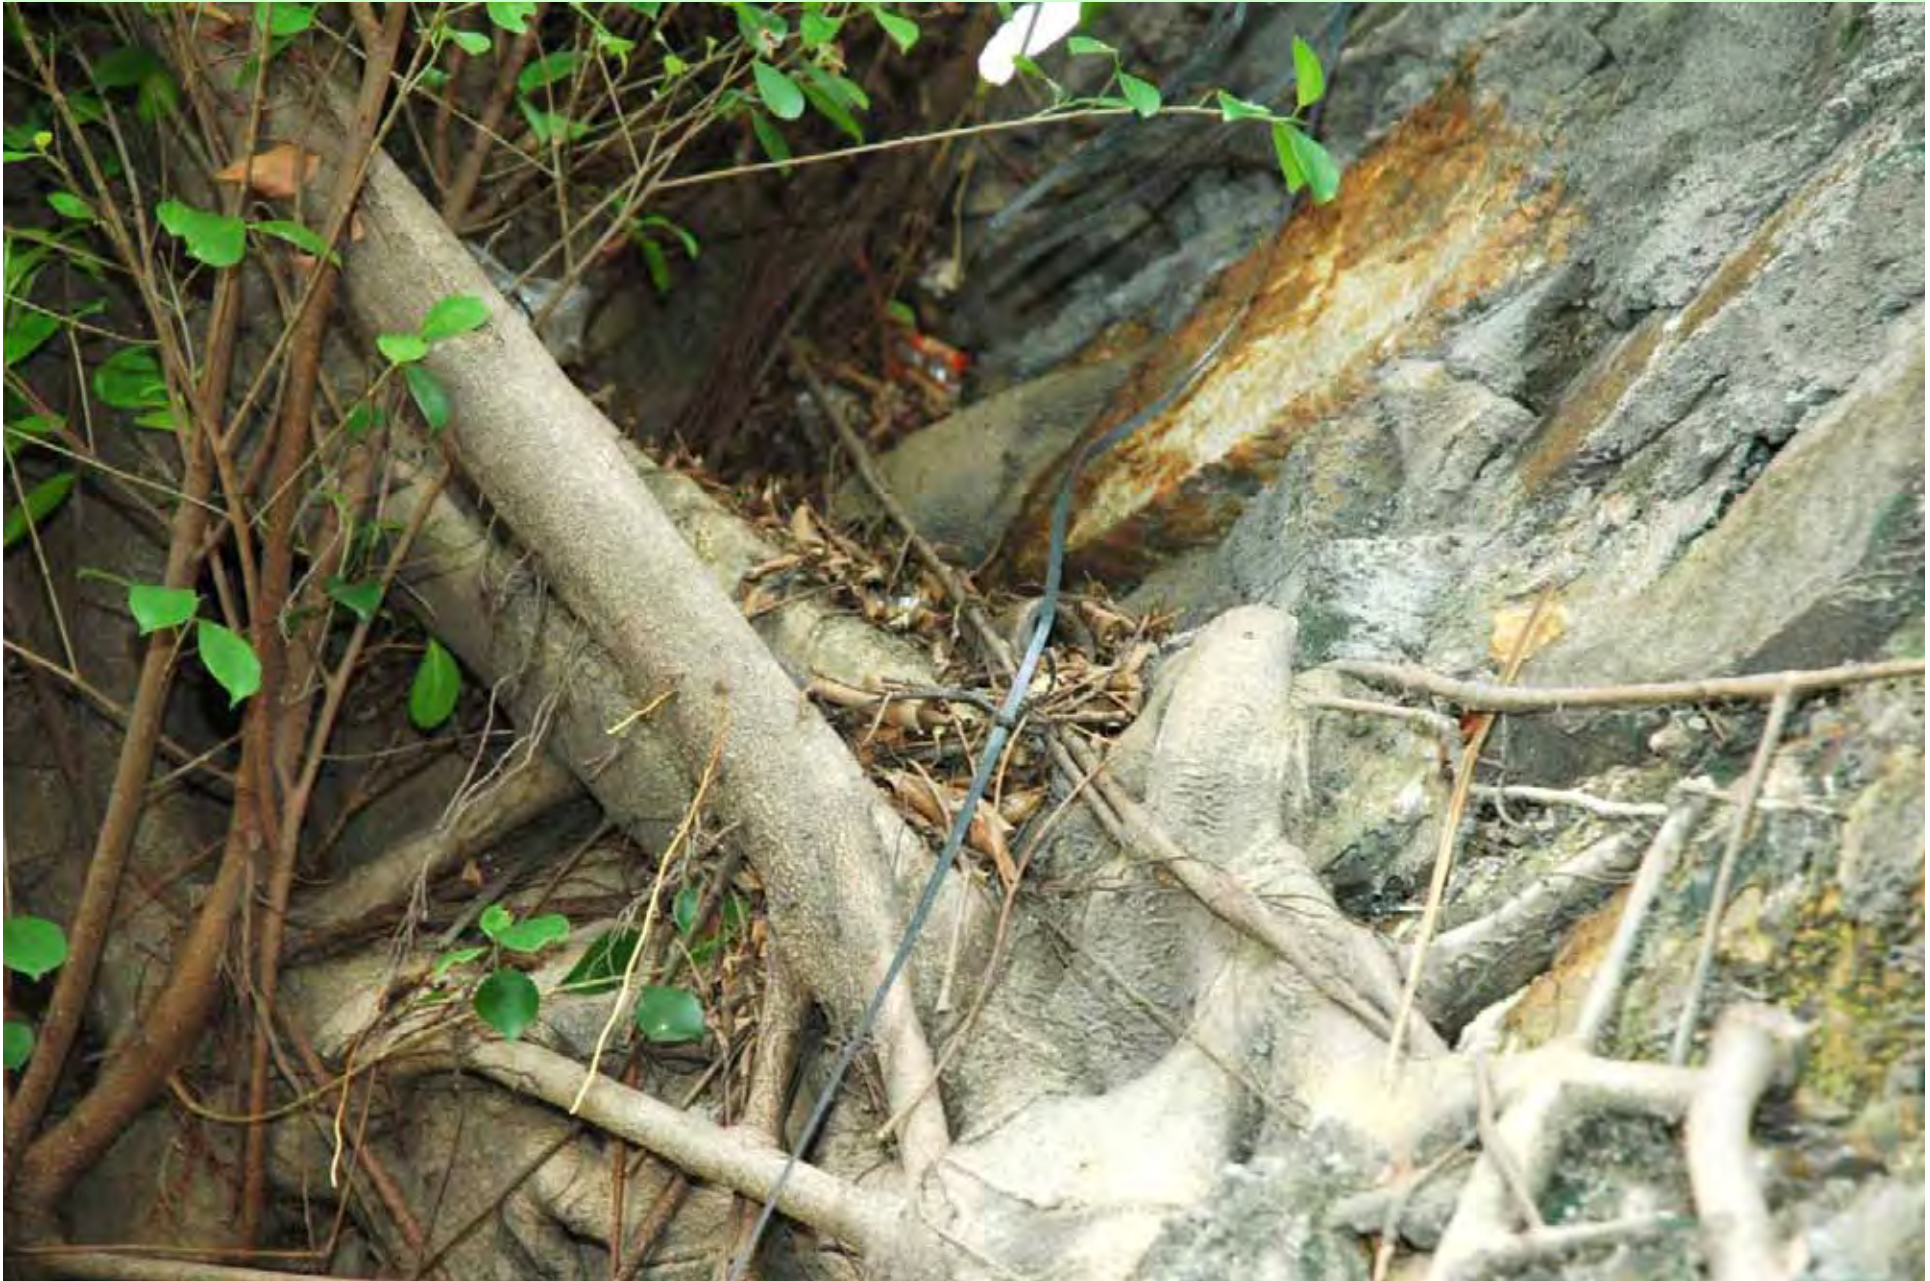
Photo T2-18. West side of the surface root spread near the trunk base indicating slightly protruding masonry blocks.

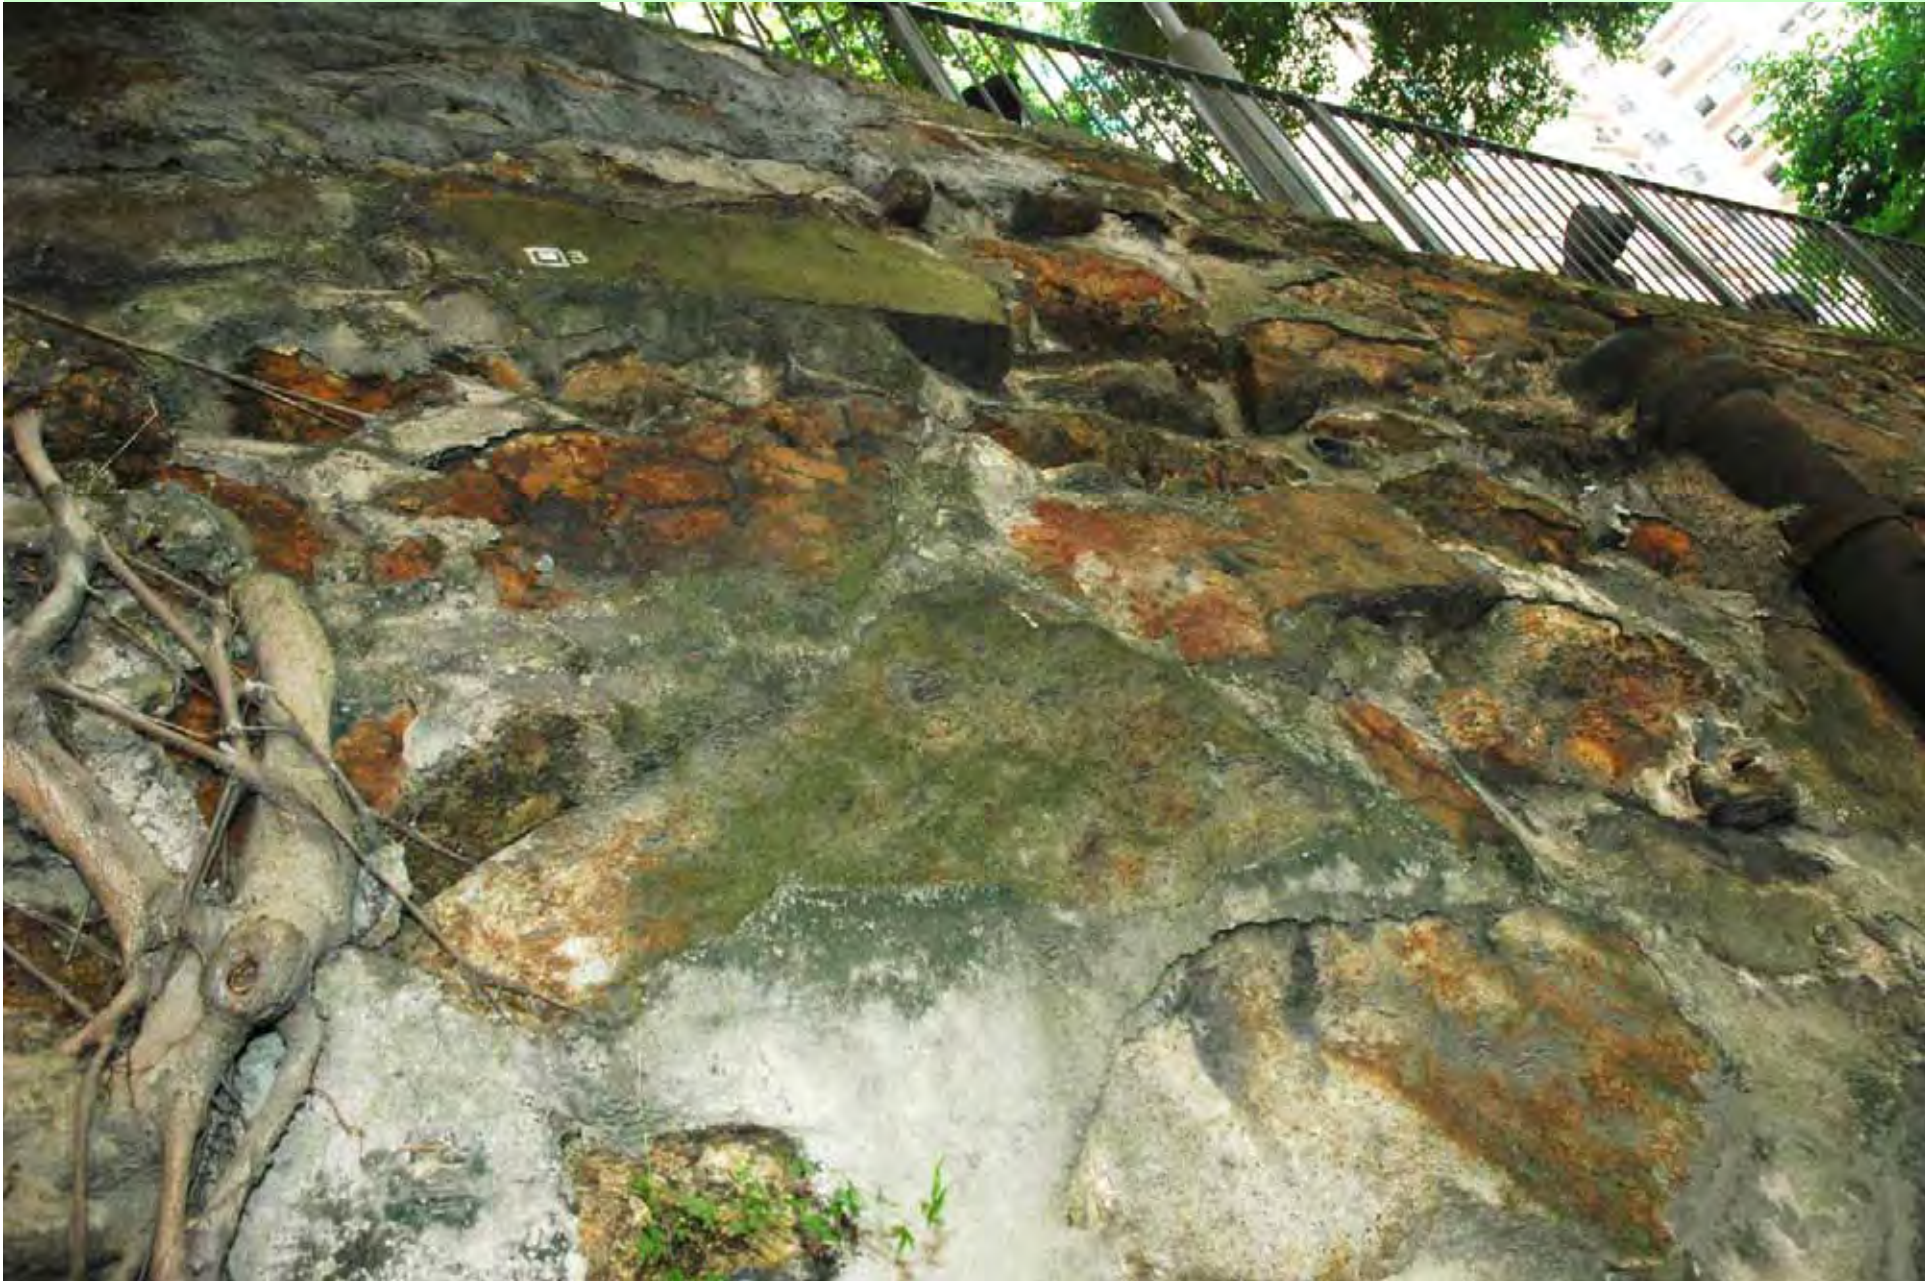
Photo T2-19. West of the surface roots showing uneven surface and new cement pointing of the rubble wall.

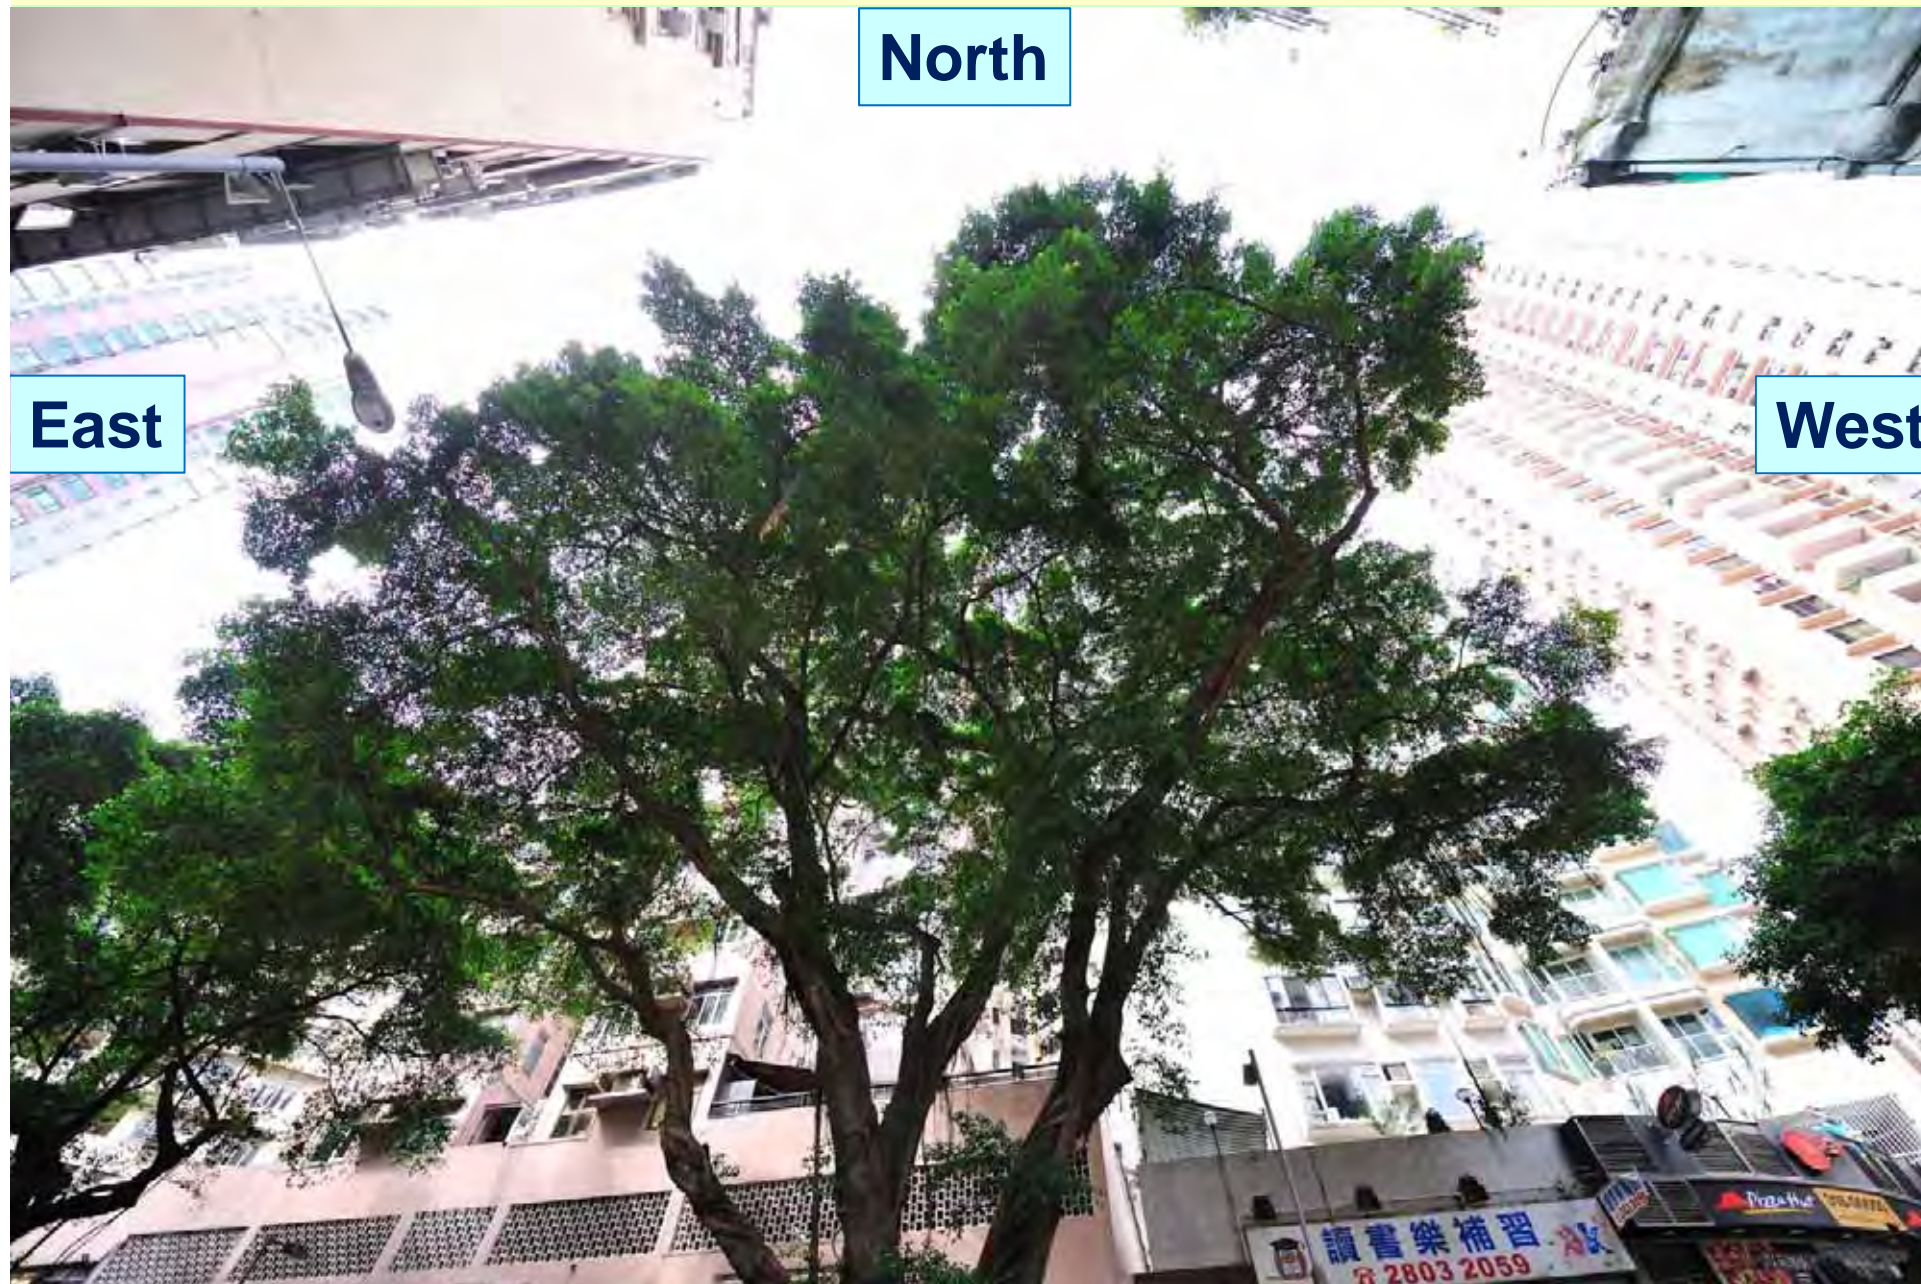
Photo T2-20. The broad and well-balanced east-west spread of the tree crown. Note excessive loss of lower branches.

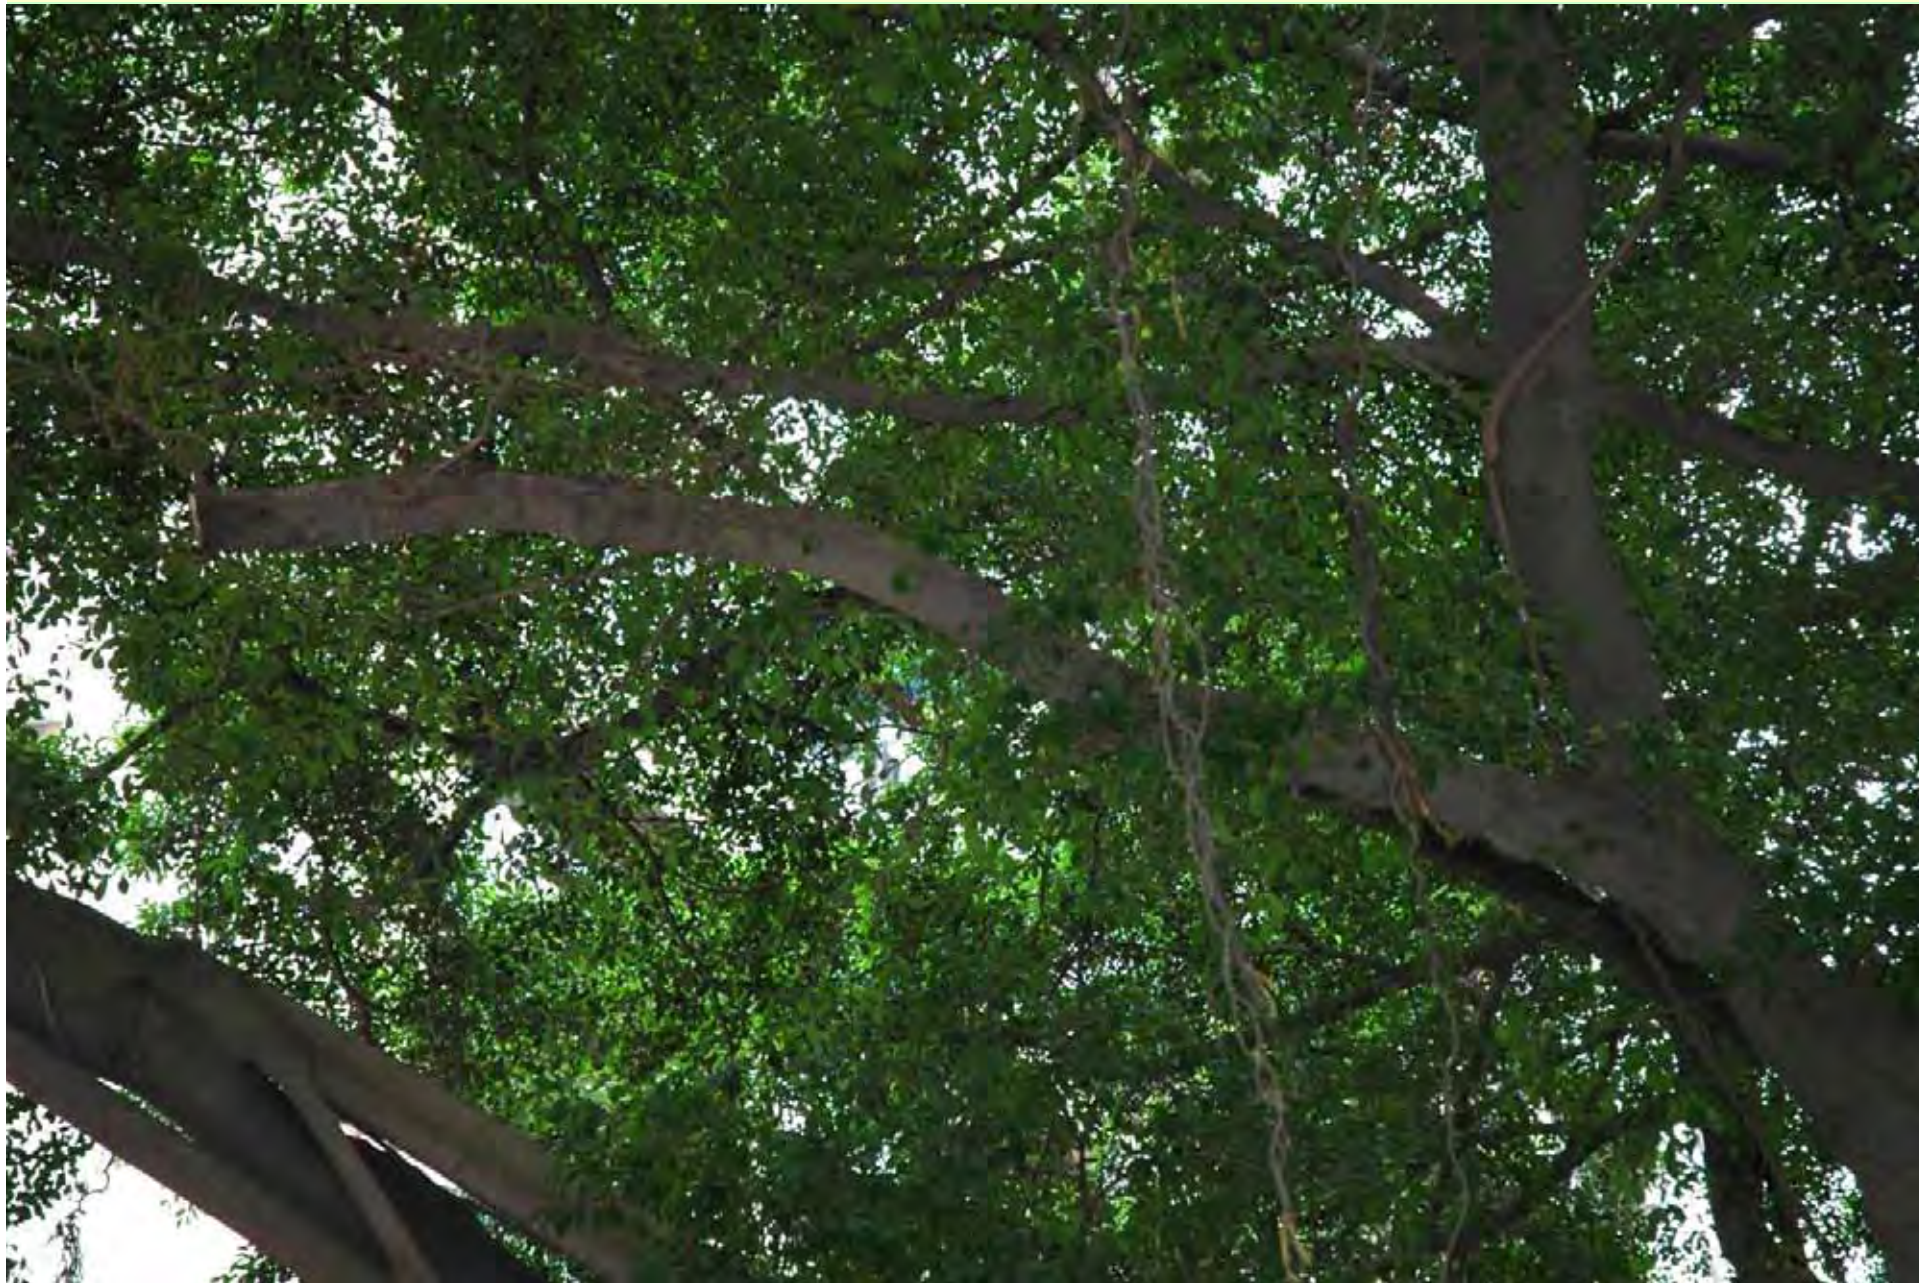
Photo T2-21. Dense branching habit and foliage in the tree's sprawling crown.

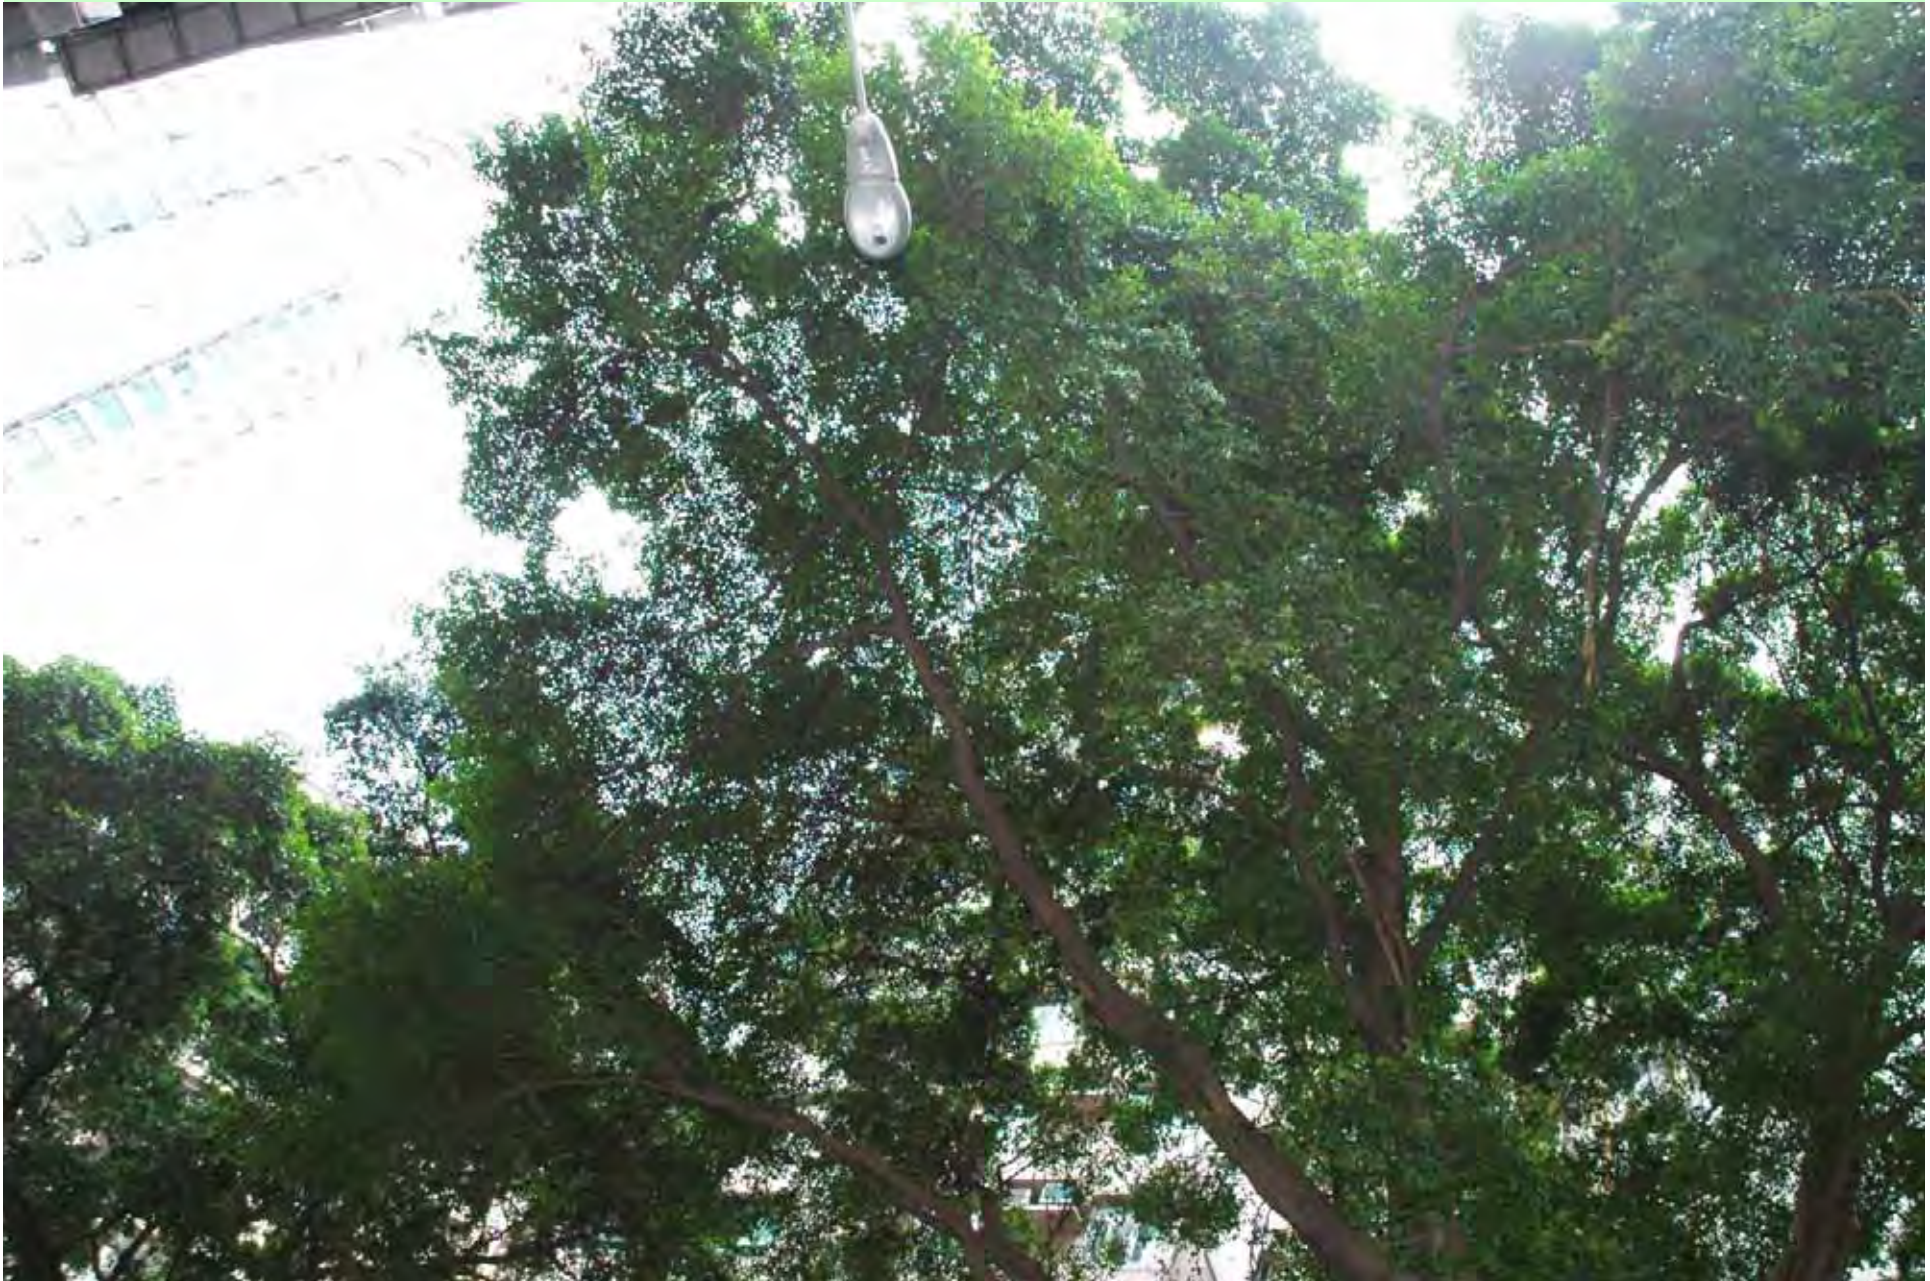
Photo T2-22. The east side of the crown with dense and healthy branches and foliage.

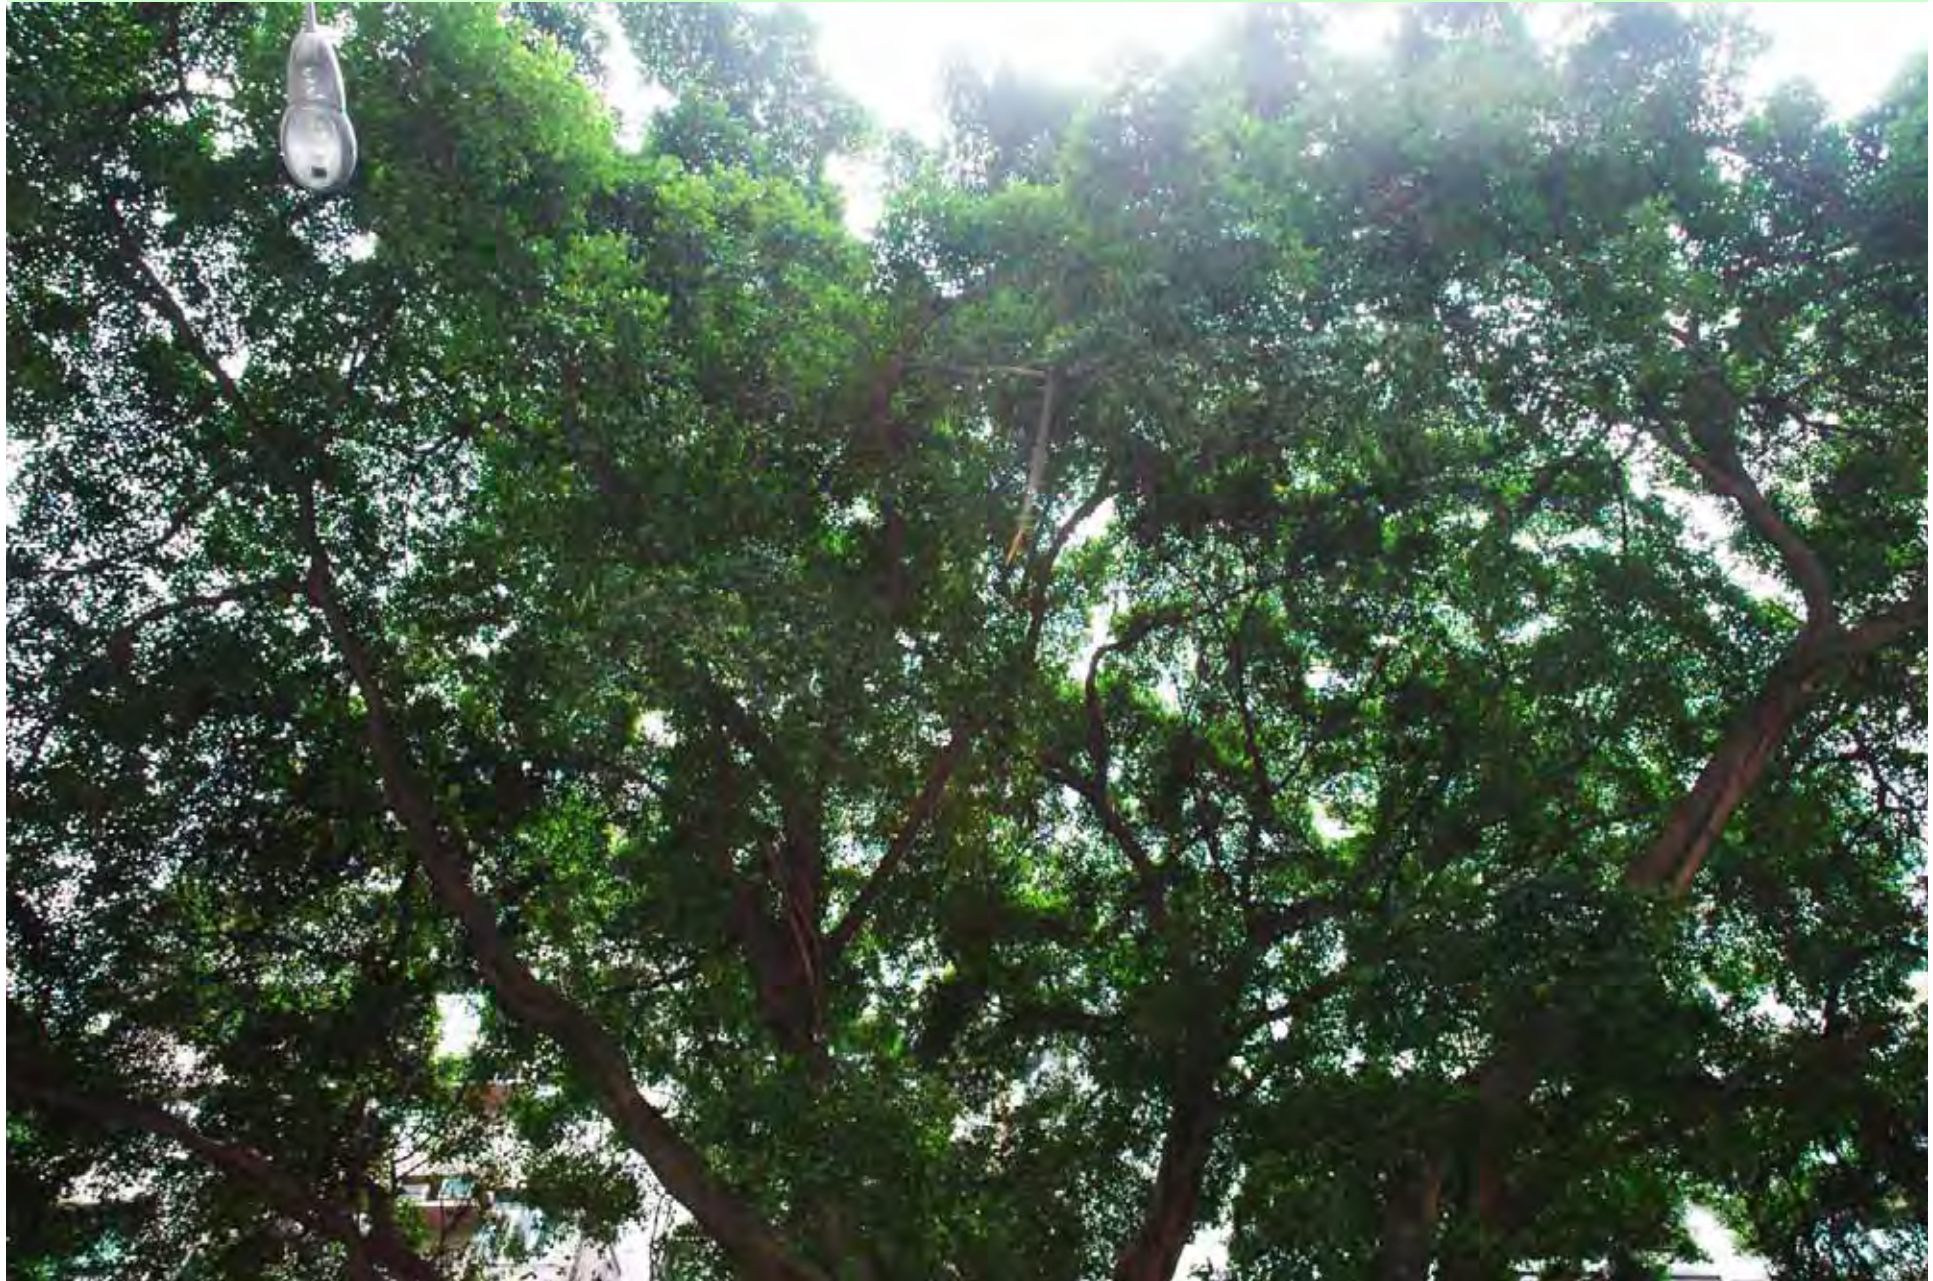
Photo T2-23. The central part of the dense crown with high foliage density and high leaf area index.

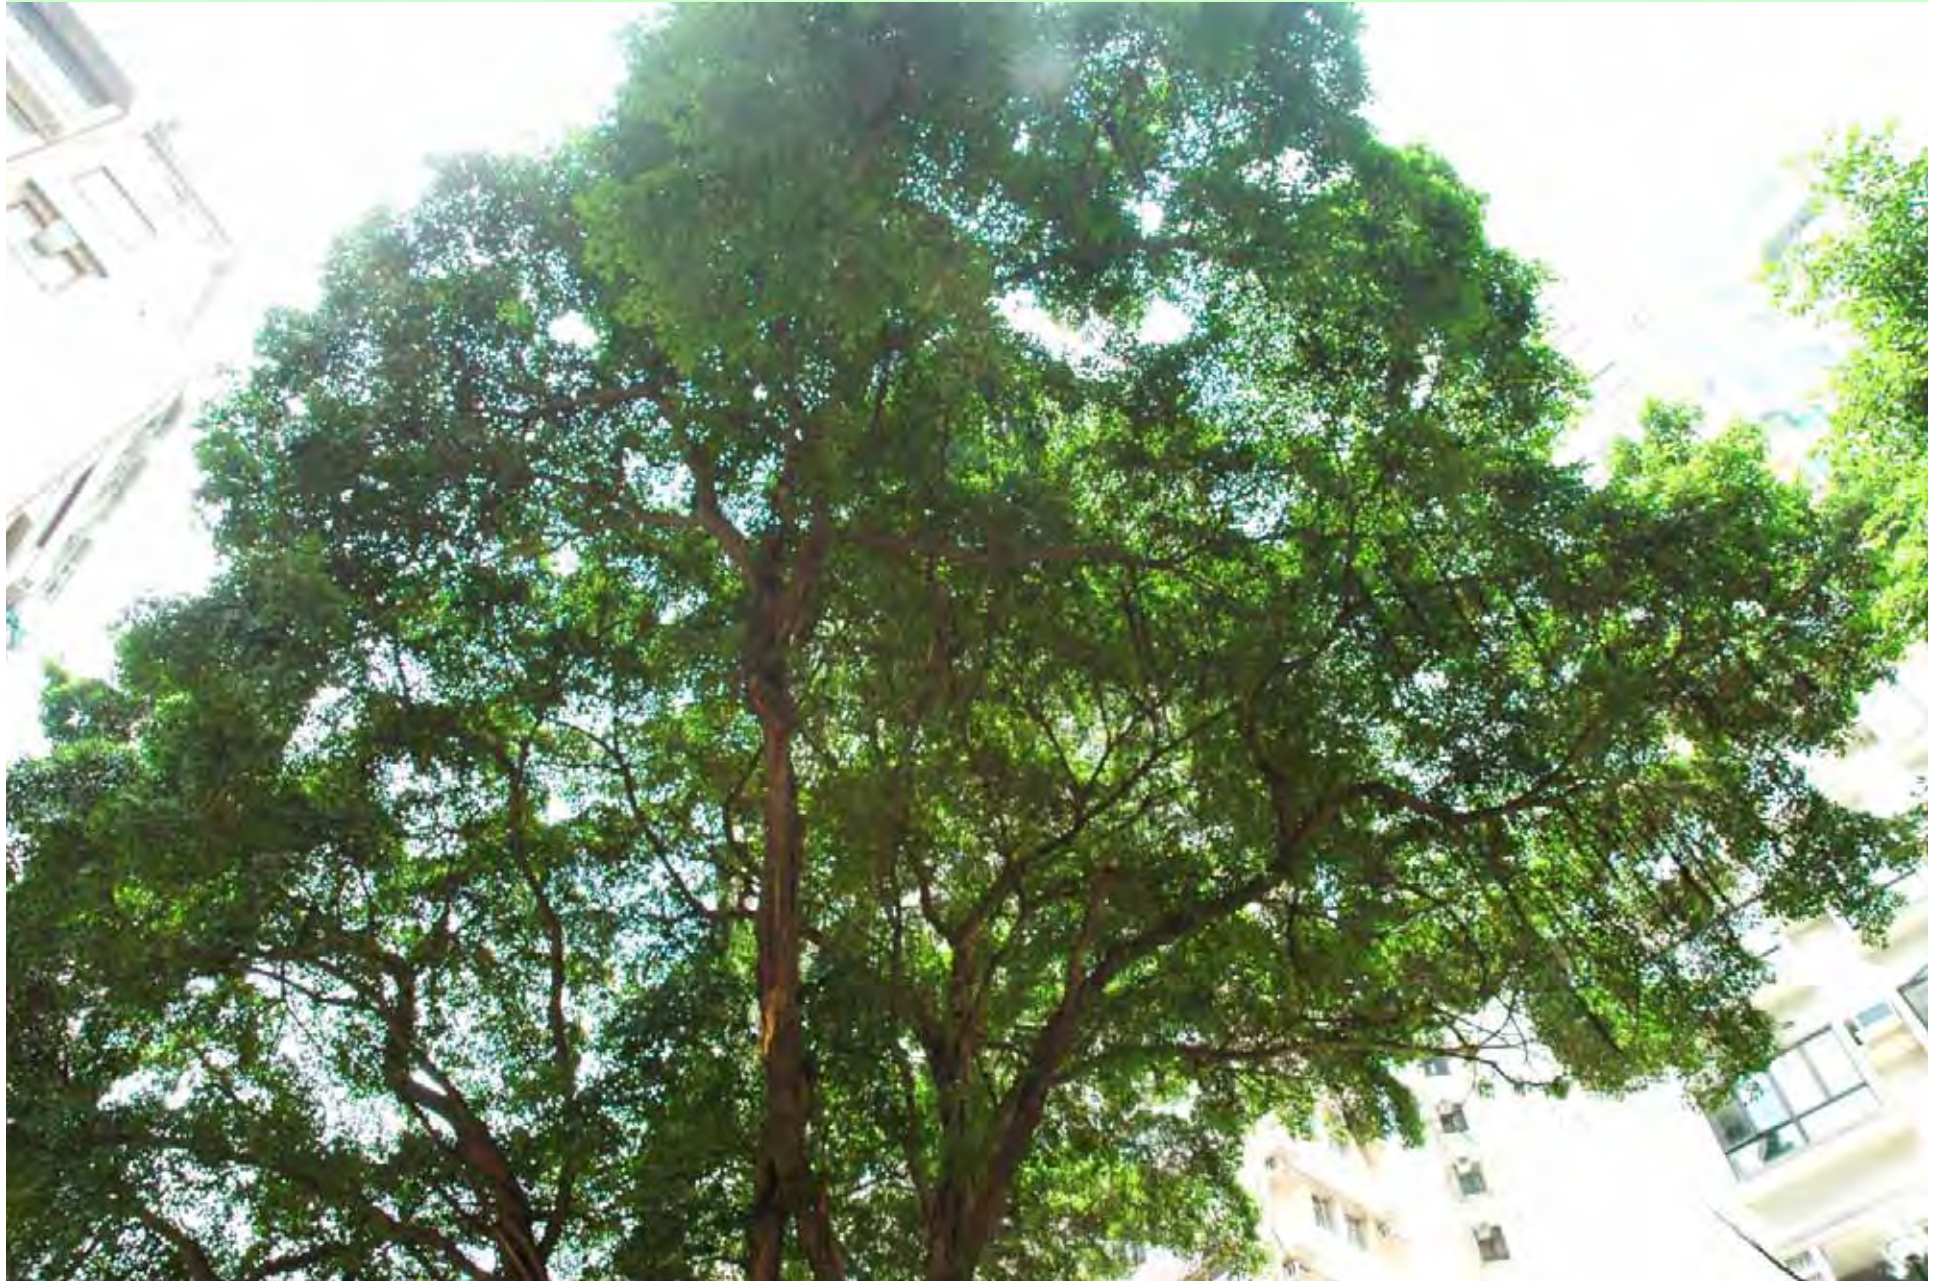
Photo T2-24. The west side of the crown with equally dense and healthy branches and foliage.

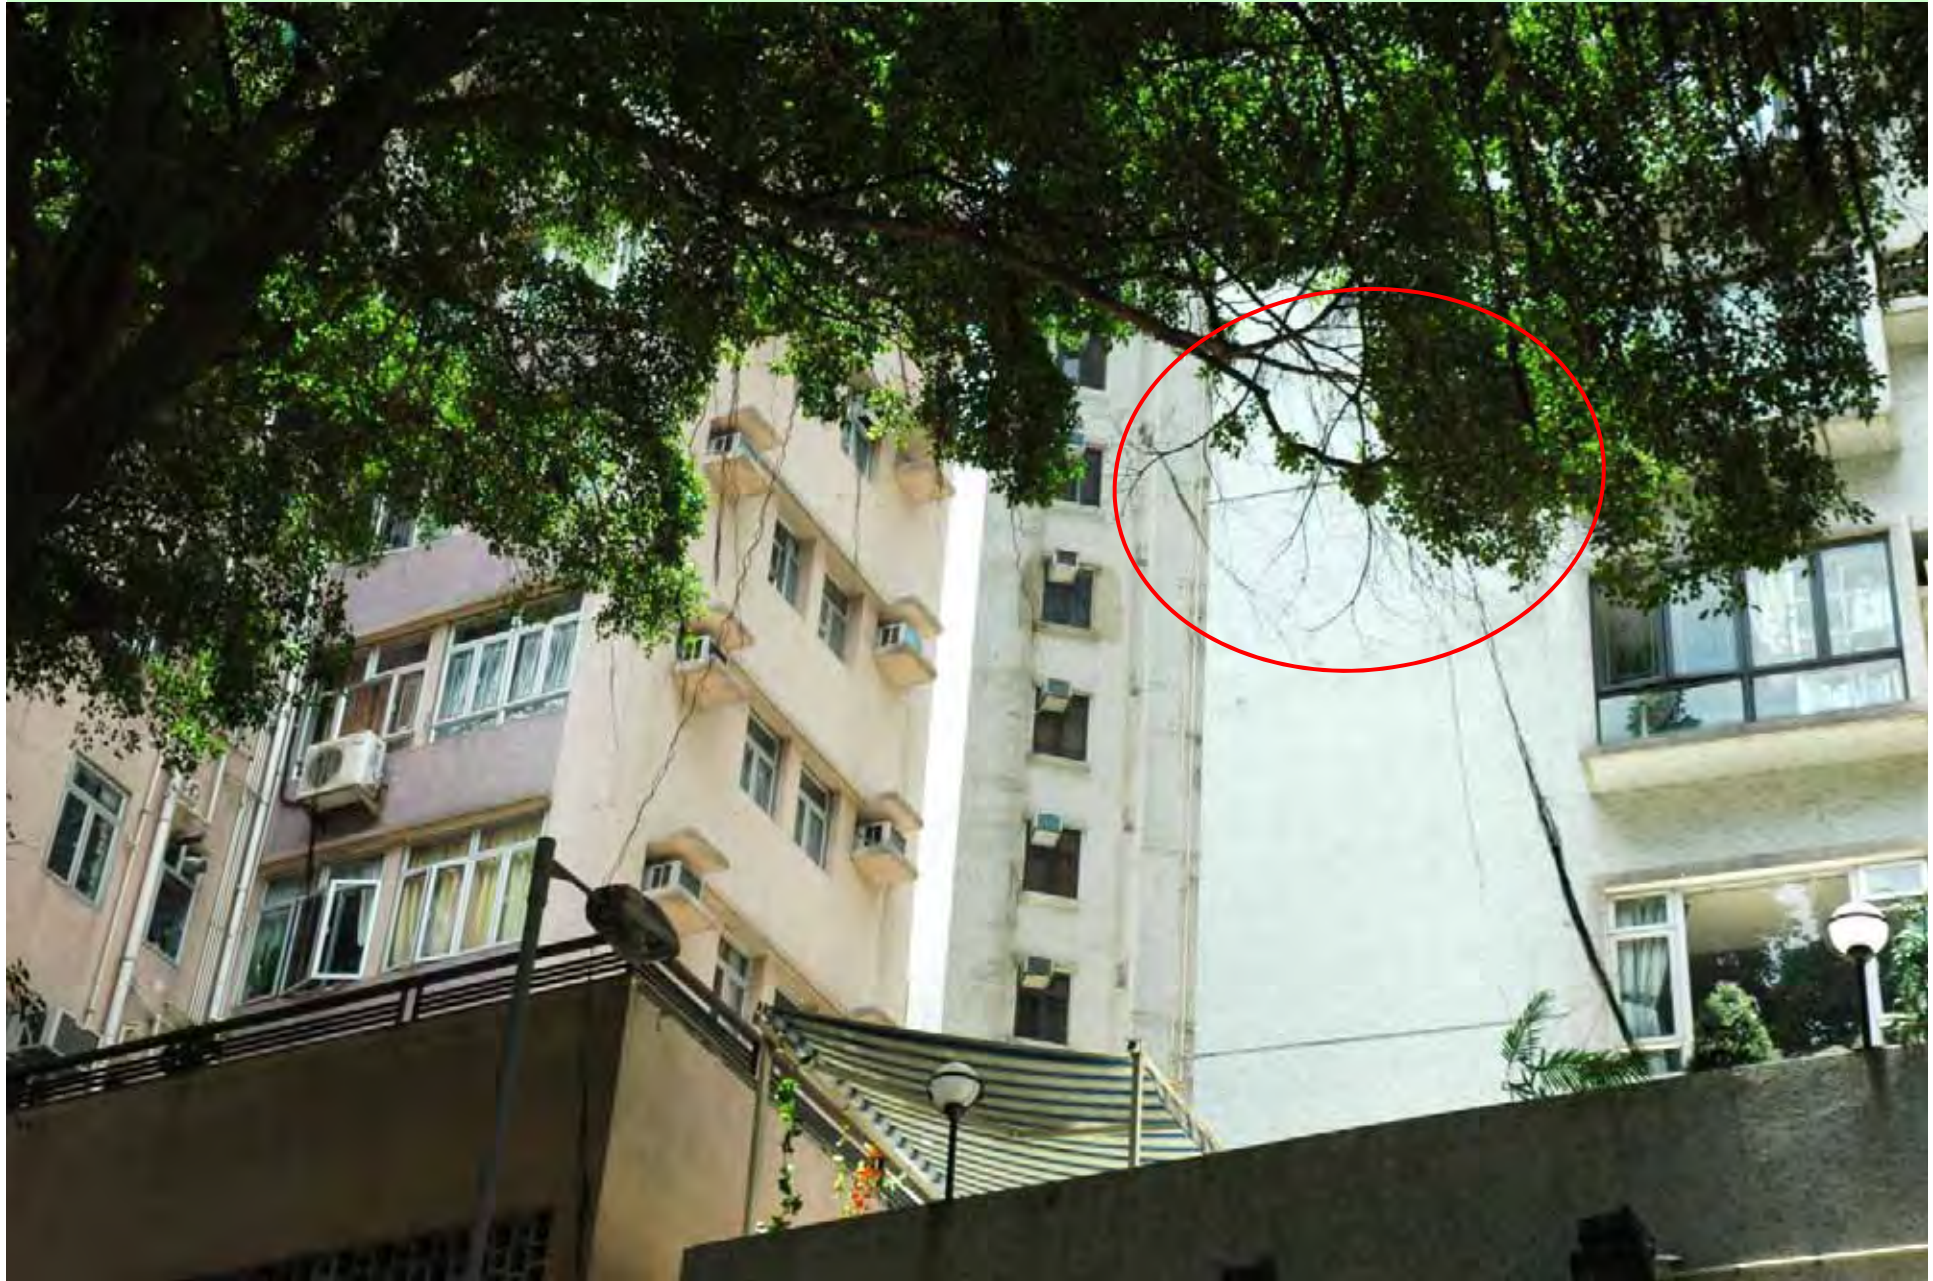
Photo T2-26. A small cluster of twigs of trunk A pointing south (St Stephen's Lane) have developed dieback symptoms.
