Assessment of Wall Trees on Slope 11SW-A/R577 at Bonham Road

**Highways Department
HKSAR Government**

**C.Y. Jim
The University of Hong Kong
hrajcy@hku.hk**

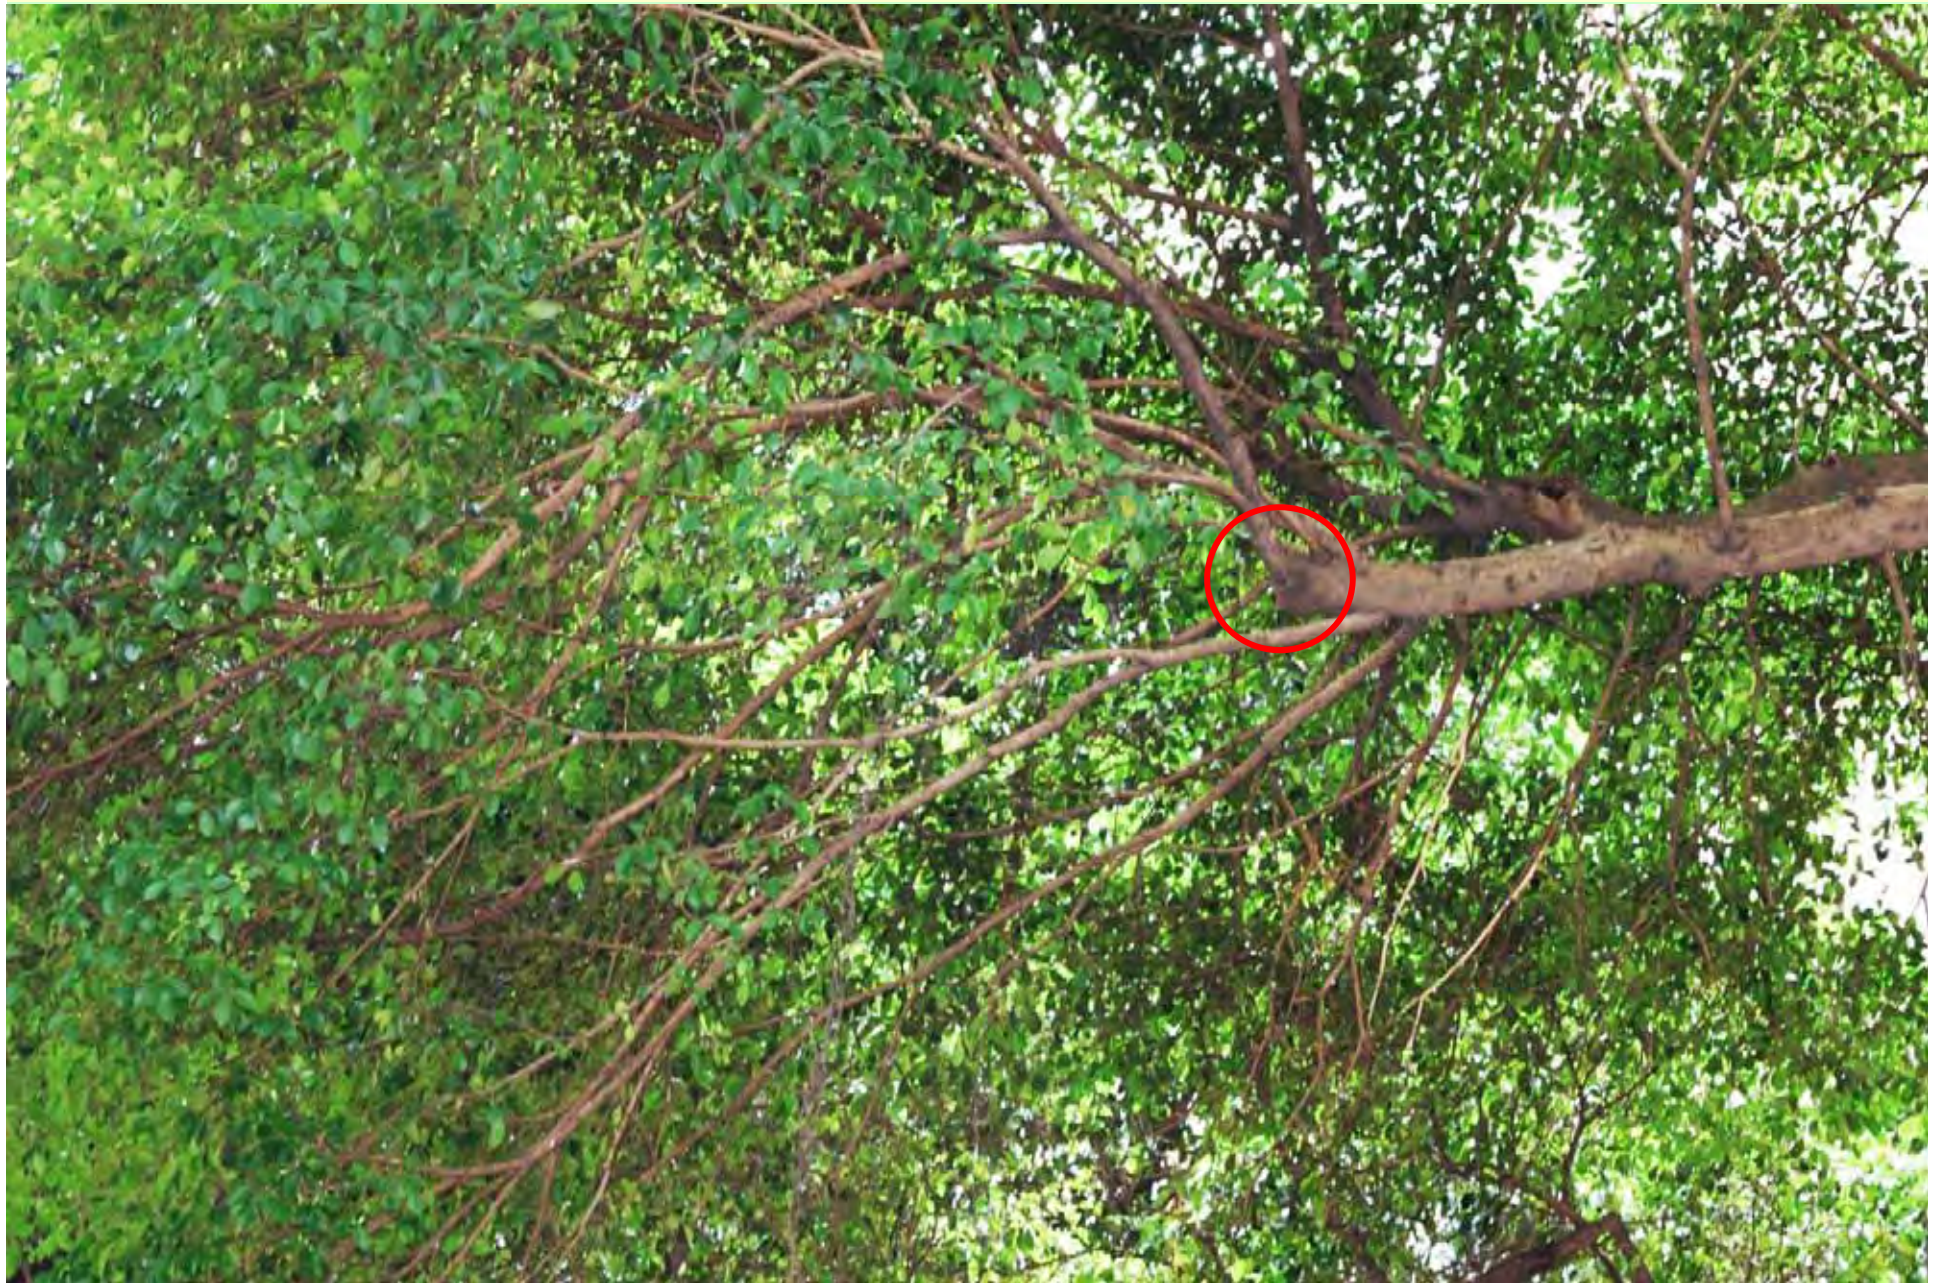
Photo T2-33. Tipped branch of stem A1 with a cluster of sprouts near the wound.

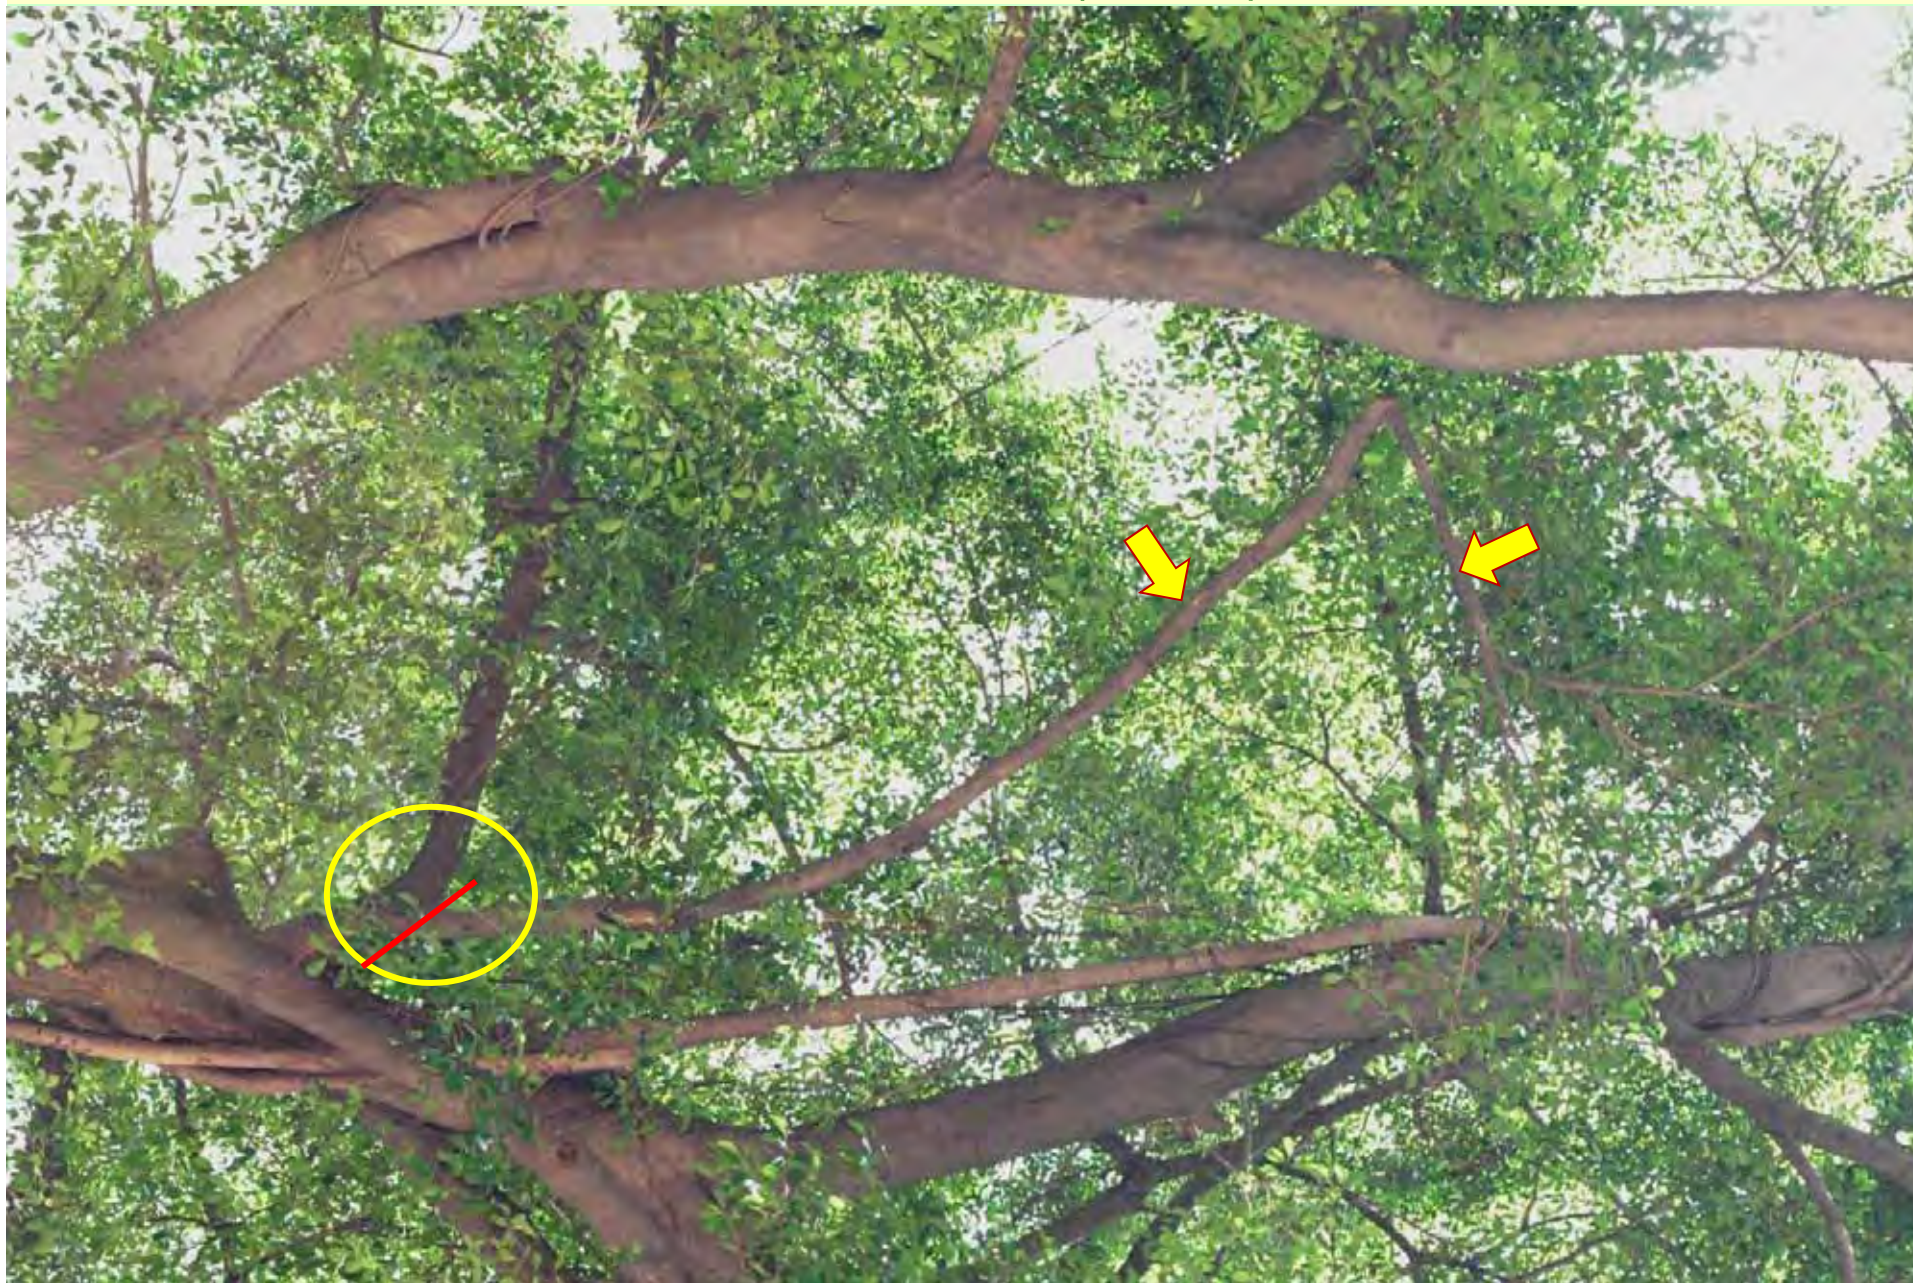
Photo T2-40. Stem B branch with curved section (circle) and kinked branch (arrow).

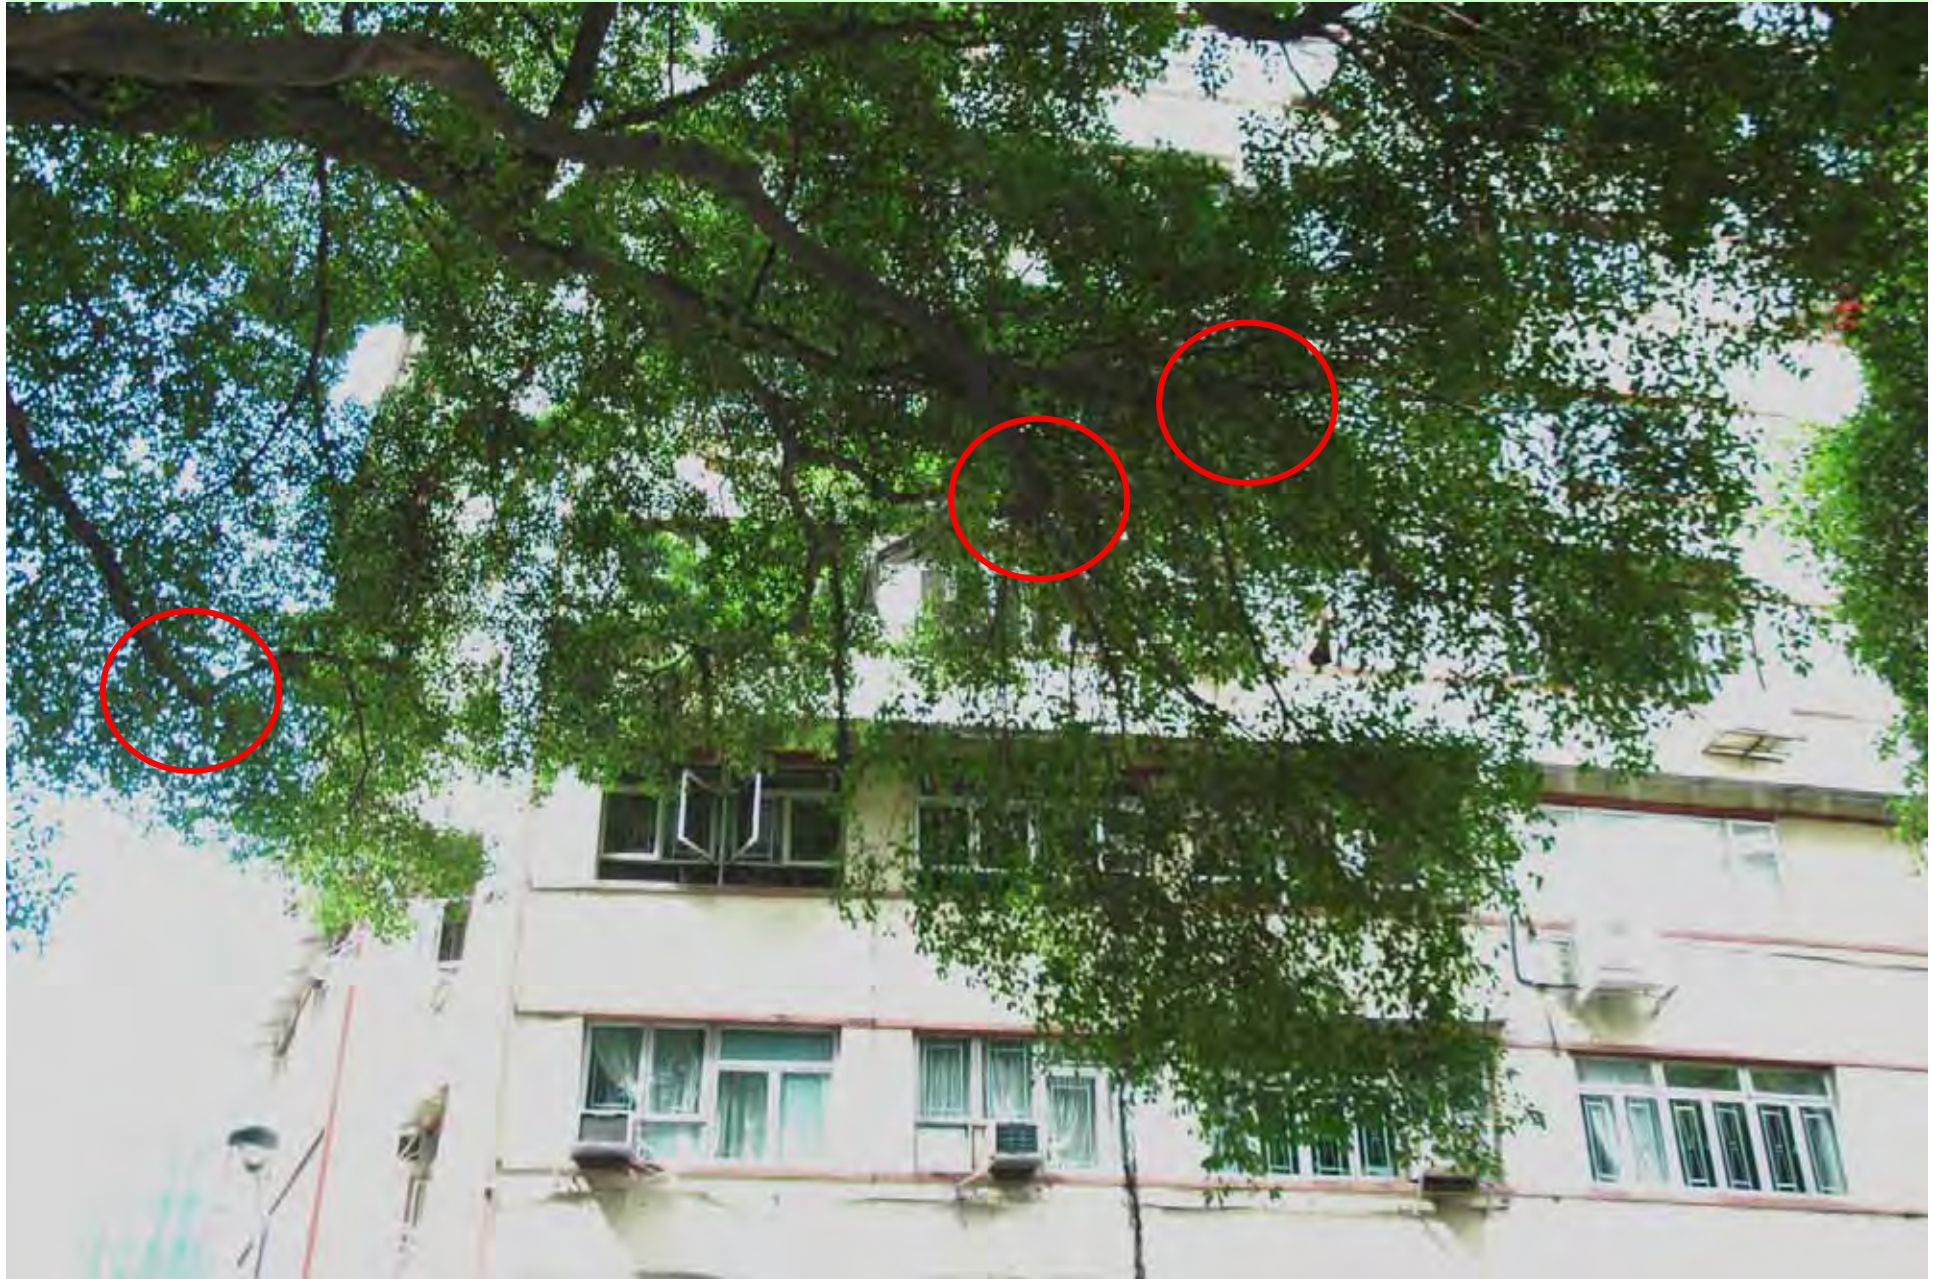
Photo T2-45. Branches above Bonham Road near buildings have been tipped with sprout clusters emerging from the wounds.

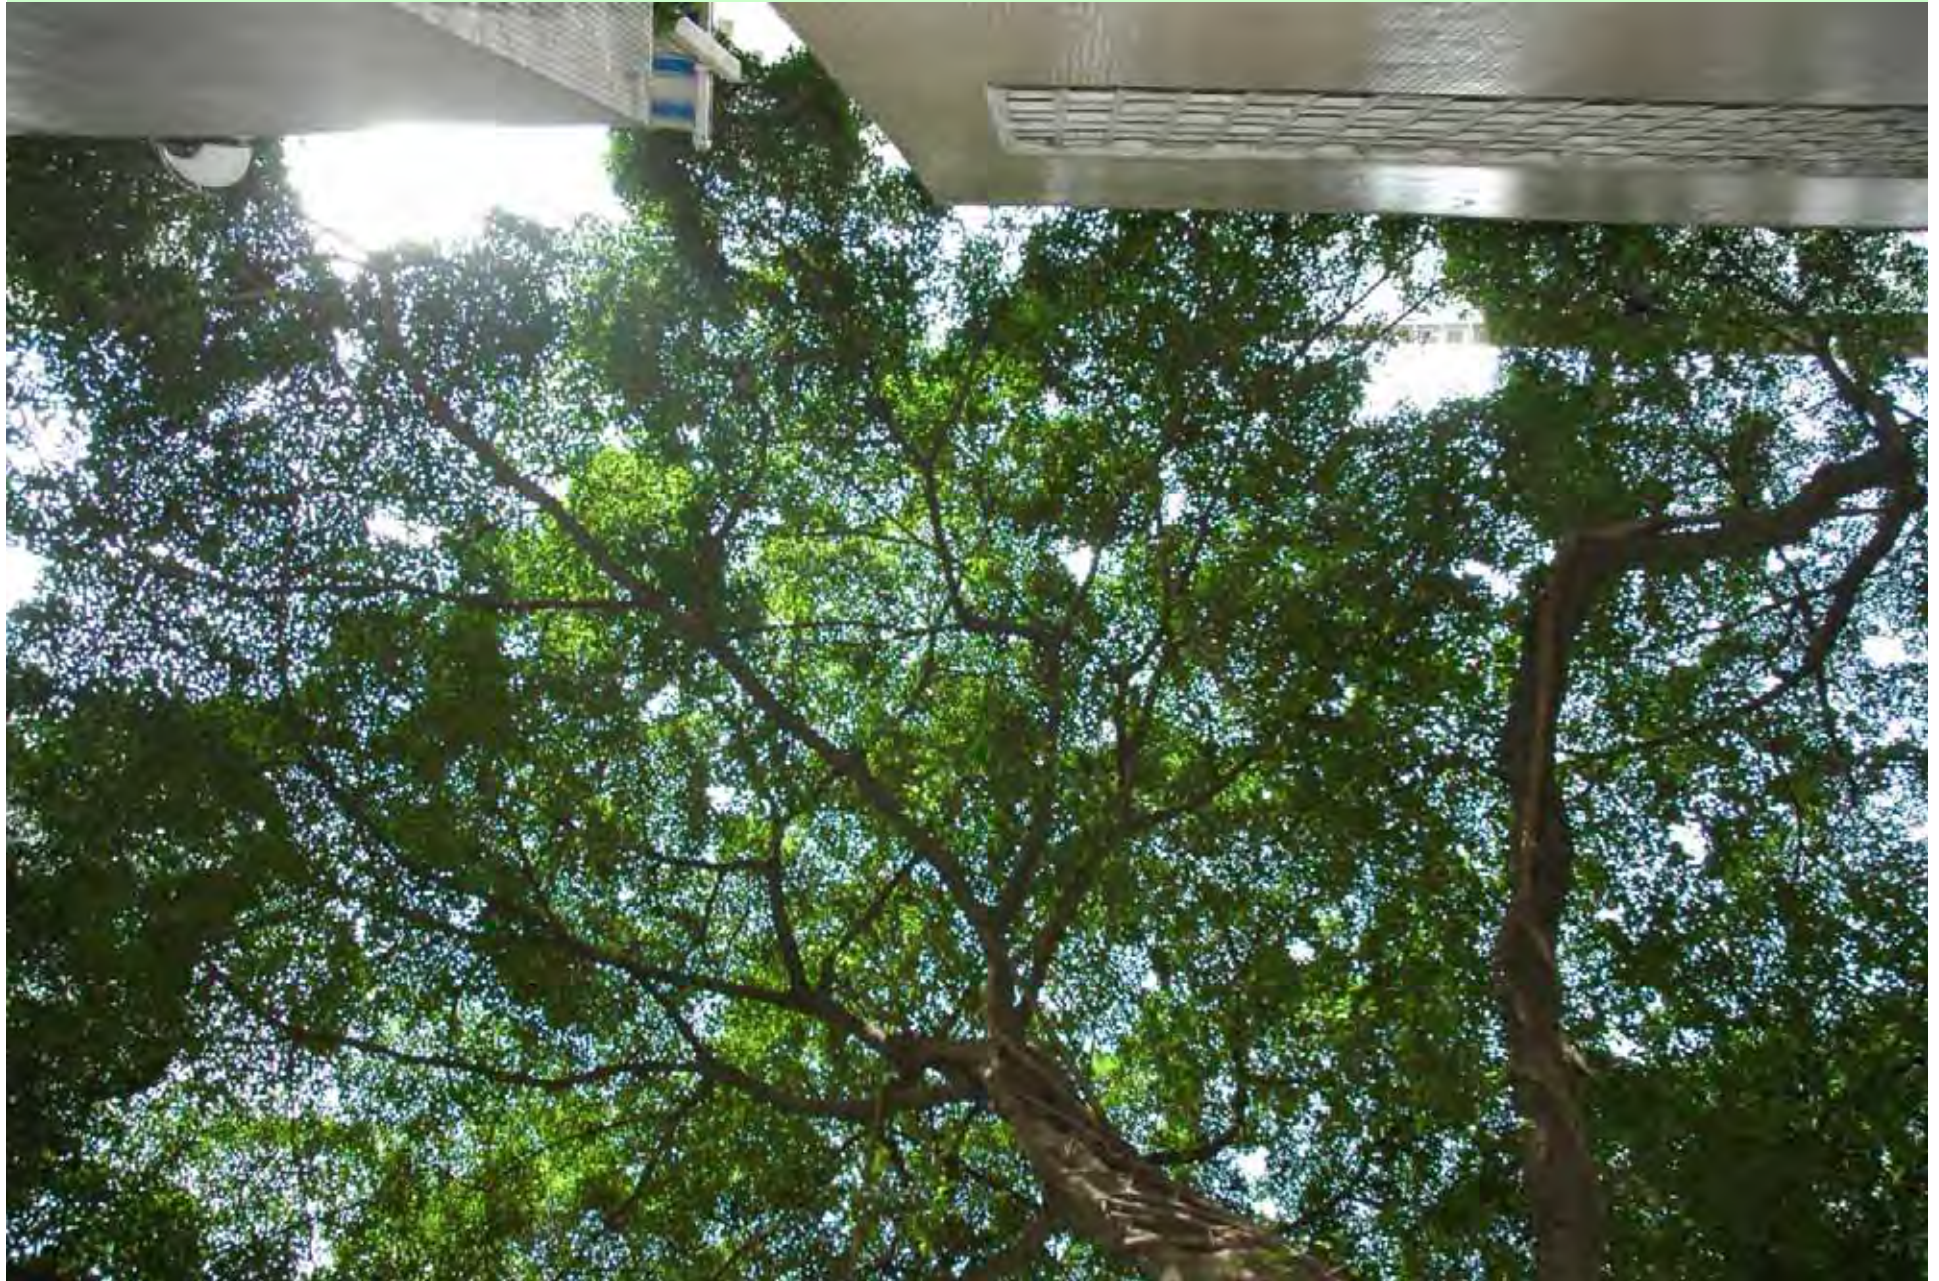
Photo T2-46. South part of the crown extending towards buildings at St Stephen's Lane.

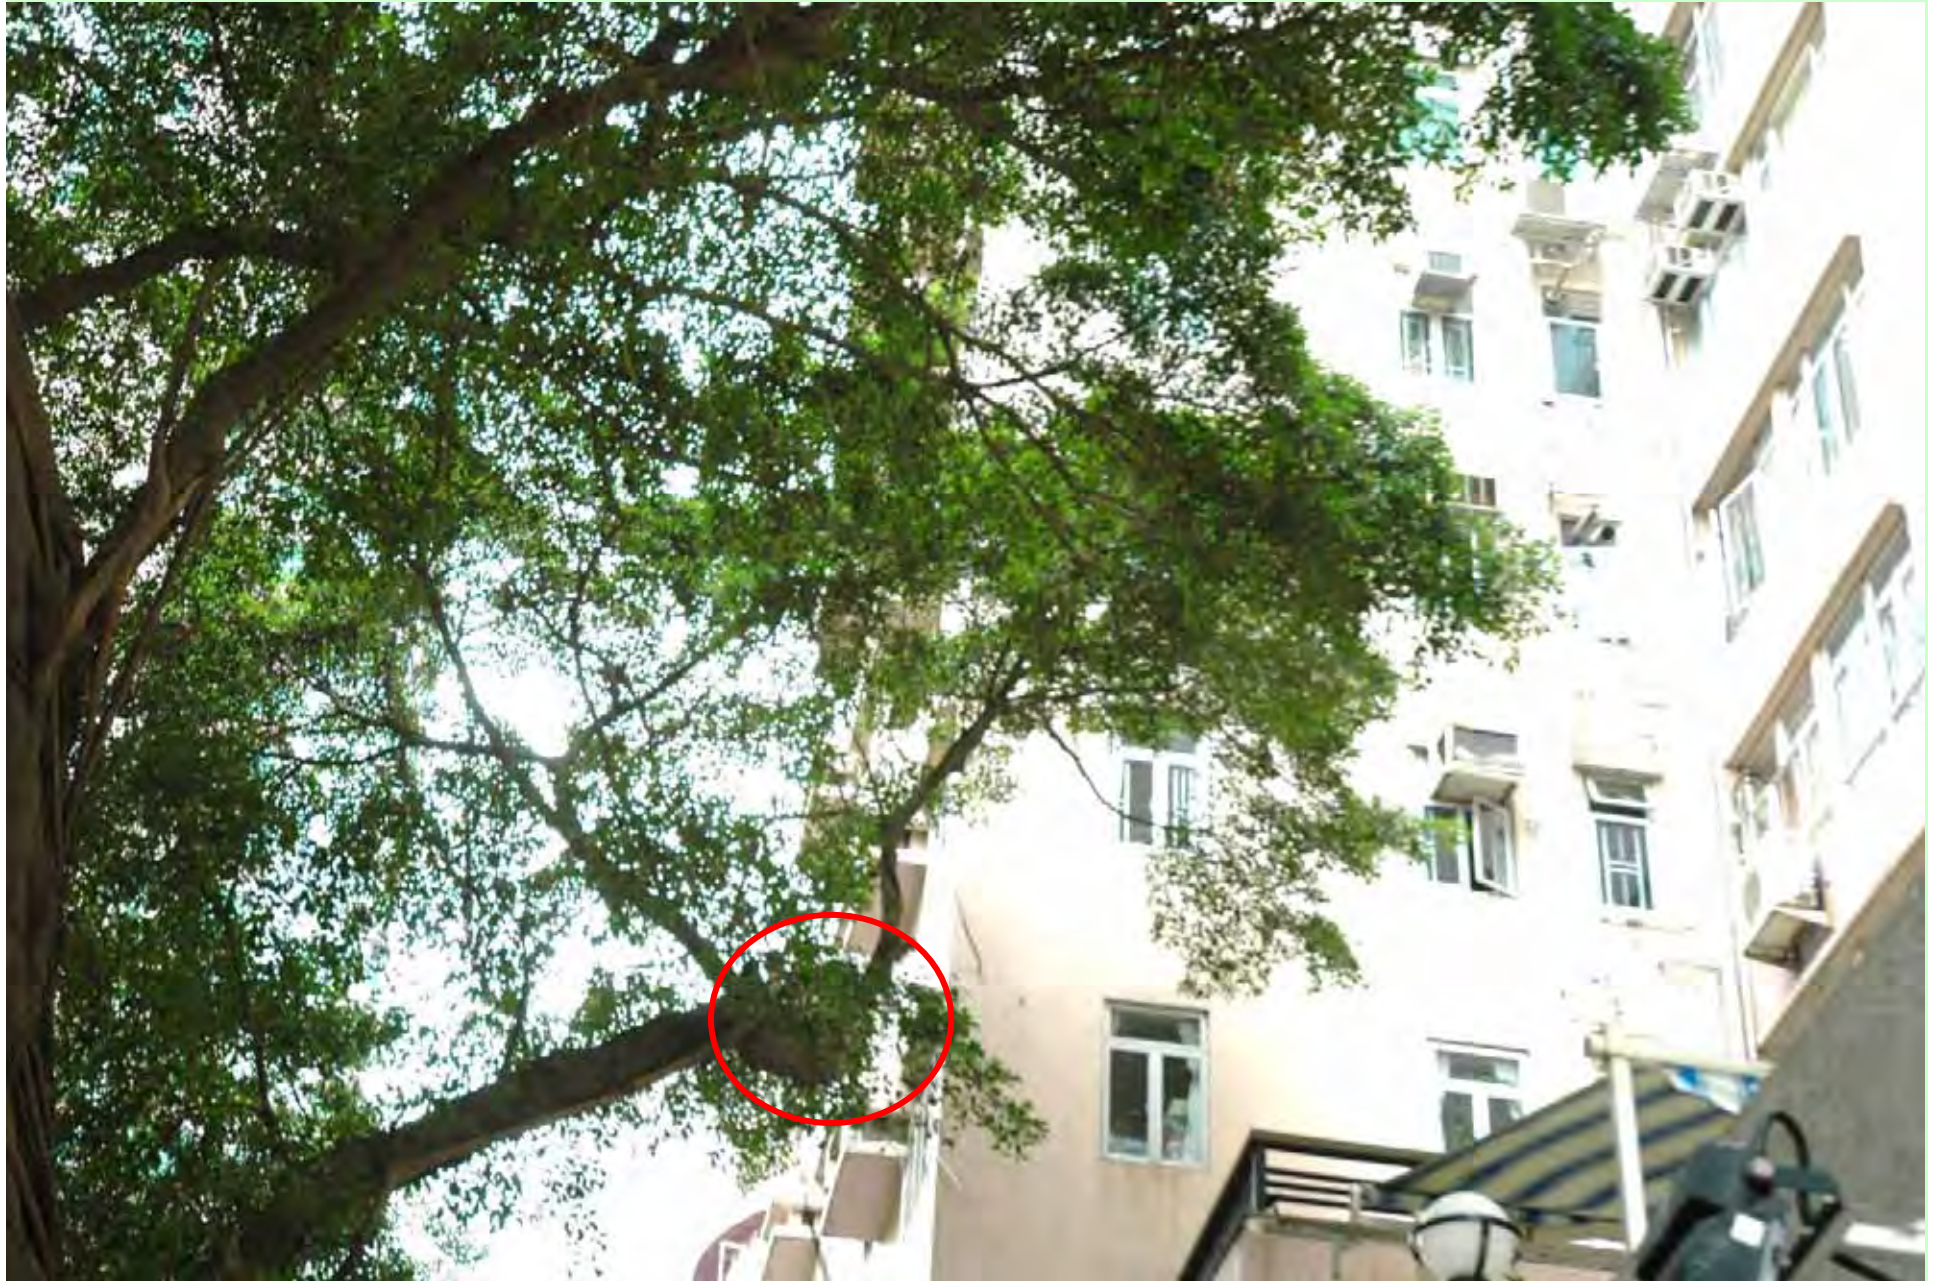
Photo T2-47. Branches above St Stephen's Lane near buildings have been tipped with sprouts emerging from the wounds.

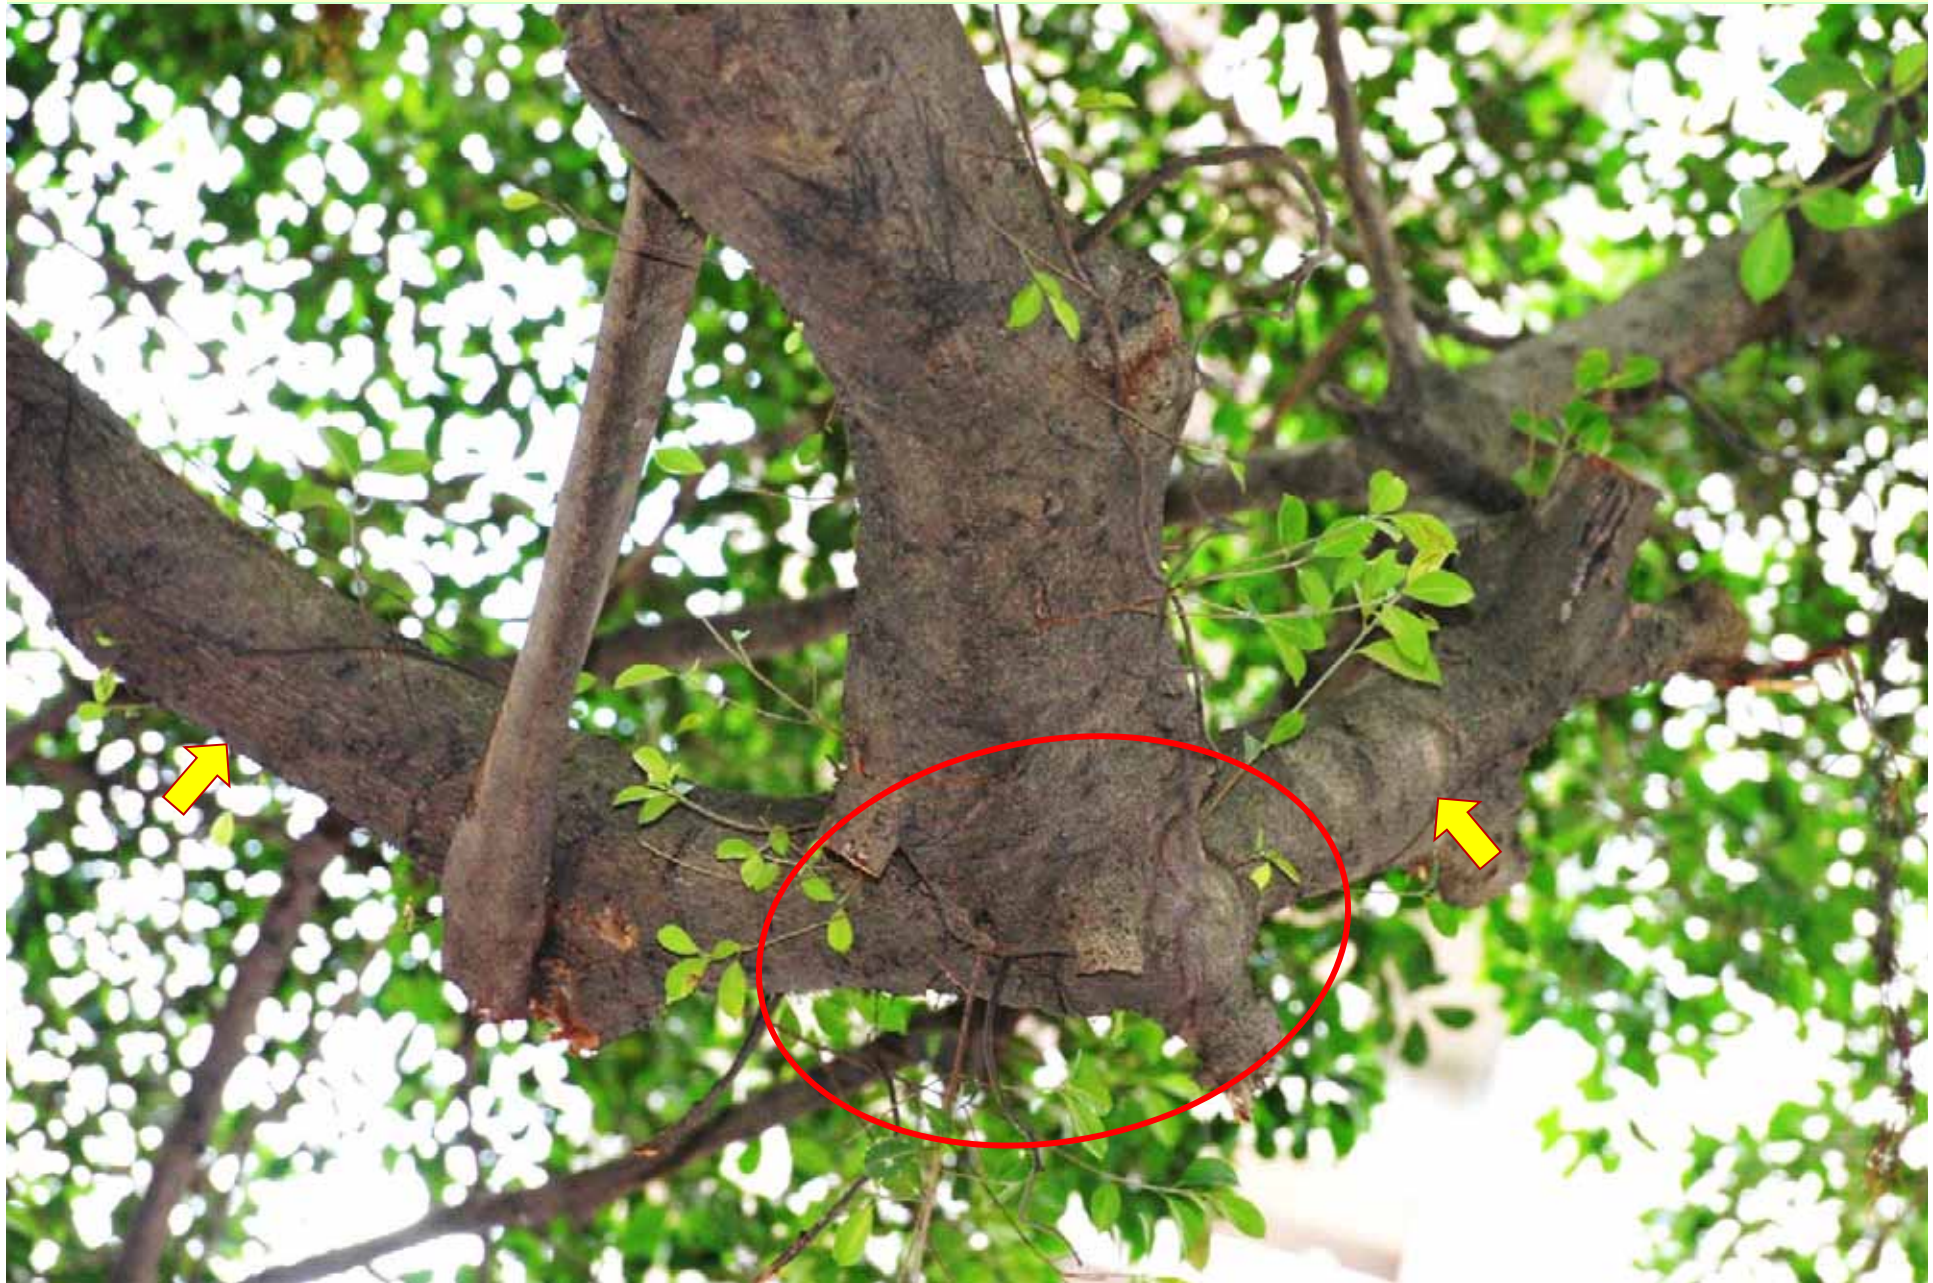
Photo T2-48. Stem A2 point south indicating truncated branch (circle) with thickened epicormic branches (arrow).

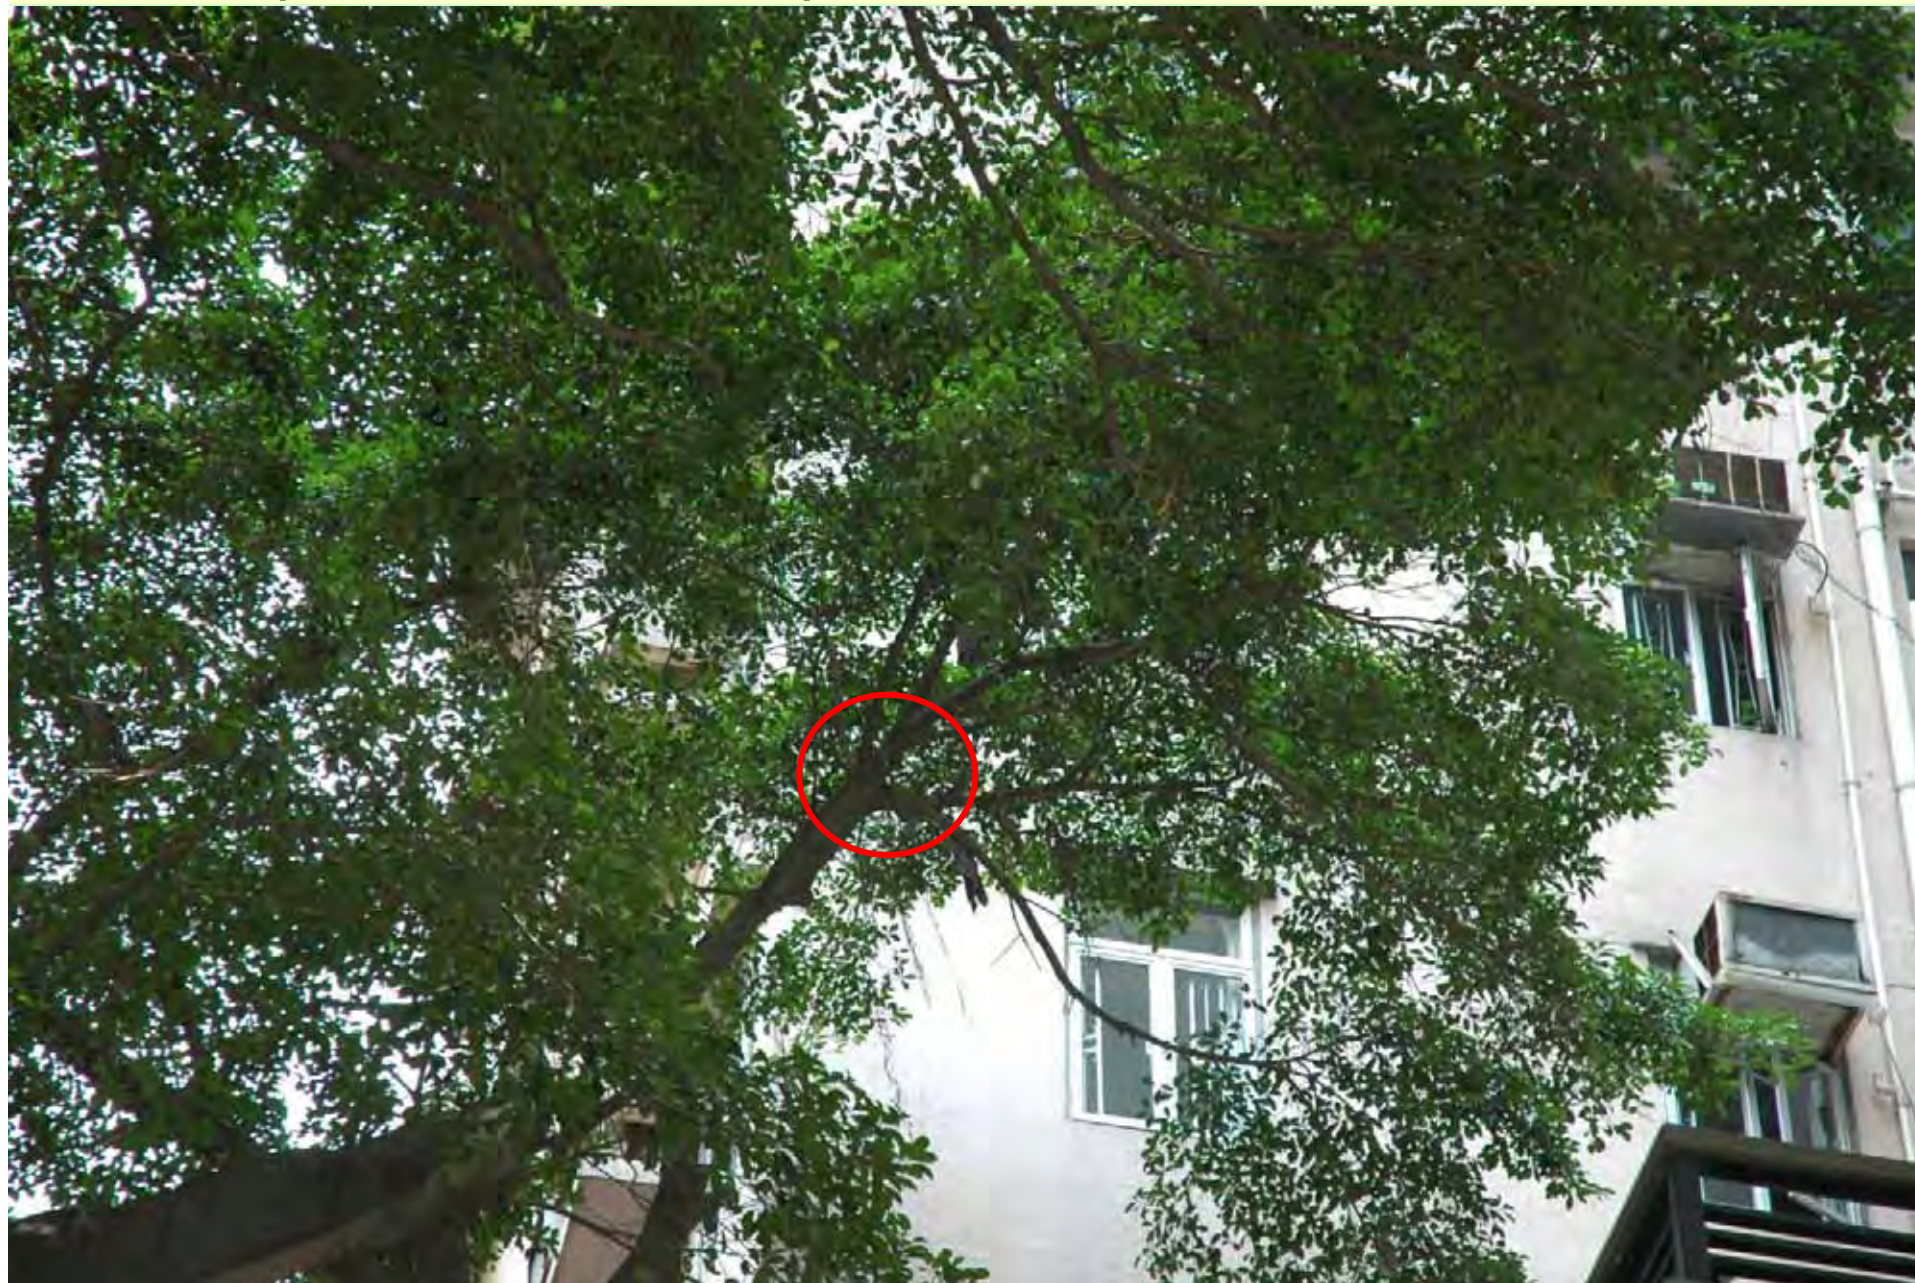
Photo T2-49. Tipped branch above St Stephen's Lane with multiple and crowded epicormic branches from the wound.

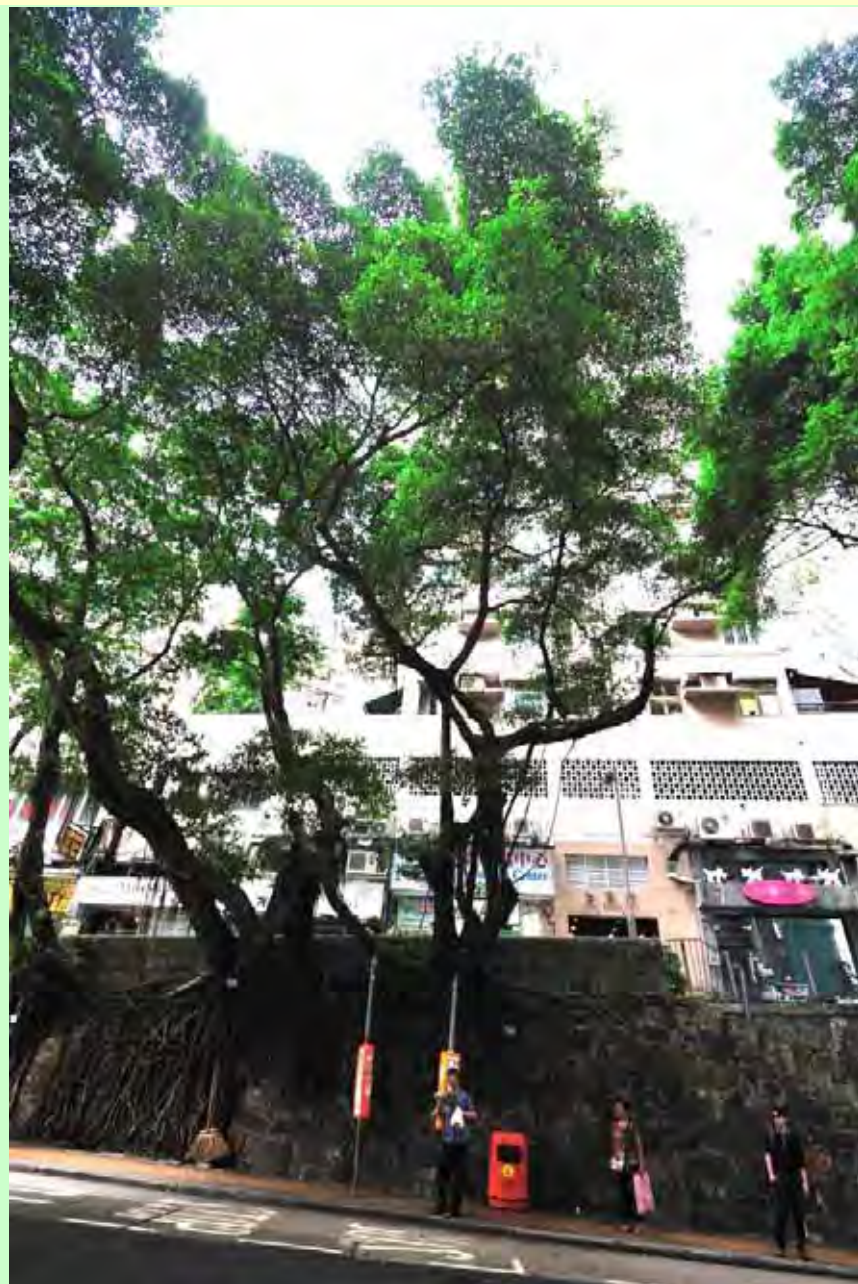
Photo T3-2. Tree scaffold and crown viewed from the north at Bonham Road.

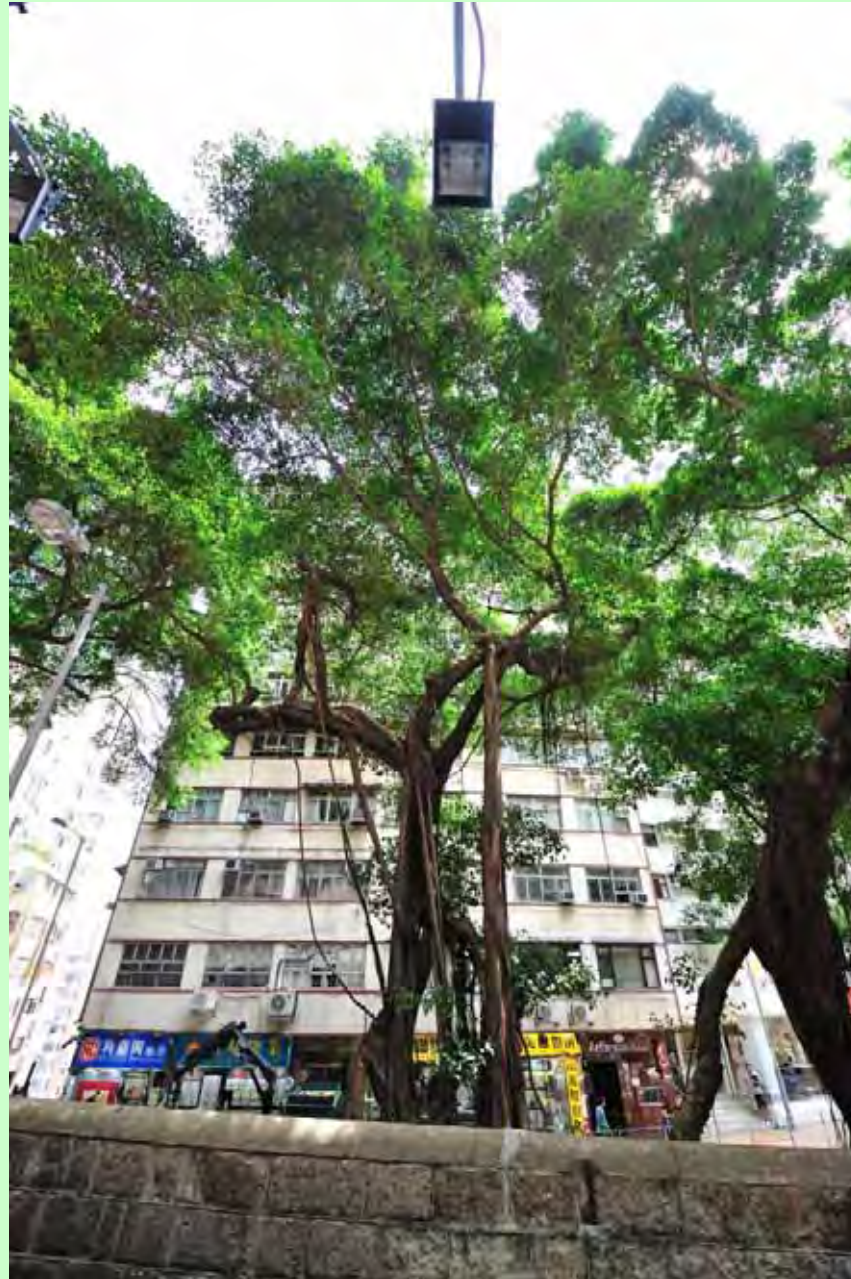
Photo T3-4. Tree scaffold and crown viewed from the south at St Stephen's Lane.

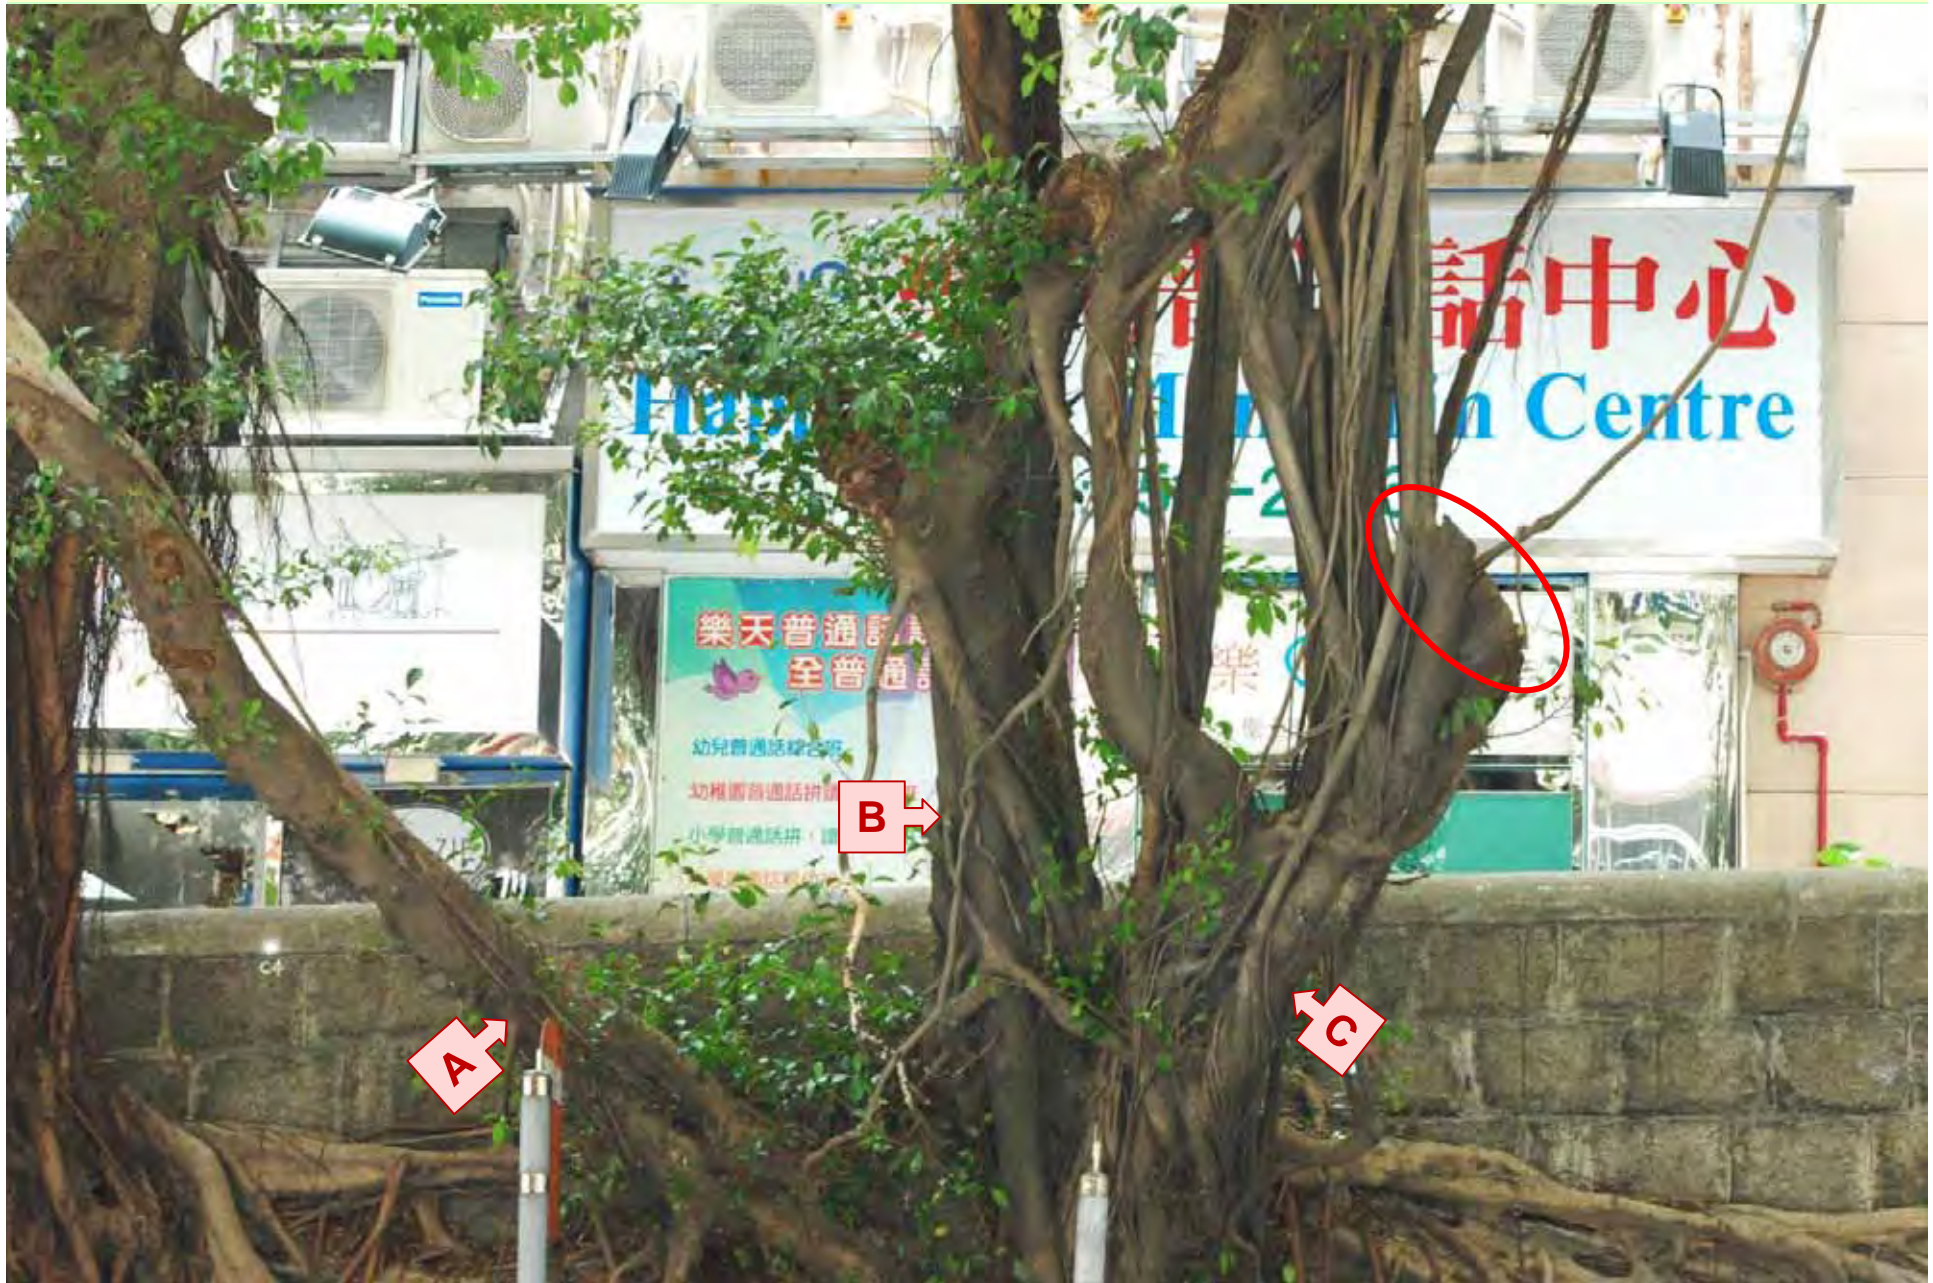
Photo T3-5. Three trunks of the tree, with stem C truncated (oval) and connected to stem B via a cluster of lignified aerial roots.
