Assessment of Wall Trees on Slope 11SW-A/R577 at Bonham Road

**Highways Department
HKSAR Government**

**C.Y. Jim
The University of Hong Kong
hrajcy@hku.hk**

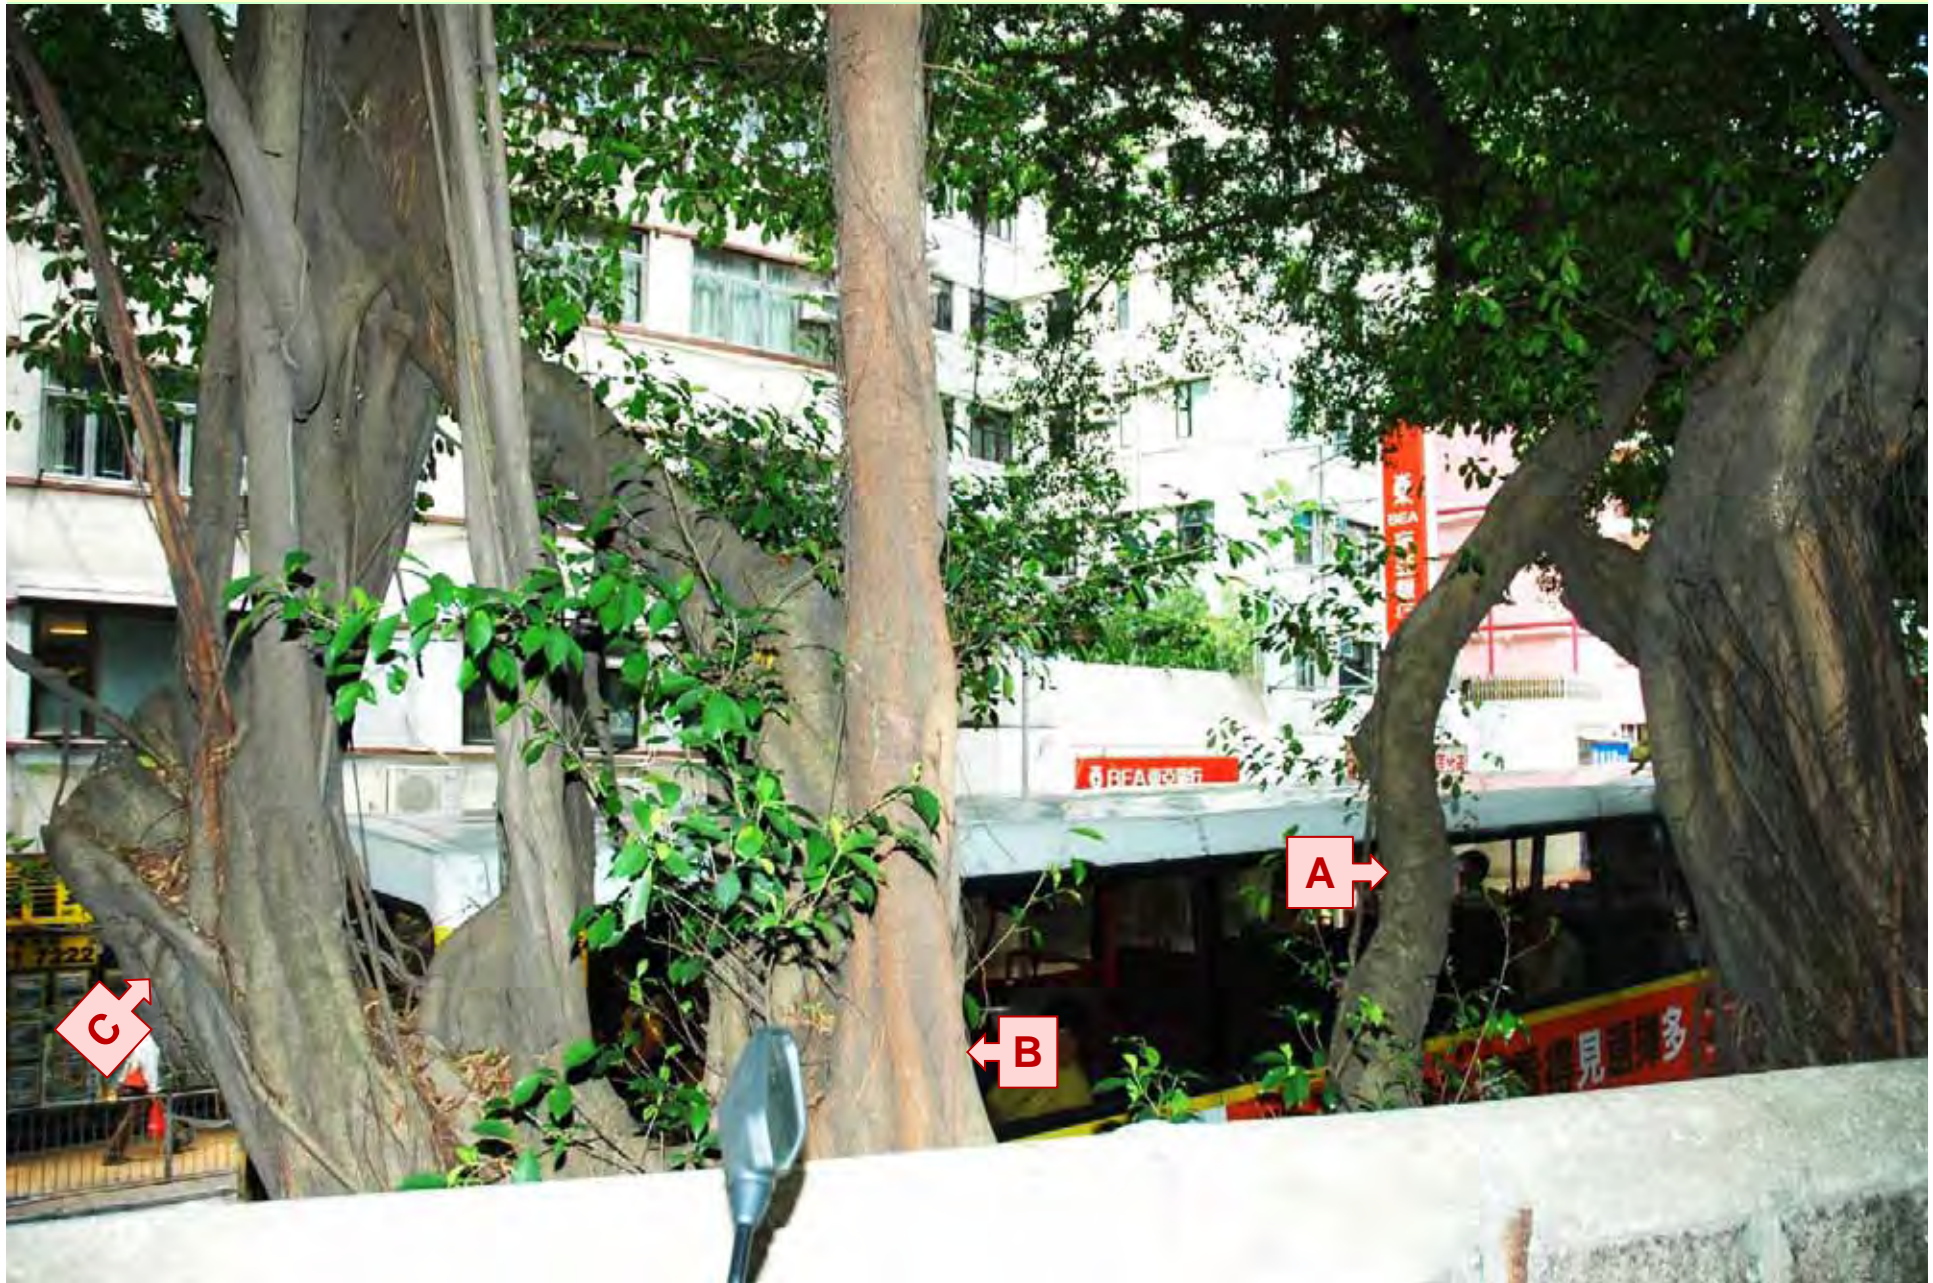
Photo T3-6. Three trunks of the tree viewed from the south at St Stephen's Lane.

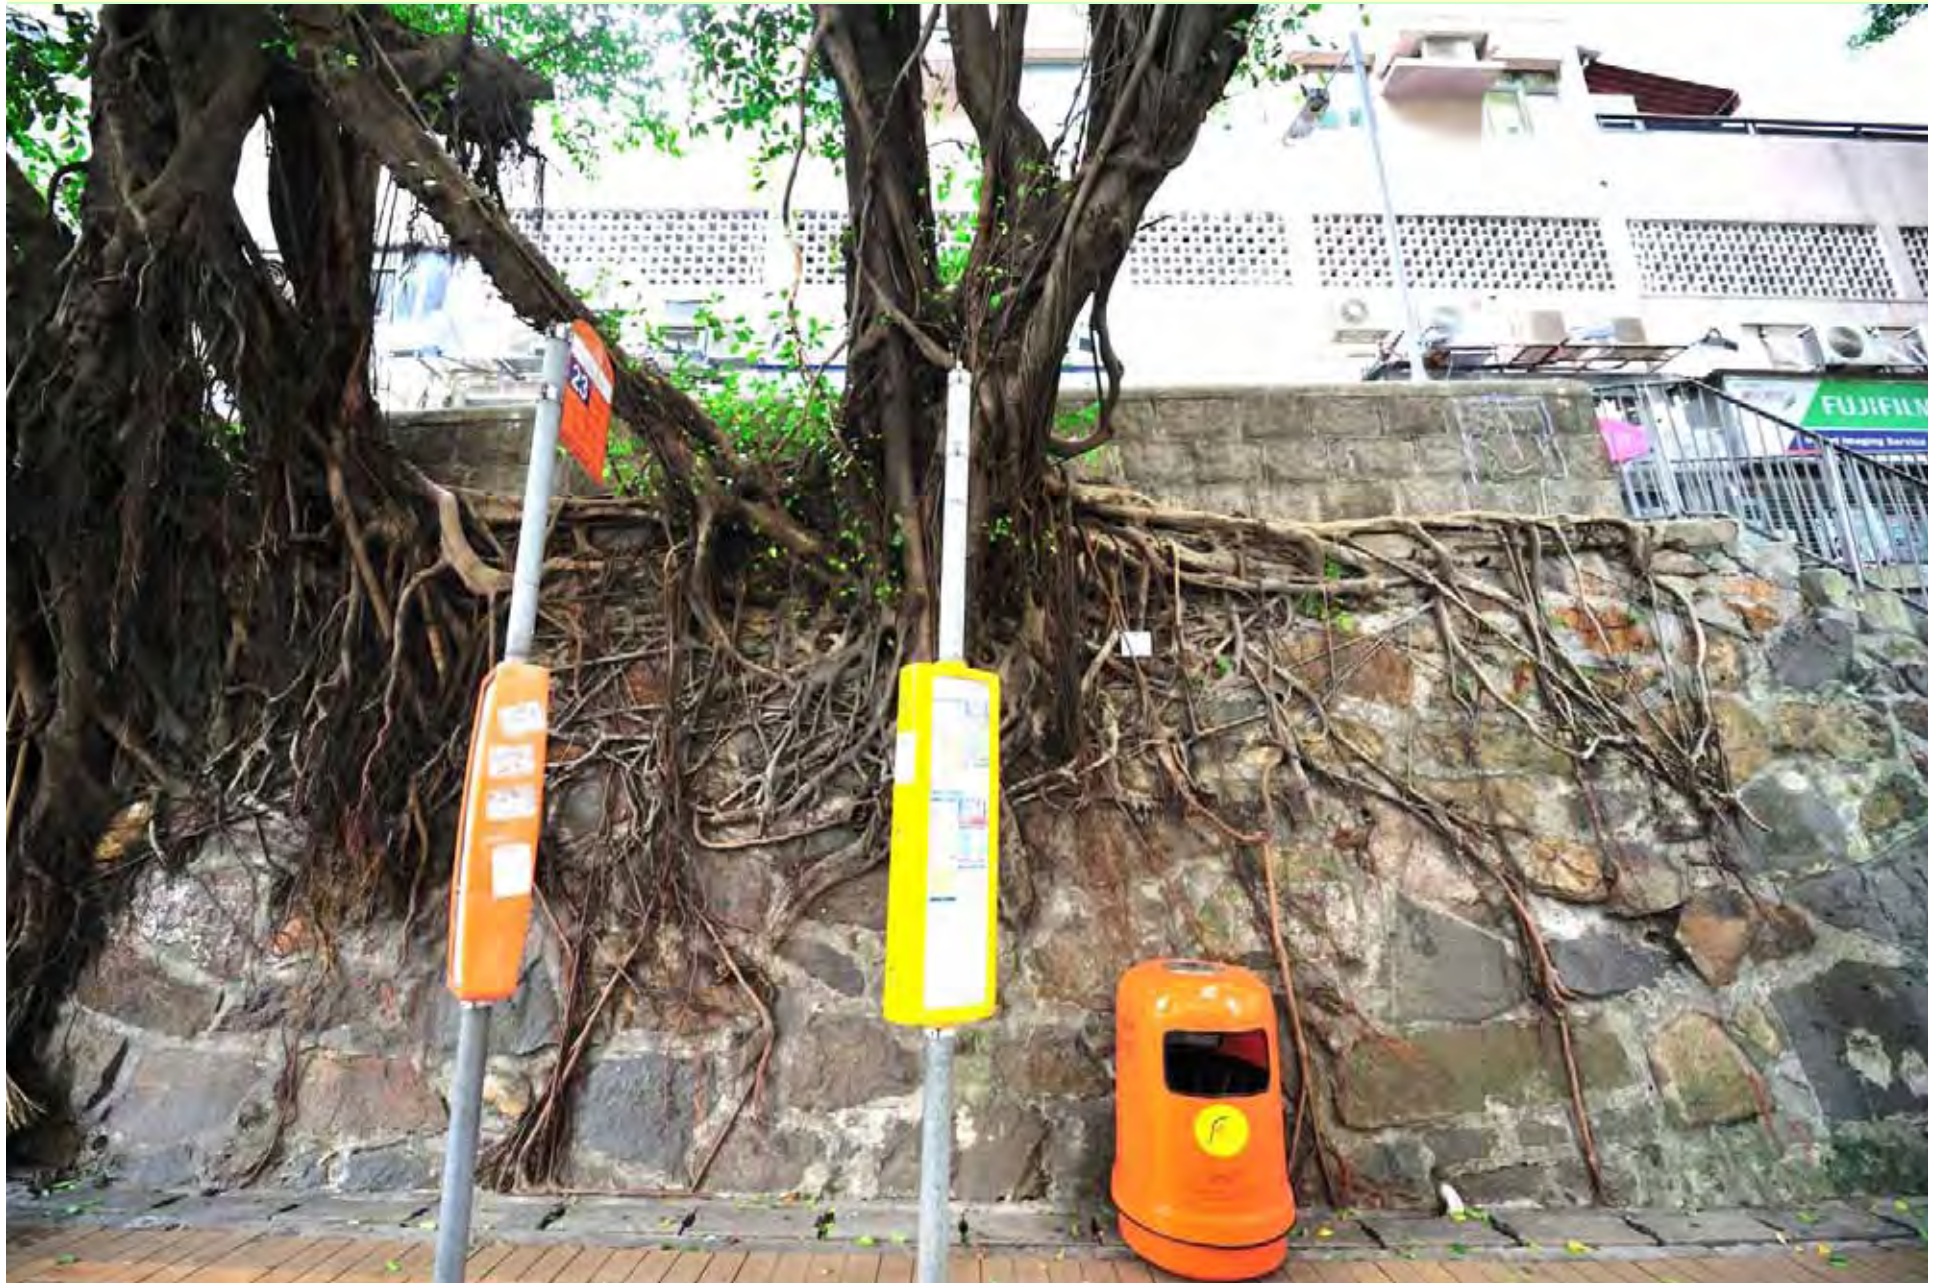
Photo T3-7. Limited spread of surface roots, cement filling of wall joints, and restriction to root penetration at wall toe.

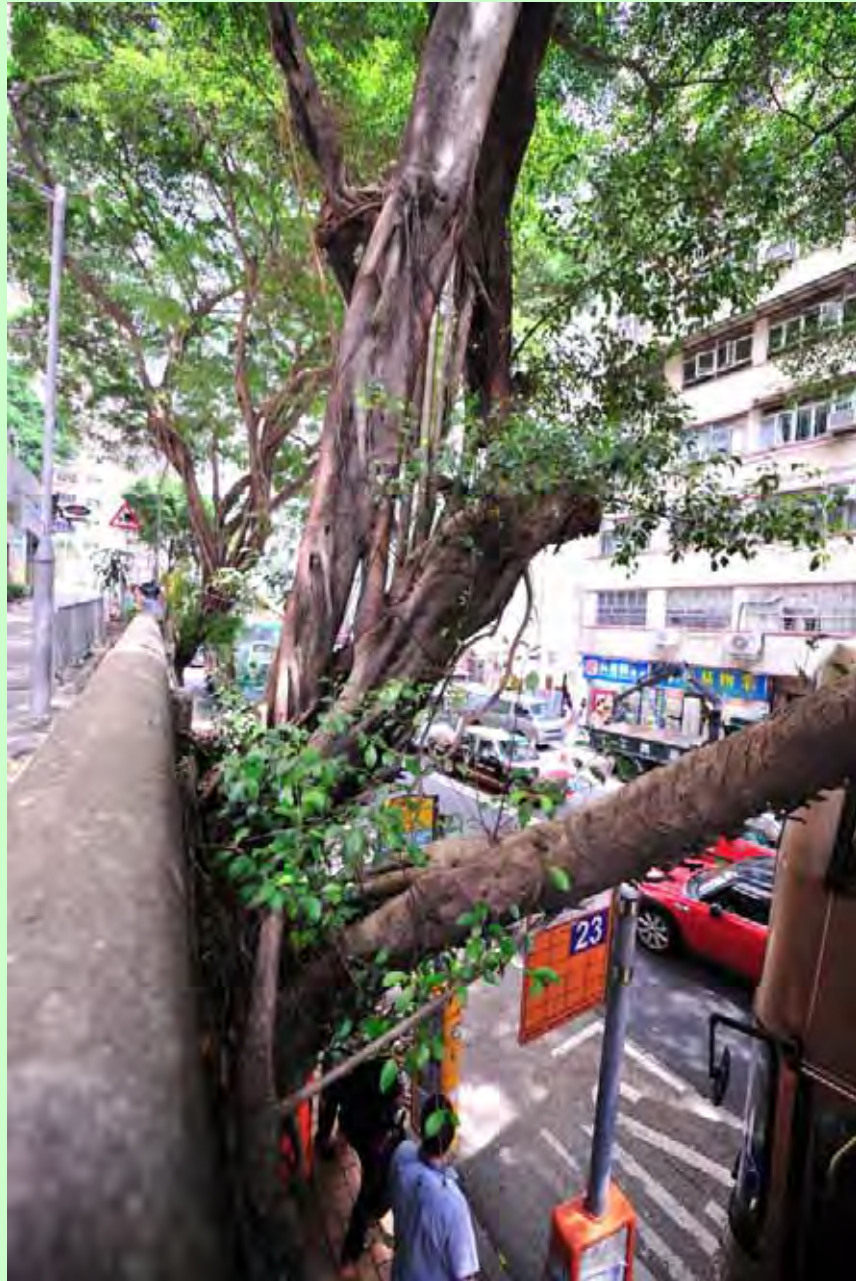
Photo T3-8. Relationship between tree and wall crest, viewed from the east.

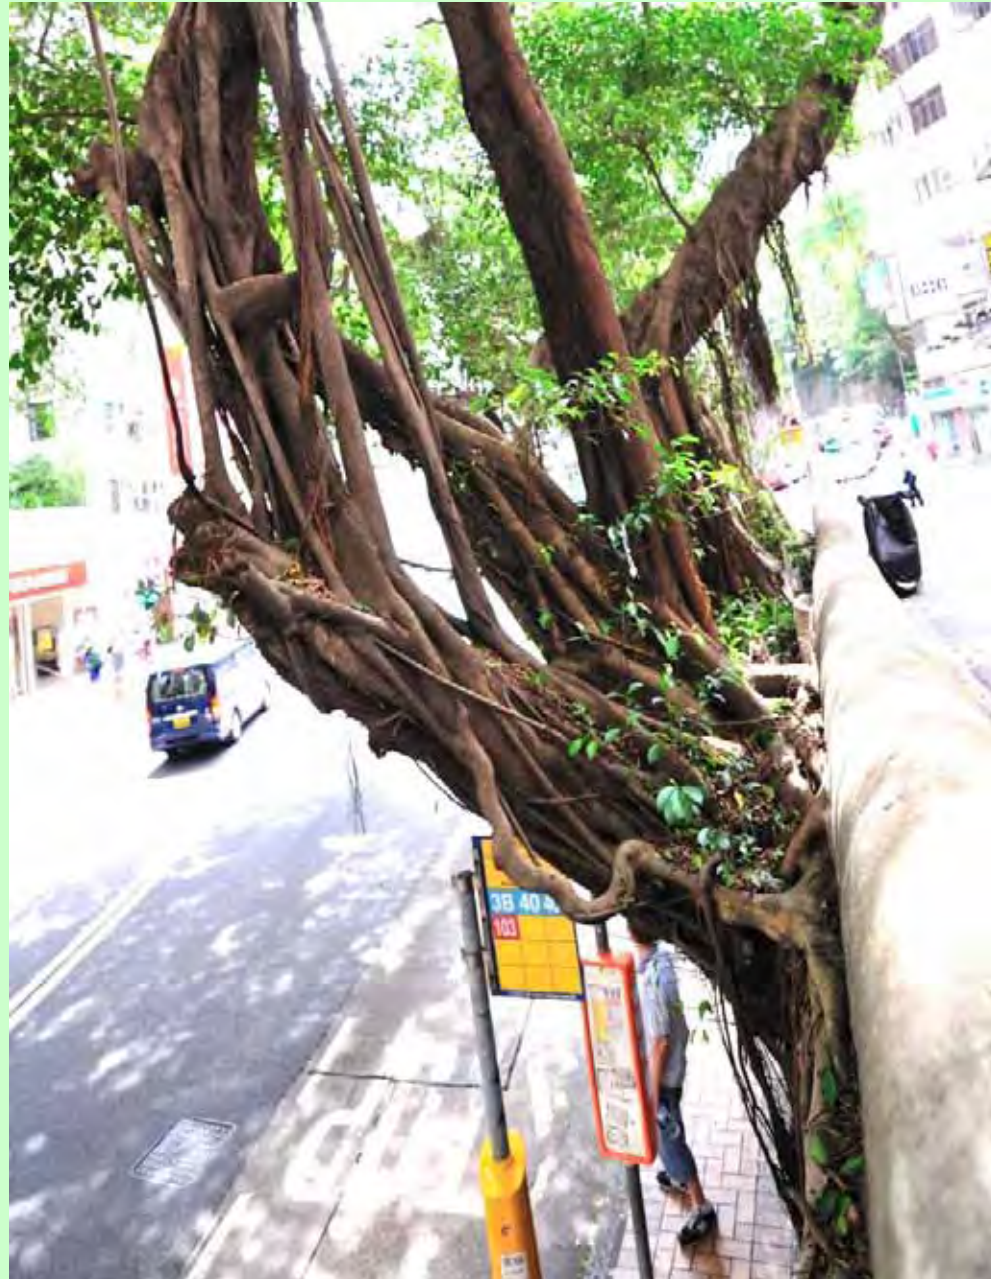
Photo T3-9. Relationship between tree and wall crest, viewed from the west.

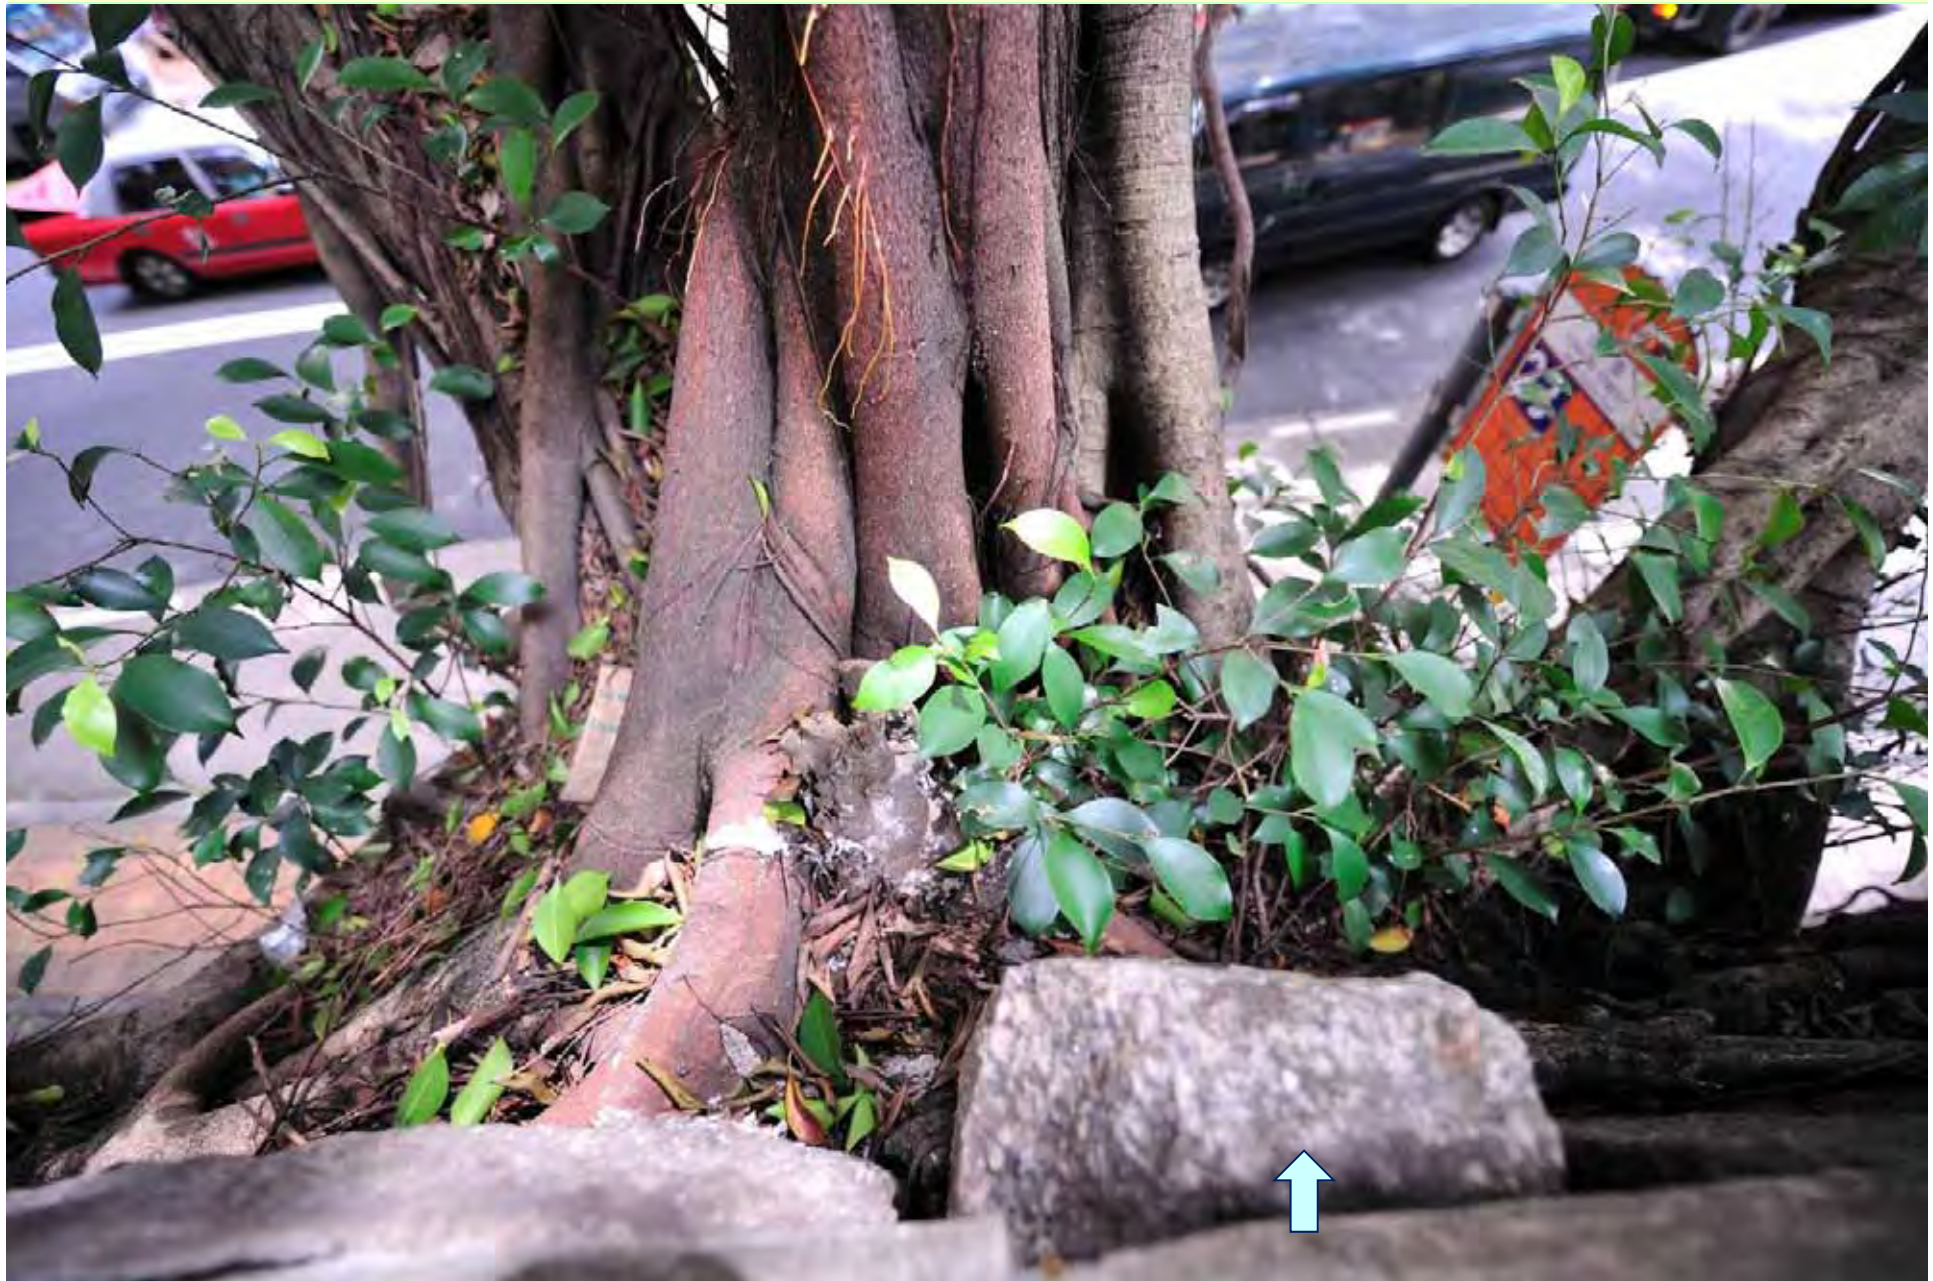
Photo T3-10. Relationship between tree and wall crest, viewed from the south. Shifted masonry block.

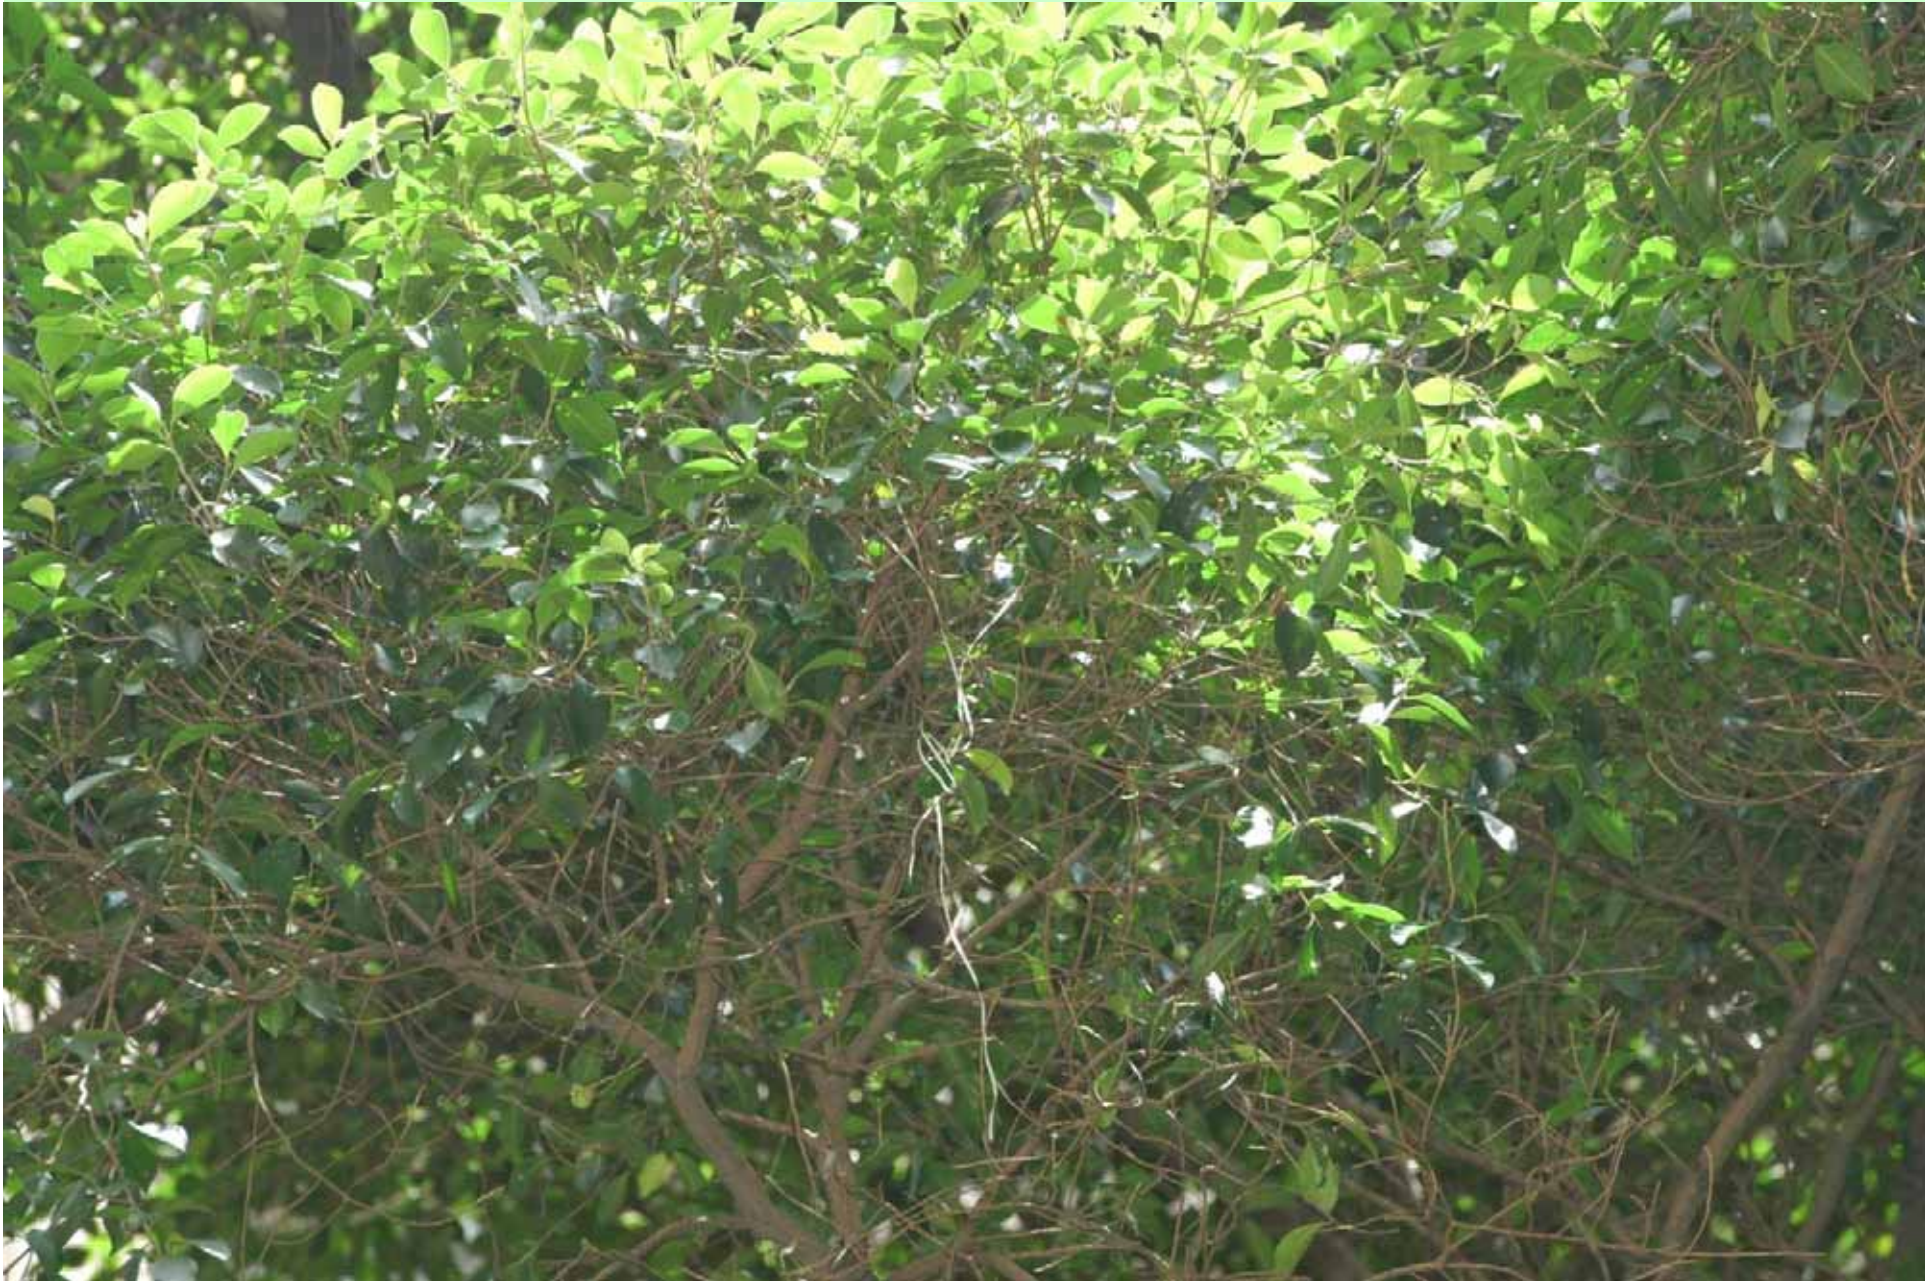
Photo T3-11. Dense and healthy foliage at the centre of the crown.

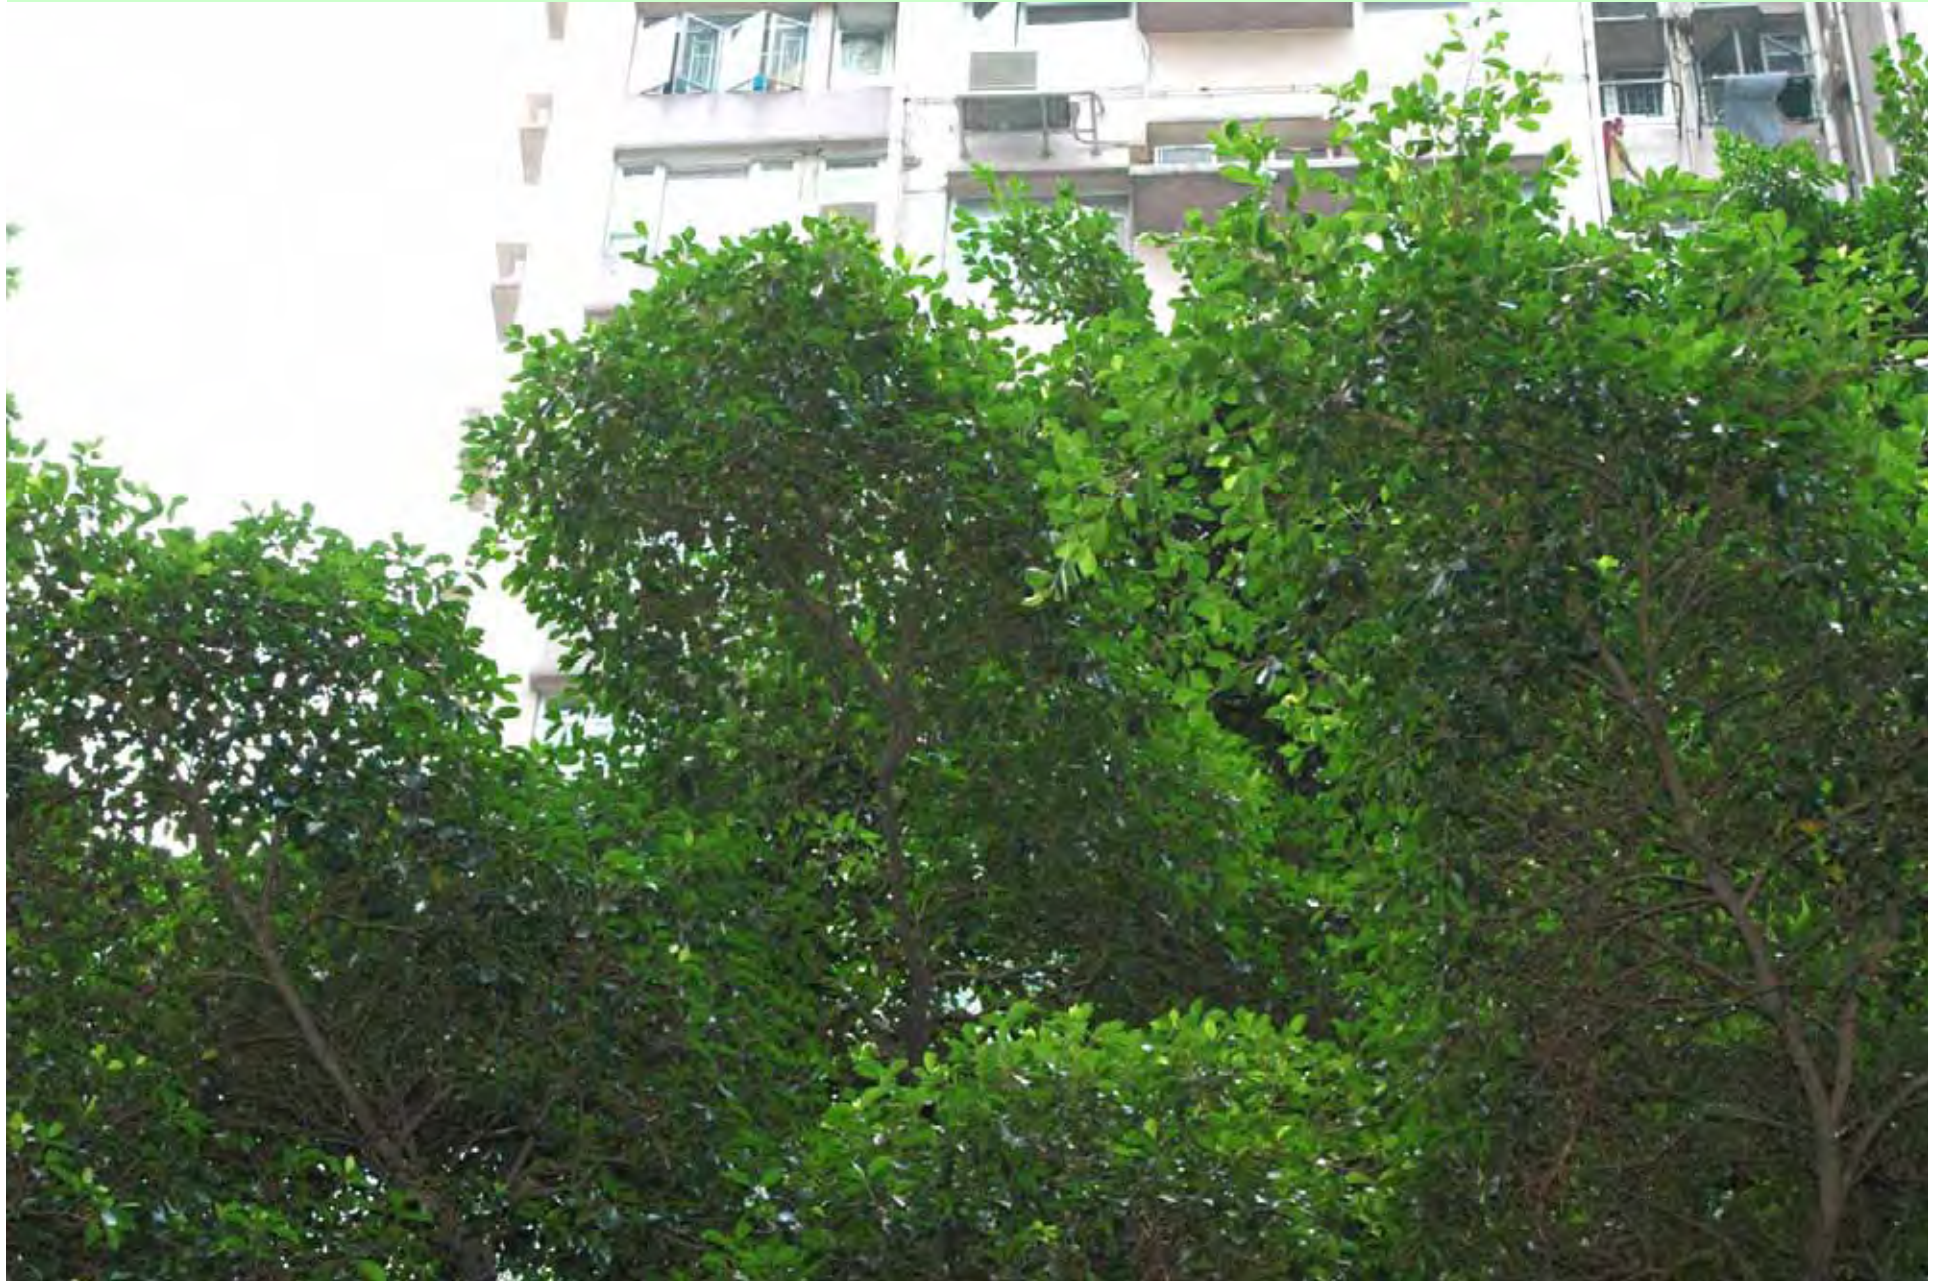
Photo T3-12. Dense and healthy foliage at the edge of the crown.

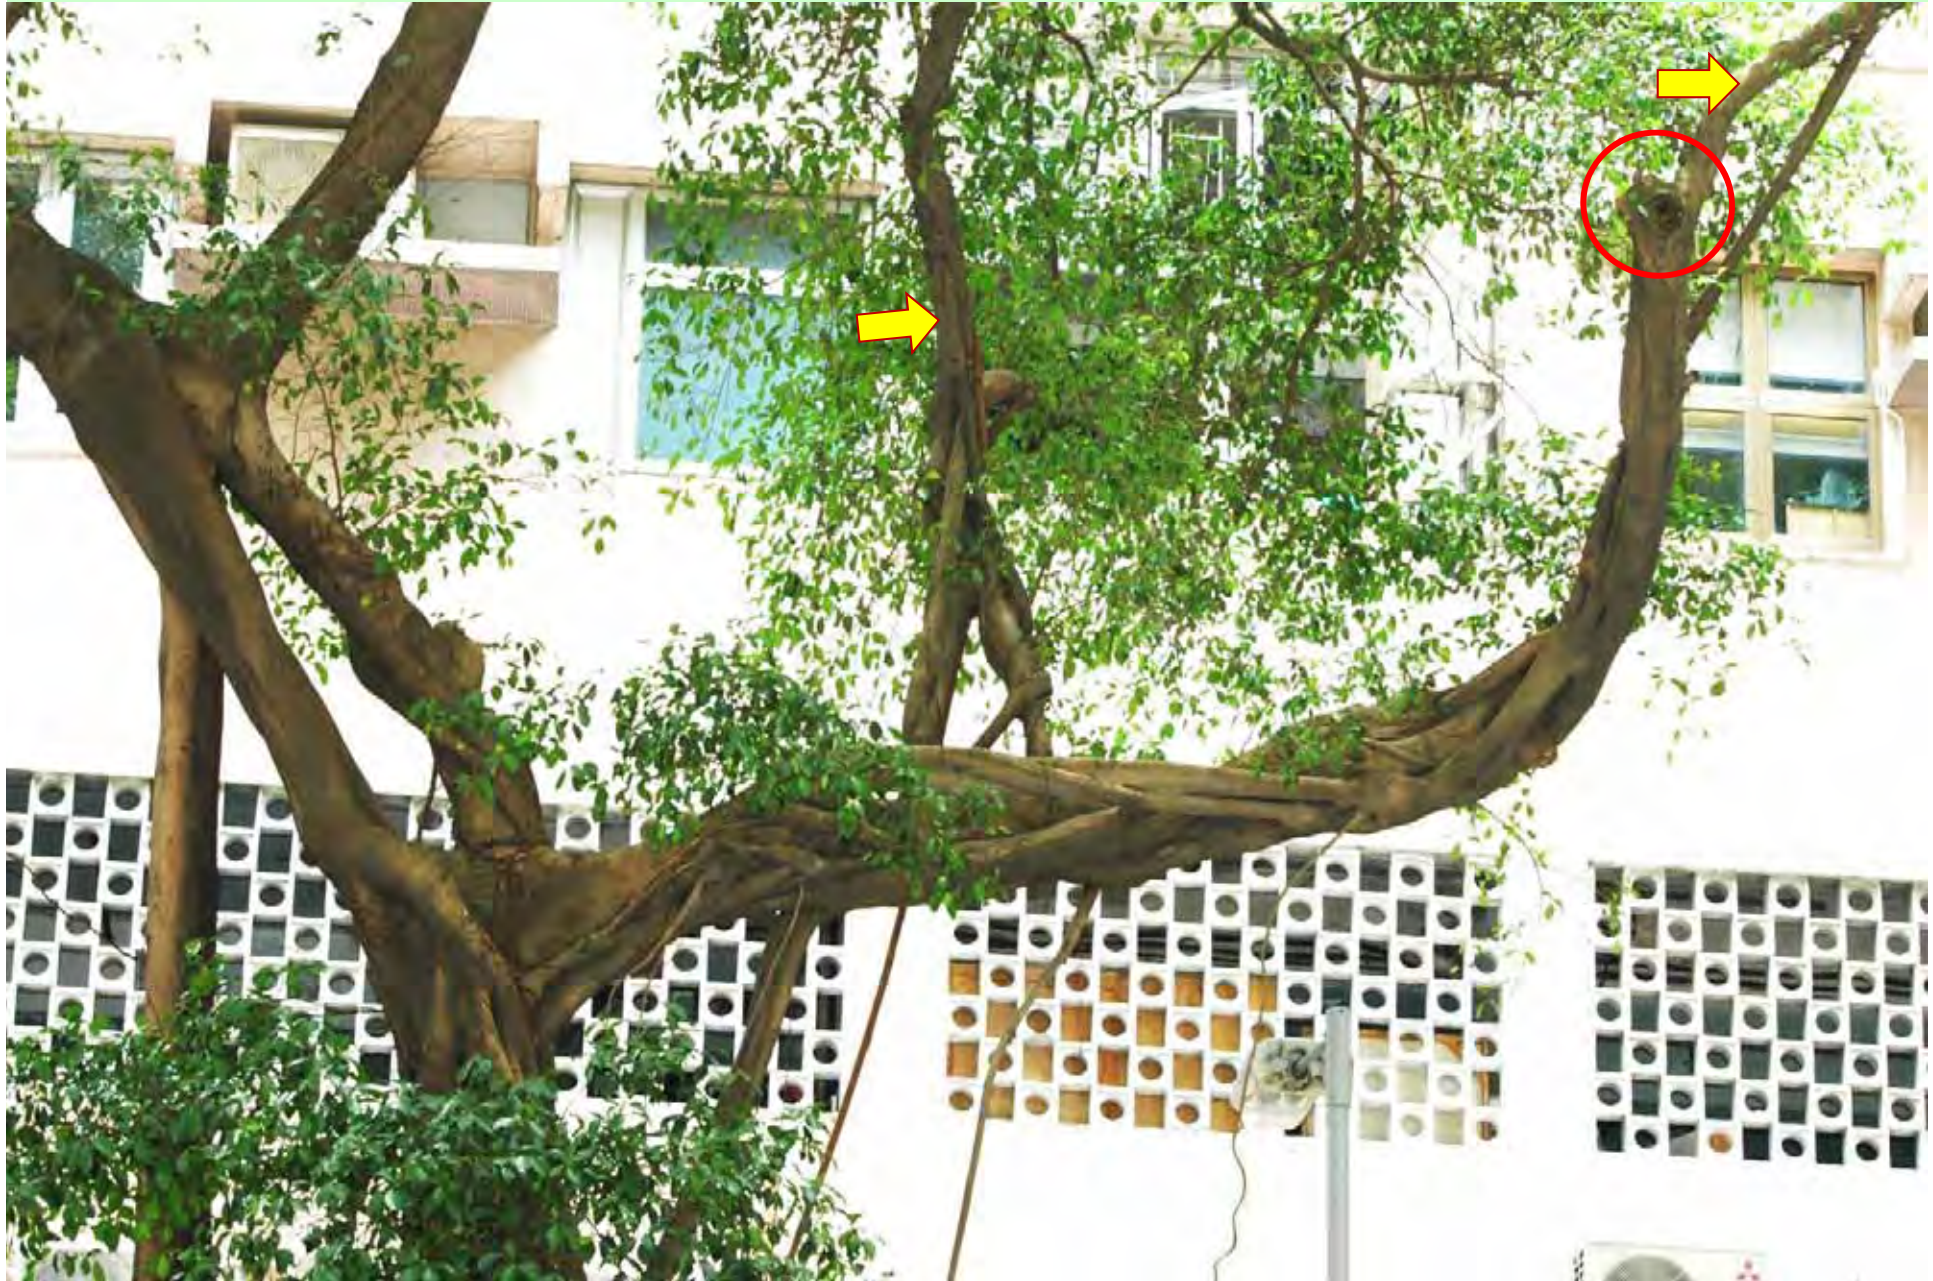
Photo T3-16. Low, upward-curving and truncated (circle) limb of stem B supports two long ascending epicormic branches (arrows).

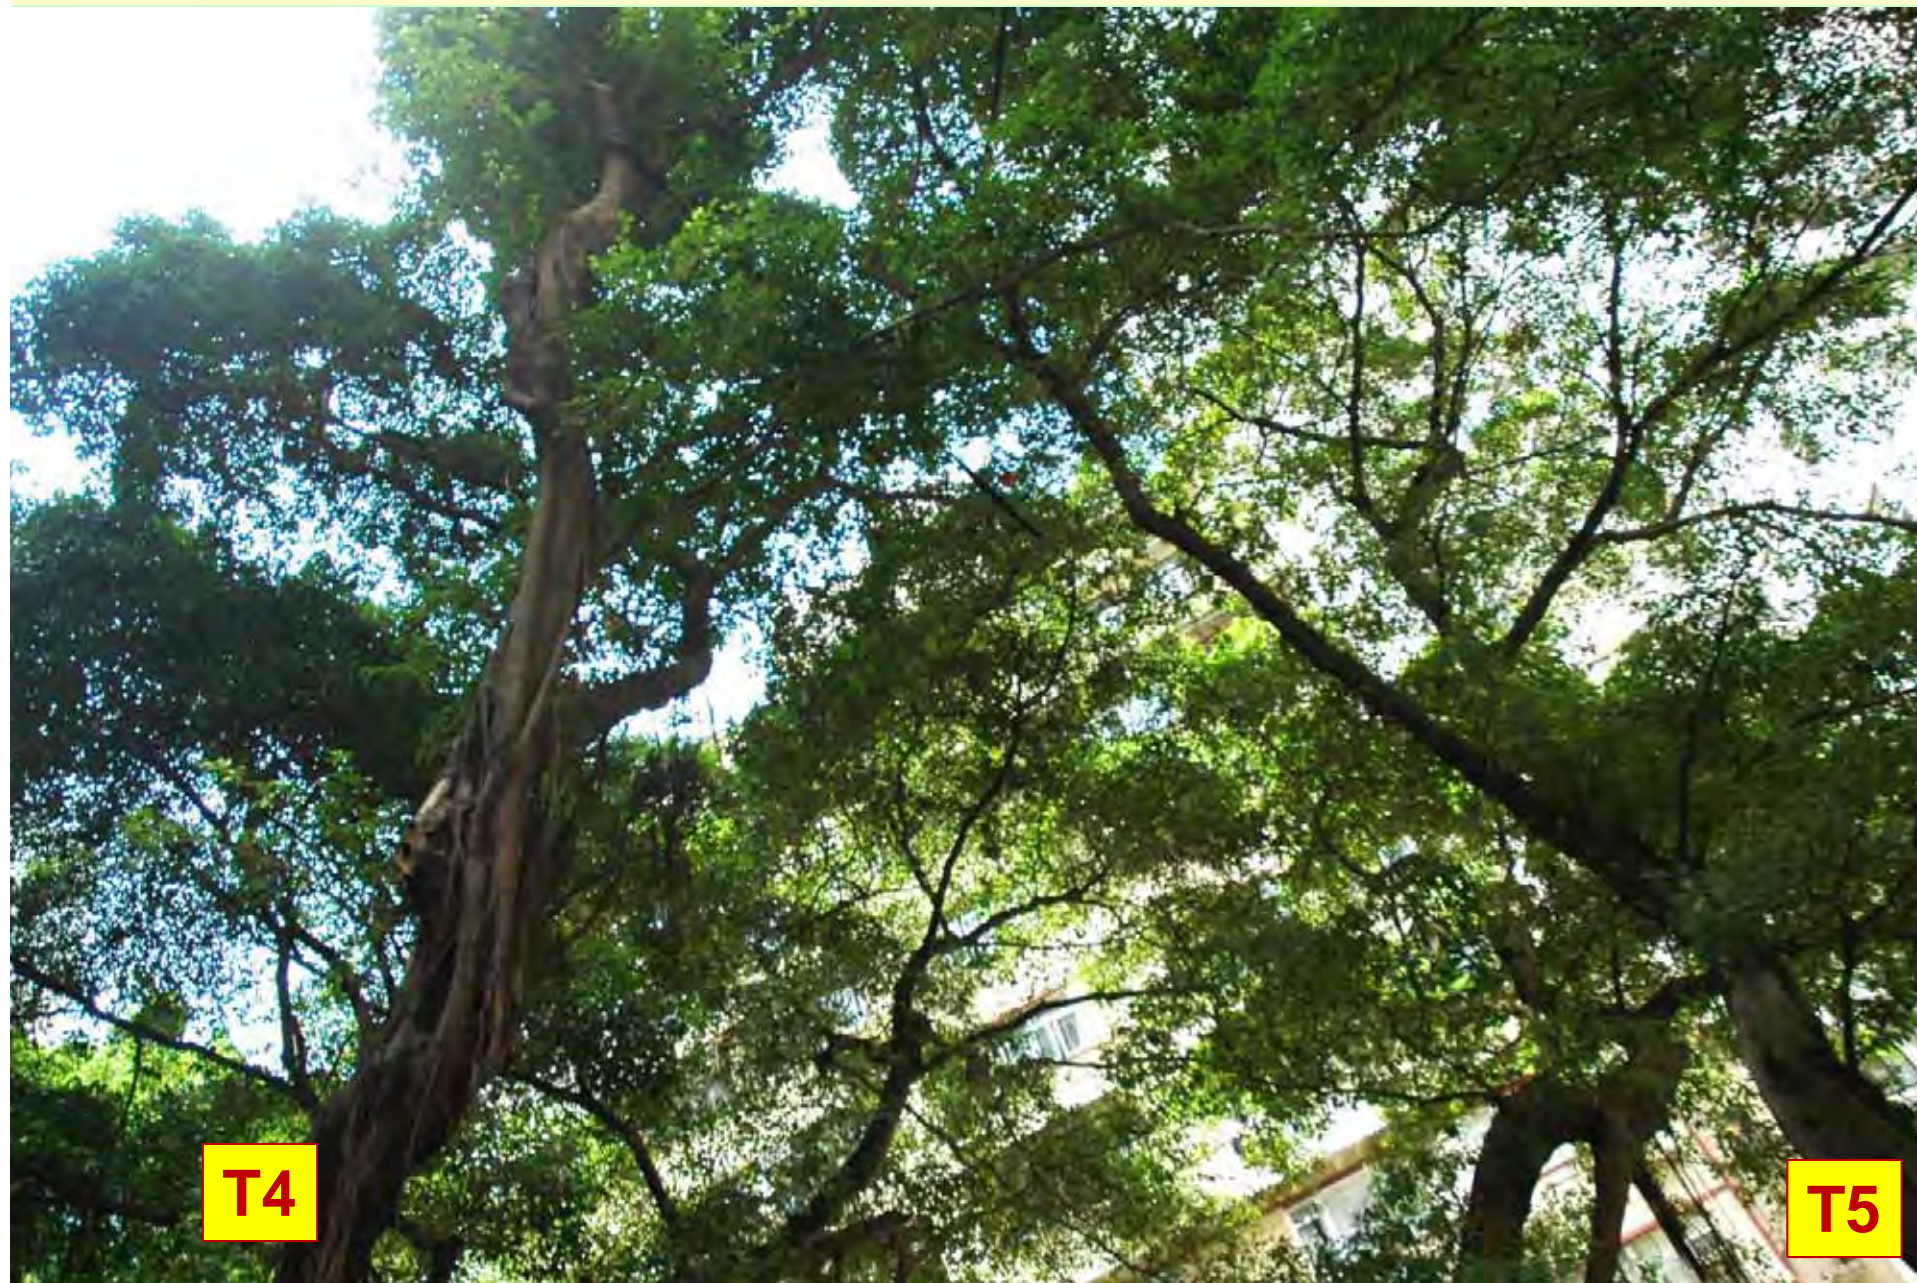
Photo T4-3. The crown has partly interlocked with its neighbour trees T5 and T3.

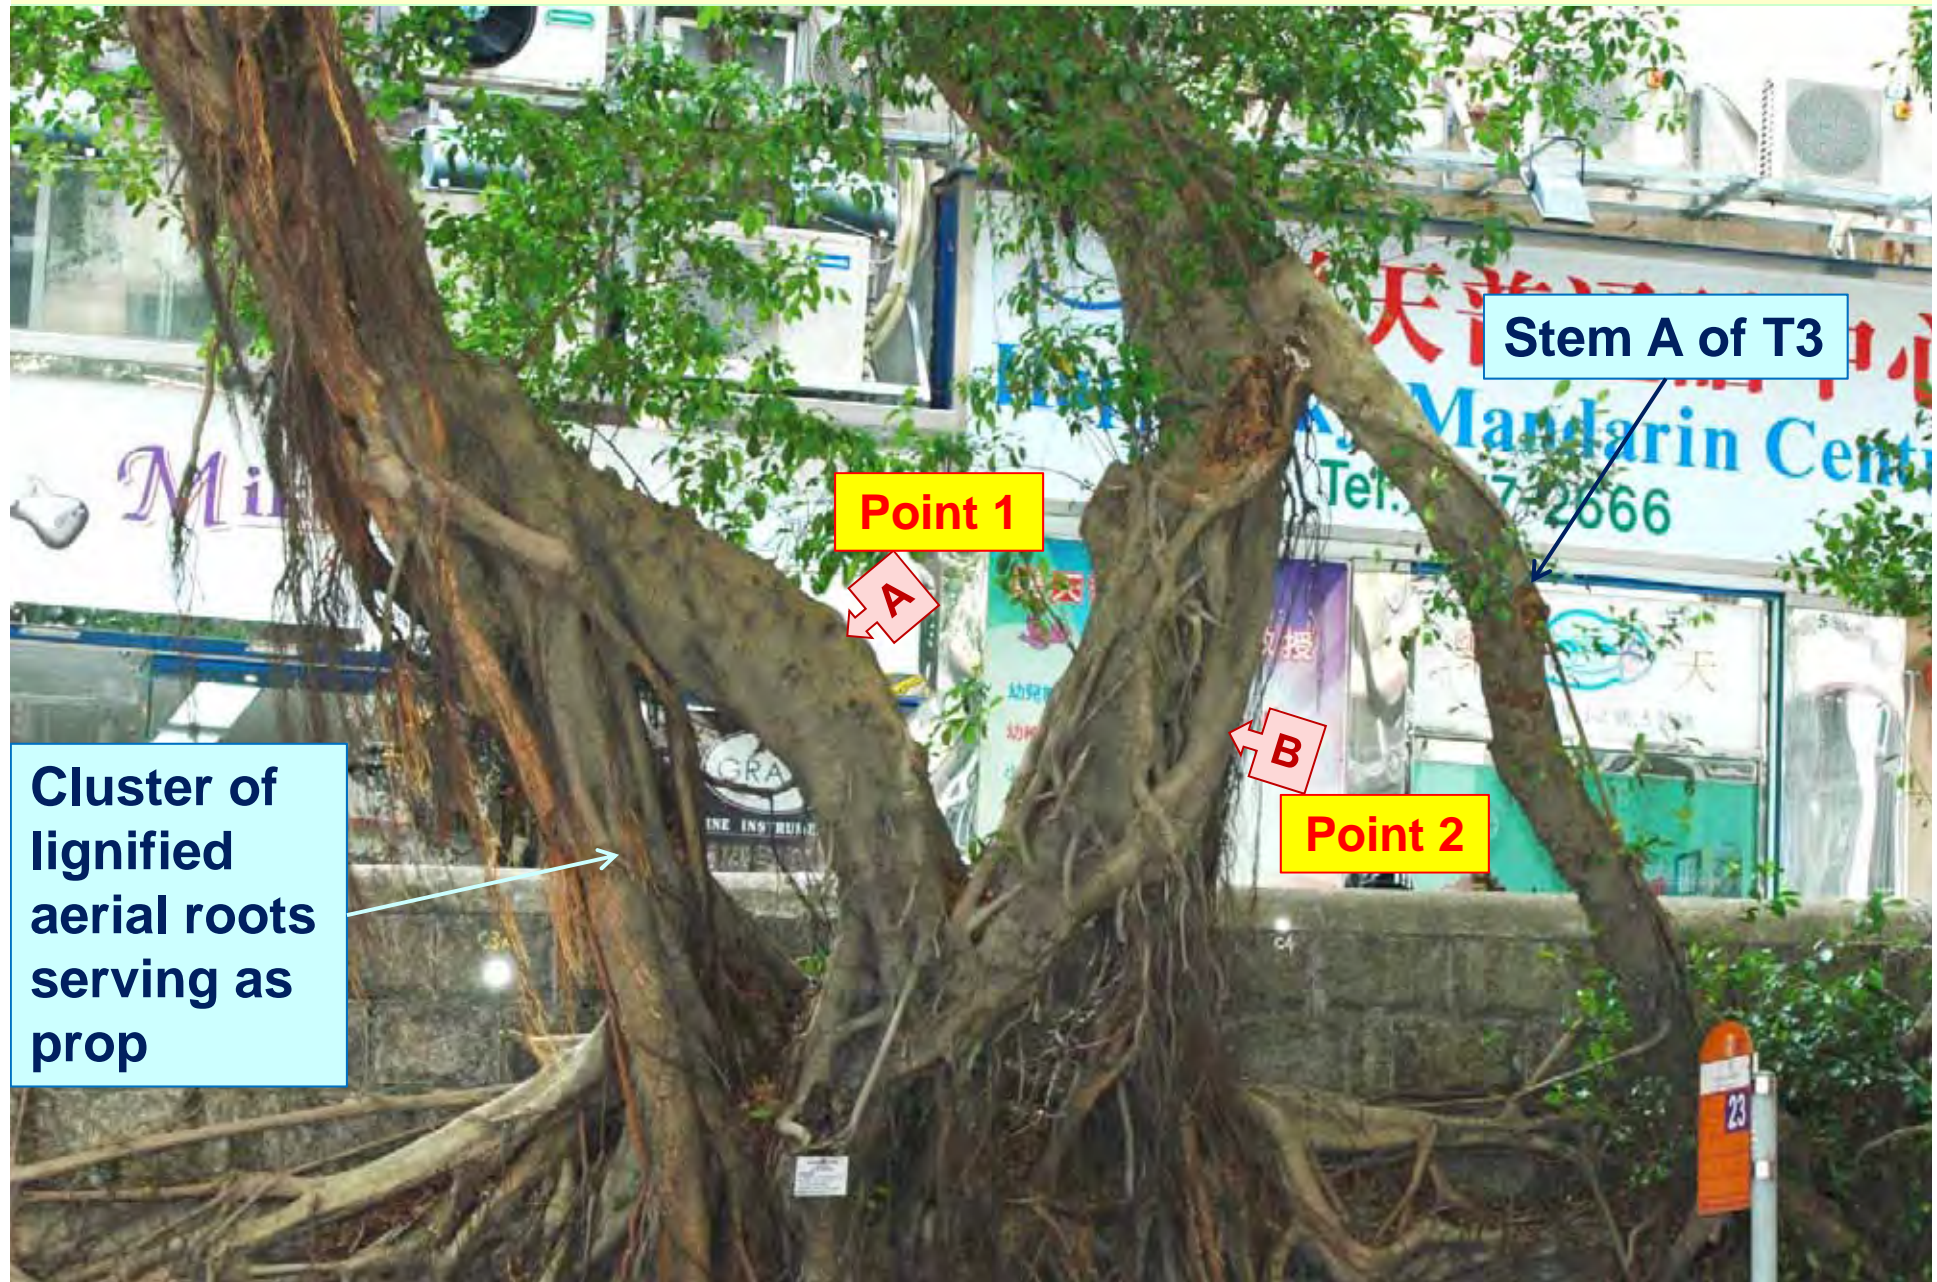
Photo T4-5. The curved stem A is propped by a cluster of lignified aerial roots. The curved stem B crosses with stem A of T3.
