Assessment of Wall Trees on Slope 11SW-A/R577 at Bonham Road

**Highways Department
HKSAR Government**

**C.Y. Jim
The University of Hong Kong
hrajcy@hku.hk**

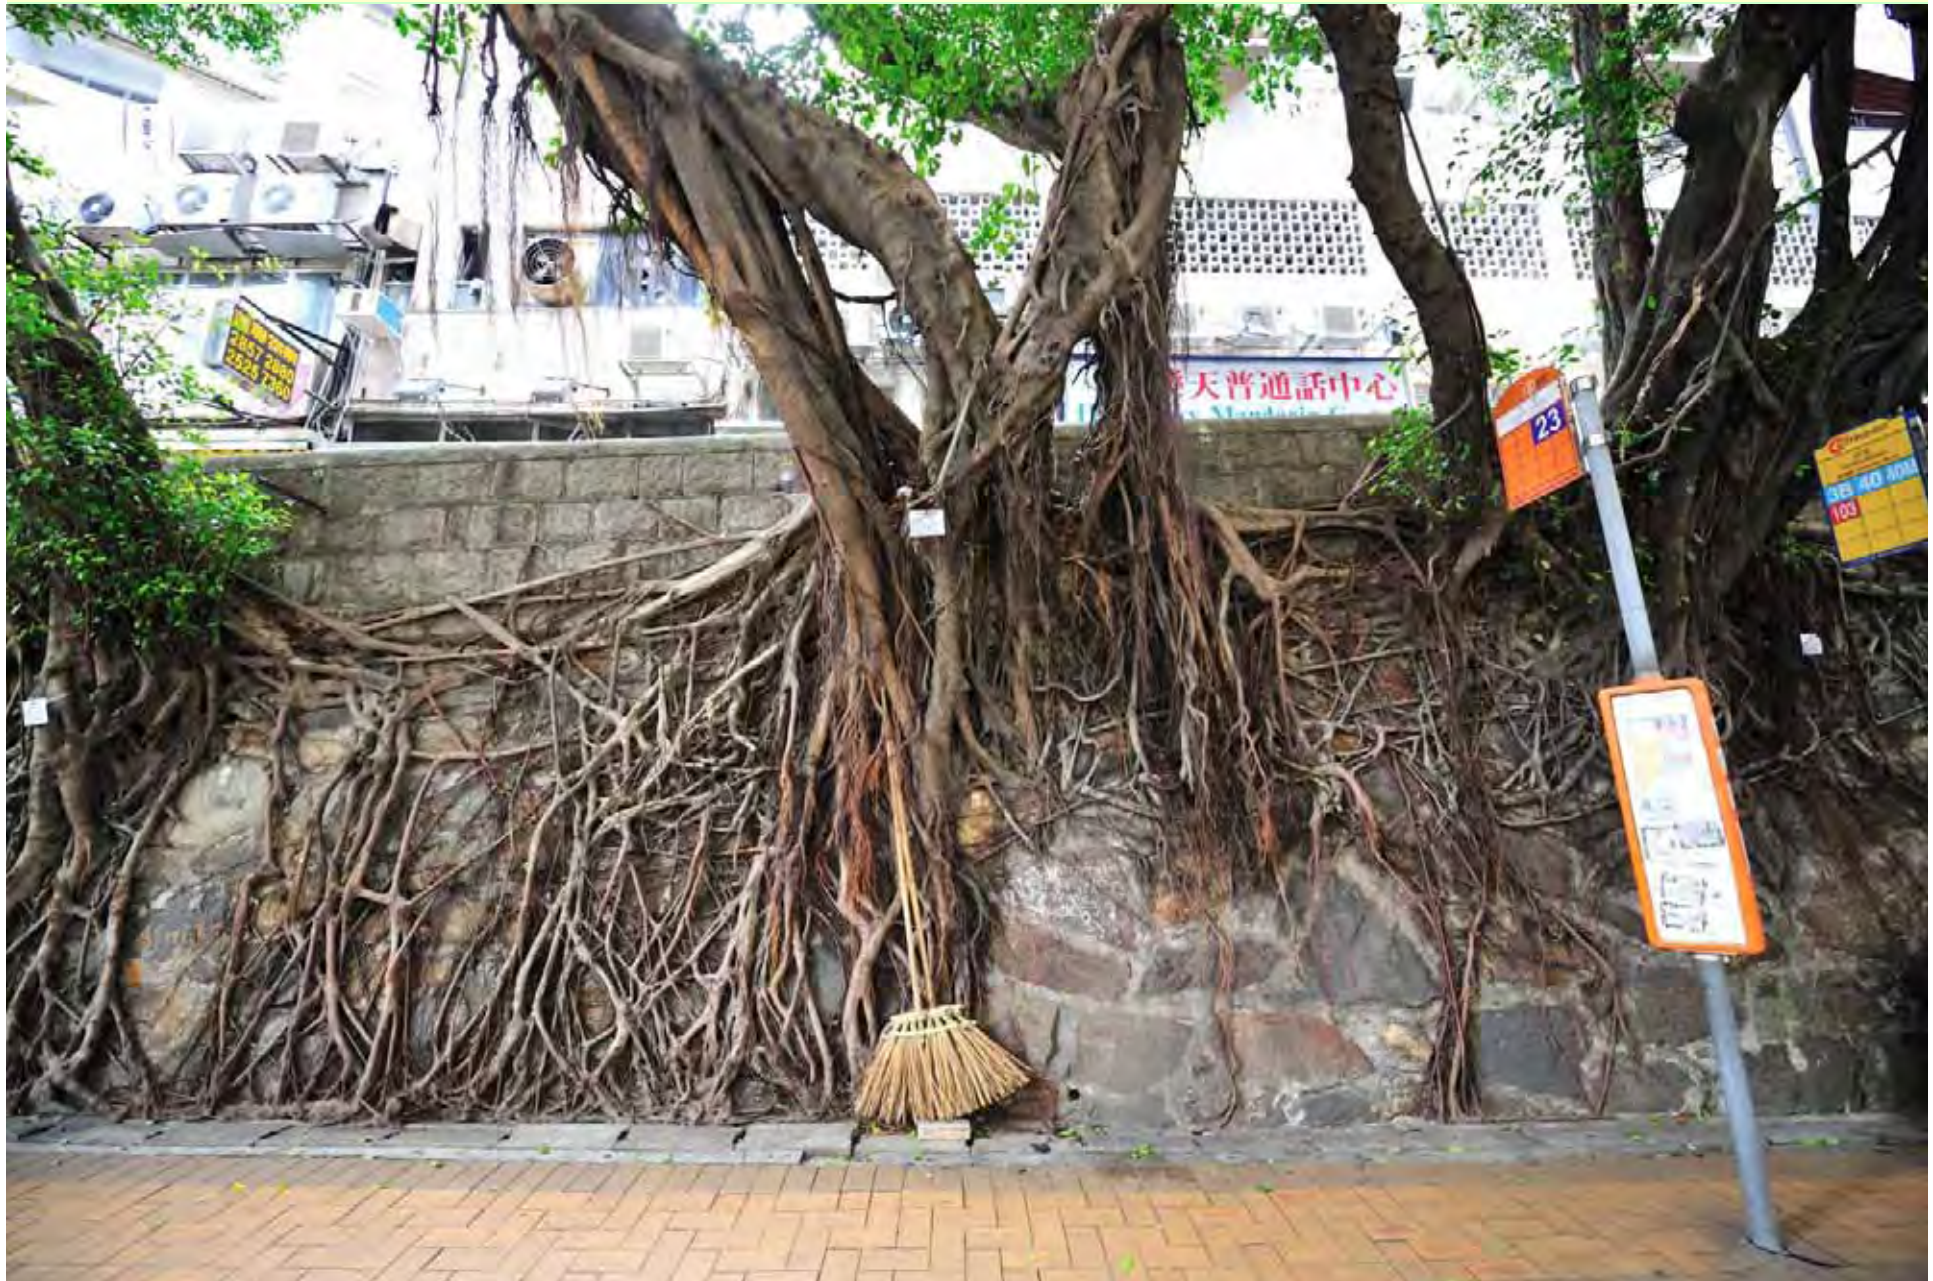
Photo T4-6. Liberal spread of surface roots on east side, and truncation on the west.

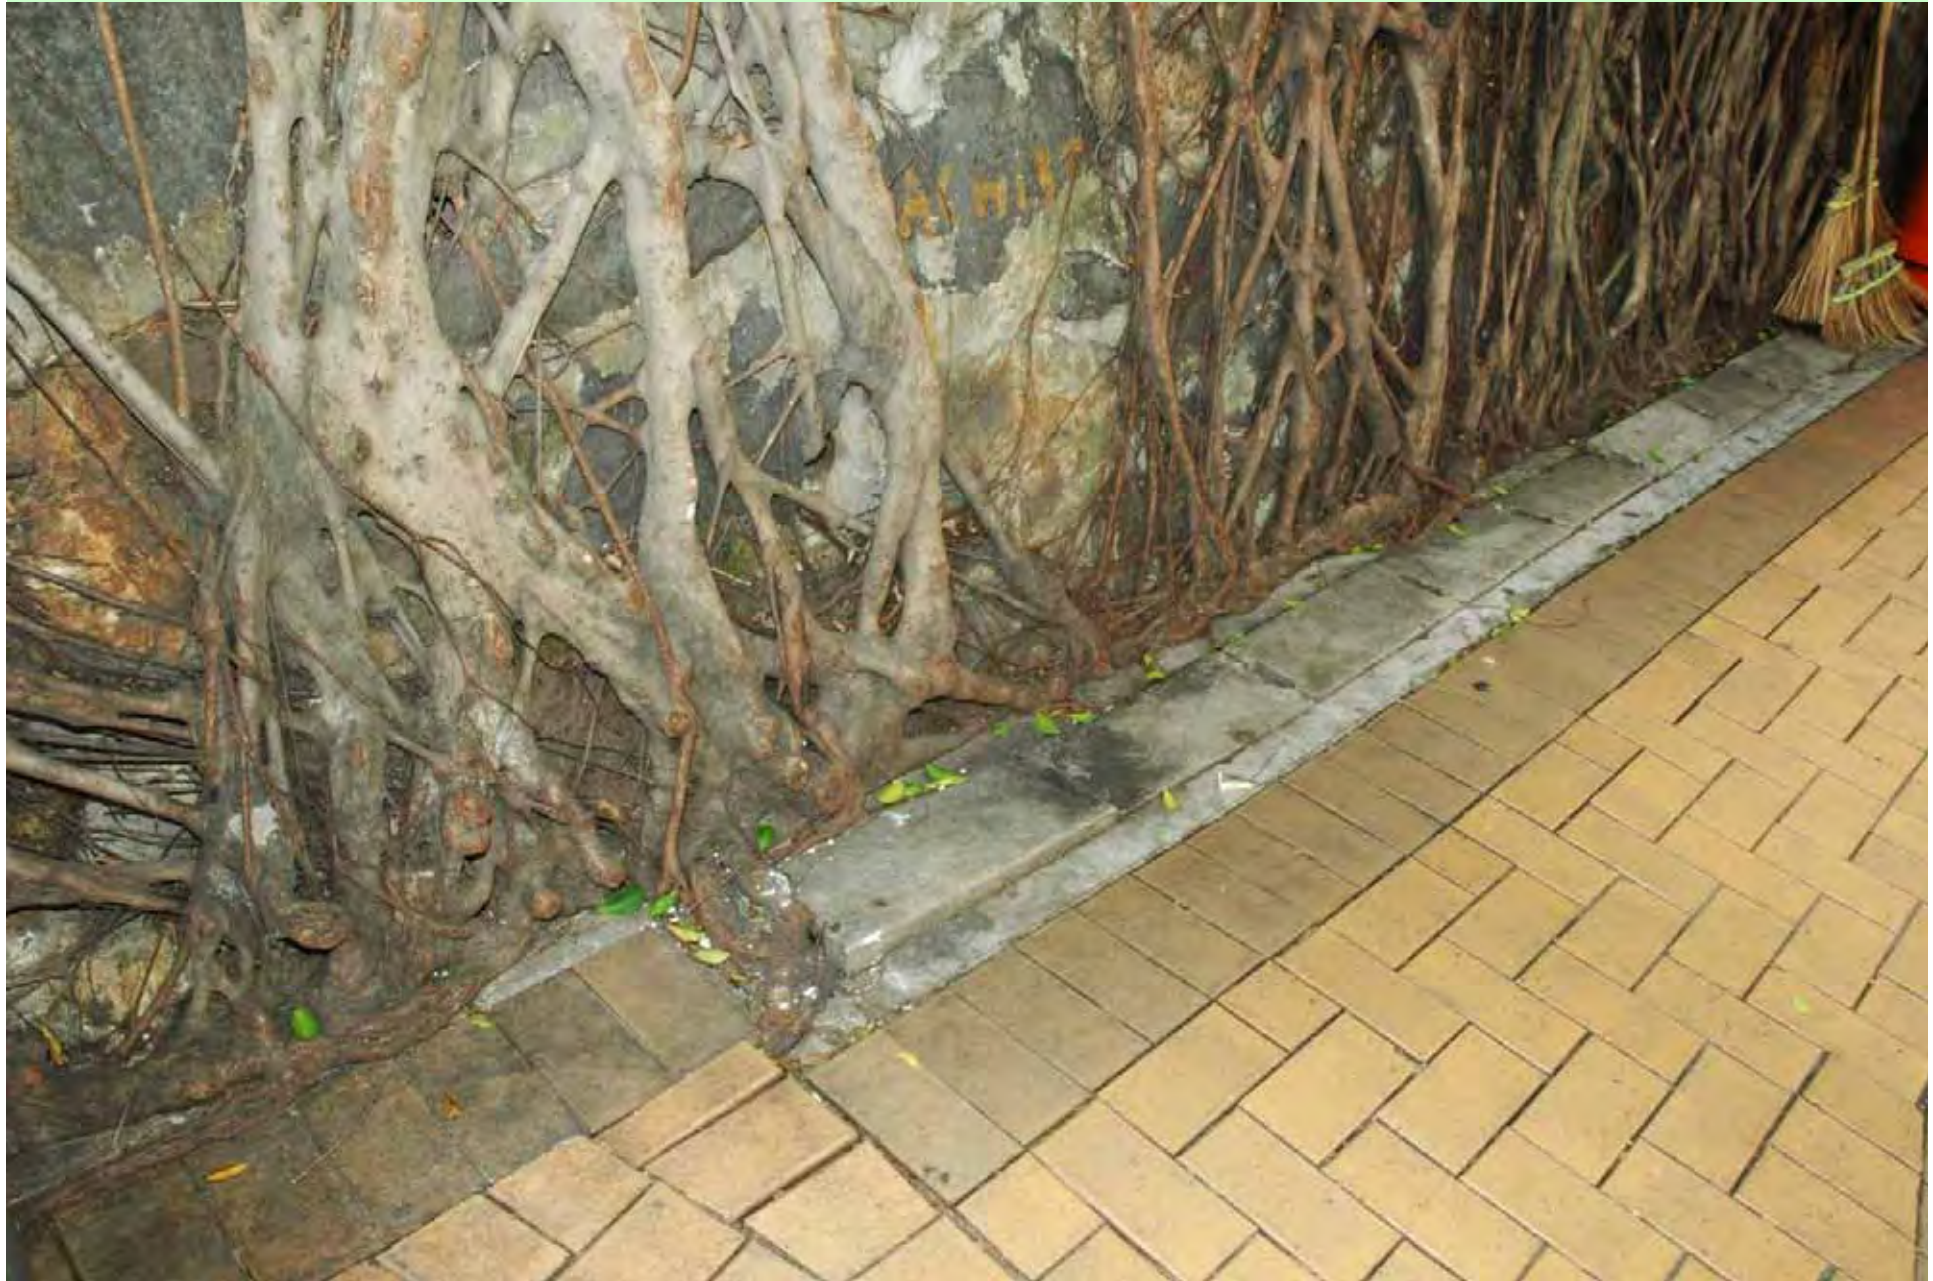
Photo T4-7. The drainage channel at the wall toe restricts root penetration into the soil below the pavement.

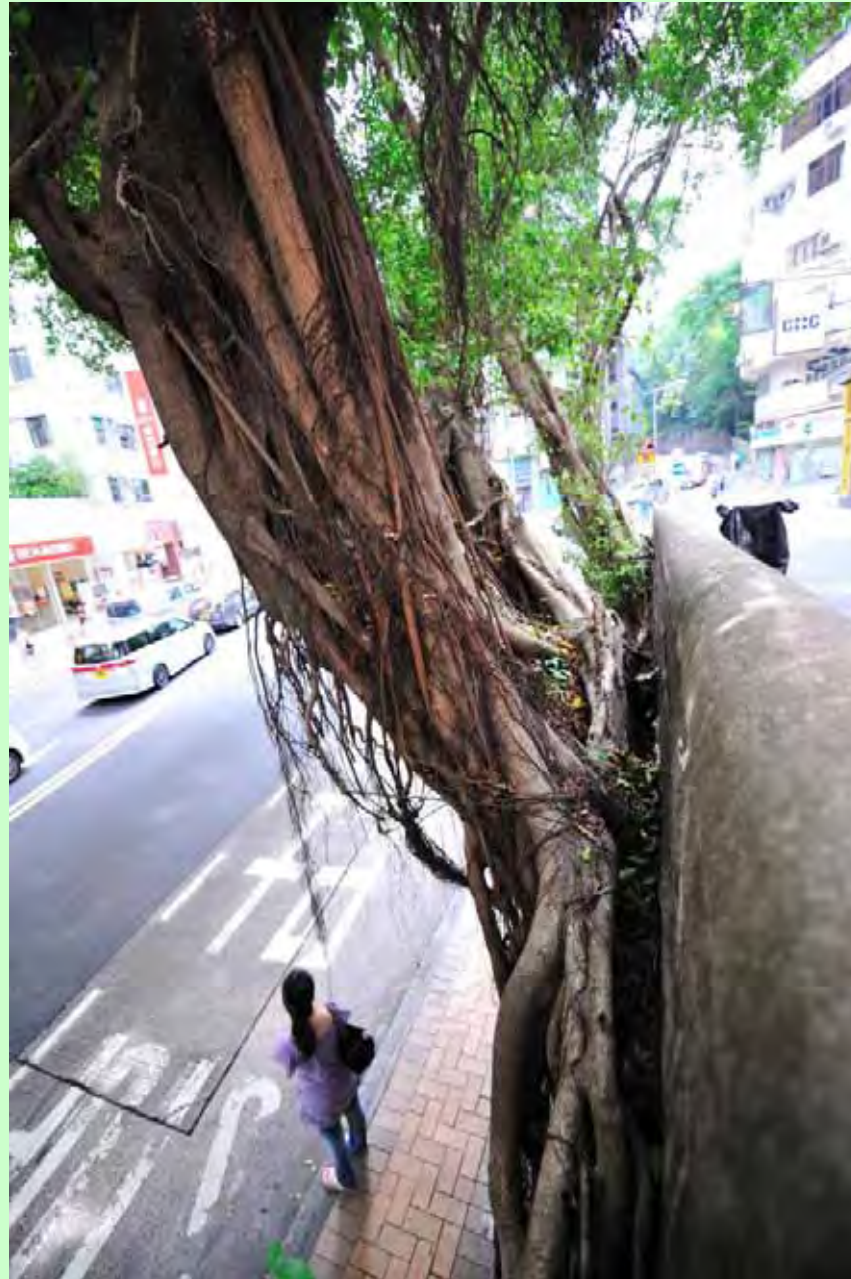
Photo T4-8. Partial detachment of tree based from wall crest viewed from the west.

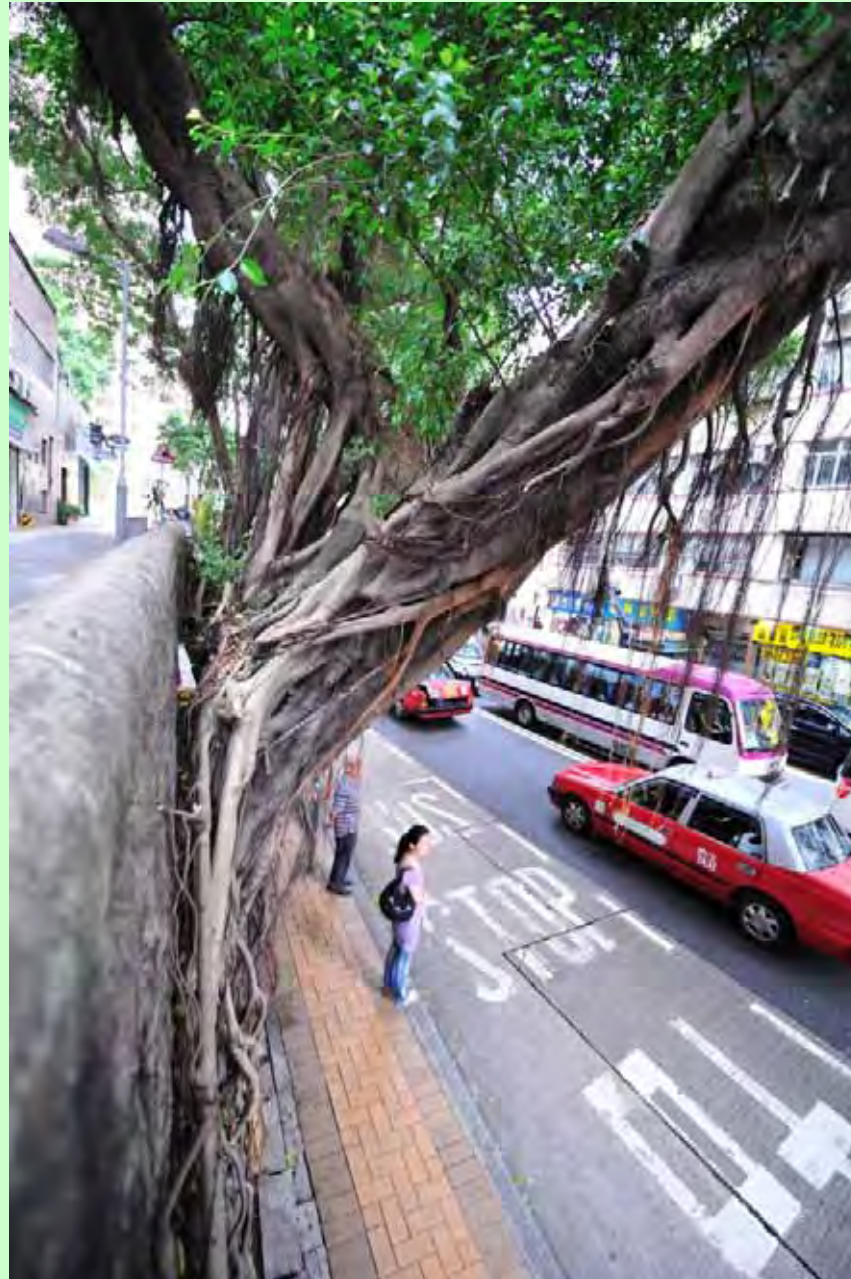
Photo T4-9. Partial detachment of tree based from wall crest viewed from the east.

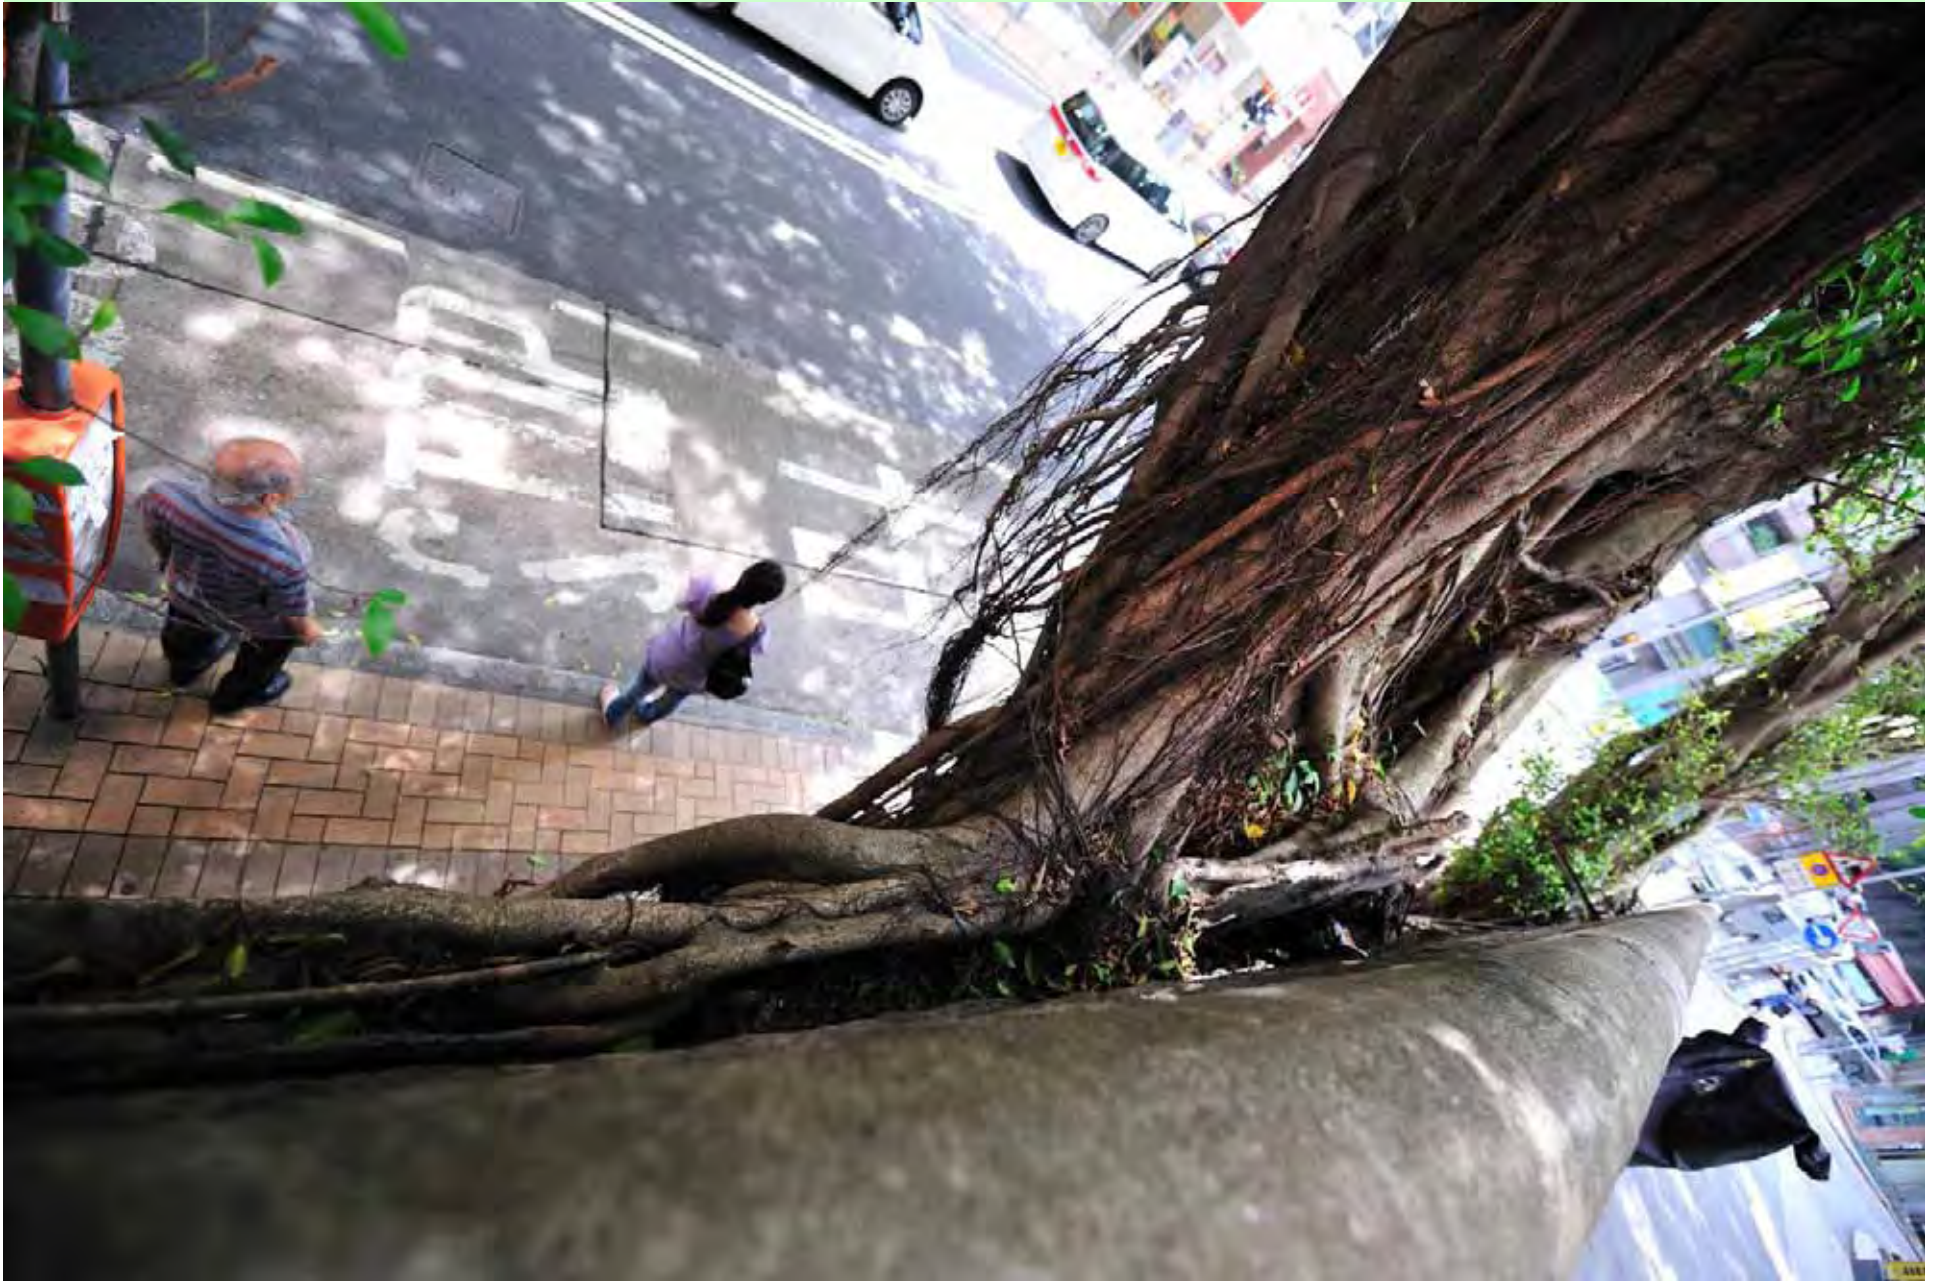
Photo T4-10. Partial detachment of tree based from wall crest, close-up view from the west.

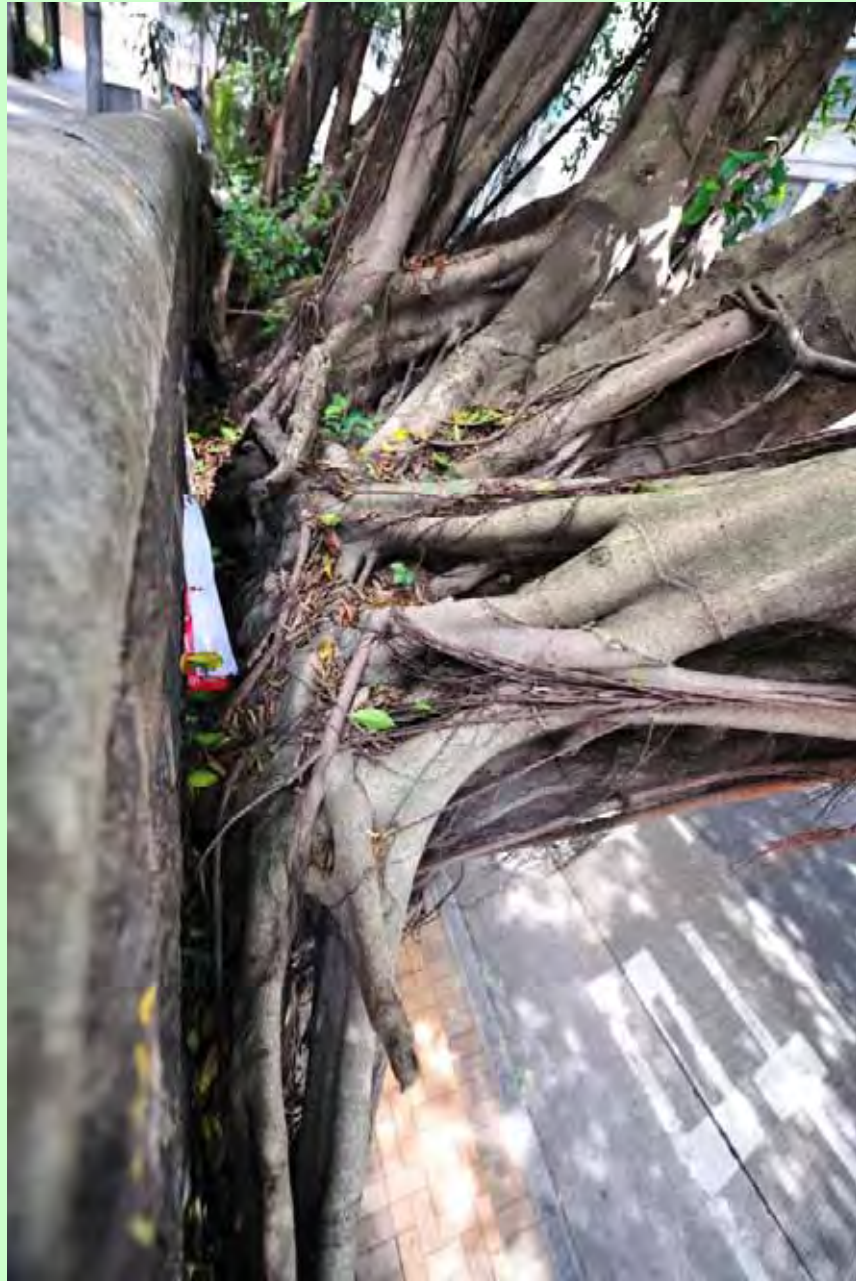
Photo T4-11. Partial detachment of tree based from wall crest, close-up view from the east.

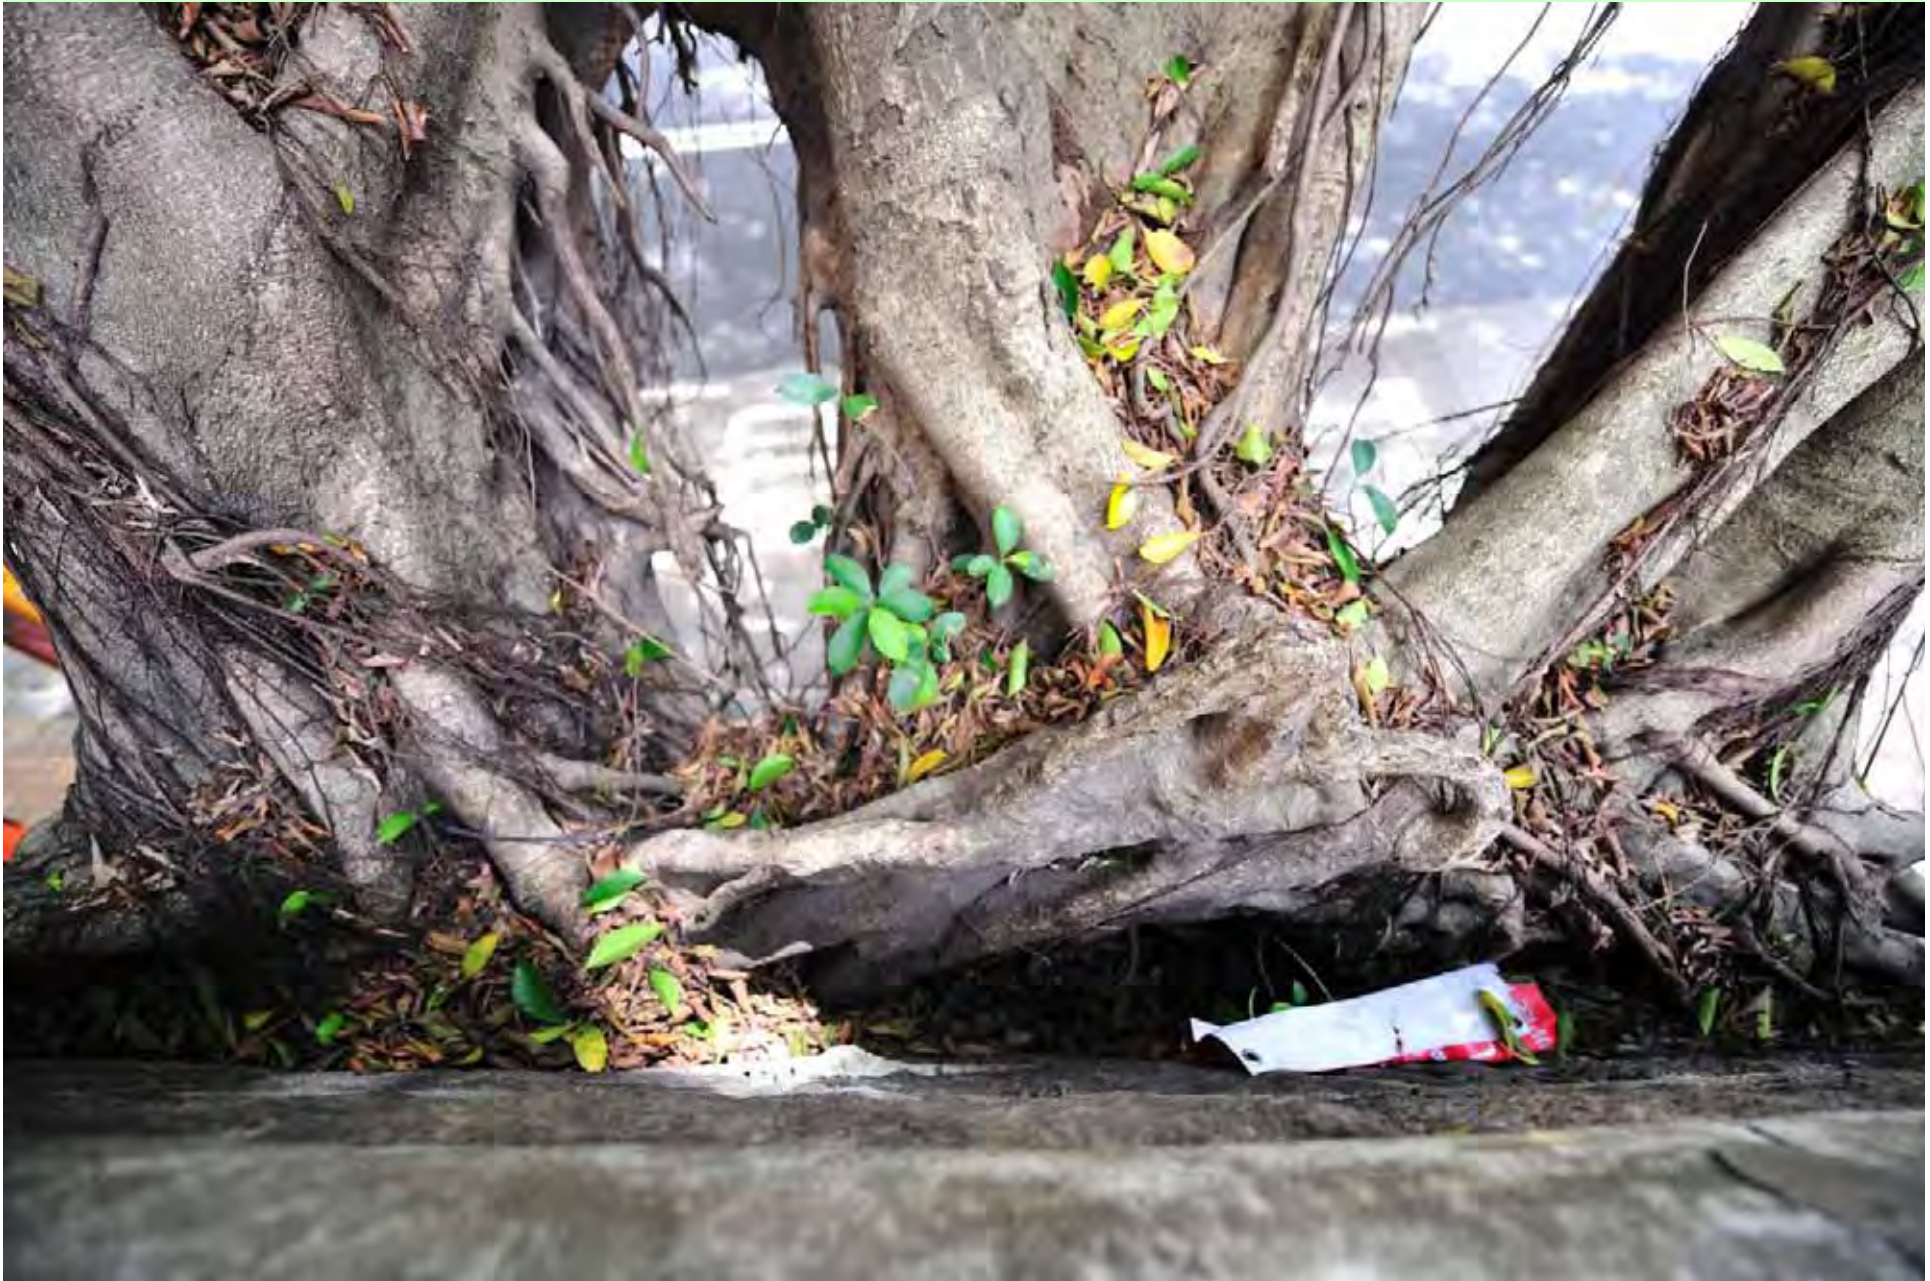
Photo T4-12. Partial detachment of tree based from wall crest, close-up view from the south.

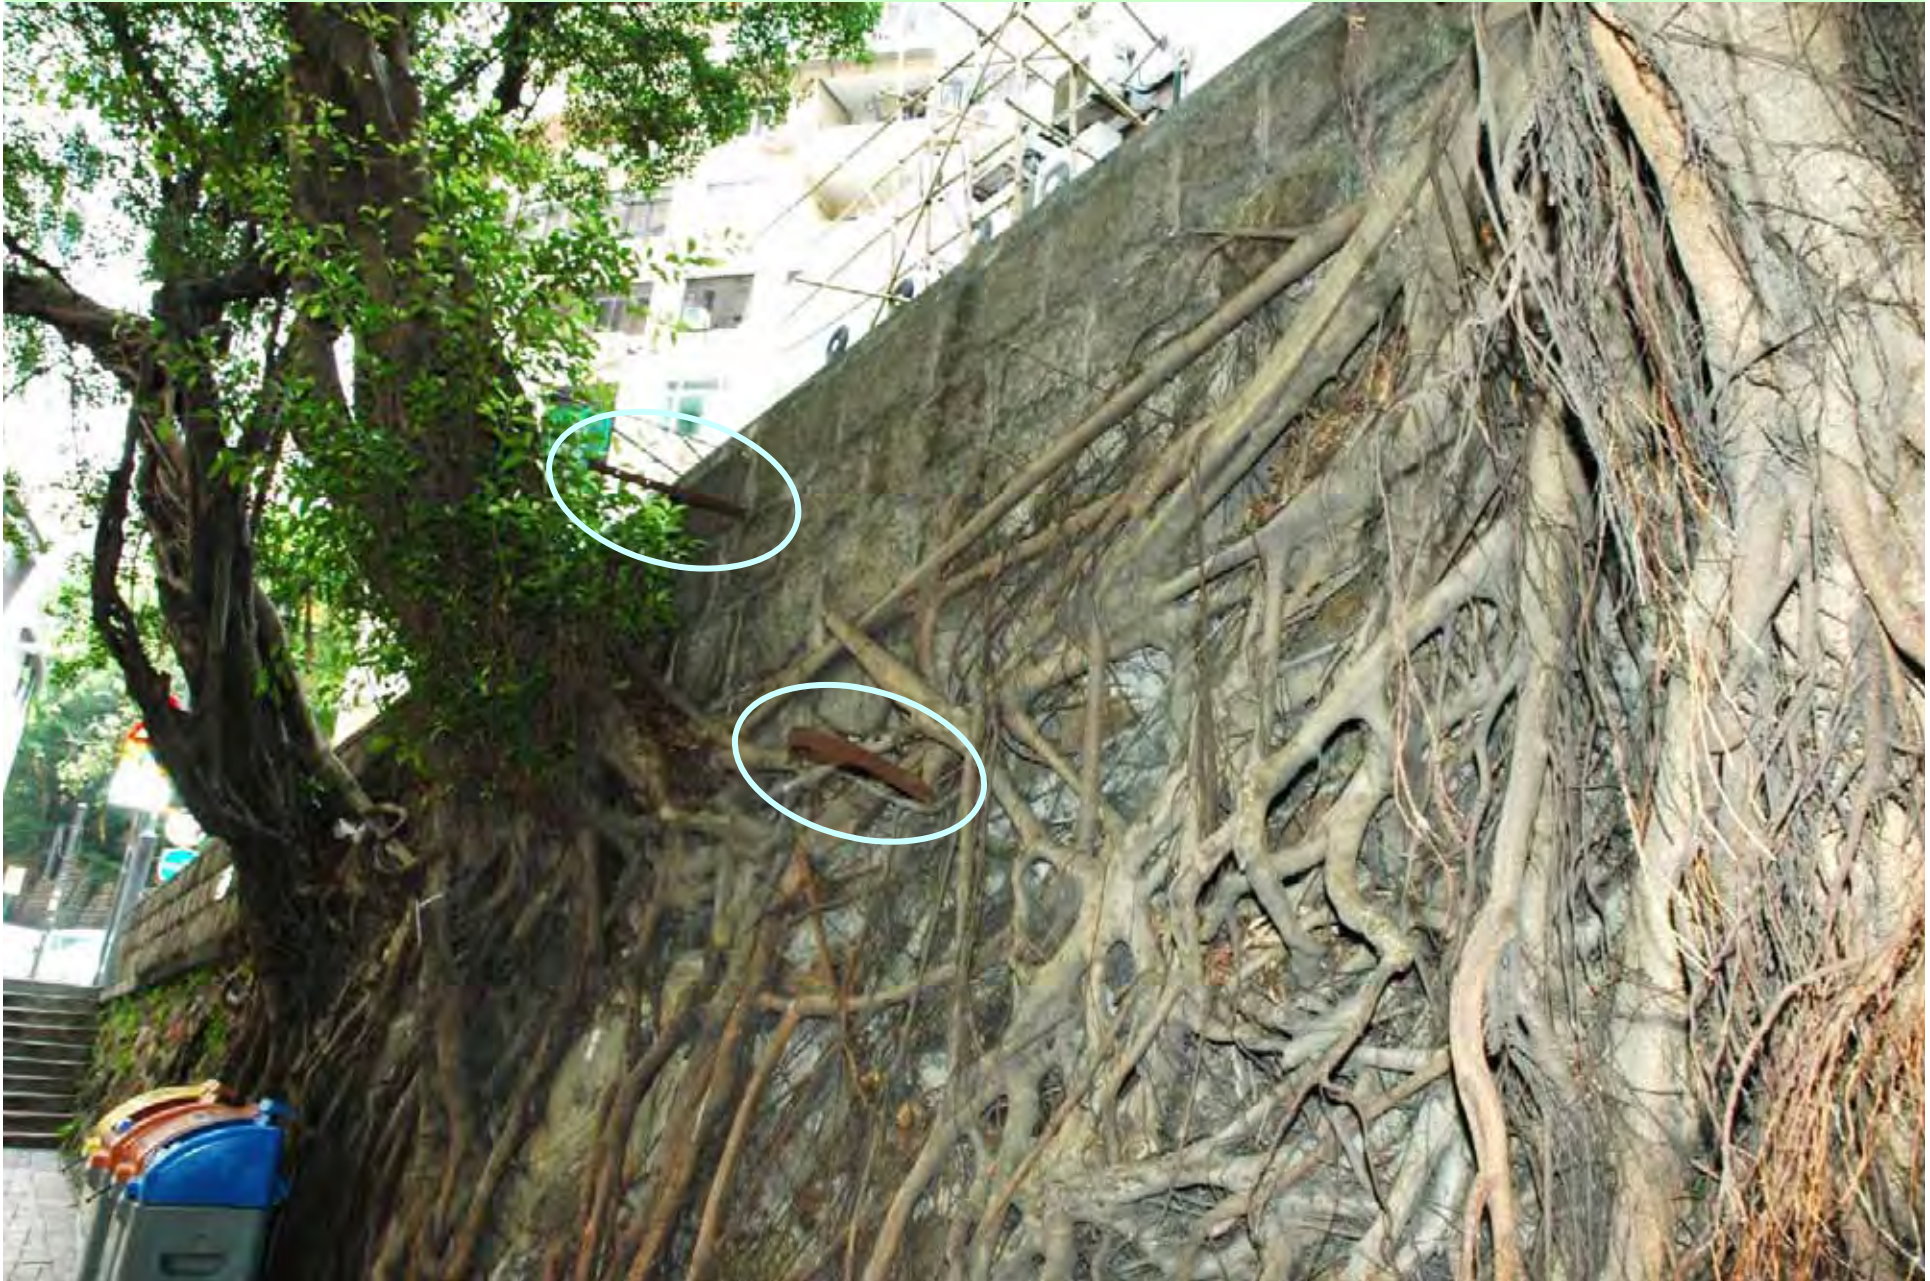
Photo T4-13. East side of surface root mass with obsolete angled iron installation.

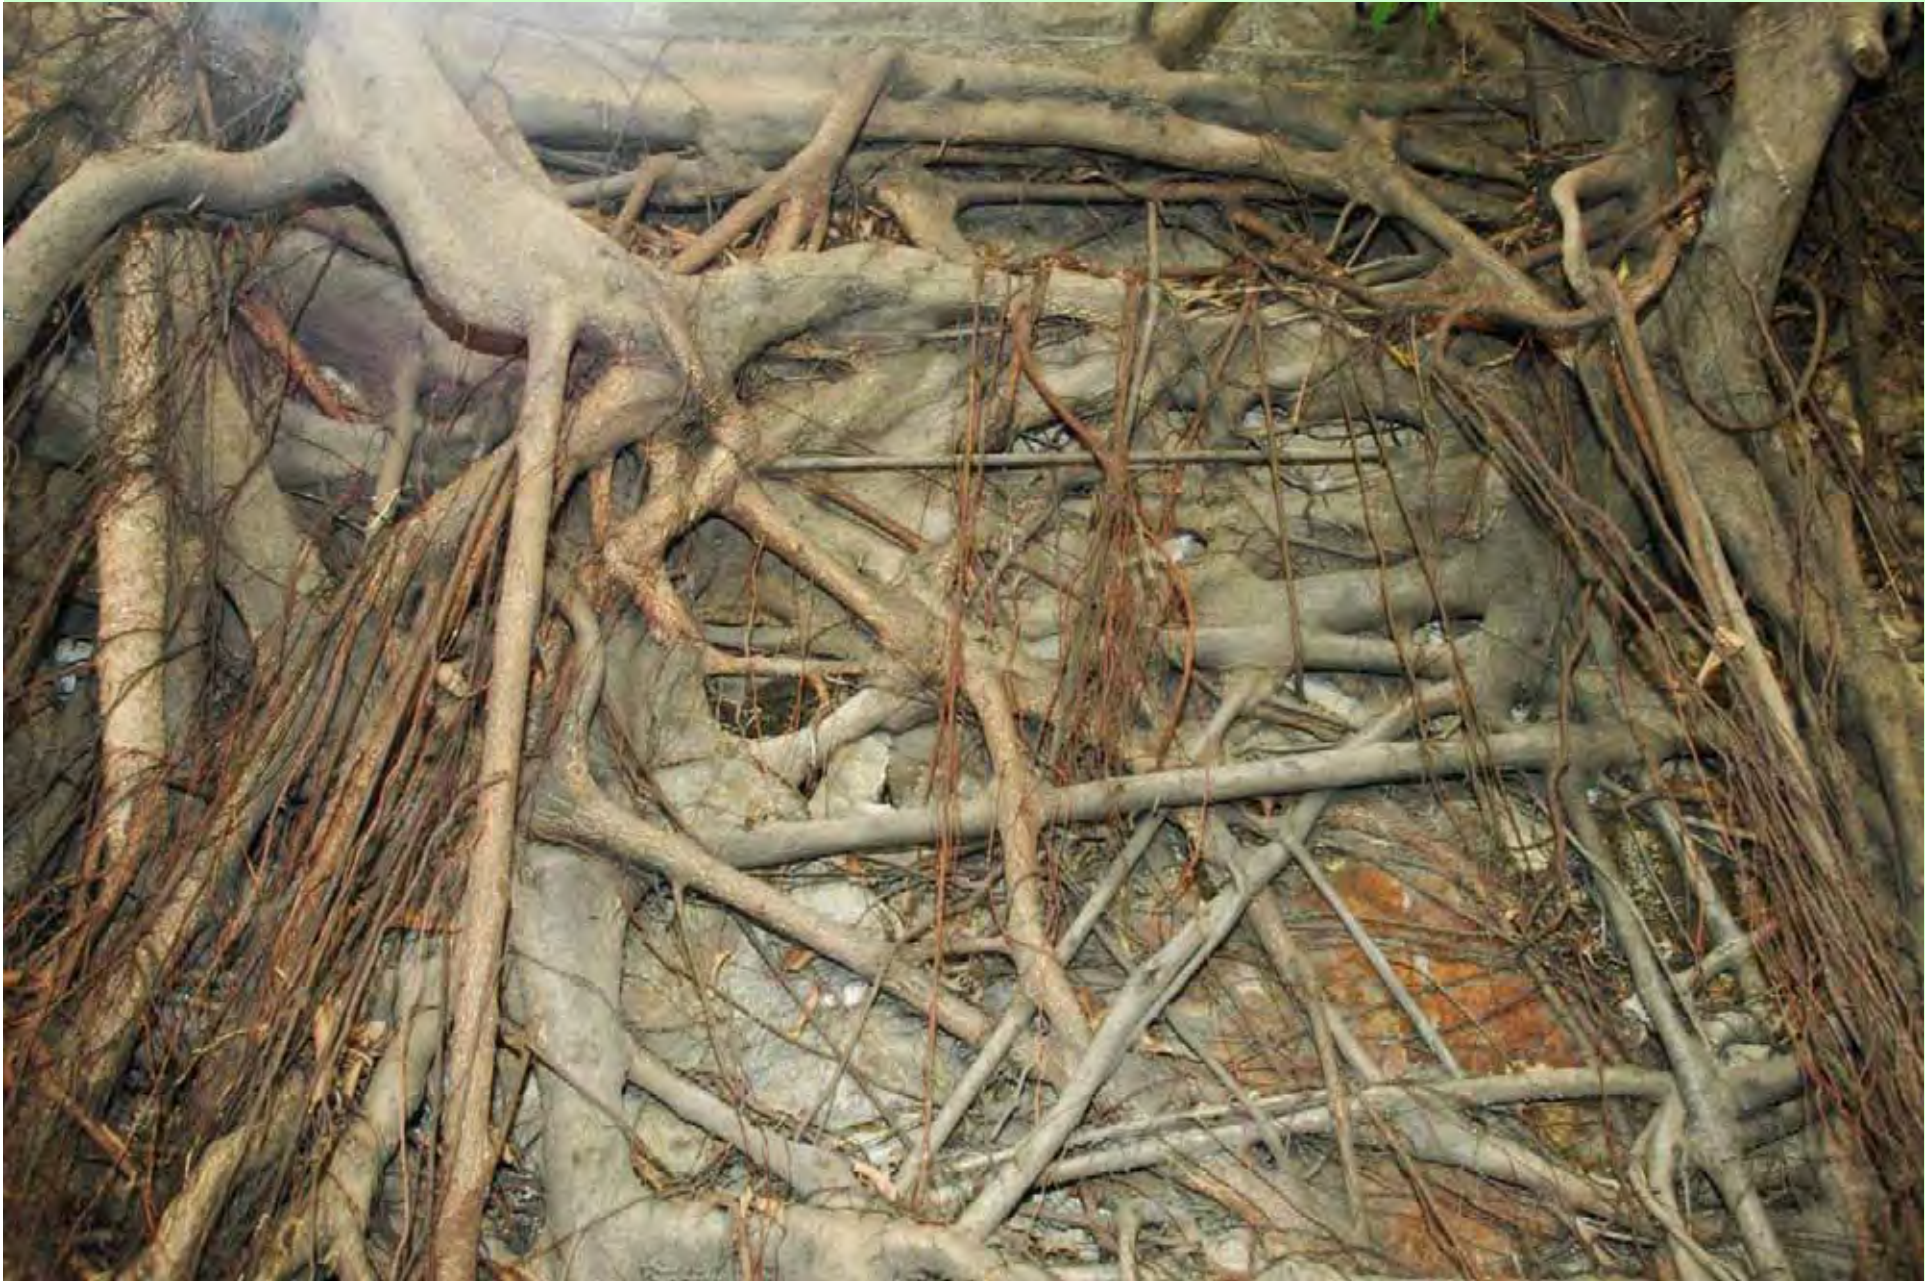
Photo T4-14. West side of surface root mass with dense and grafted roots.

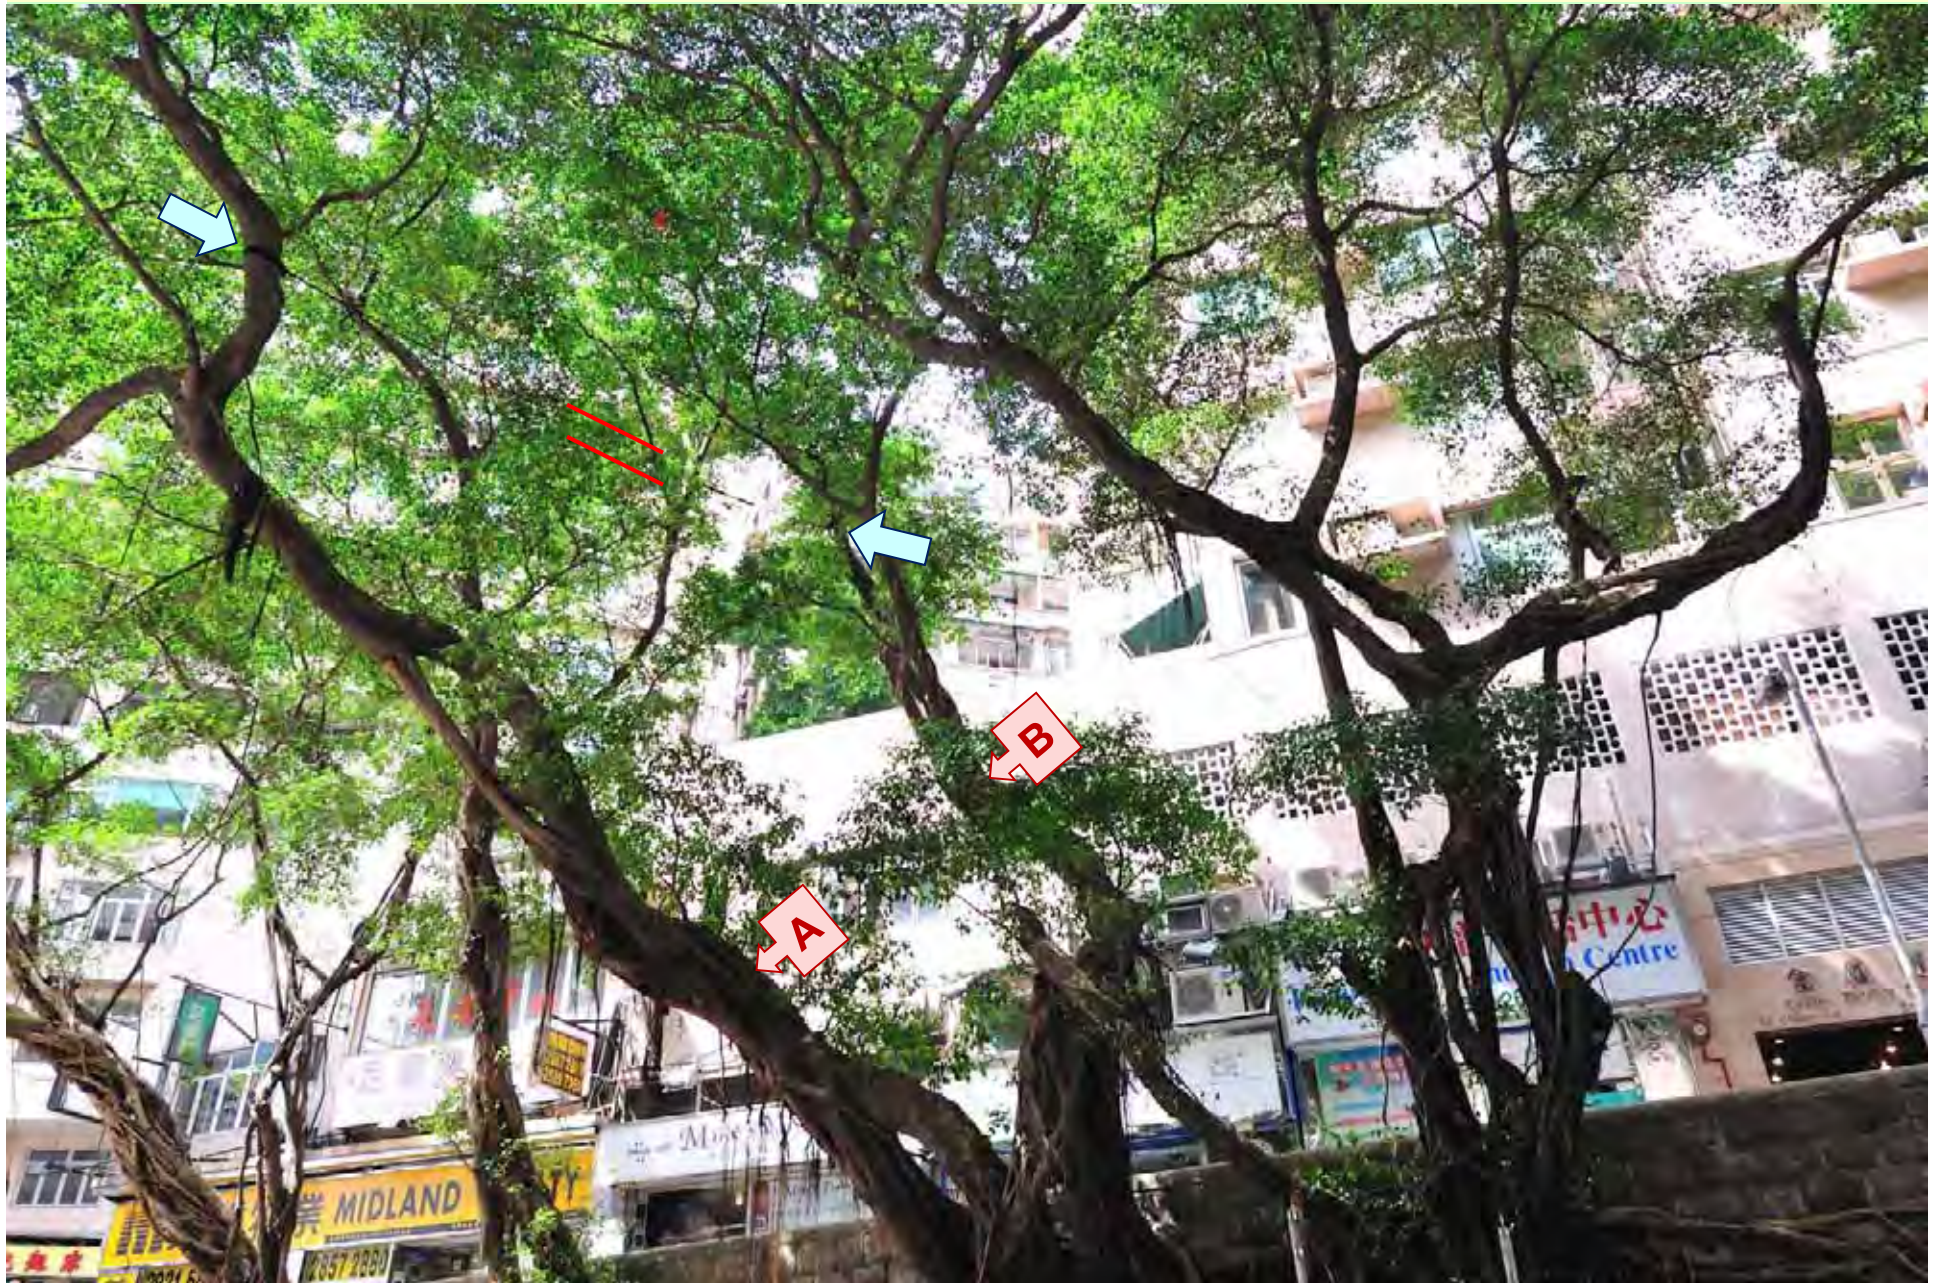
Photo T4-29. Existing Cobra cable bracing using Stem B to hold Stems A.

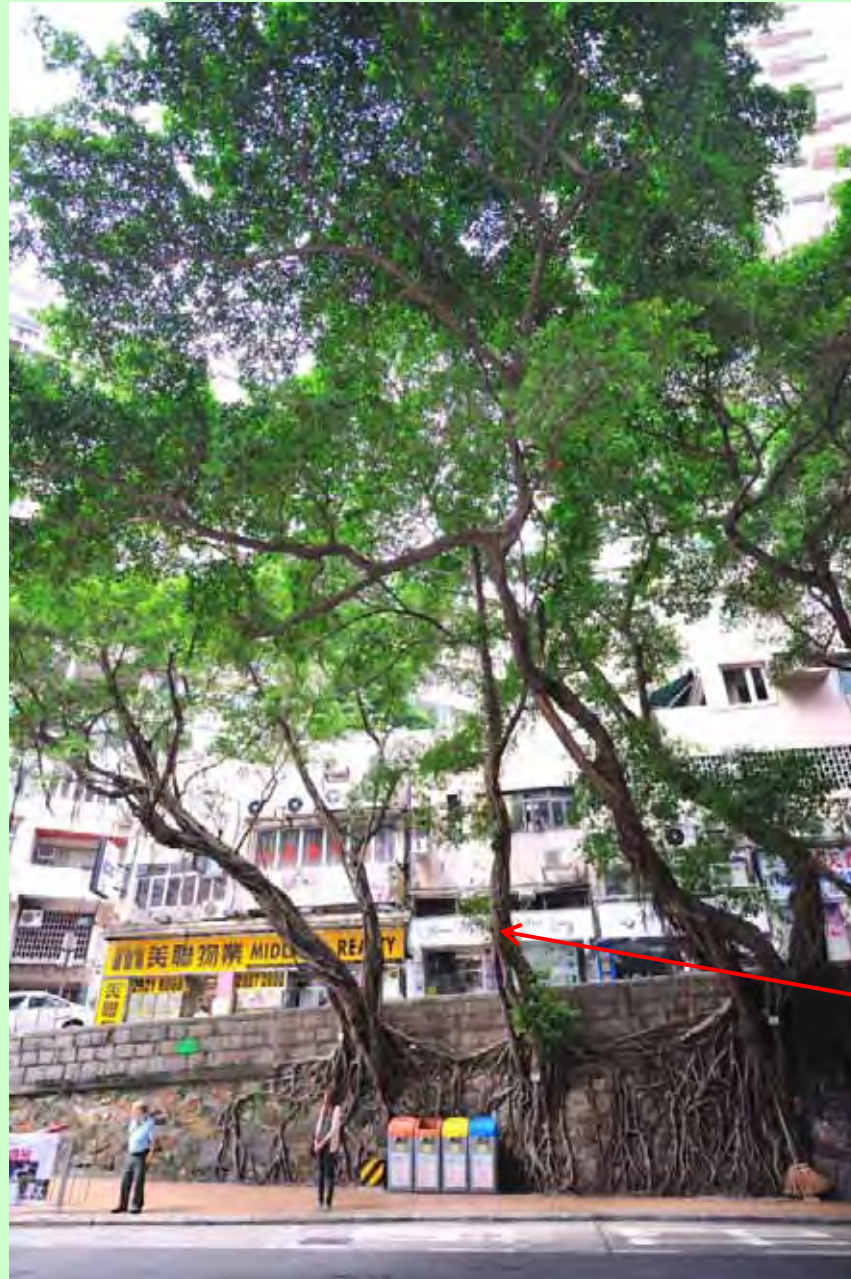
Photo T5-2. The rather upright tree with single trunk viewed from Bonham Road.

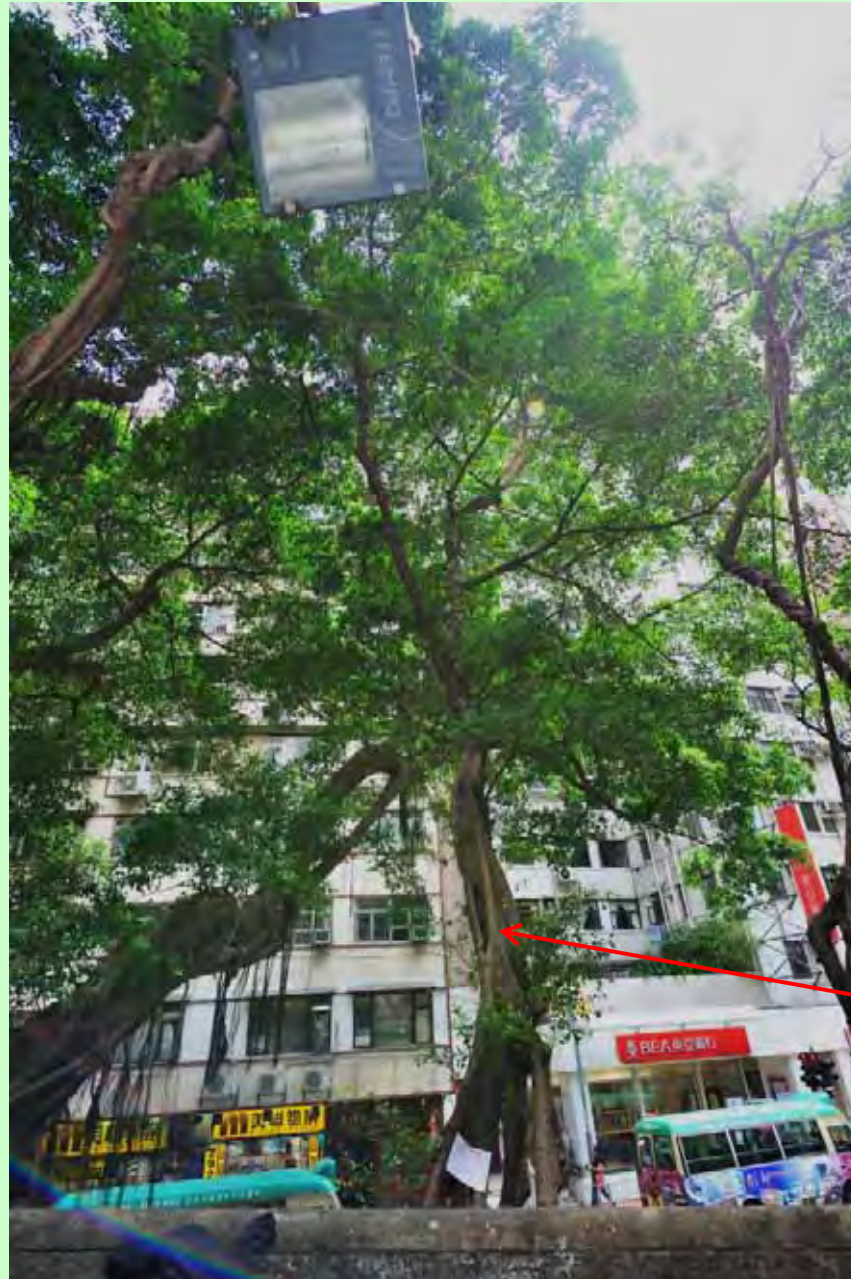
Photo T5-3. The rather upright tree with single trunk viewed from St Stephen's Lane.
