Assessment of Wall Trees on Slope 11SW-A/R577 at Bonham Road

**Highways Department
HKSAR Government**

**C.Y. Jim
The University of Hong Kong
hrajcy@hku.hk**

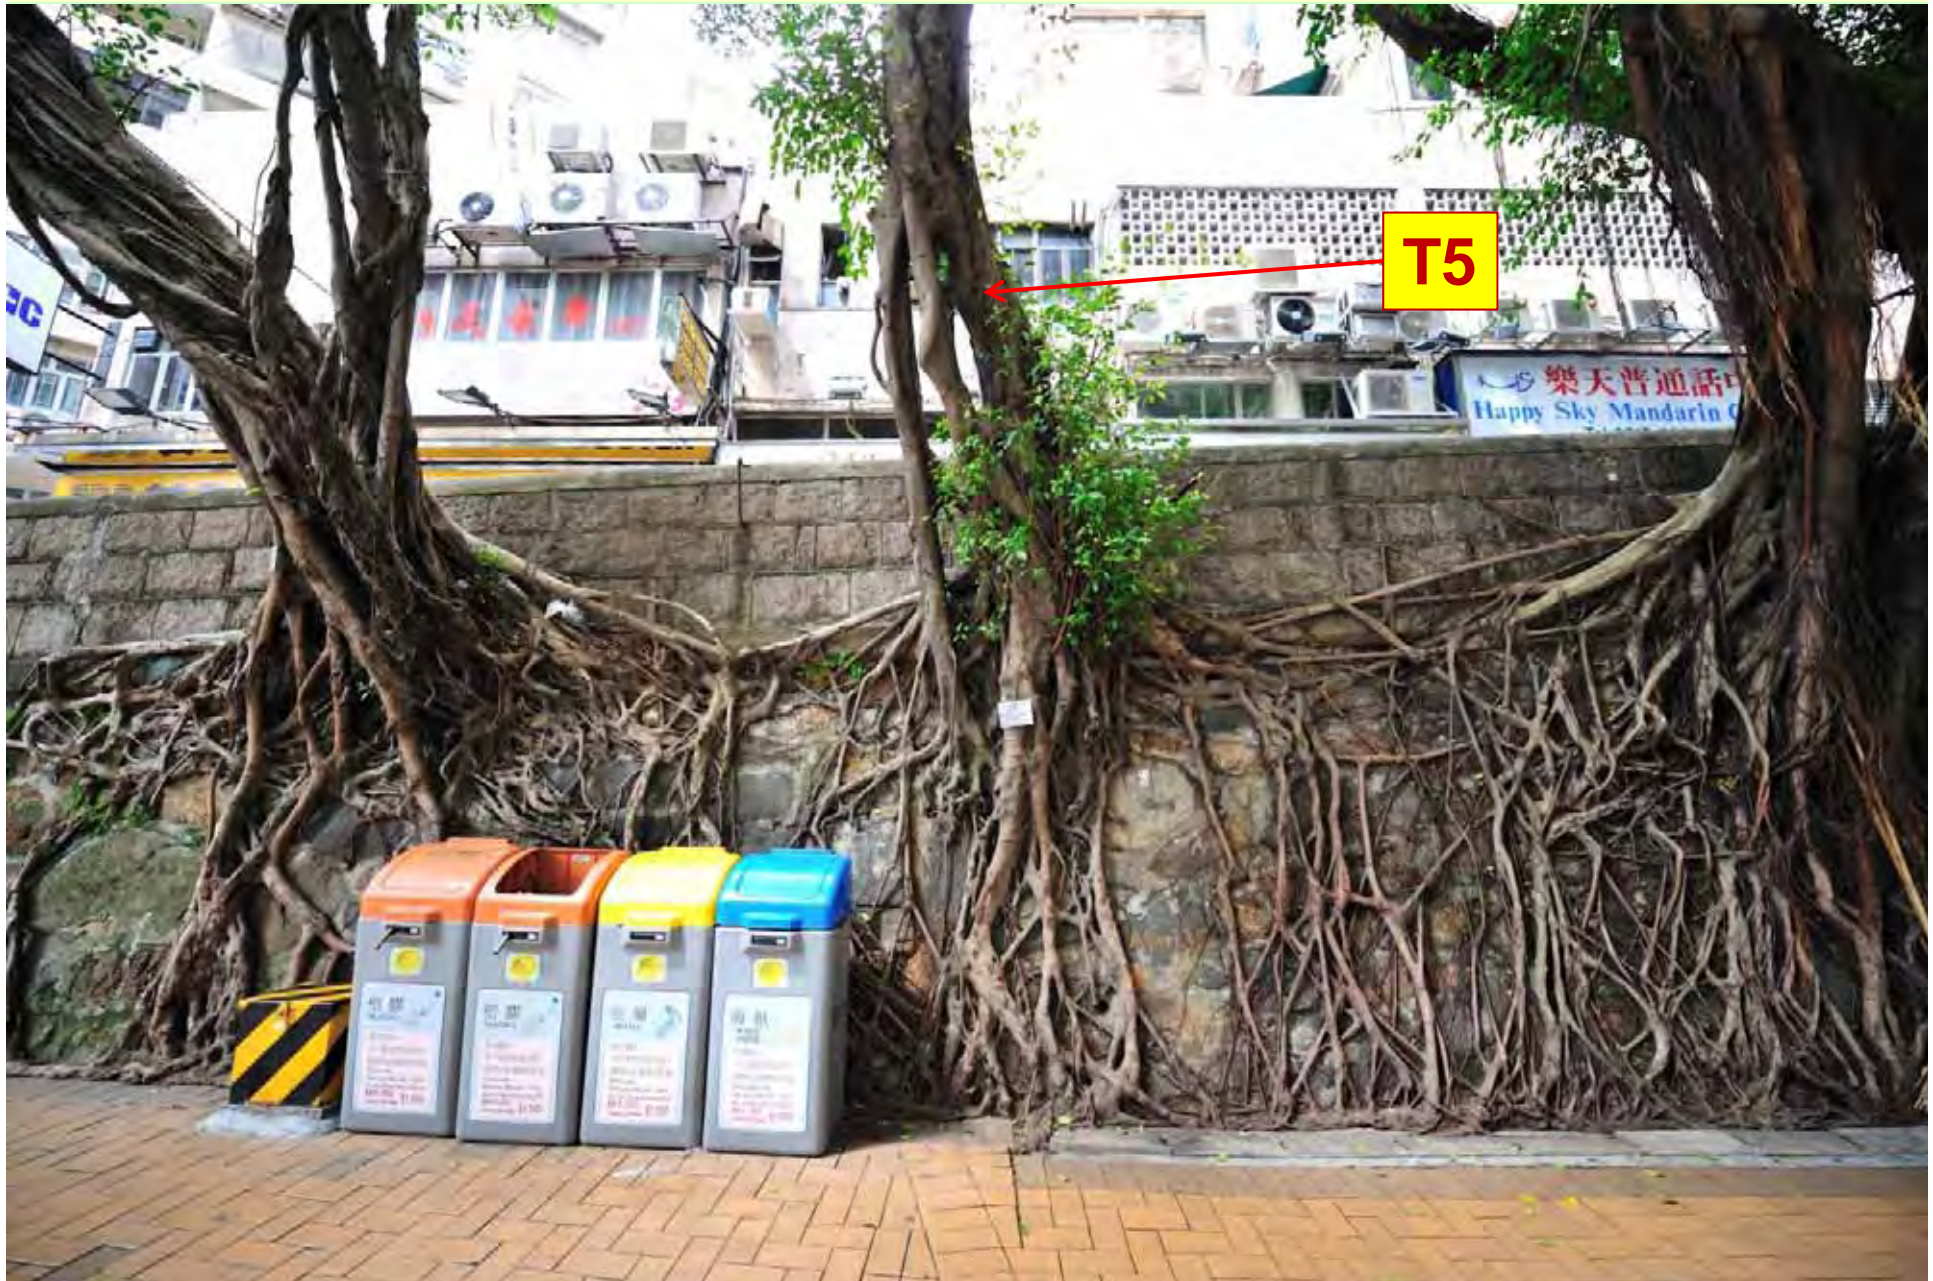
Photo T5-4. Limited spread of surface roots and their grafting with neighbours T4 & T6, and restriction to root penetration at wall toe.

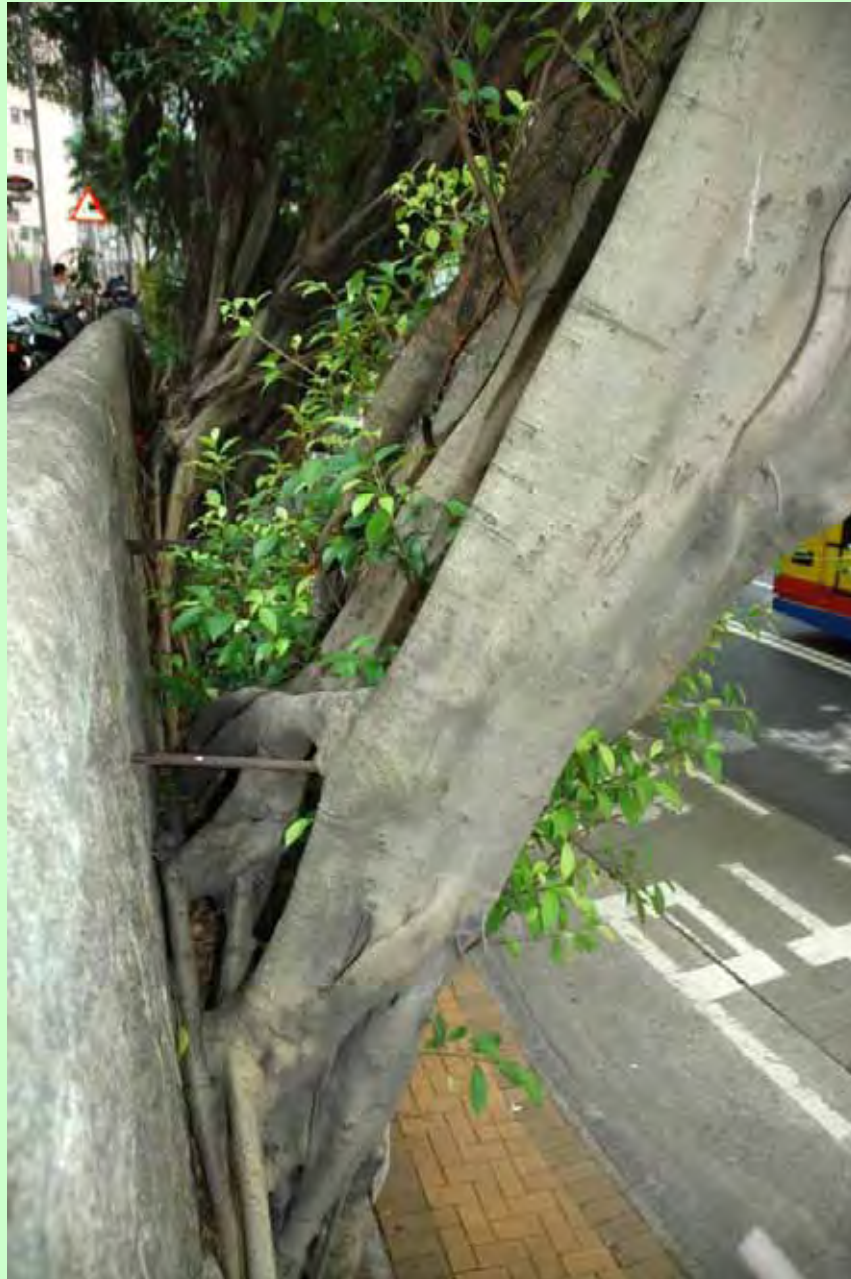
Photo T5-5. Relationship between tree and wall crest, viewed from the east.

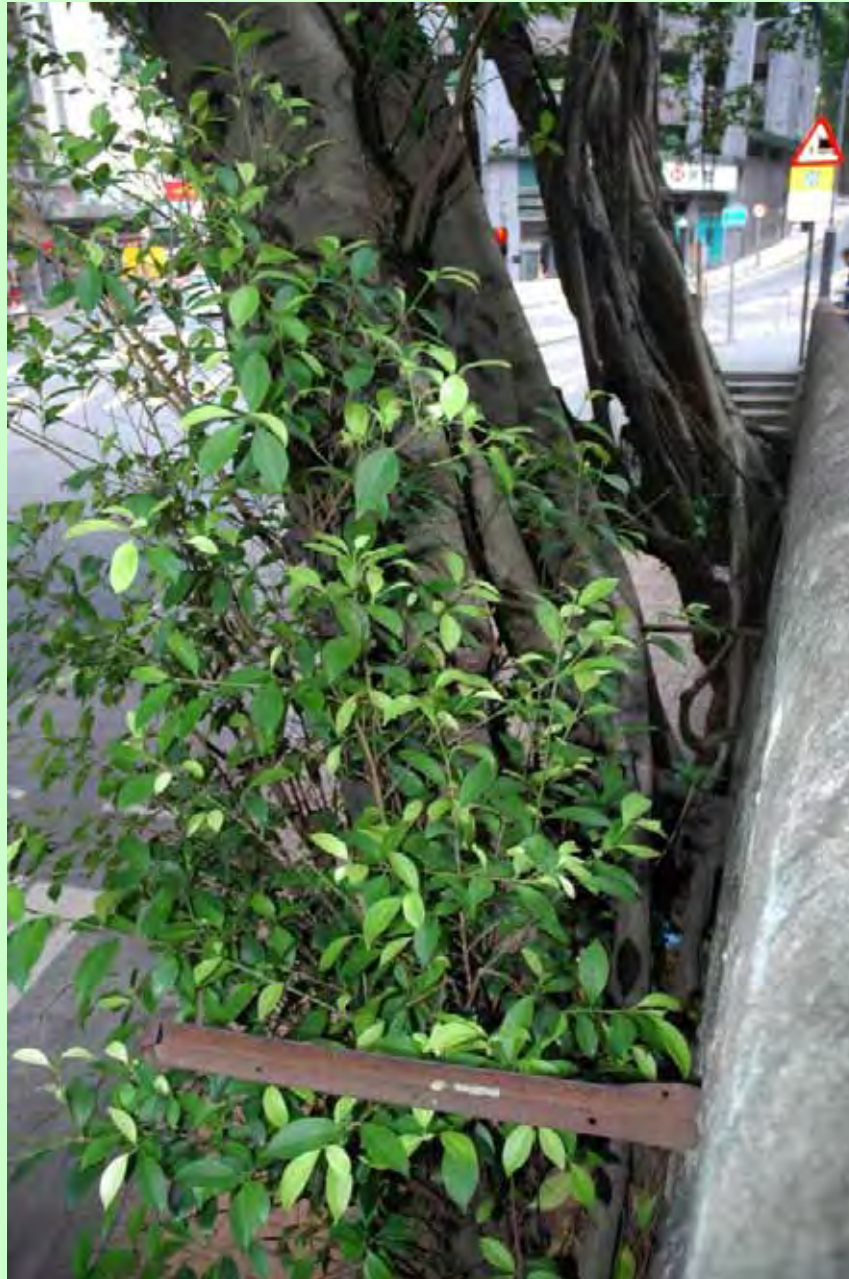
Photo T5-6. Relationship between tree and wall crest, viewed from the west.

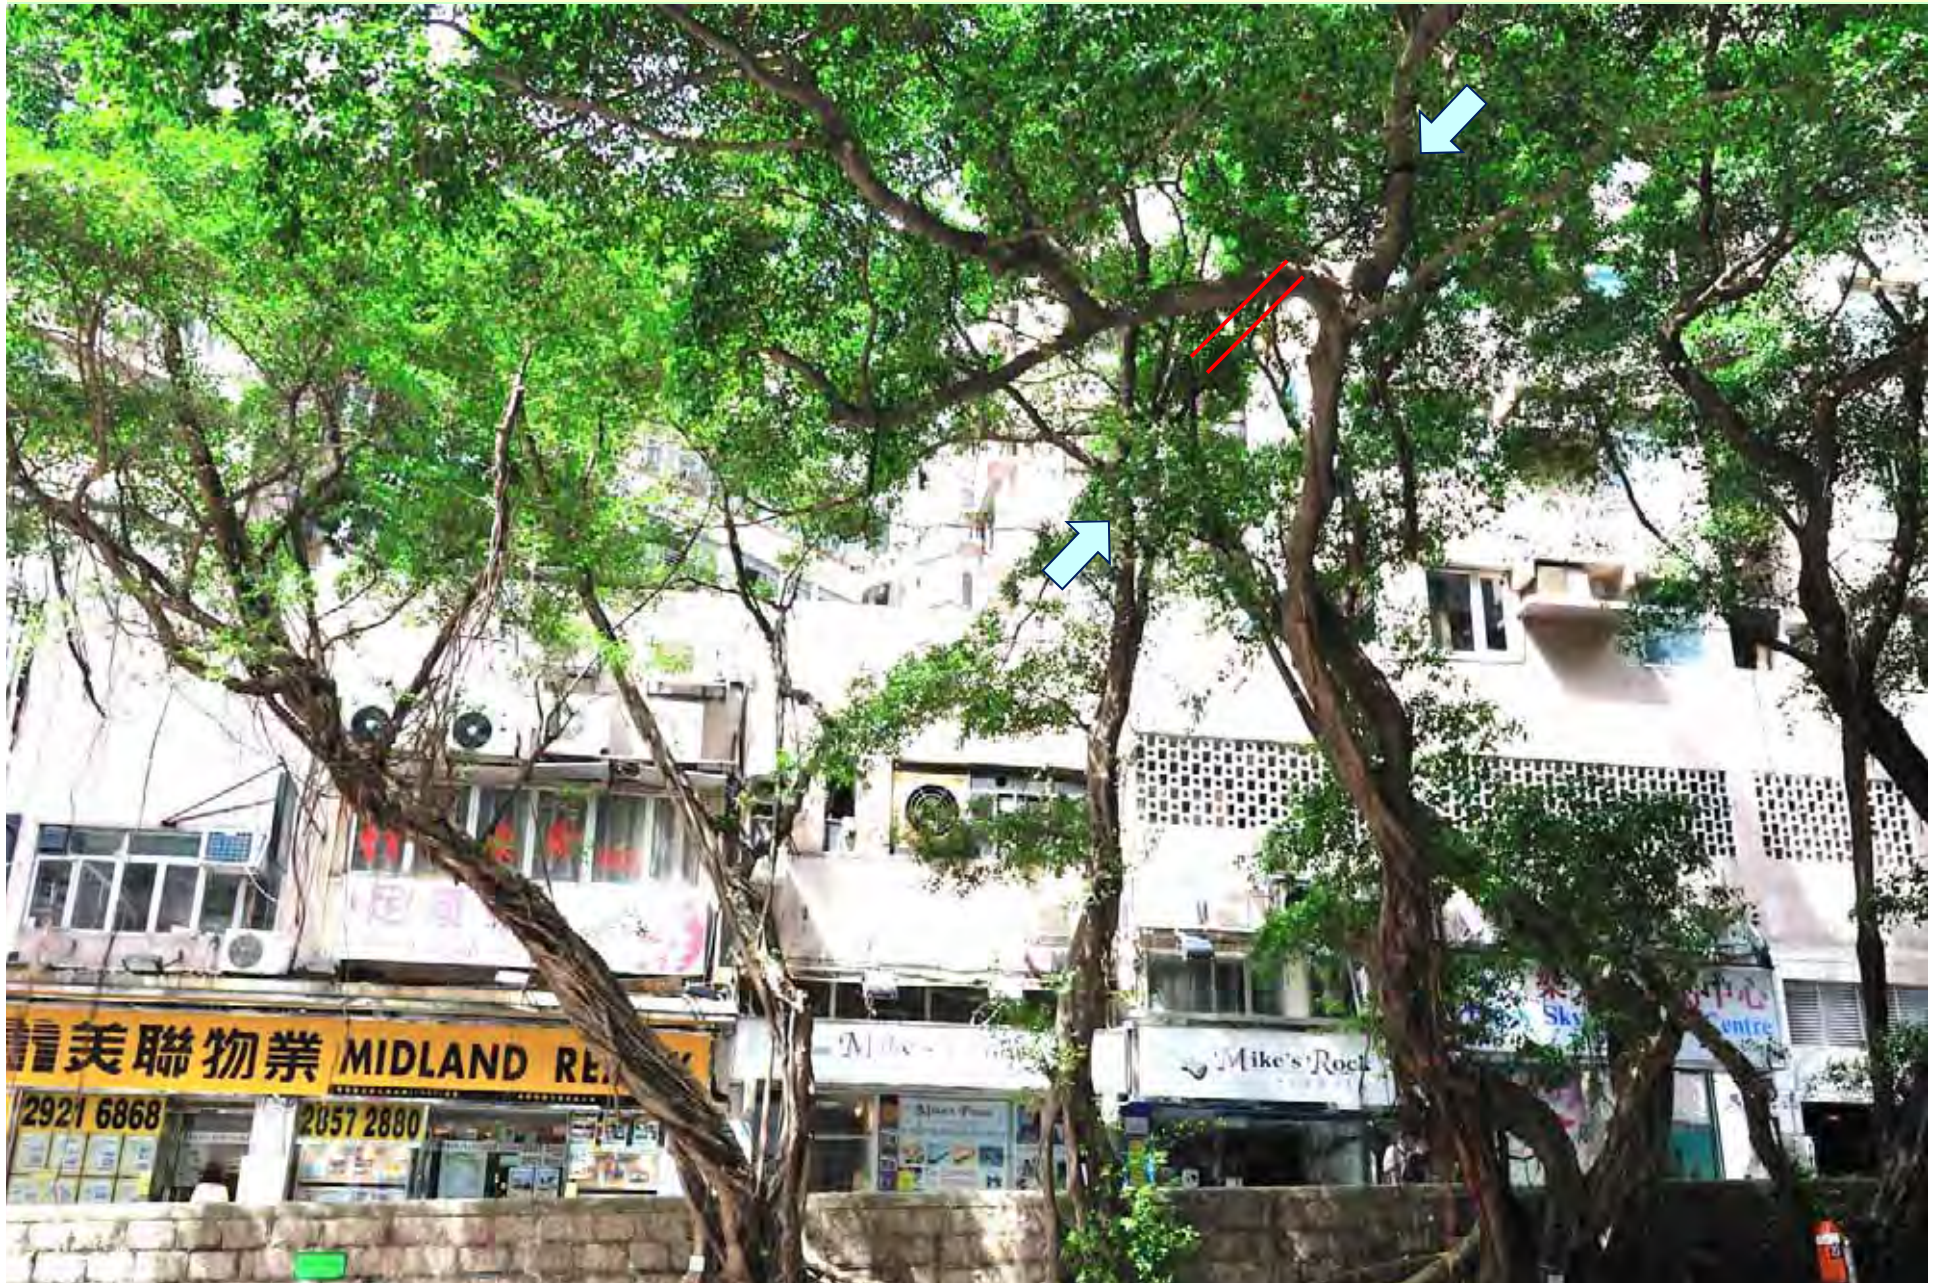
Photo T5-18. Existing Cobra cable bracing using T6 to hold T4 stem A.

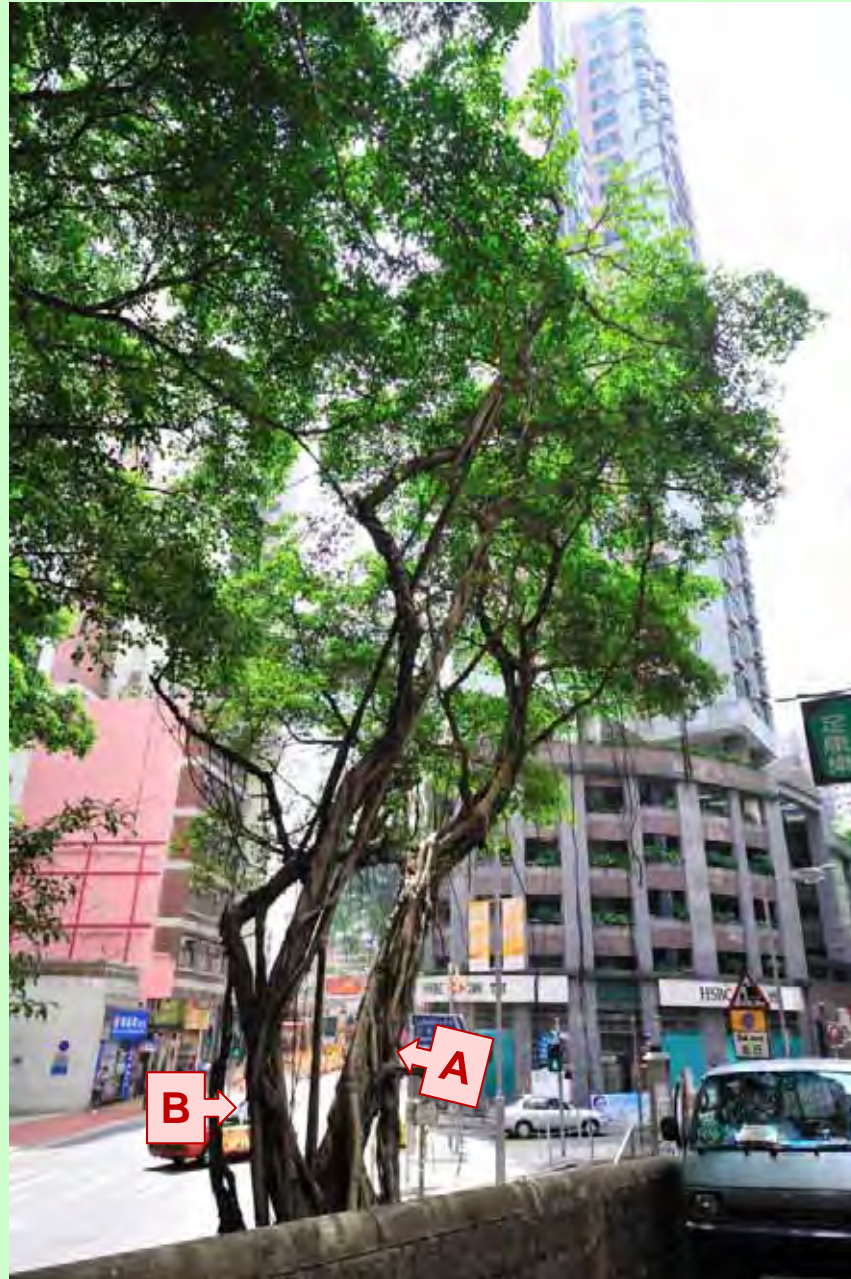
Photo T6-3. The tree viewed from the west at St Stephen's Lane, with rather low live crown ratio.

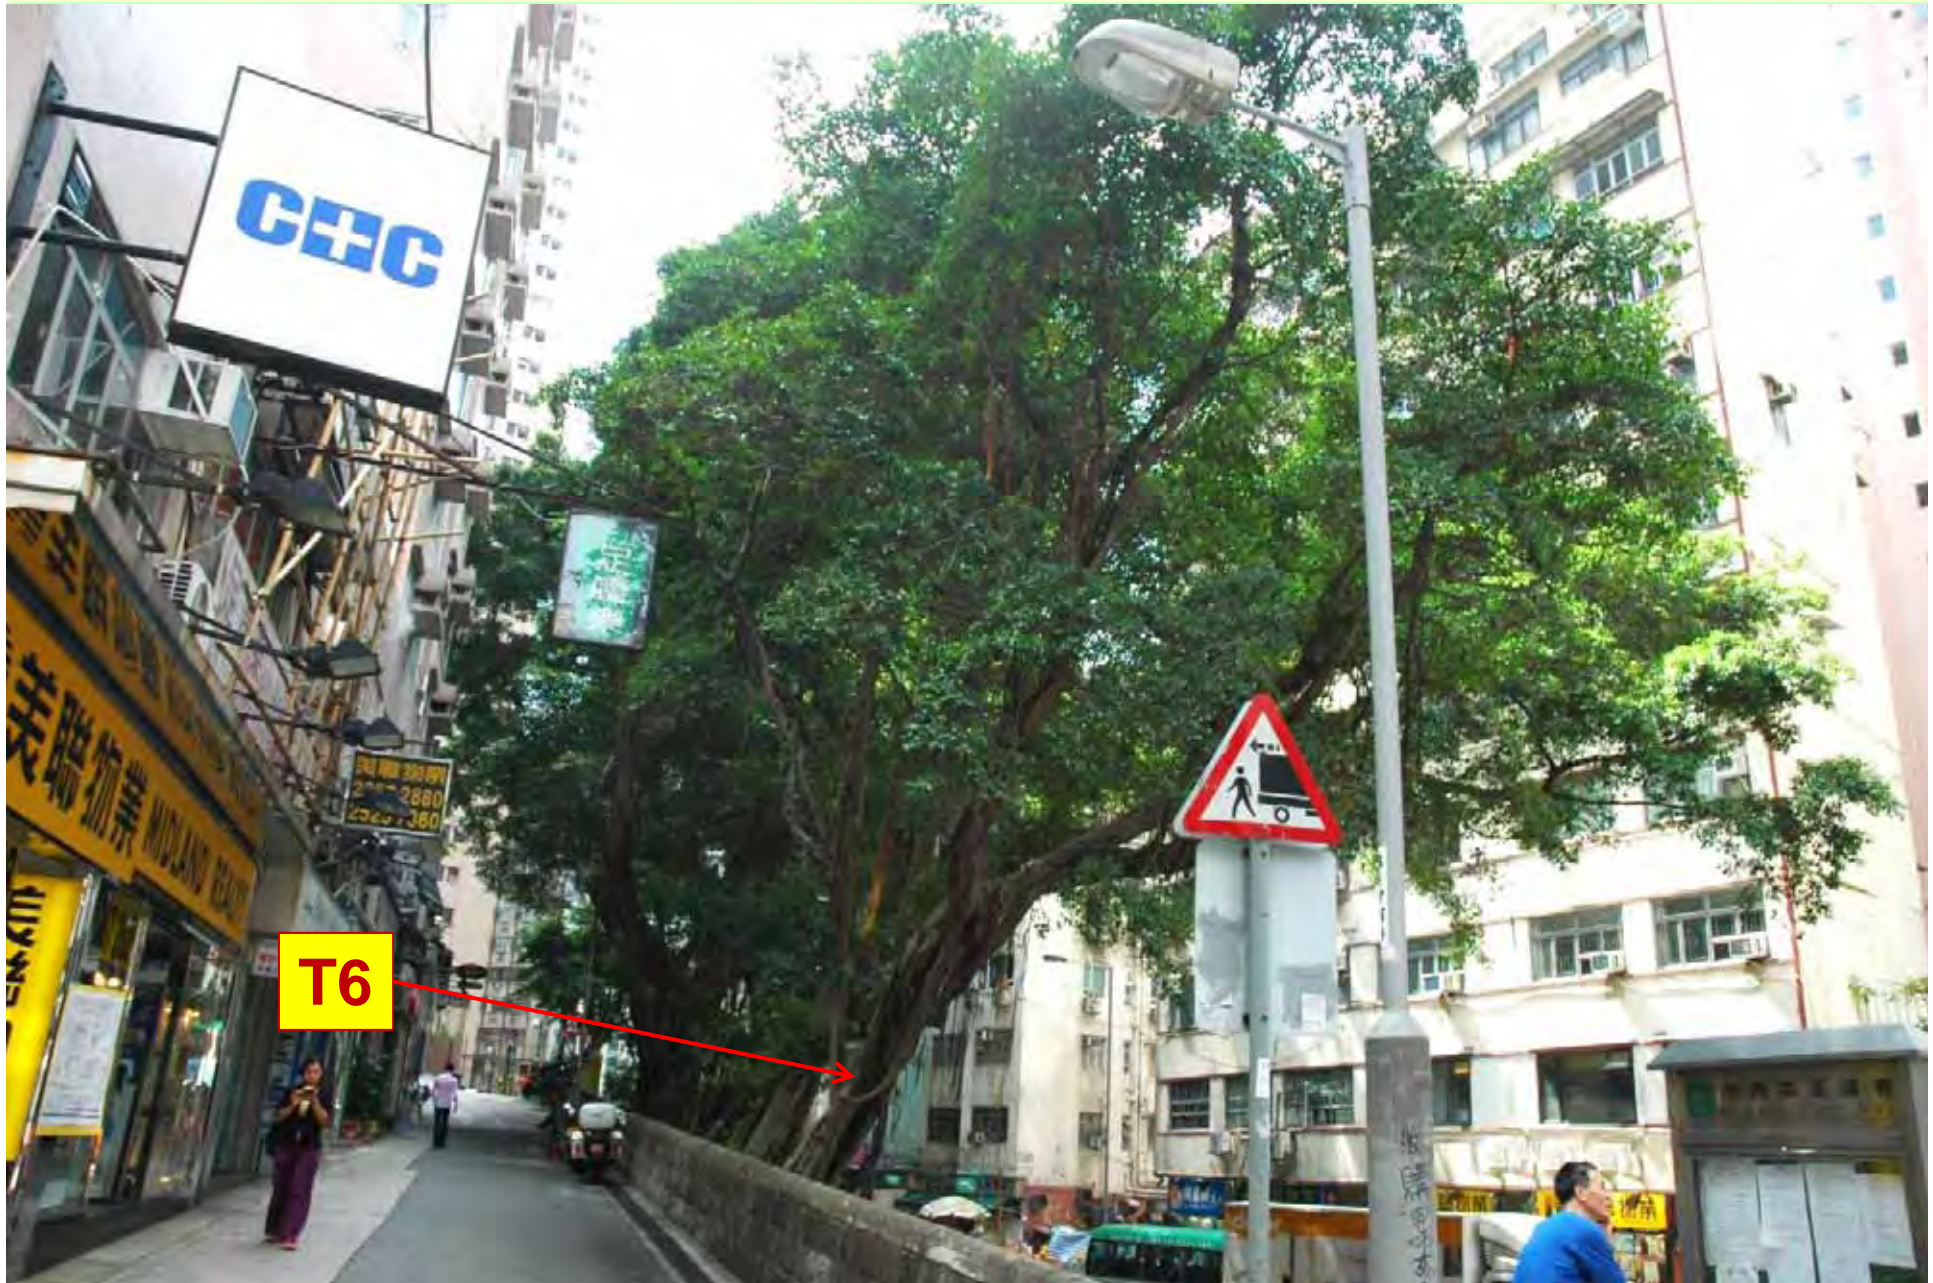
Photo T6-4. The tree viewed from the east at St Stephen's Lane, indicating tilting towards Bonham Road.

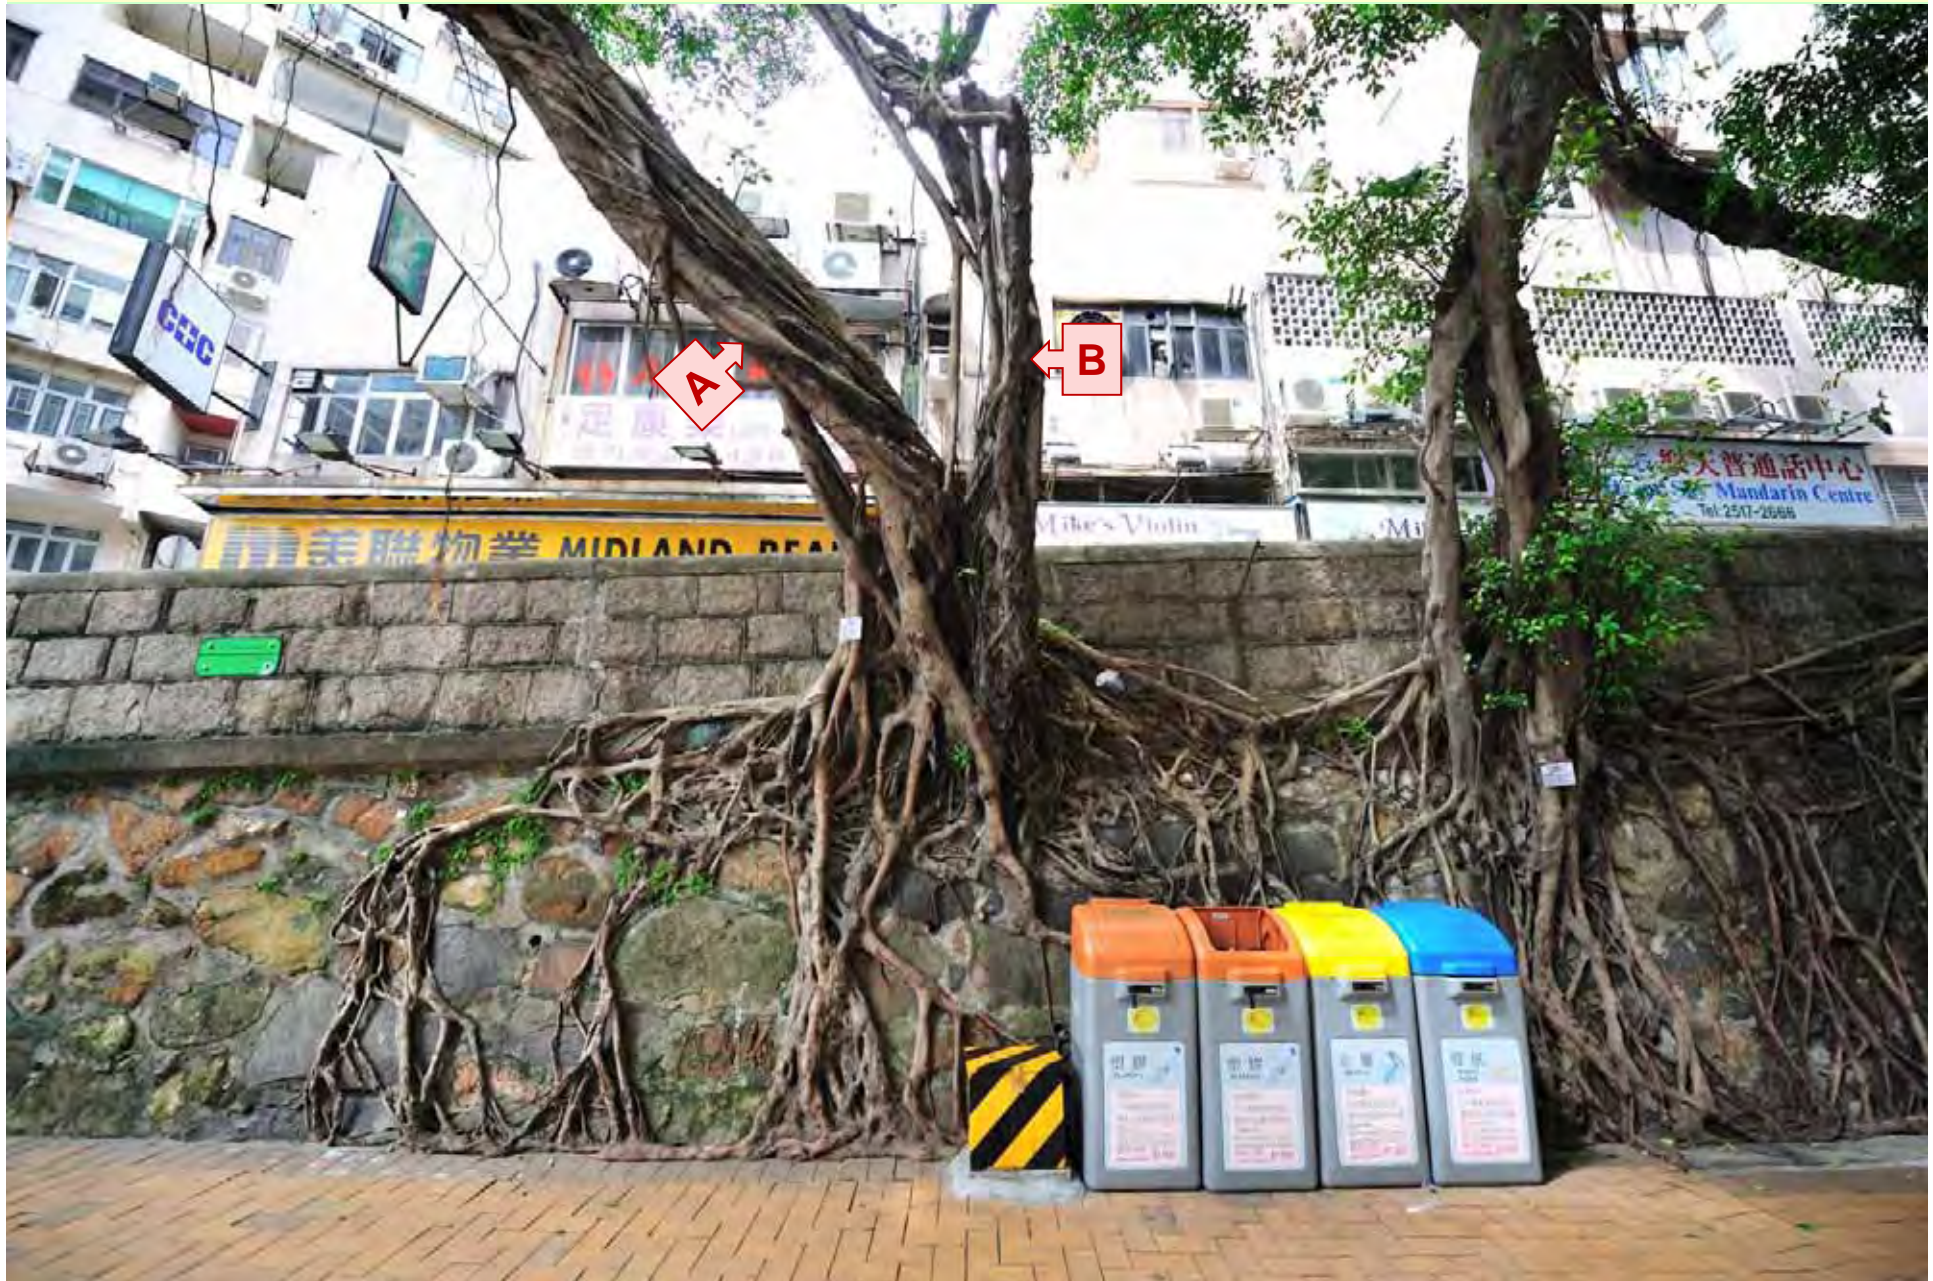
Photo T6-5. Limited spread of surface roots and their grafting union with neighbour T5; twin-stem tree.

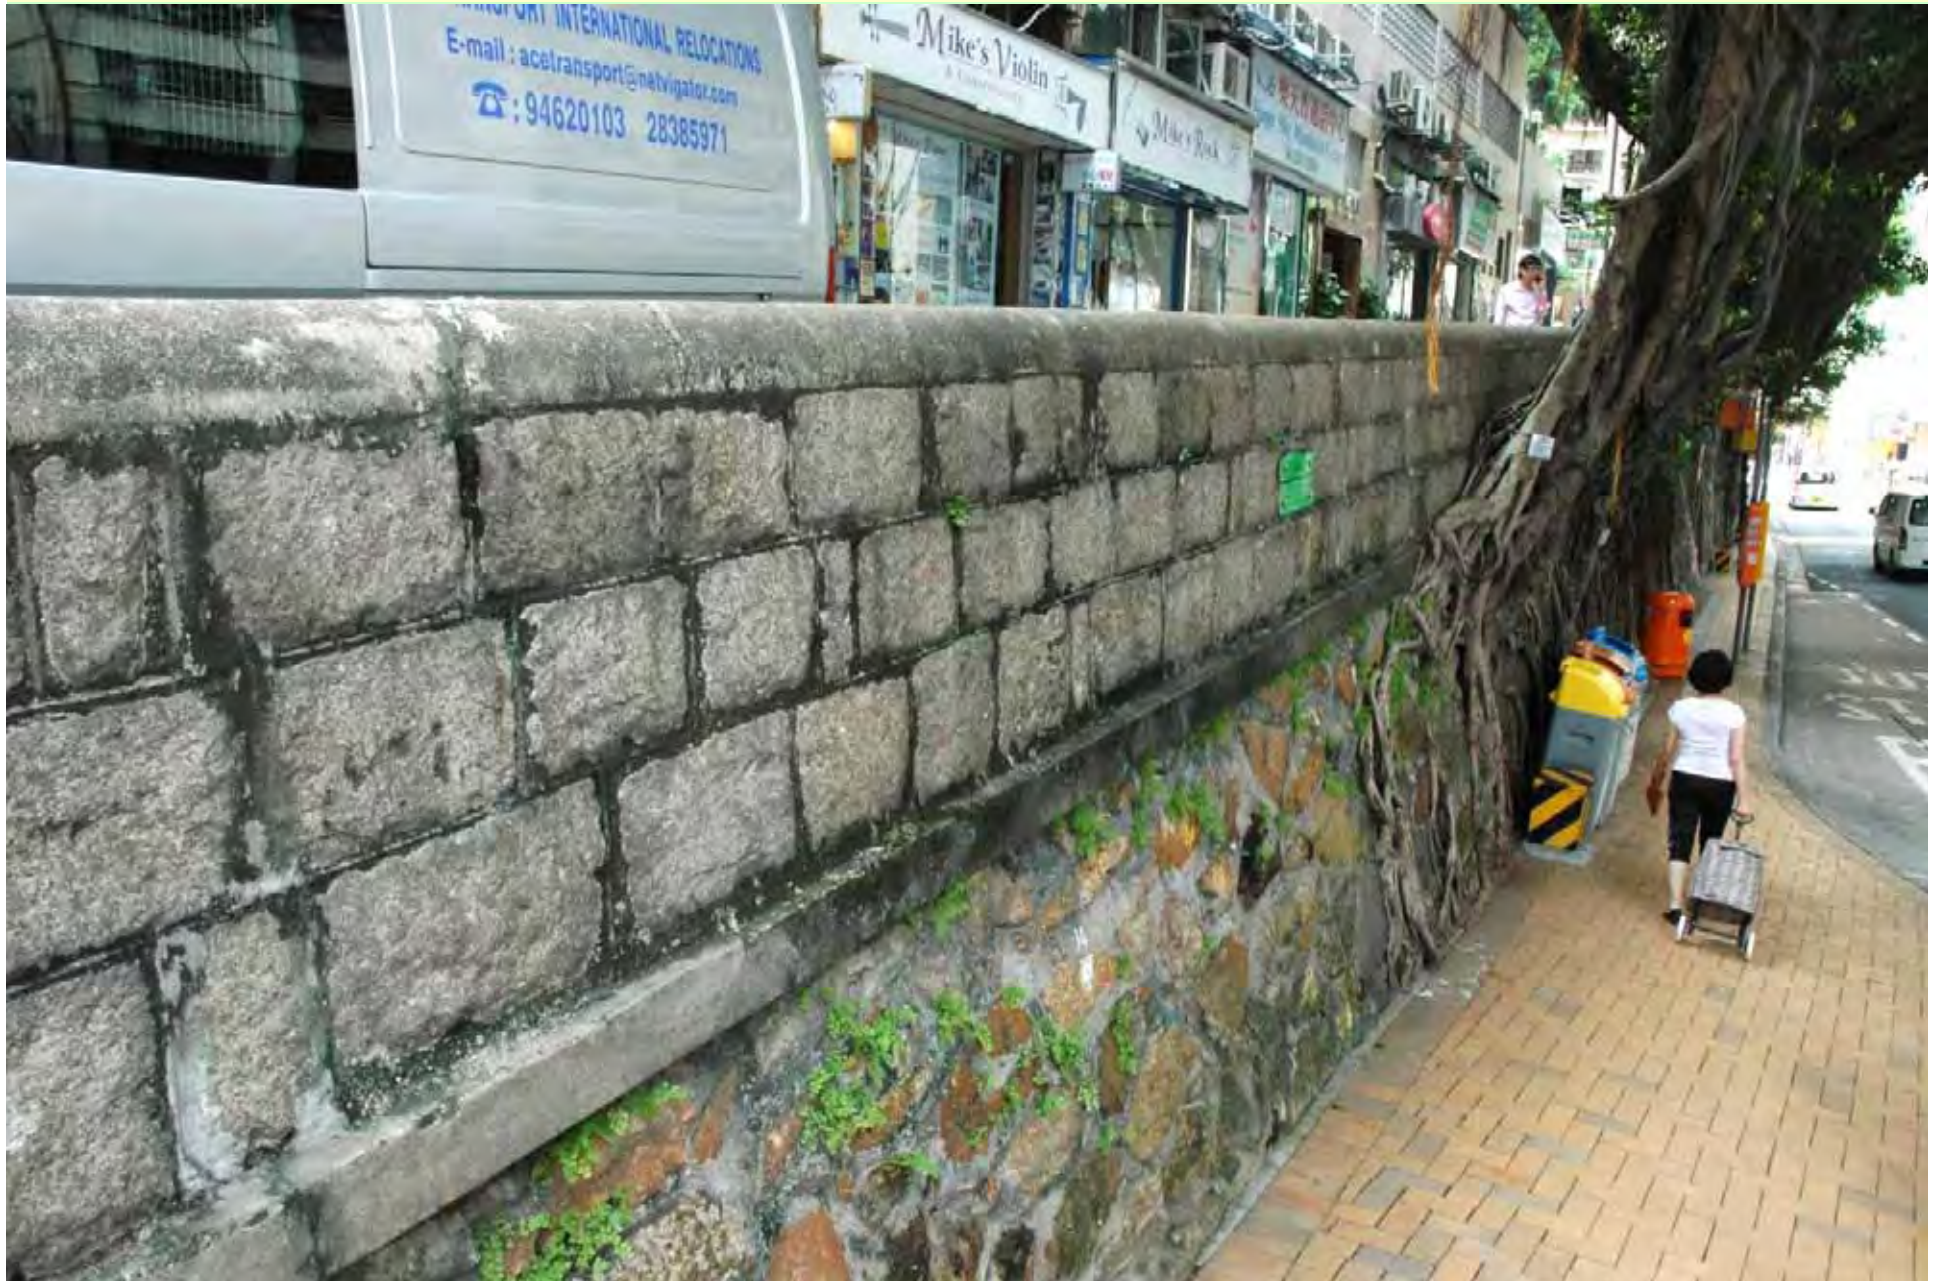
Photo T6-6. Restriction to root penetration at the toe of the rather low retaining wall.

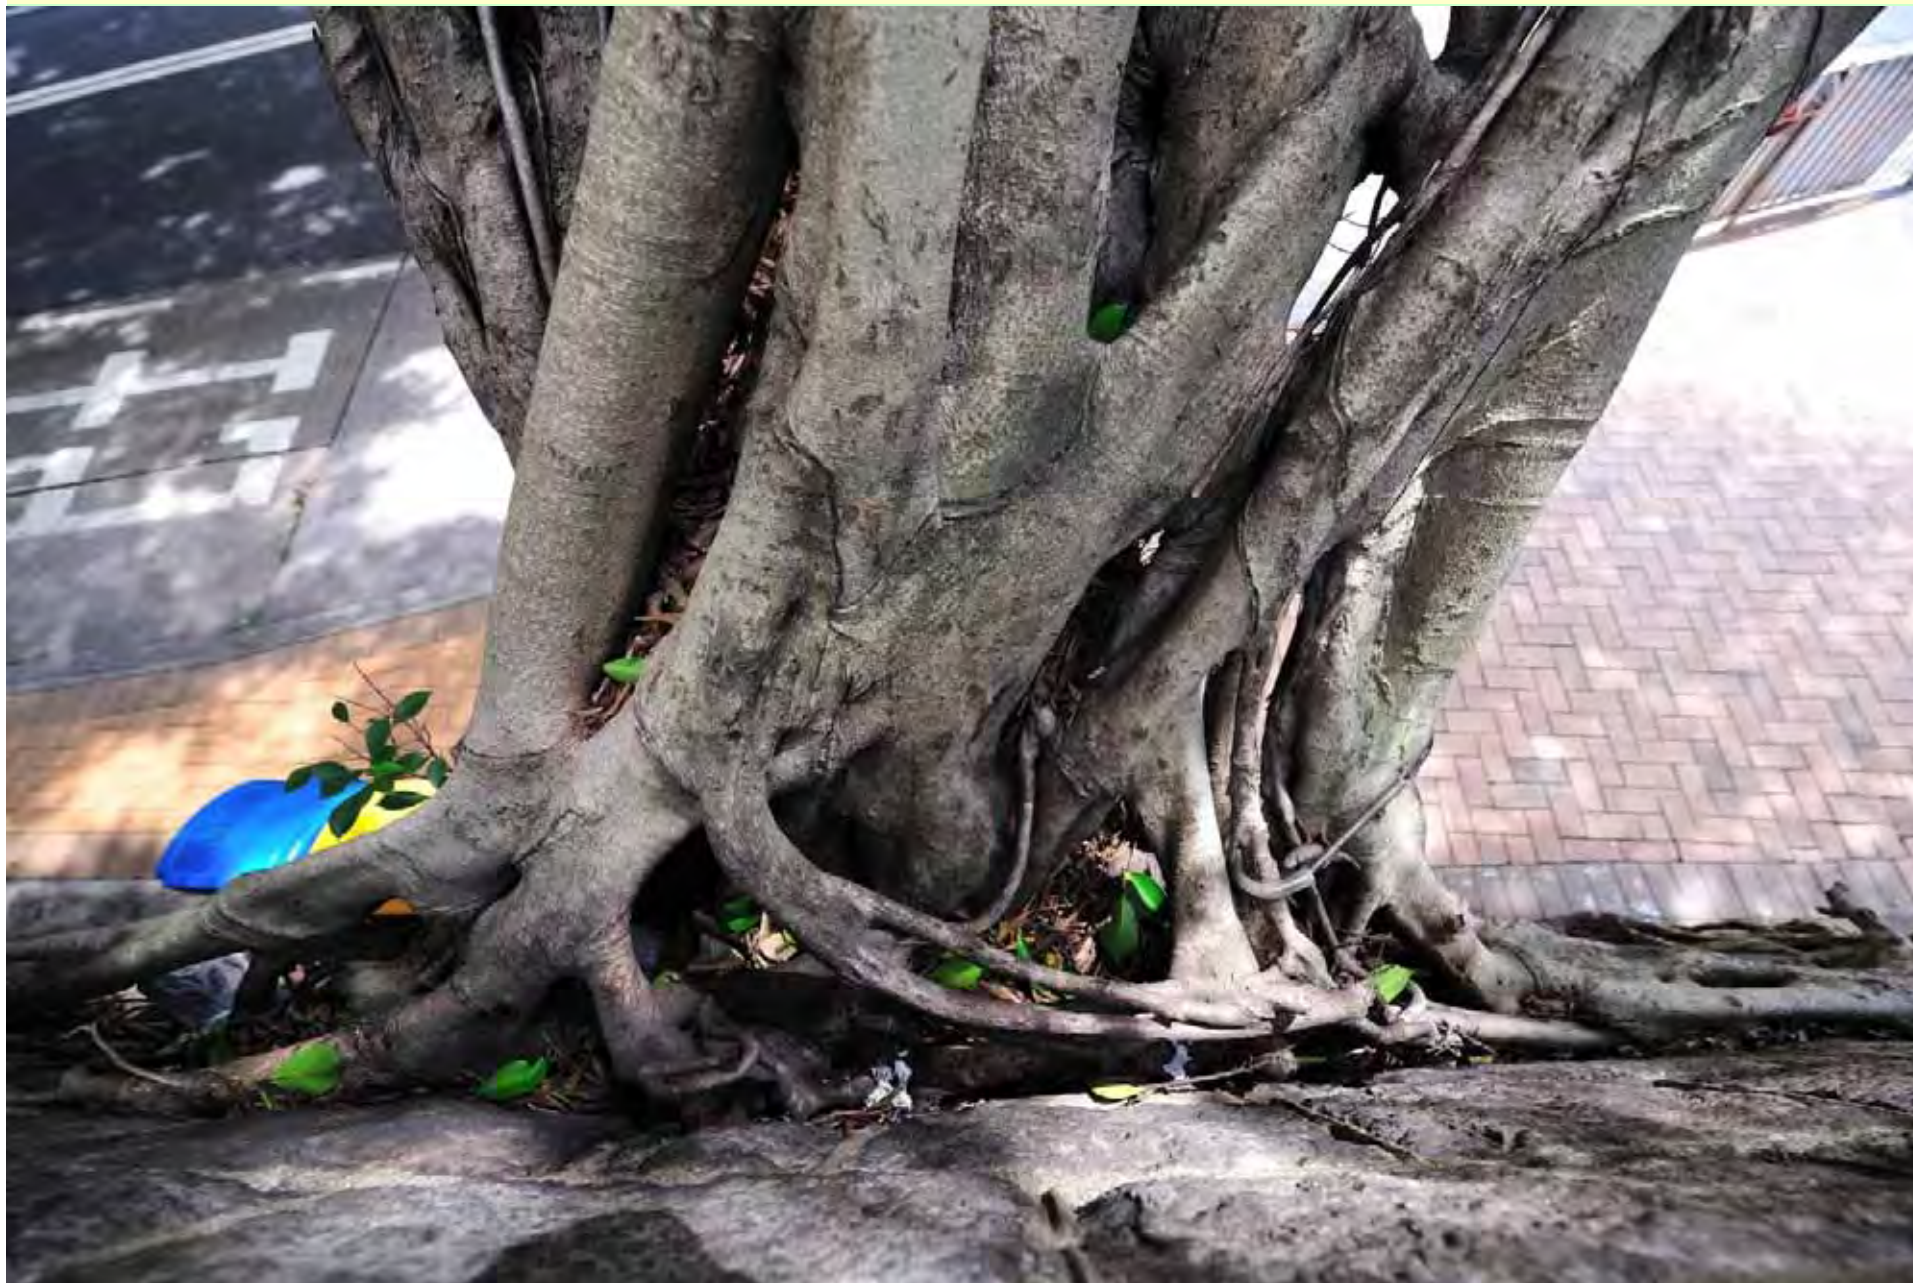
Photo T6-7. Relationship between tree and wall crest, viewed from the south.

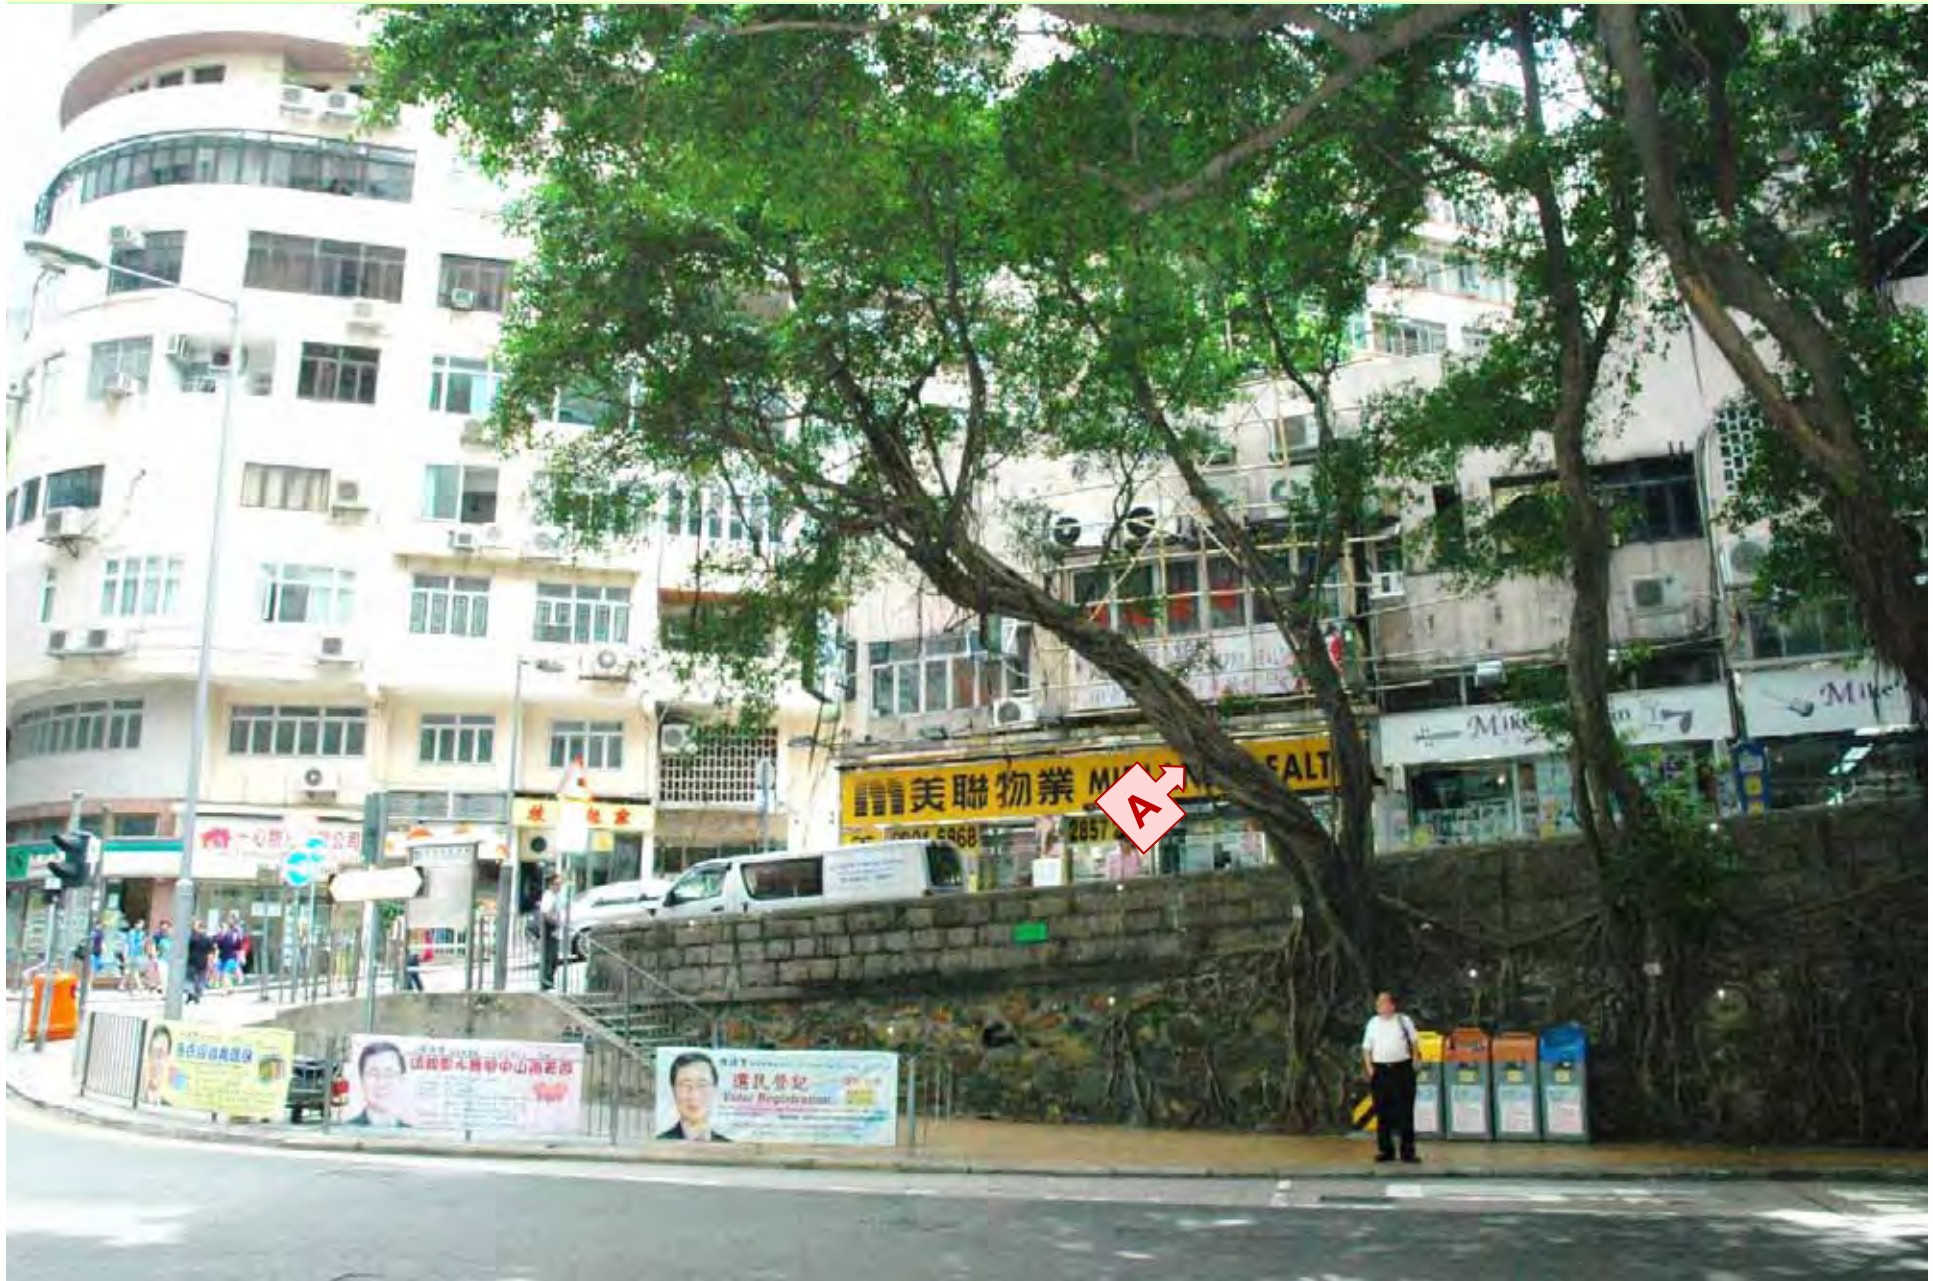
Photo T6-10. Stem A tilts notably towards the east.

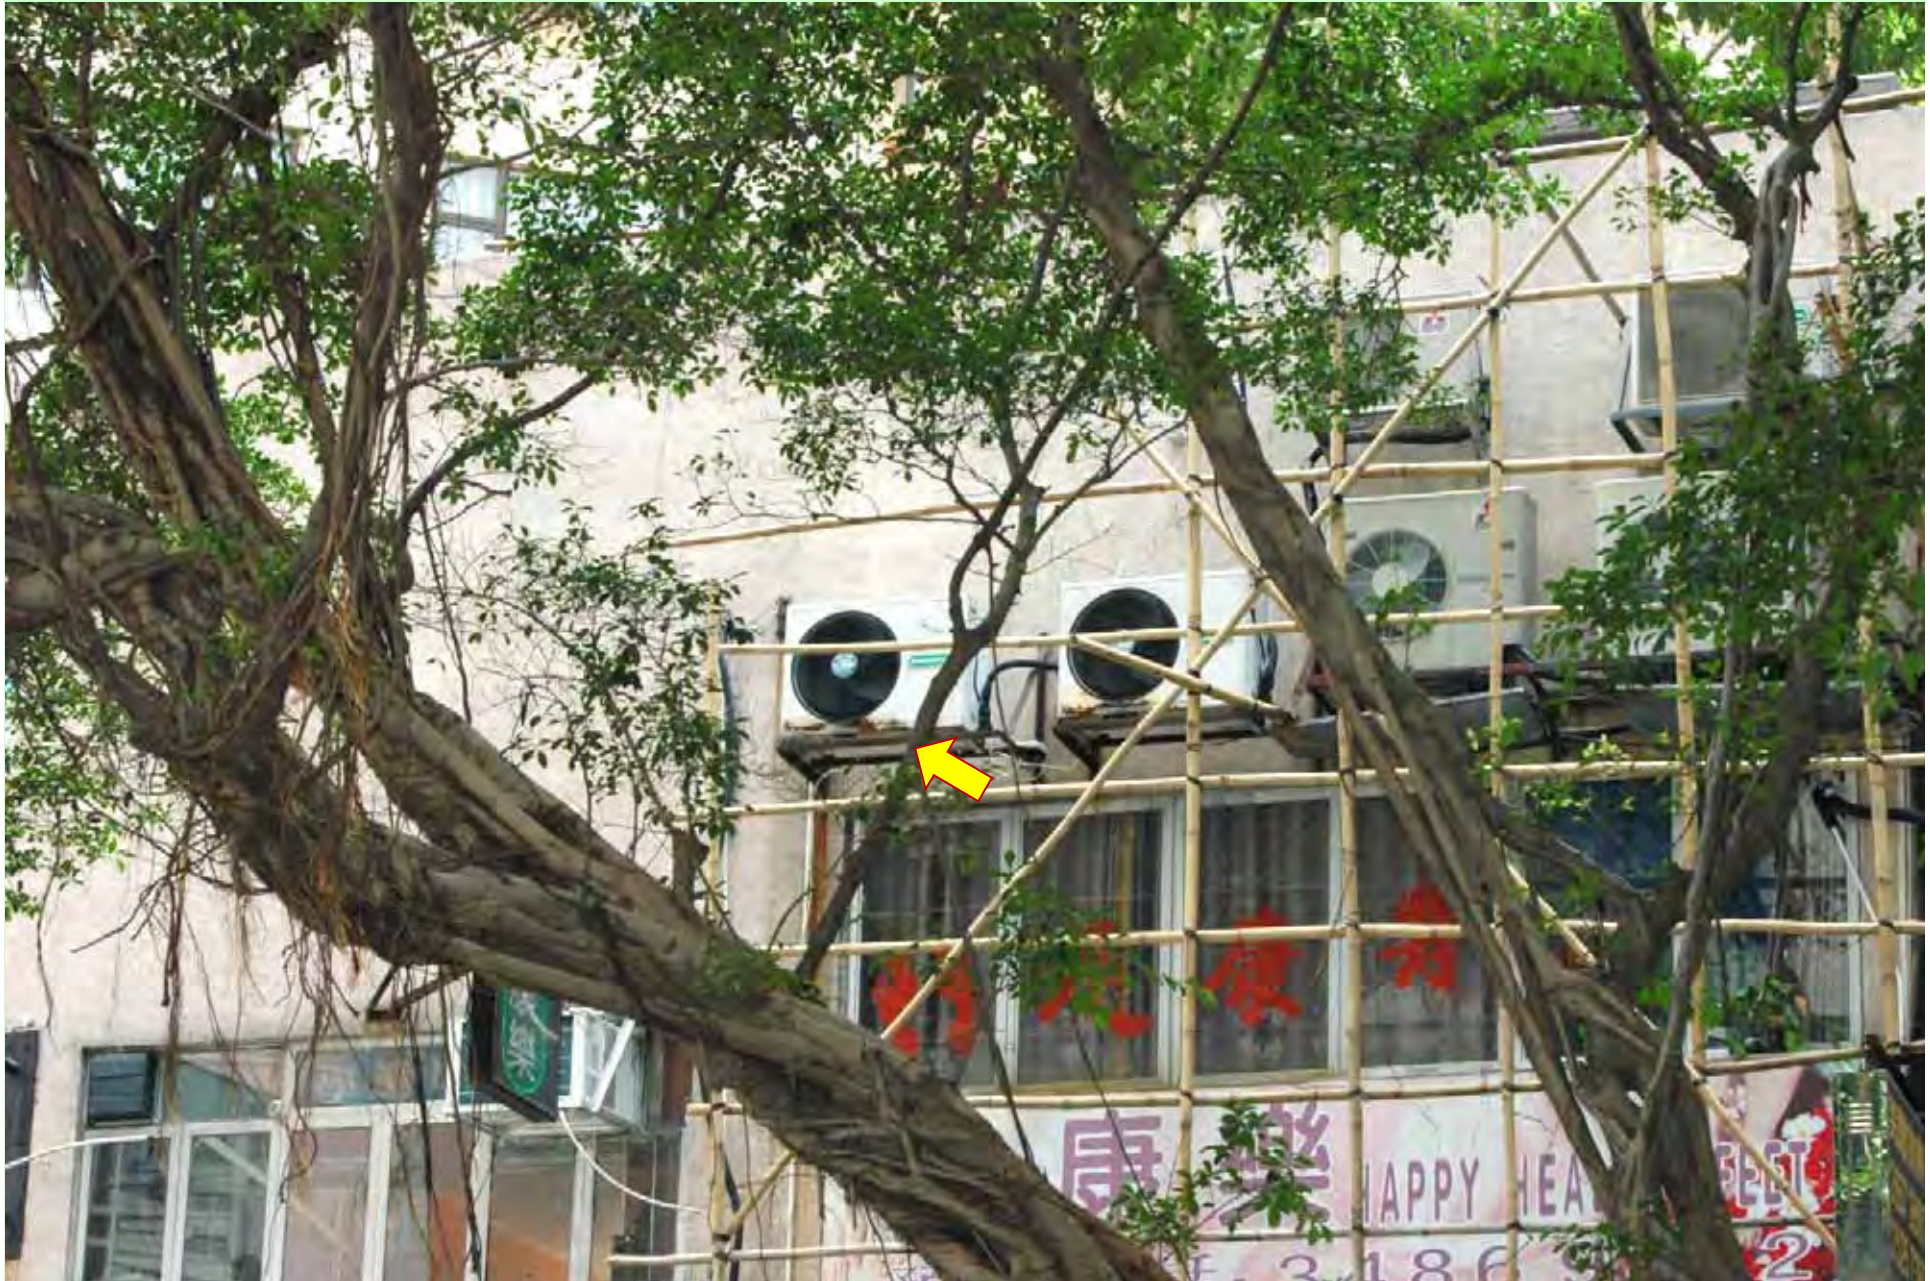
Photo T6-11. Rather upright epicormic branch emerging with an elbow joint from the parent stem A.
