Assessment of Wall Trees on Slope 11SW-A/R577 at Bonham Road

**Highways Department
HKSAR Government**

**C.Y. Jim
The University of Hong Kong
hrajcy@hku.hk**

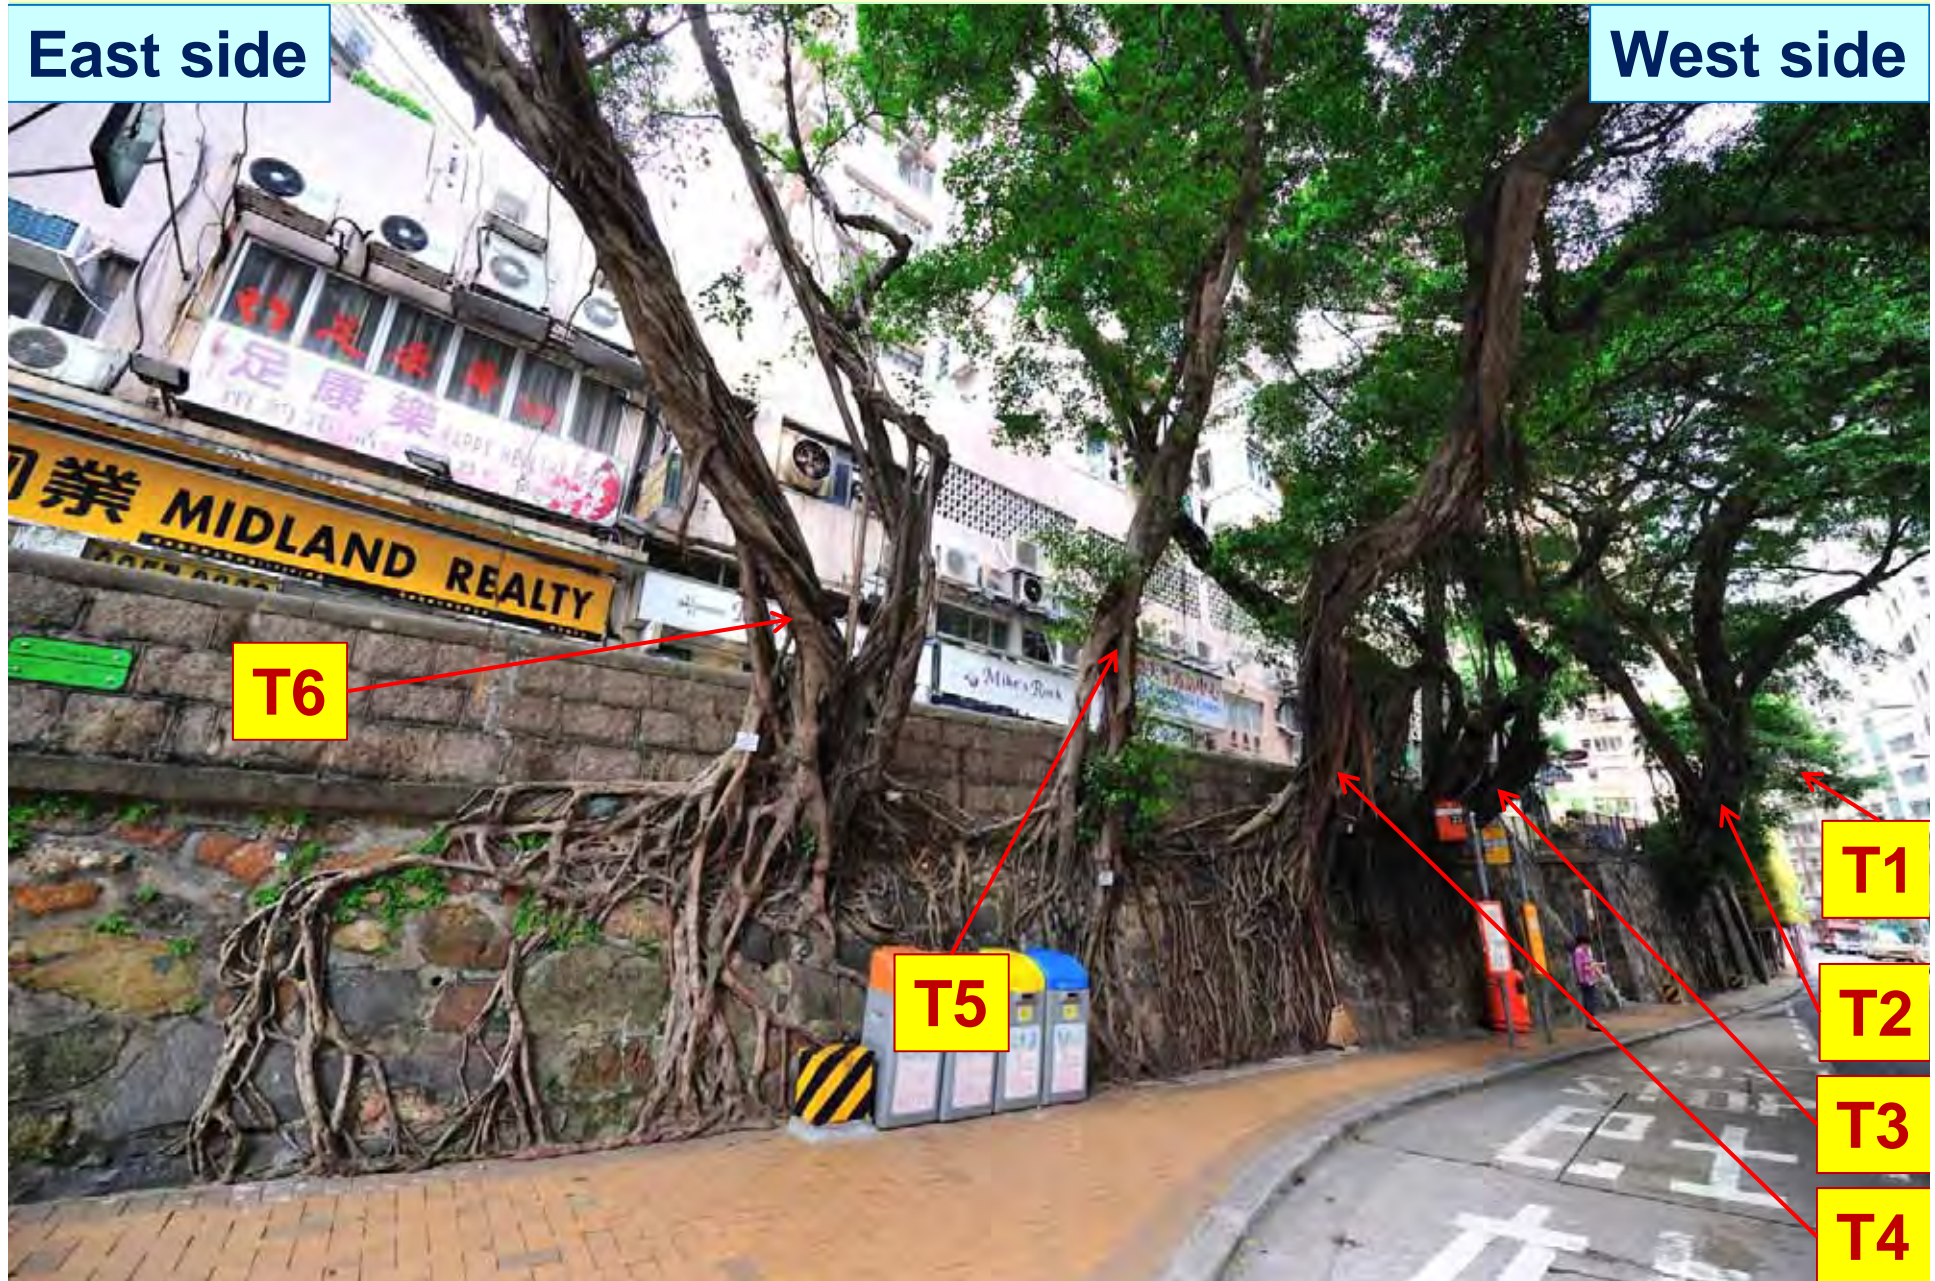
Photo T0-7. The six trees (left to right T6 to T1) hanging on the stone wall at Bonham Road facing Centre Street (north at right).

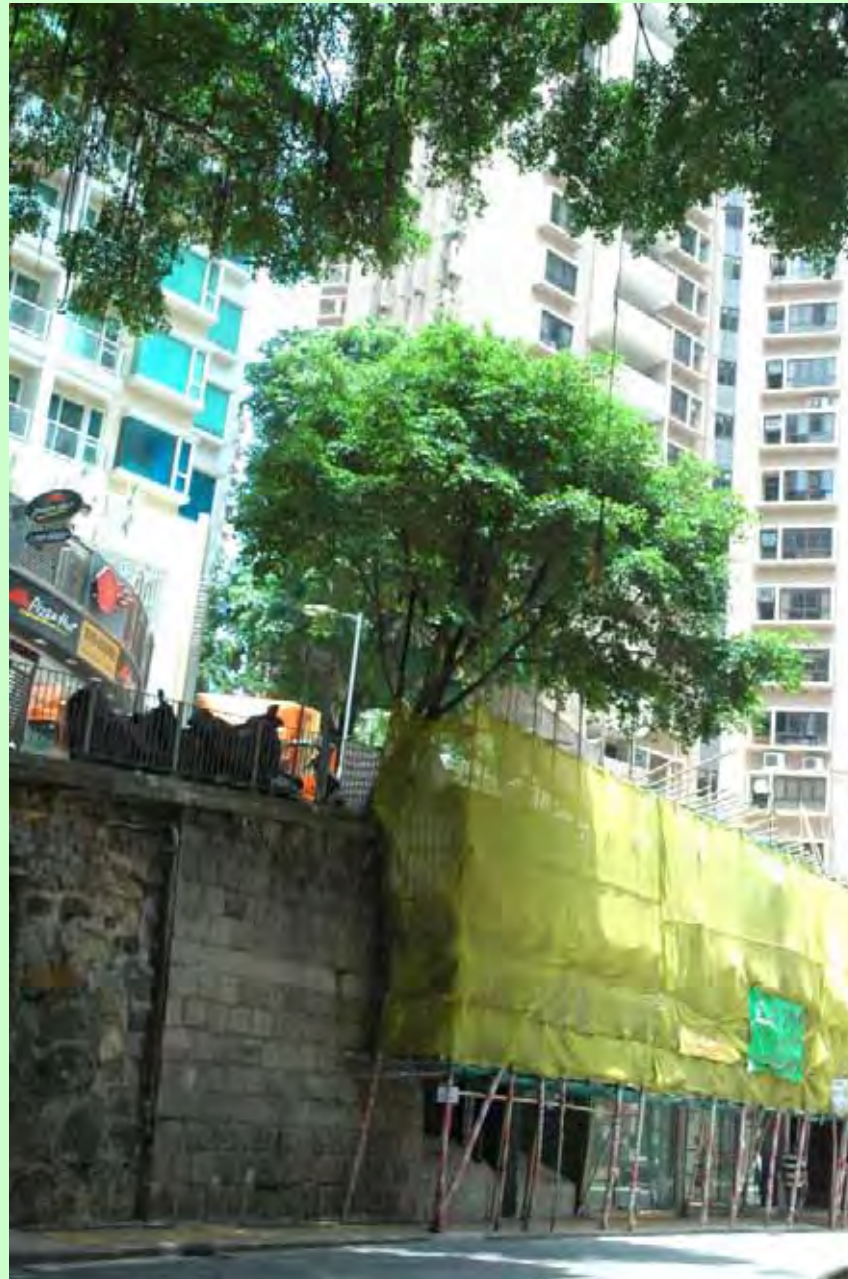
Photo T1-1. The smallest of the six stonewall trees, it clings on the crest at the west end of the wall.

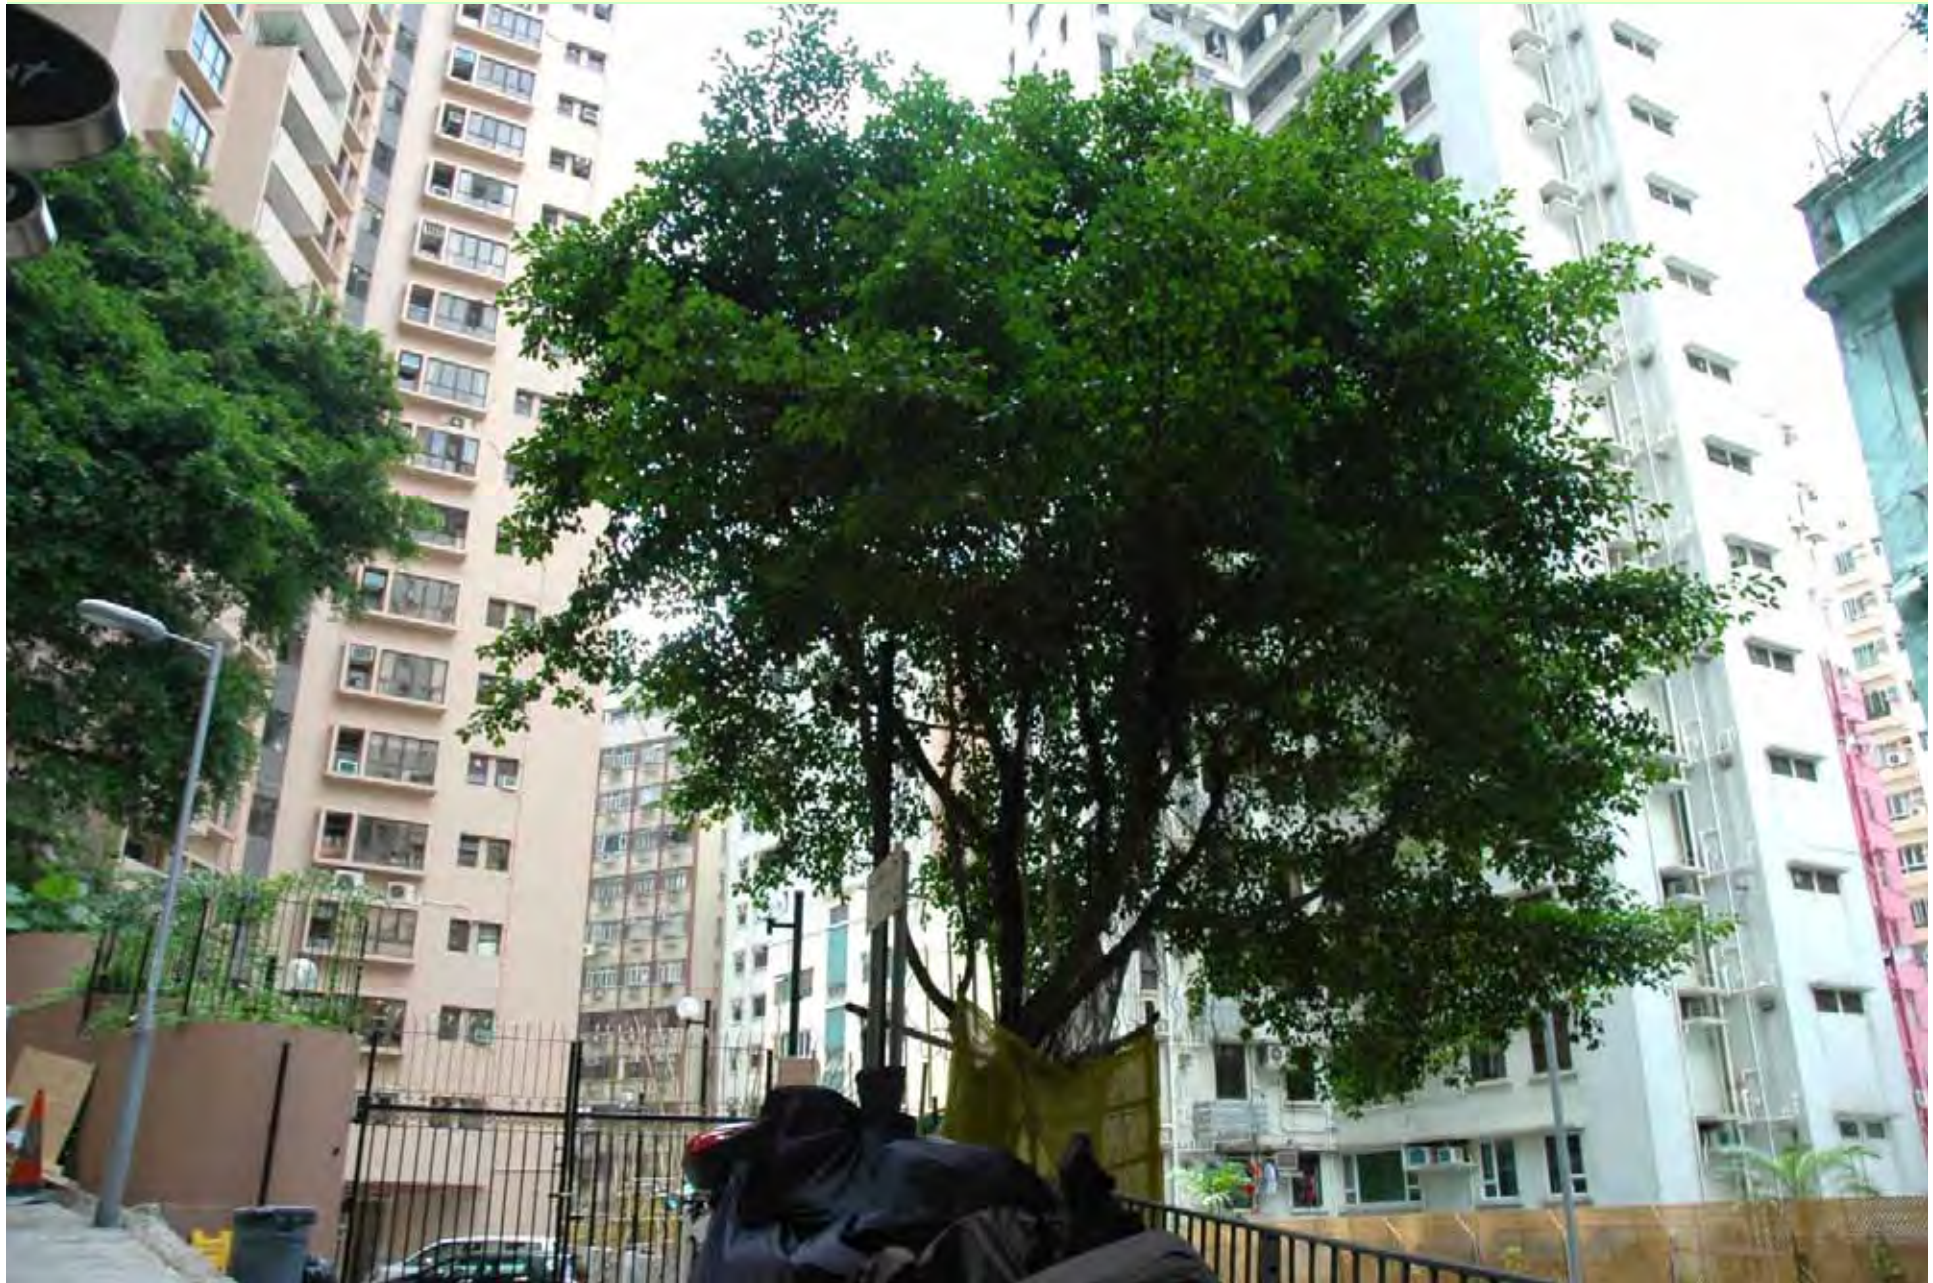
Photo T1-2. Viewed from the east at St Stephen's Lane, the compact and rounded crown keeps intact most of its branches.

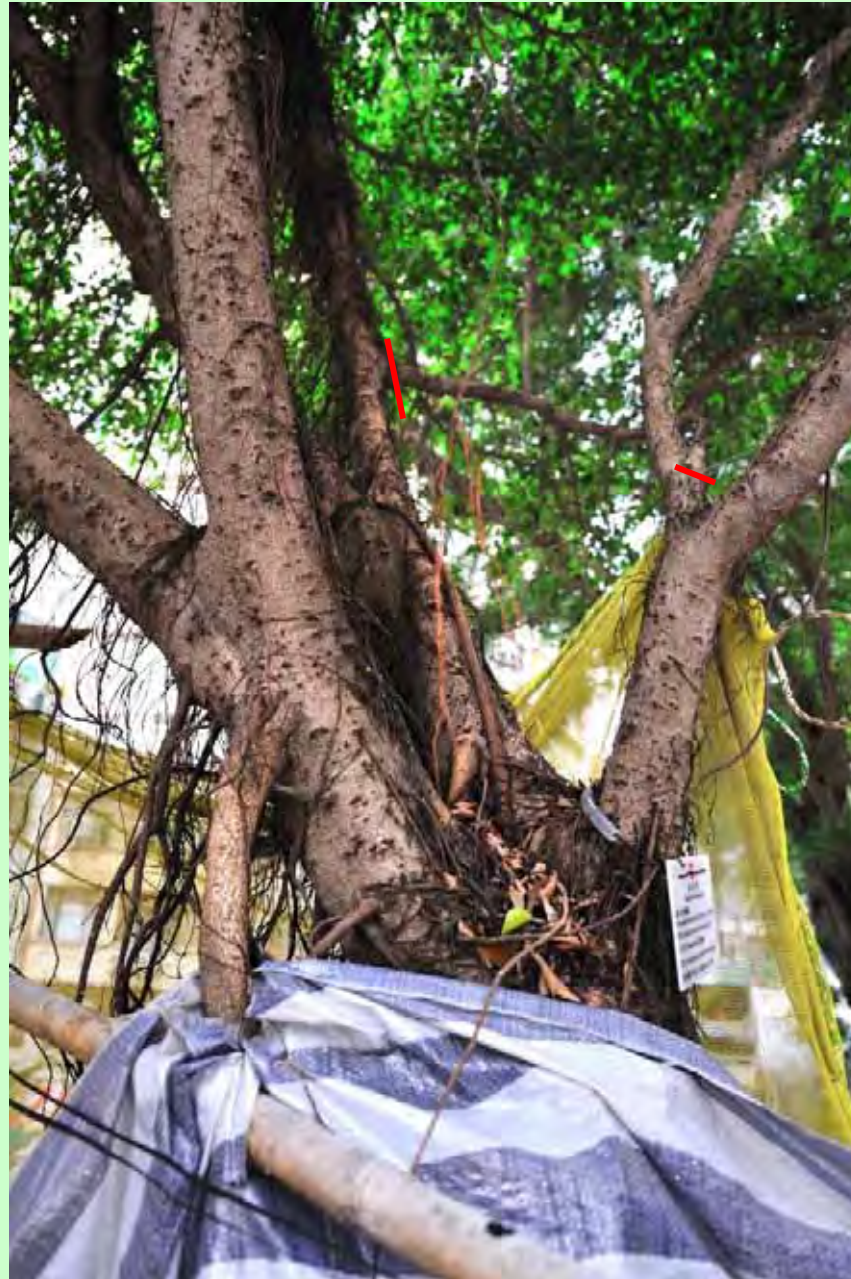
Photo T1-7. All three limbs of the tree emerge at the same height of the trunk, resulting in crowded branching.

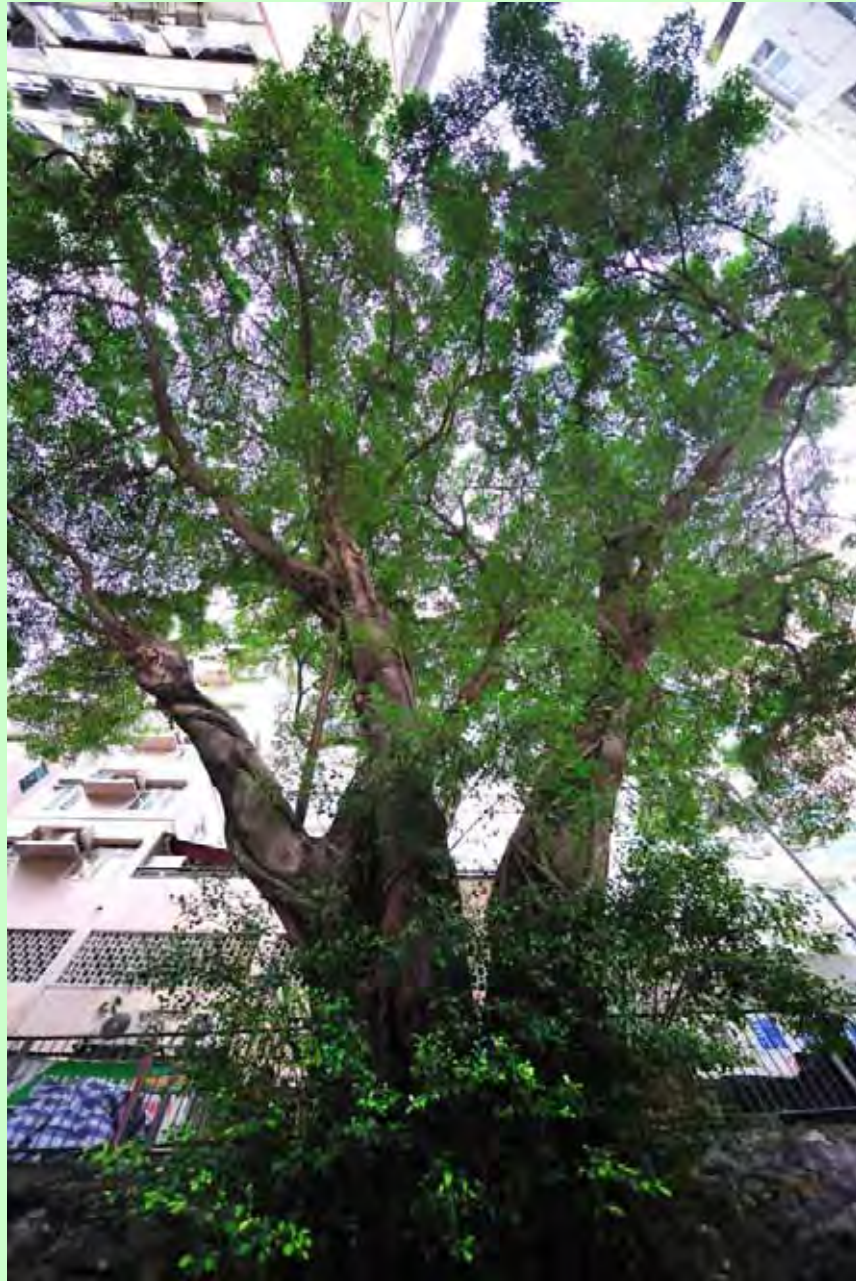
Photo T2-7. The stout multiple trunks support the large and wide crown.

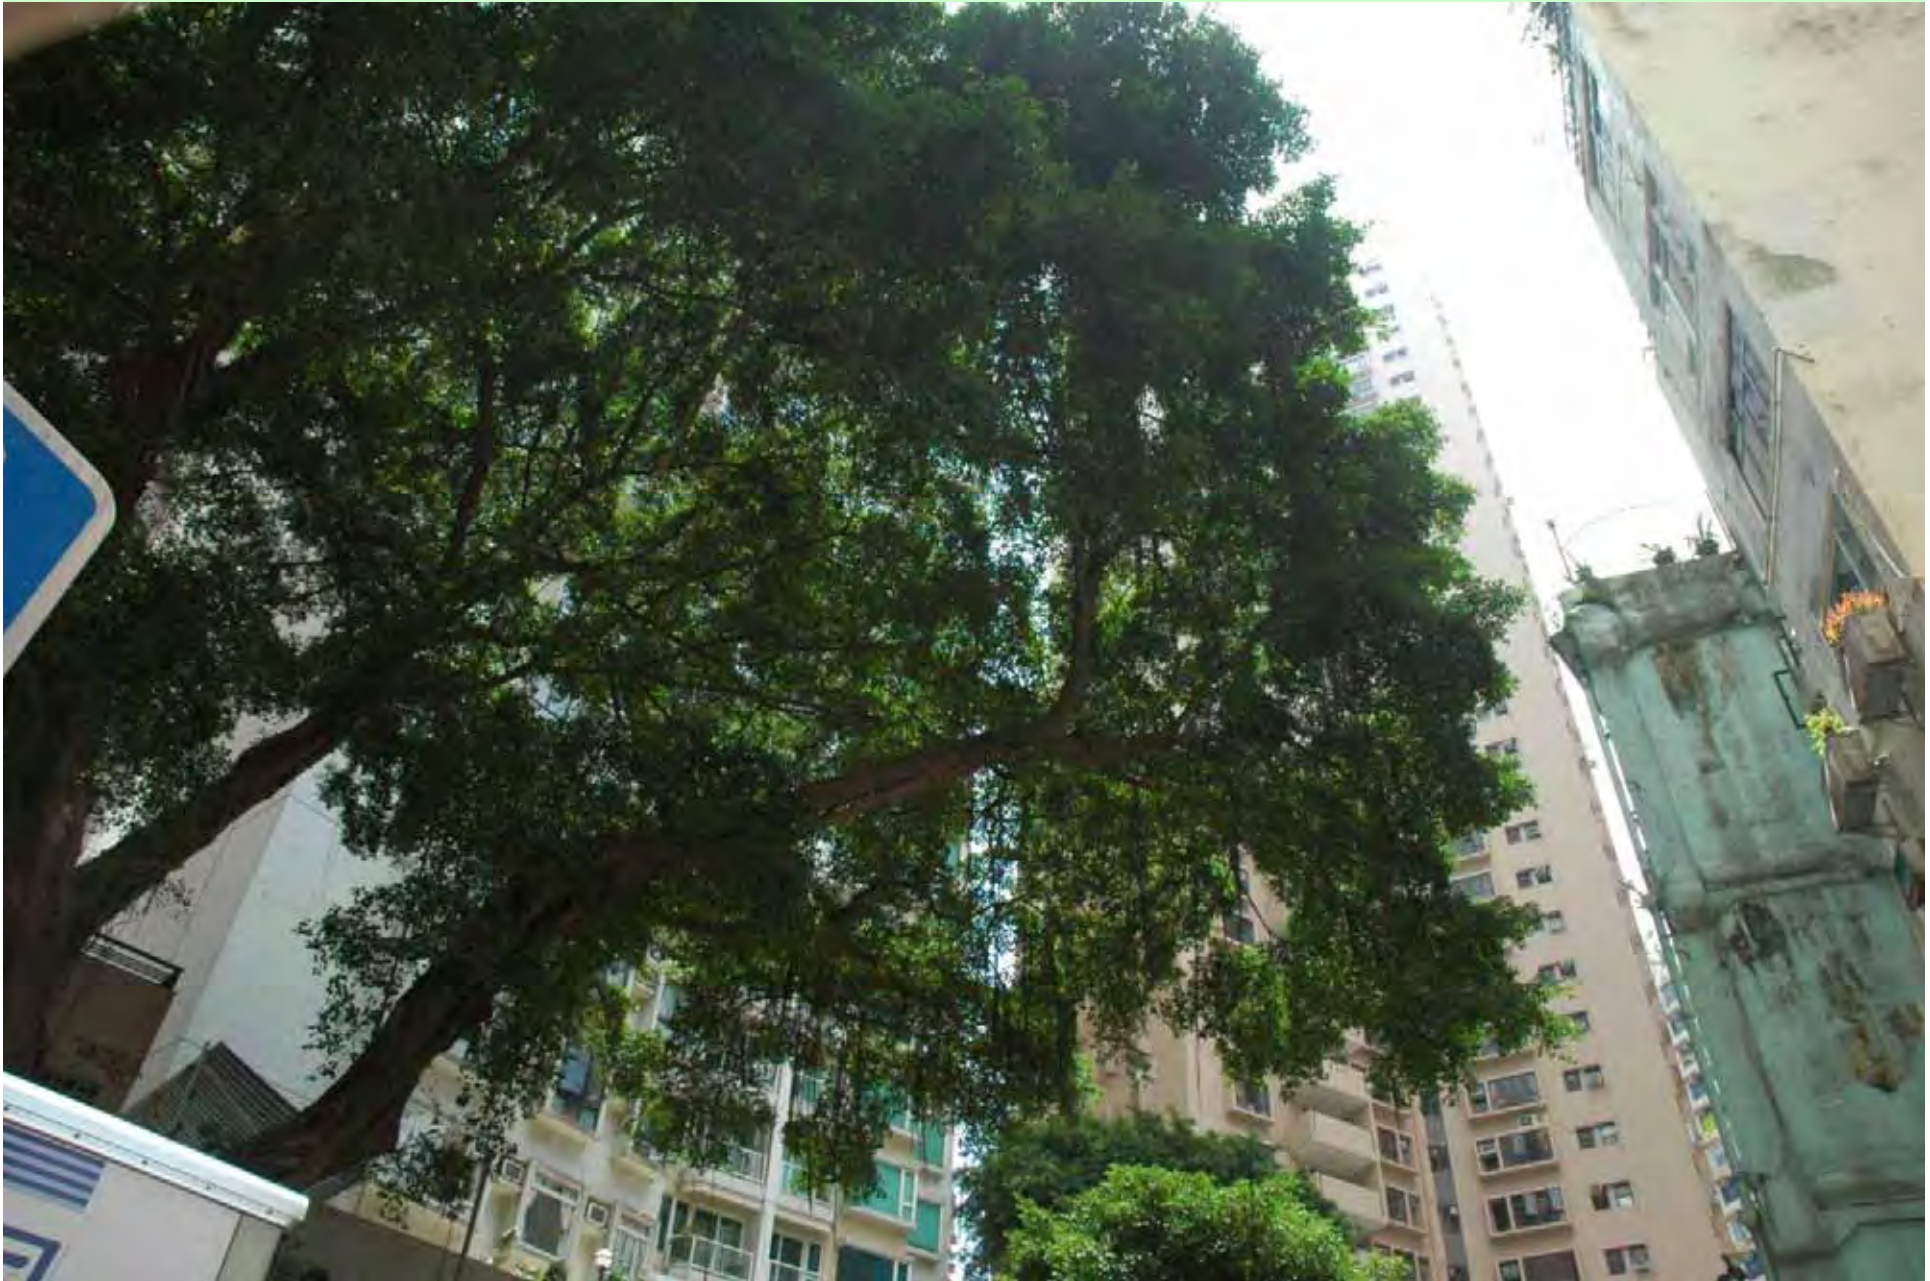
Photo T2-27. The west part of the crown extends northwards across Bonham Road to approach the opposite old building.

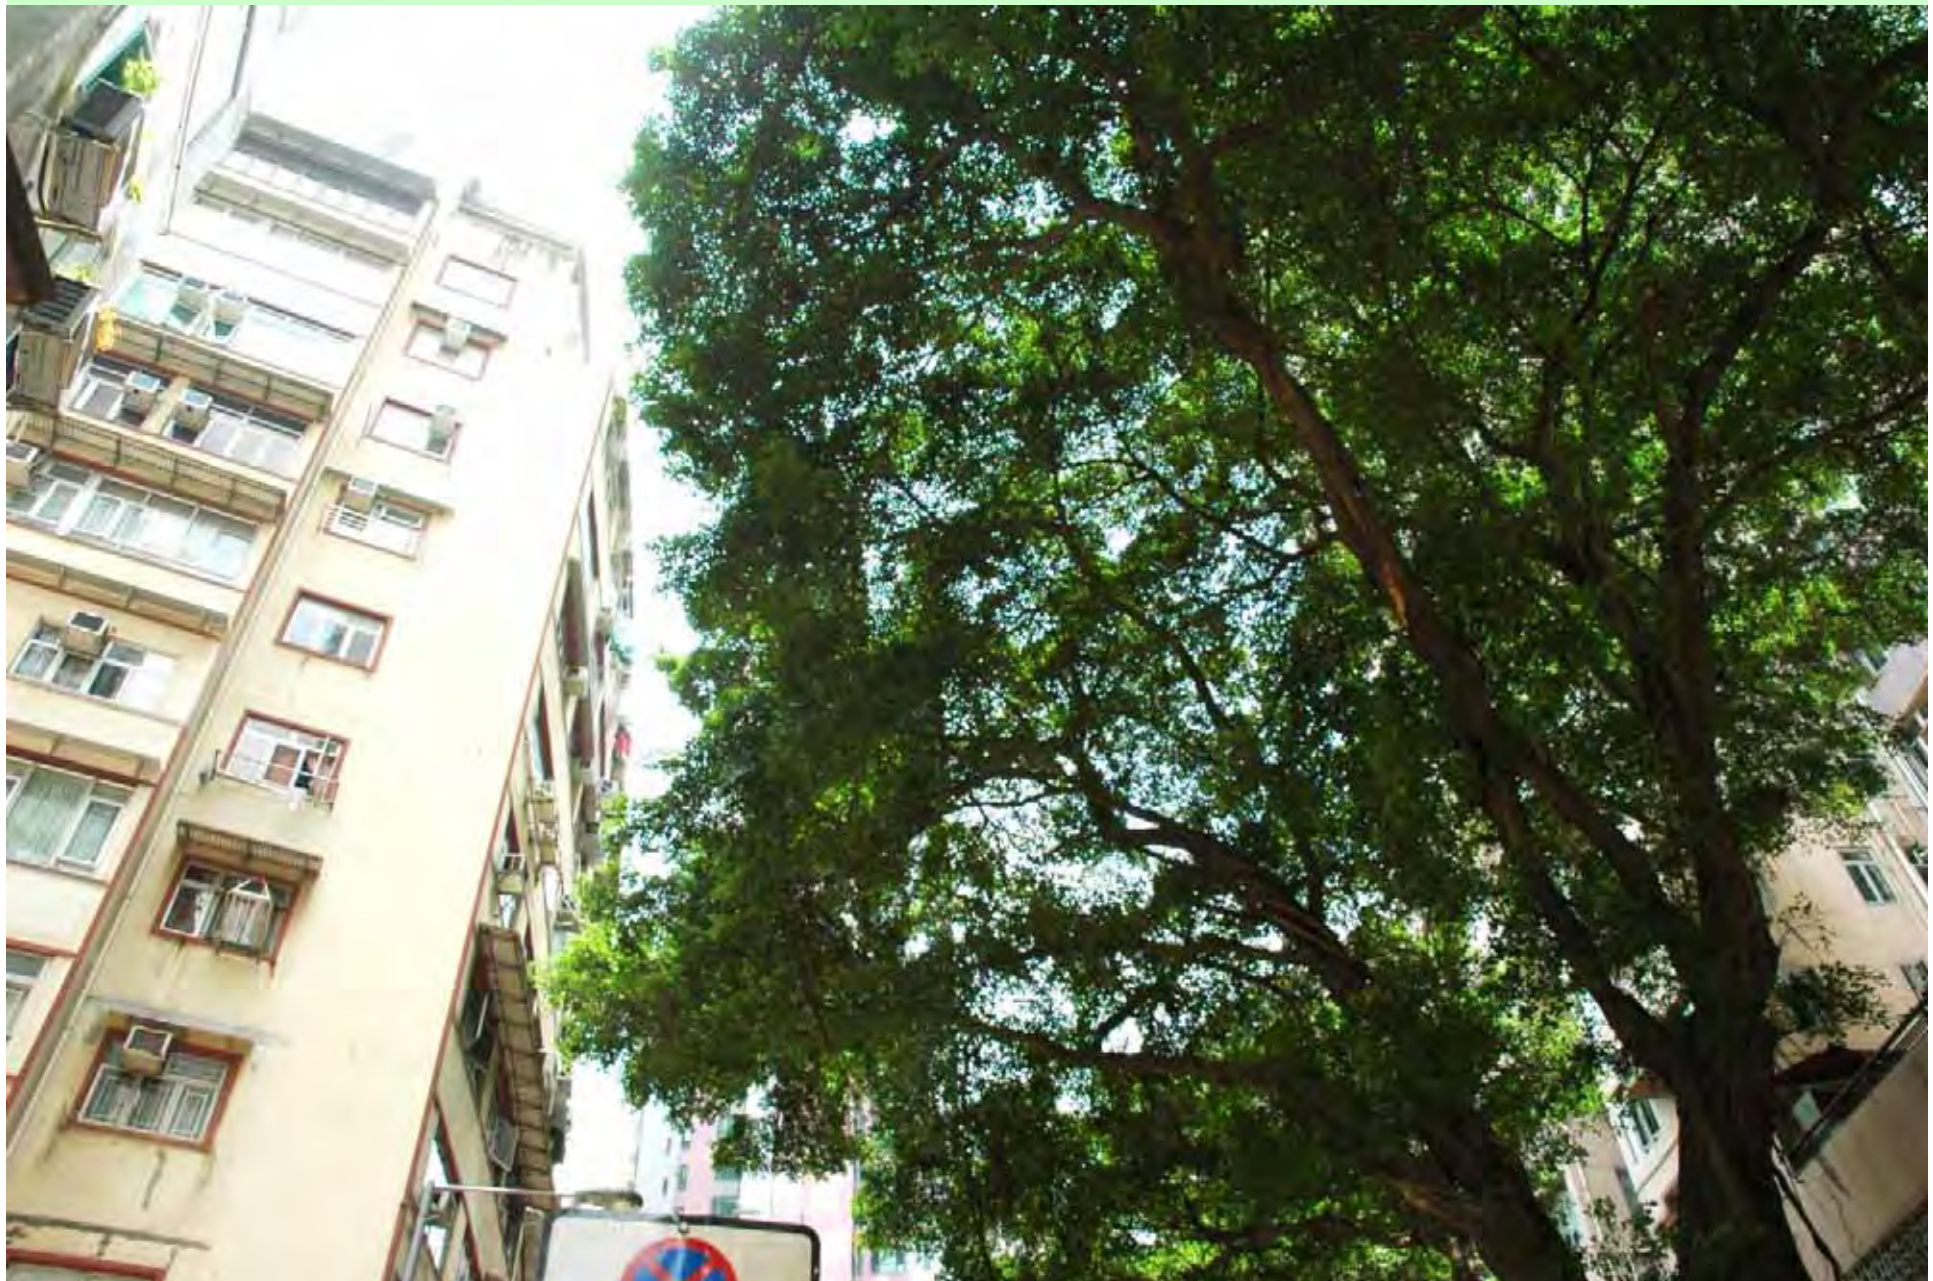
Photo T2-28. The east part of the crown also extends northwards across Bonham Road to approach the opposite building.

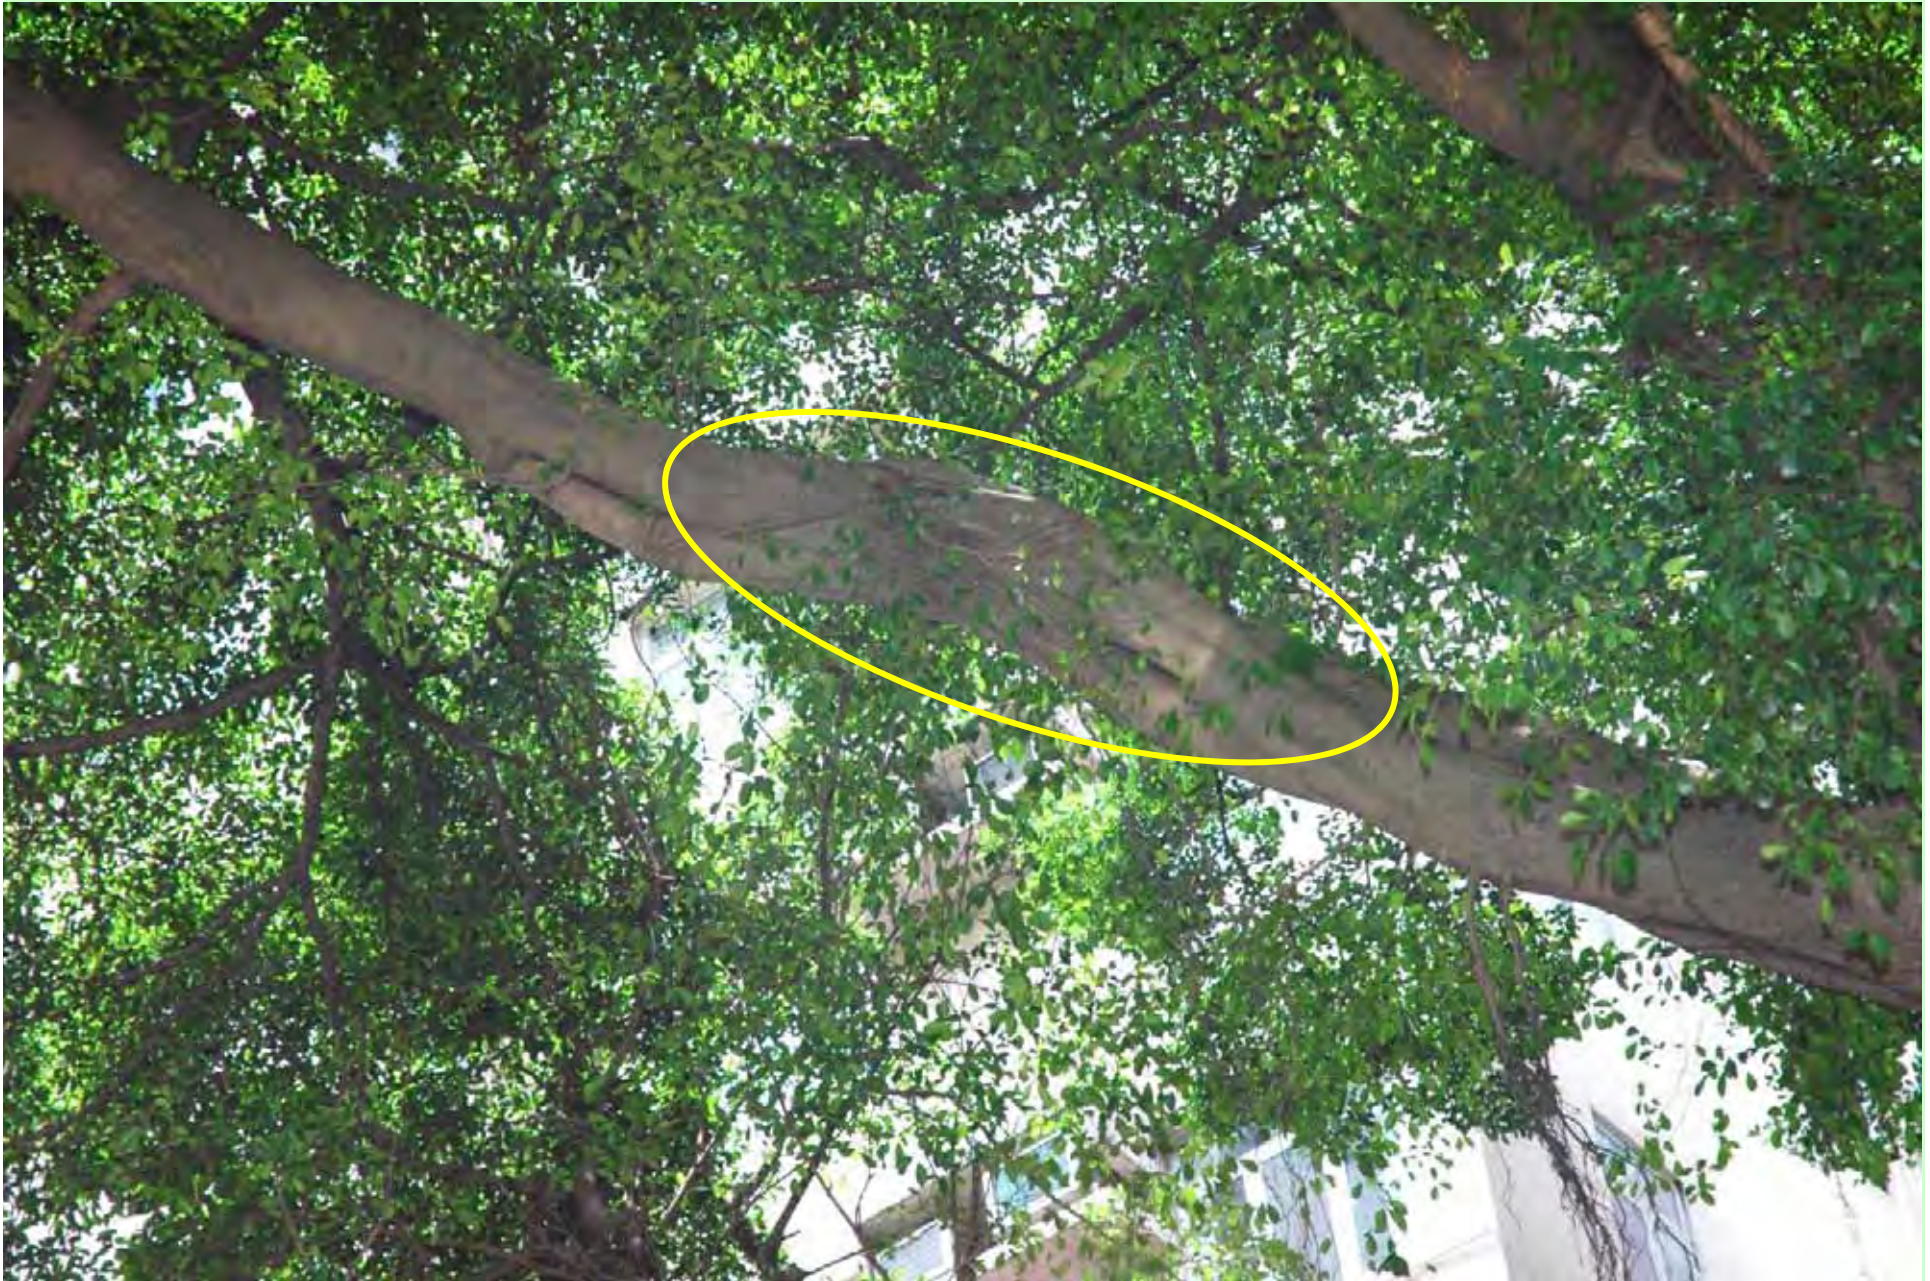
Photo T2-34. Stem A1 branch with a somewhat crooked section.

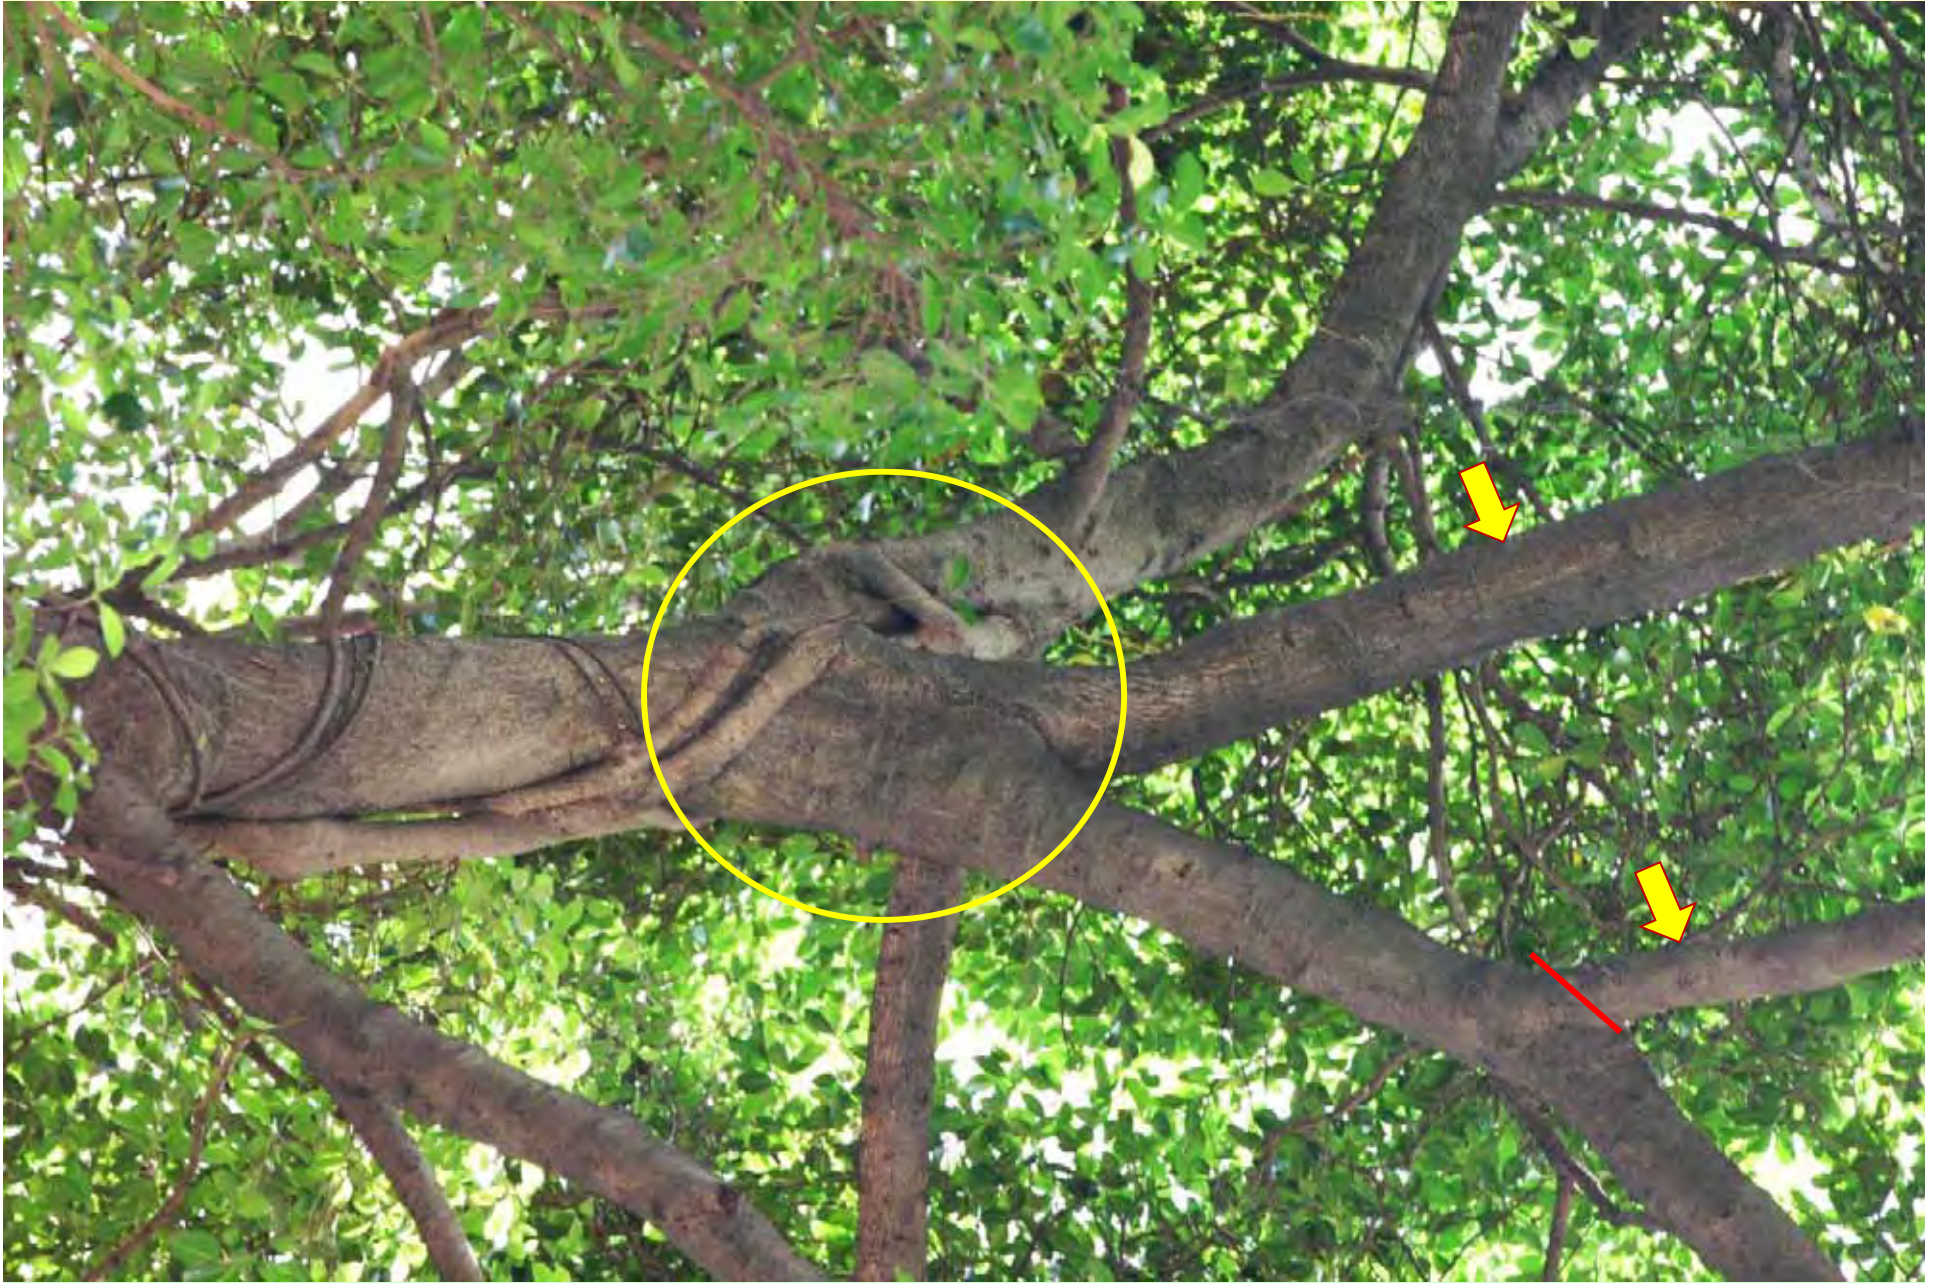
Photo T2-39. Stem B with crowded (circle) and parallel (arrows) branches.

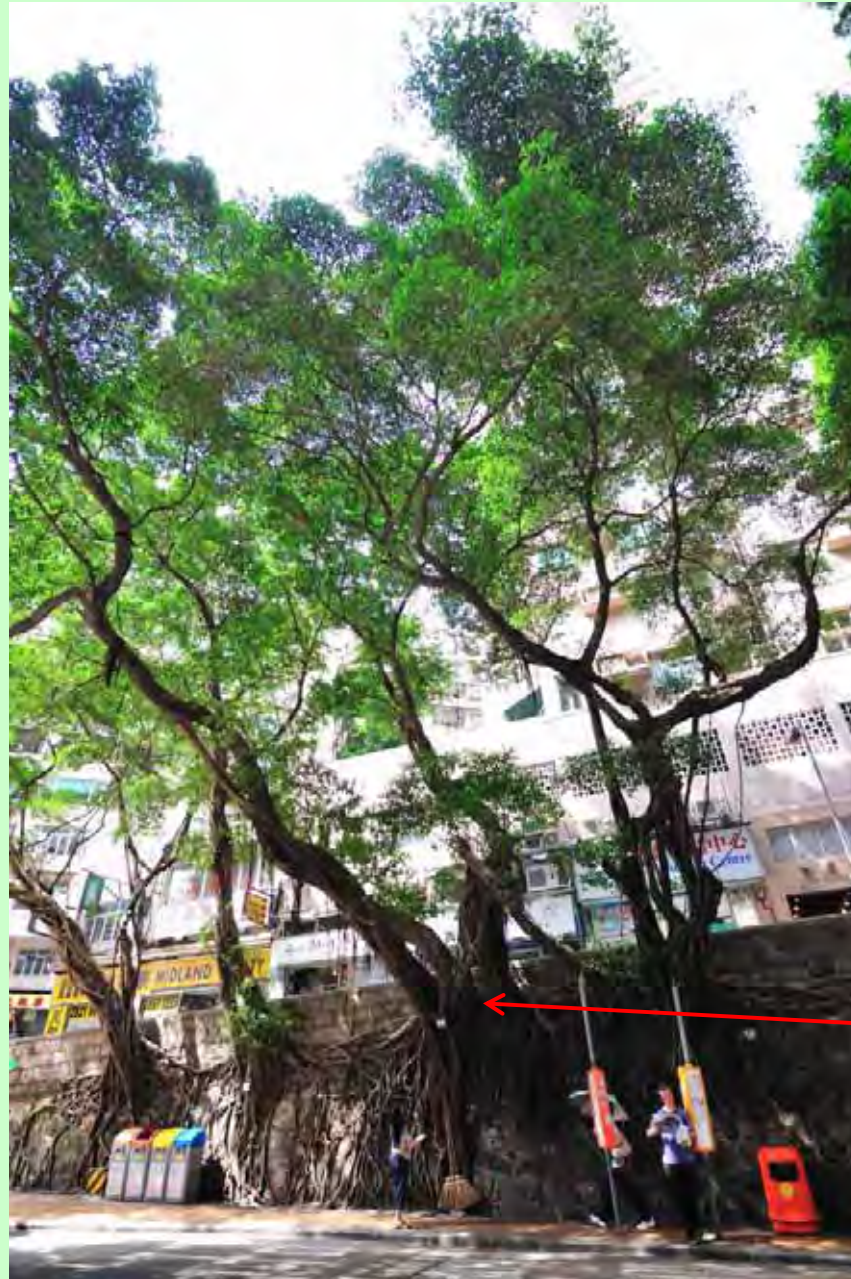
Photo T4-2. The twin-stem tree viewed from Bonham Road.

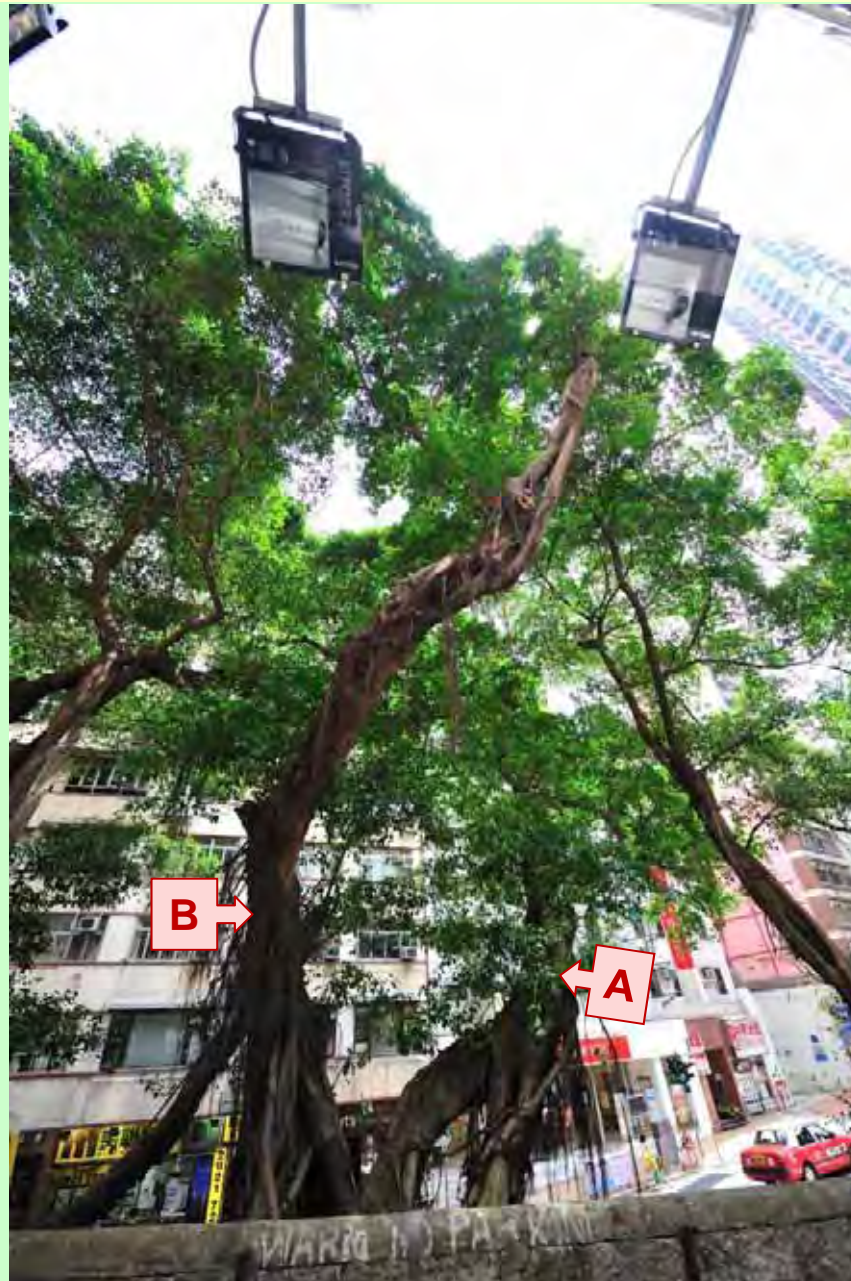
Photo T4-4. The twin-stem tree viewed from St Stephen's Lane.

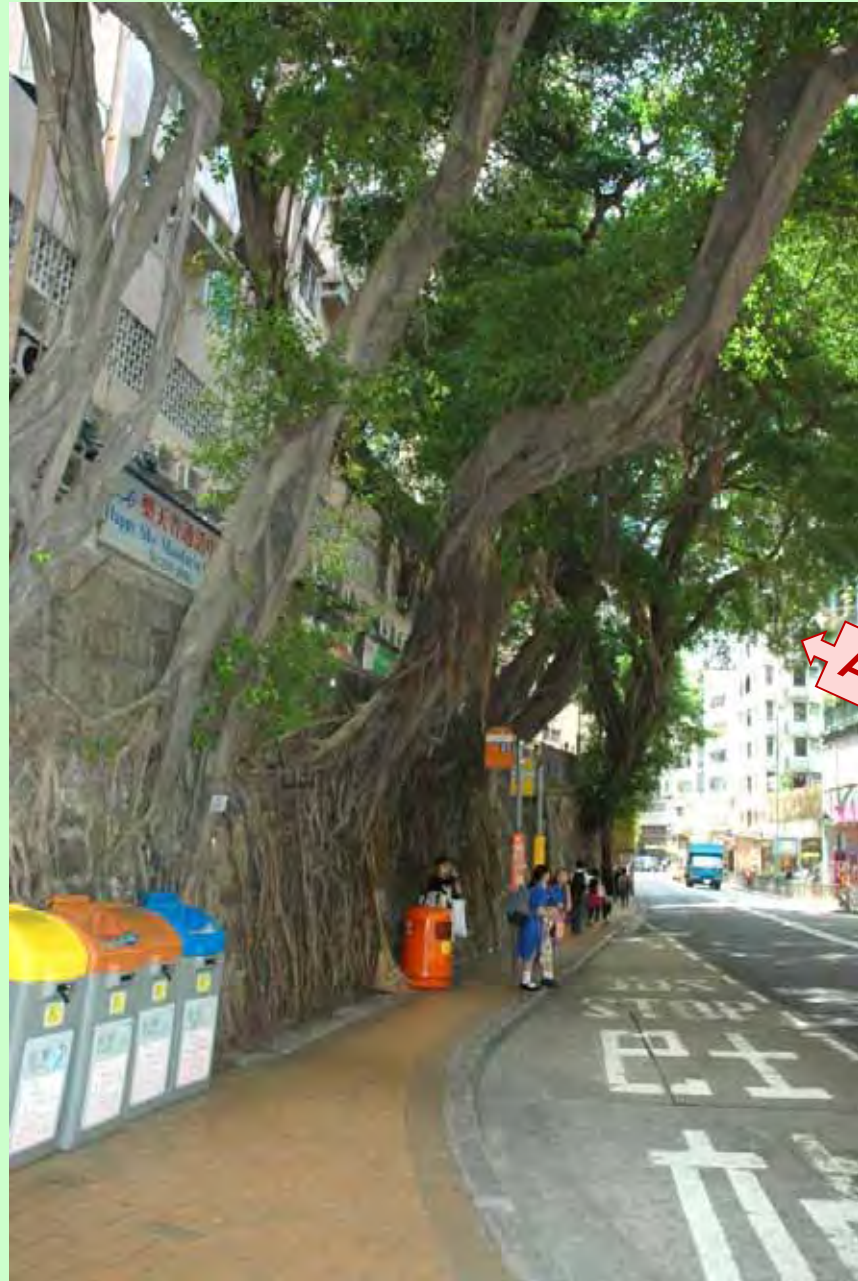
Photo T4-25. Meandering shape of the lower section of Stem A.
